Senior Project:

The Leading Contributor of the Fukushima Daiichi Nuclear Power Plant Accident

Christopher Torres

06.04.2012

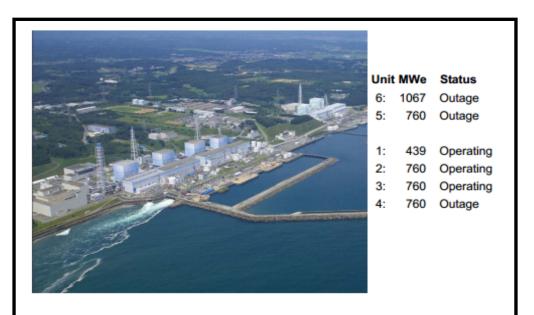
Three of the six reactor units at Fukushima Daiichi Nuclear Power Plant were operating at the time—units 1, 2, and 3 (Figure 1). These three units automatically "scrammed" right after the earthquake hit onshore; a process that allows a set of control rods to be inserted into the reactor core to suppress nuclear fission. Once the process was completed, the reactors were no longer generating electricity, an alternative electricity supply is required in order to operate the emergency cooling system since highly radioactive material still continues to decay and produce heat after a shutdown. The earthquake managed to destroy all six external power lines from Japan's grid to the plant. Fortunately, the emergency diesel generator began operating and enough electricity was provided to cool unit 2 and 3. For reasons that are not yet known, Unit 1 unexpectedly dropped in temperature and pressure. In order to avoid damage to the reactor and in maintaining with the plant's operating procedure, the operators repeatedly turned on and off the emergency cooling to slow the rate of cooling.

Figure 1: An image of Fukushima Daichii Nuclear Power Plant and the status of the six boiling water reactors before the accident.

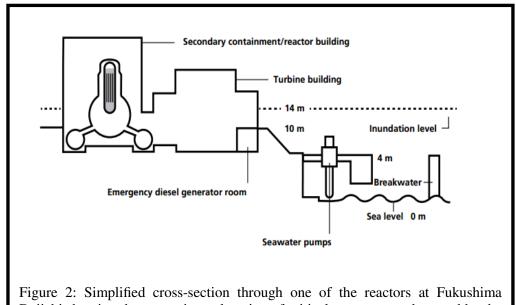
The seawater pump and their motors, known as the ultimate heat sink, are responsible for transferring heat extracted from the reactor cores to the ocean and for cooling most of the emergency diesel generators. These seawater pumps were located four meters above sea level (Figure 2). They were heavily damaged and became unfeasible after the tsunami hit Fukushima Daiichi.

Daiichi showing the approximate location of critical components damaged by the tsunami. Not drawn to scale.

The seawater pumps and their motors, known as the ultimate heat sink, were located at sea-level outside the Fukushima Daiichi Nuclear Power Plant. After the tsunami arrived, these pumps were flooded and completely destroyed. It became unfeasible to extract and transfer heat to the ocean from the reactor cores and emergency diesel generators. Even if electricity had been available to operate the emergency cooling systems, there would have been no way of dissipating the heat and the engine would have overheated. The protection of these seawater pumps should have been enhanced and/or constructed a backup means to dissipate heat.
