PRELIMINARY REPORT ON DECEMBER 22, 2003 SAN SIMEON EARTHQUAKE

Rakesh K. Goel, M.EERI

Department of Civil & Environmental Engineering,
California Polytechnic State University, San Luis Obispo, CA 93407rgoel@calpoly.edu

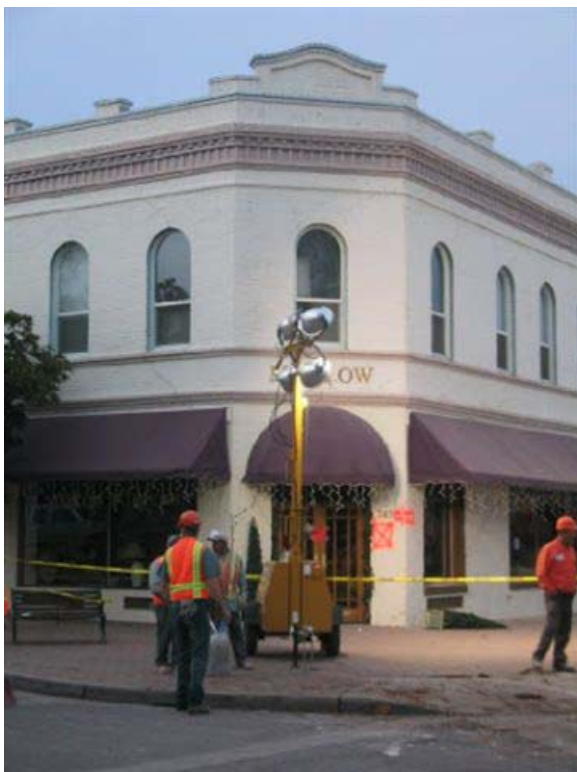
Located on the corner of 12th and Park Streets, the south and east elevations of this two-story building – the two sides facing the streets – have large window openings in the first story and some windows in the second story (Figure 9). The other two sides, which face away from the streets, have only a few window openings in the second story and solid wall in the first story without openings. This configuration led to significant eccentricity between the center of mass and center of rigidity. The damage pattern described next for this building is consistent with that expected due to torsion.

Figure 9. Marlow Interior building located at the corner of 12th and Park Streets in downtown Paso Robles (Picture by Josh Marrow).

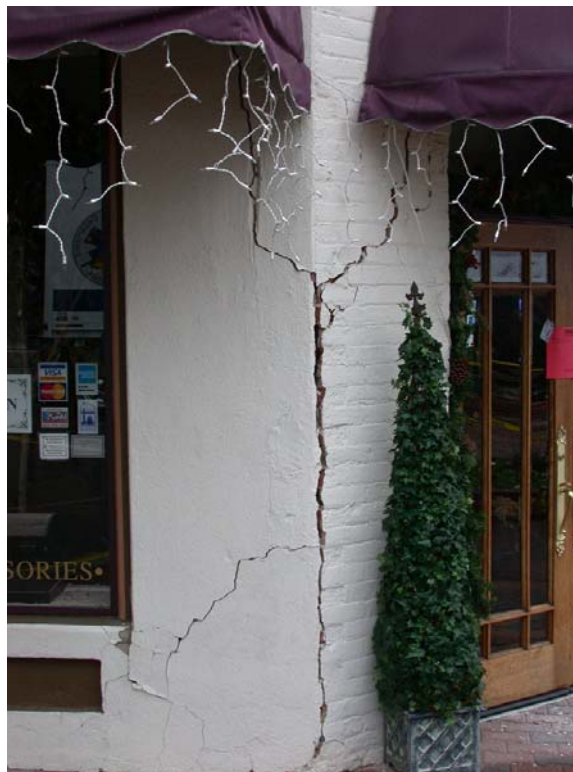
This building suffered major structural damage and was red-tagged after the earthquake. Large cracks appeared on the south-east corner – the corner farthest away from the center of rigidity – of the building (Figure 10). Apparently, this corner experienced large drifts due to torsion of the building during the earthquake. Significant diagonal shear cracks appeared in the first story wall on the east as well as the south sides; both these sides of the building face the streets (Figure 11). This appears to be consistent with the expected large drifts in this wall of the first story. Much less cracking is visible in the second story wall (Figure 12). Drifts are expected to be much smaller in this wall of the second story because of much fewer openings compared to the first story. No cracks were visible in the north and west walls of the building.

Figure 10. Large cracks at the corner of the Marlow Interior building (Picture by Sam Vigil).

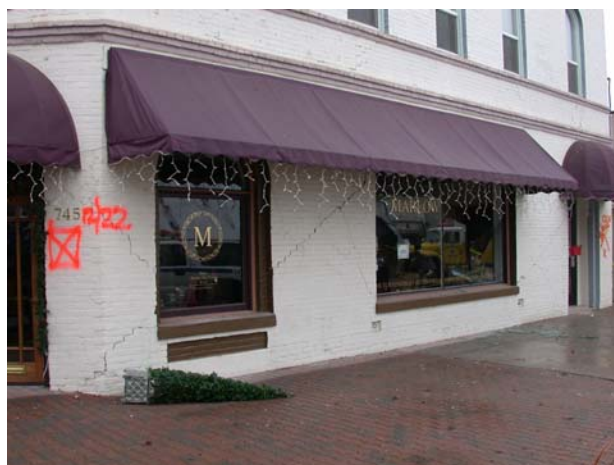
Figure 11. Crack pattern in the first story of the Marlow Interior building on the Park Street face (Picture by Sam Vigil).

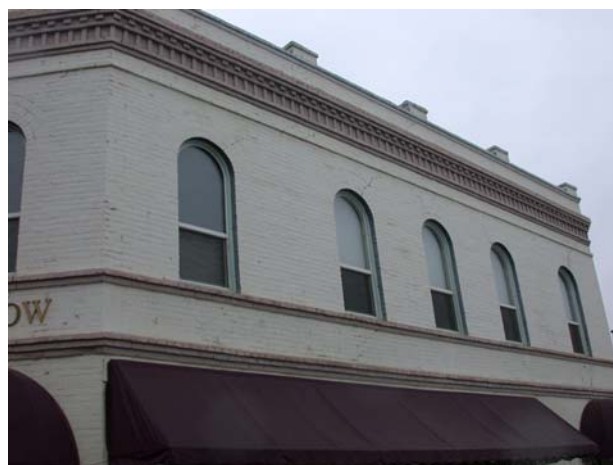
Figure 12. Crack pattern in the second story of the Marlow Interior building on the Park Street face (Picture by Sam Vigil).

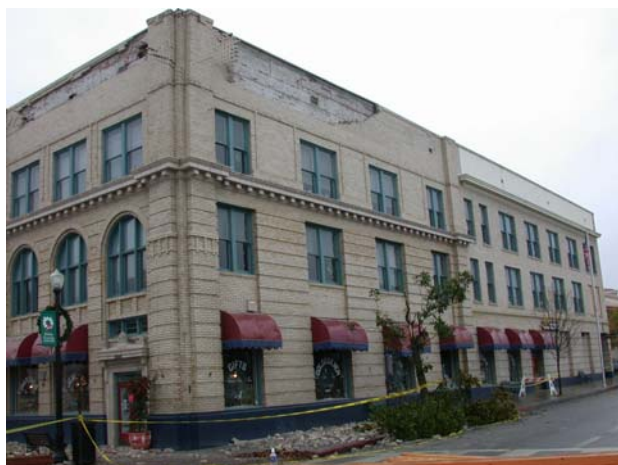
This two story building located on the south-west corner of Park and 13th Streets suffered extensive loss of its cladding. The brick façade peeled off from near the roof level from faces on both the Park and 13th Street. It appears that the brick façade was attached to the wall with cement mortar. No ties were noticeable on the open face of the building or the rubble below. The other external structural damage appears to be minimal in this building.

Figure 13. Peeling of the brick facade in the second story of the Ali's Persian Rug building on the corner of Park and 13th Streets in downtown Paso Robles (Picture by Sam Vigil).

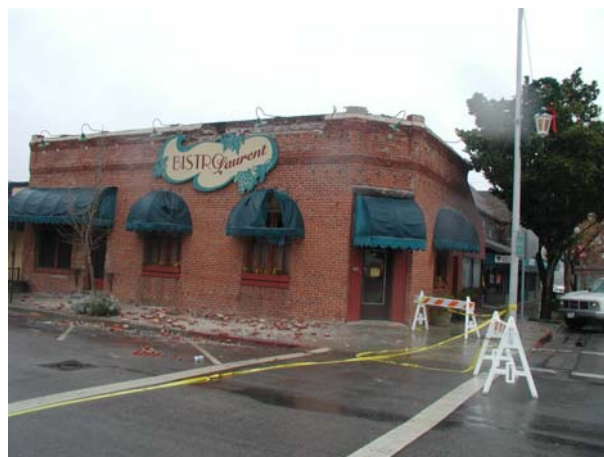
Located on the corner of Pine and 12th Streets, this one-story masonry building suffered minor structural damage (Figure 14). A few bricks separated and fell from the decorative parapet. This masonry building appears to have been retrofitted by tying the roof to the walls. The anchor bolts are clearly visible along the roof-line of this building. Clearly, this basic retrofit scheme appears to have prevented major damage to this building.

Figure 14. Minor peeling of bricks from the decorative parapet of the Bistro Laurent building on the corner of Pine and 12th Streets in downtown Paso Robles (Picture by Rakesh Goel).

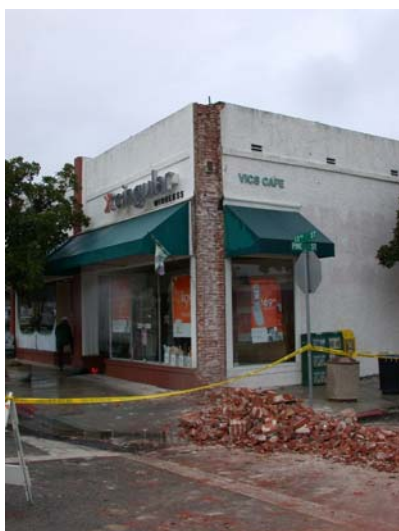
Figure 15. Damage to the Cingular Wireless building on the corner of Pine and 13th Streets in downtown Paso Robles (Picture by Sam Vigil).

Located on the corner of Pine and 13th Streets, this one-story masonry building suffered minor structural damage (Figure 15). The brick façade on the south-west corner of the building separated and fell. This masonry building also appears to have been retrofitted by tying the roof to the walls. The anchor bolts are clearly visible along the roof-line of this building (Figure 16). As noted previously for the Bistro Laurent building, this basic retrofit scheme appears to have prevented major damage to this building.

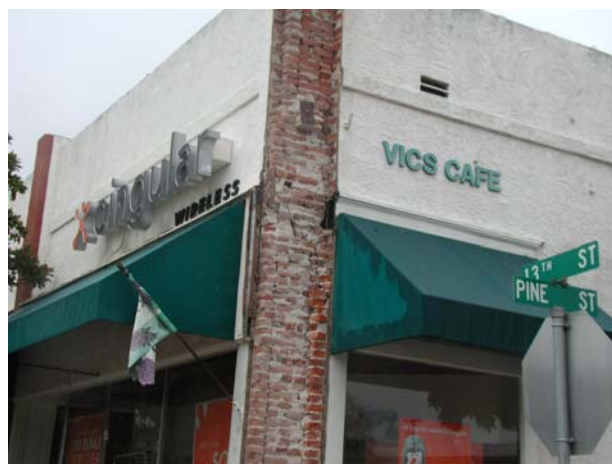
Figure 16. A close-up view of the seismic retrofit anchors in the Cingular Wireless building (Picture by Rakesh Goel).

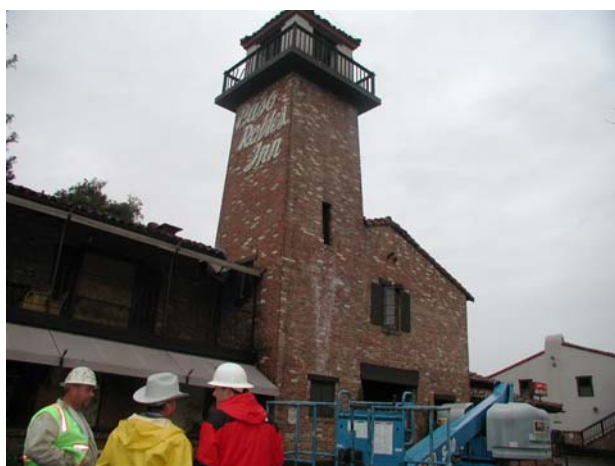
Paso Robles Inn is located a short distance south-east of the historic downtown district. This Inn consists of a main restaurant with a three-story tall observation tower and several two-story buildings that house the guest quarters. The observation tower consists of a frame supporting the brick façade. Very little damage was noticeable in the observation tower (Figure 17). The attached restaurant suffered moderate nonstructural damage: a few clay roof tiles came loose and a glass broke in a few windows in the first and second stories (Figure 18).

Figure 17. Observation tower of the Paso Robles Inn on Spring Street in Paso Robles (Picture by Rakesh Goel).

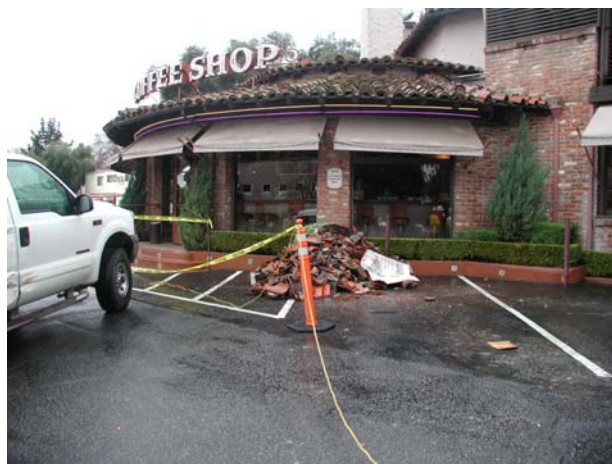
Figure 18. Loss of windows and roof tile in restaurant of the Paso Robles Inn (Picture by Rakesh Goel).

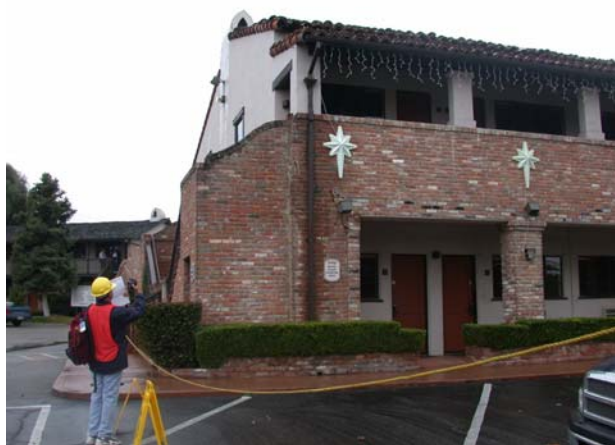
Figure 19. Two-story guest quarter building at the Paso Robles Inn (Picture by Sam Vigil).

The two-story brick building housing the guest quarters in the front of the Paso Robles Inn (Figure 19) suffered significant cracking in the masonry walls (Figure 20). This portion of the Inn was closed. Other parts of the Inn were open for business as the damage was minor and mostly non-structural in nature.

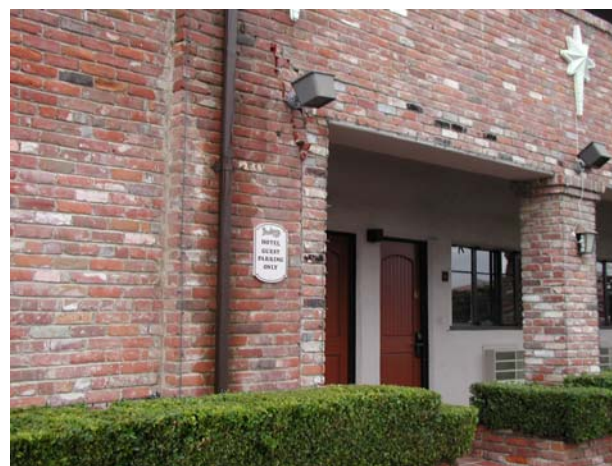
Figure 20. Cracks in the brick walls of the guest quarter building at the Paso Robles Inn (Picture by Rakesh Goel).

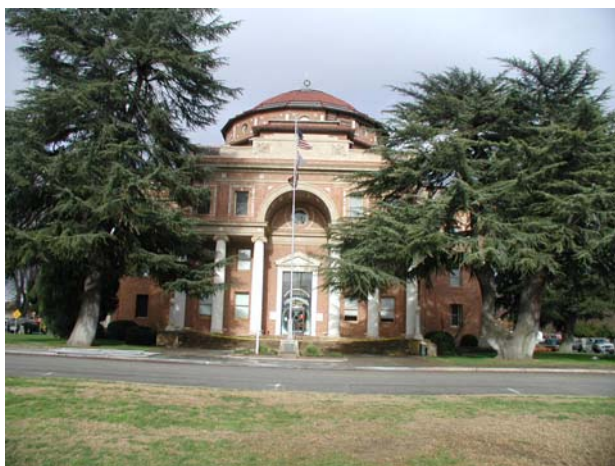
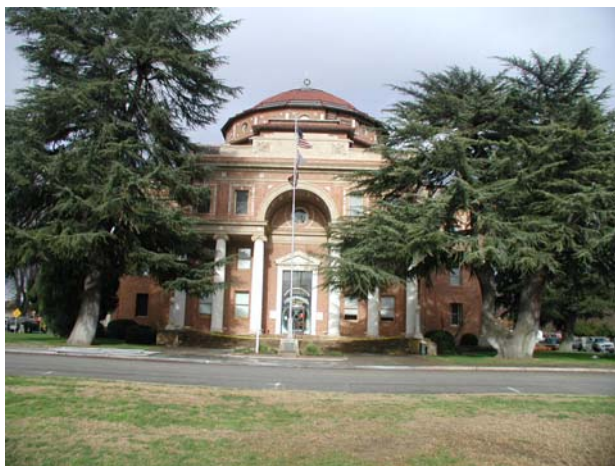
Built in 1918, the Atascadero City Hall (Figure 21) is located about 63 km (39 mile) from the epicenter. Discussion with the city engineer indicated that the structure consists of reinforced concrete space frame with brick façade. The exterior damage primarily consisted of cracks and severe spalling of the brick façade on the rotunda (Figure 22). Falling bricks from the façade took out a sky-light and fell on the tables of a room located at the rotunda office level. No one was injured because this room was unoccupied at the time of the earthquake. The reinforced concrete space frame supporting the dome roof was found to have suffered no damage.

Figure 21. Atascadero City Hall (Picture by Rakesh Goel).

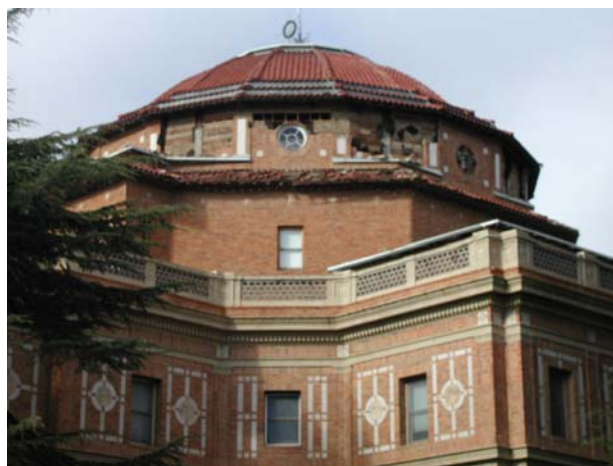
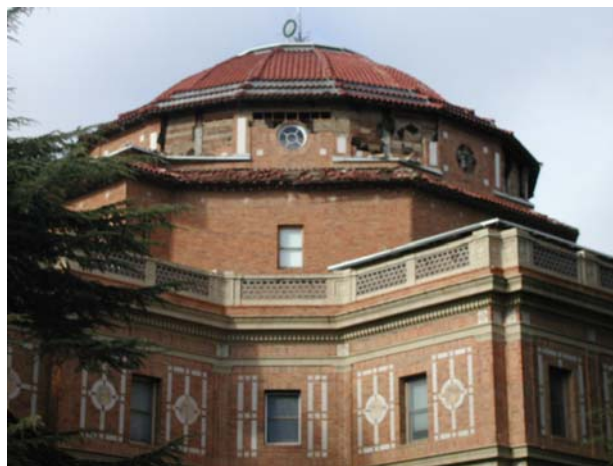
Figure 22. Peeling of brick façade from the rotunda of the Atascadero City Hall (Picture by Rakesh Goel).

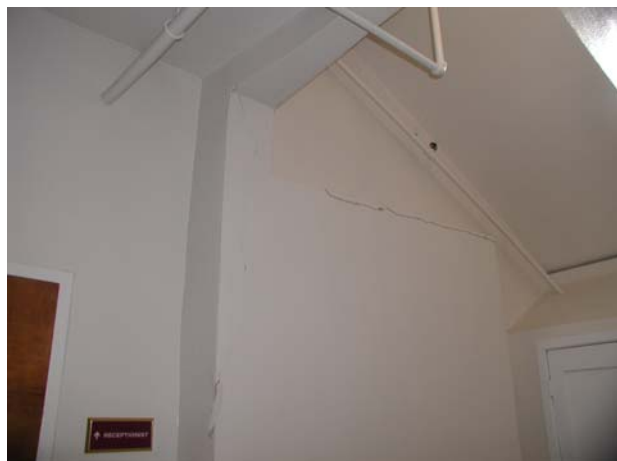
Internal damage consists of severe cracks in the walls and plaster throughout the building (Figure 23). The damage was more severe in the first story. Rotunda office where the city council meets experienced spalling of plaster from the roof and the ring beam (Figure 24). Closets in the kitchen outside the city council chambers at the rotunda level opened and spilled their contents during the earthquake (Figure 25). Contents of the display cases in the lobby were tossed around during the earthquake. Several glass display pieces fell to the ground and broke (Figure 26).

Figure 23. Typical cracks in the walls of Atascadero City Hall (Picture by Rakesh Goel).

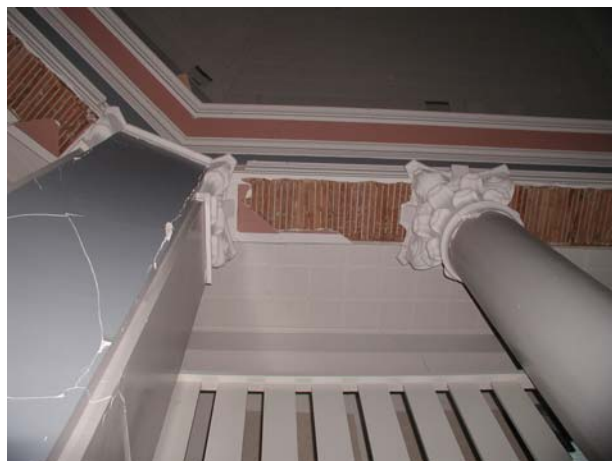
Figure 24. Peeling of plaster from ring beam of the rotunda of the Atascadero City Hall (Picture by Rakesh Goel).

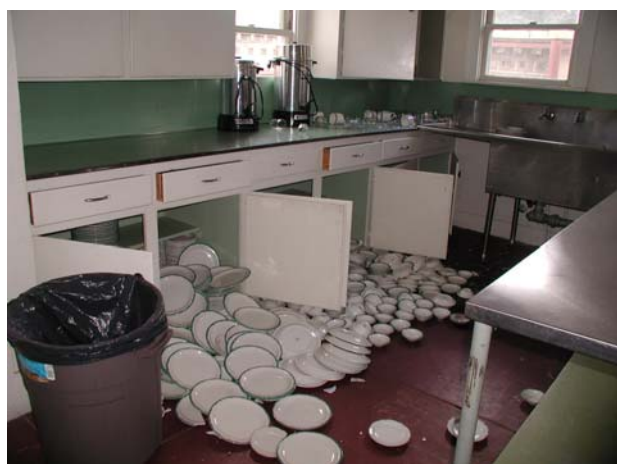
Figure 25. Damage in the kitchen of Atascadero City Hall (Picture by Rakesh Goel).

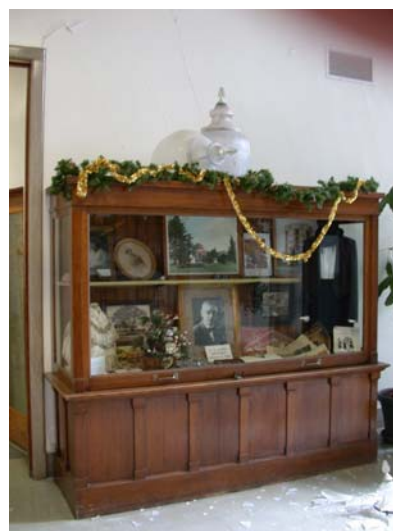
Figure 24. Damage in the lobby of the Atascadero City Hall (Picture by Sam Vigil).

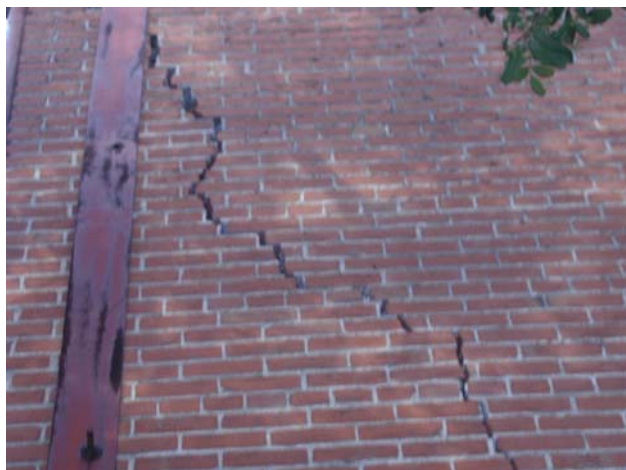
Ah Louis Store (Figure 25), a two-story unreinforced masonry building located on the corner of Palm and Chorro Streets, is designated as a historic landmark in the city. No noticeable change in cracks on the south-west wall, which has been retrofitted, was observed after the earthquake (Figure 26). However, new cracks appeared on the north-east wall of the building

Figure 26. Cracks existing prior to the earthquake and attempt to retrofit on the south-west wall of the Ah Louis Store building (Picture by Rakesh Goel).

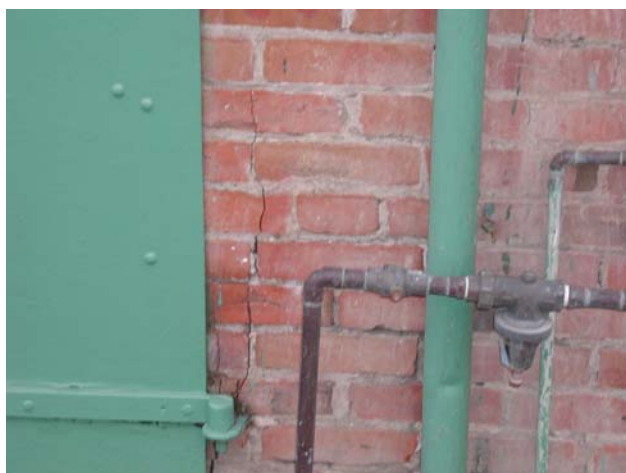
(Figure 27). The building was temporarily closed for inspection and subsequently cleared for occupancy.

Figure 27. New cracks on north-east wall of the Ah Louis Store building (Picture by Rakesh Goel).

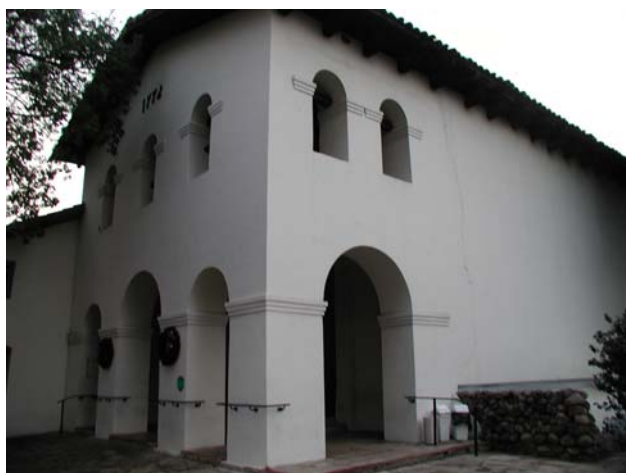
Several vulnerable buildings in San Luis Obispo are located on the campus of the Mission San Luis Obispo de Tolosa. This adobe structure survived the earthquake without damage. The only noticeable damage was widening of existing hair-line cracks at the junction of the Bell-Tower building and the adjacent building (Figure 28). The mission was open for business in the afternoon of December 22, 2003.

Figure 28. Widening of cracks at junction of the bell tower and adjacent building in the Mission San Luis Obispo de Tolosa in downtown San Luis Obispo (Picture by Rakesh Goel).
