PRELIMINARY REPORT ON SEPTEMBER 28, 2004 PARKFIELD EARTHQUAKE

Rakesh K. Goel, M.EERI and Charles B. Chadwell, M. EERI
Department of Civil & Environmental Engineering,
California Polytechnic State University, San Luis Obispo, CA 93407
Email: rgoel@calpoly.edu, chadwell@calpoly.edu

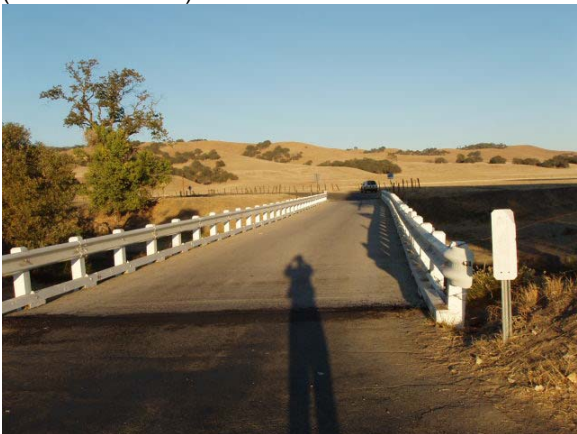
The second bridge investigated is located at the intersection of Cholame Road and Parkfield-Coalinga Road (Figure 8) in Parkfield and crosses the San Andreas Fault (Figure 21). This bridge had apparently undergone a recent retrofit and performed adequately. The minor distress to the bridge included roughly 4 cm separation between the approach slab and the bridge deck, which was filled up quickly by the bridge maintenance crew (Figure 22). Below the deck level, the concrete bent caps had minor shear cracking through the knee joints (Figure 23 and 24) as well as evidence of the flexural cracking at the top of the pile extension (Figure 25). The pile extensions at the ground level also exhibited noticeable movement (Figure 26). In addition, there was evidence of recent motion (approximately 4 cm) in the bridge bearings supporting the superstructure. Angle iron apparently installed in an effort to restrain transverse motion of the superstructure at the bearings was knocked free (Figures 27 and 28).

Figure 21. Bridge crossing the San Andreas Fault (Photo: Goel).

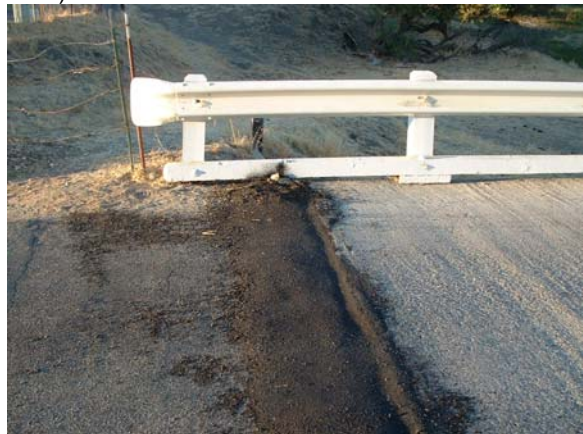
Local bridges showed minor to no damage and were open with immediate occupancy post event. The bridge located at the intersection of Cholame Road and Parkfield-Coalinga Road (Figure 8) in Parkfield, which crosses the San Andreas Fault, did show approximately 4 cm of separation between the approach slab and abutments that was quickly filled with asphalt by the bridge maintenance crew.

Figure 22. Separation between the approach slab and the bridge deck (Photo: Chadwell).

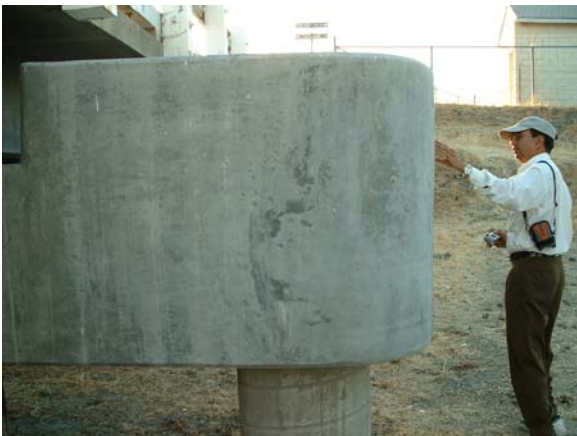
Figure 23. Knee-joint of the bent cap (Photo: Chadwell).

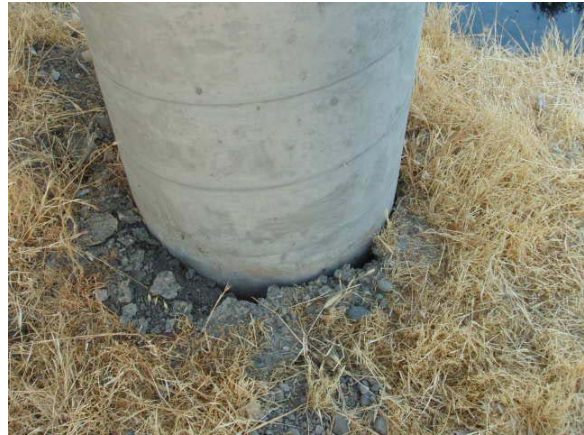
Figure 26. Movement of the pile extensions at the ground level (Photo: Goel).

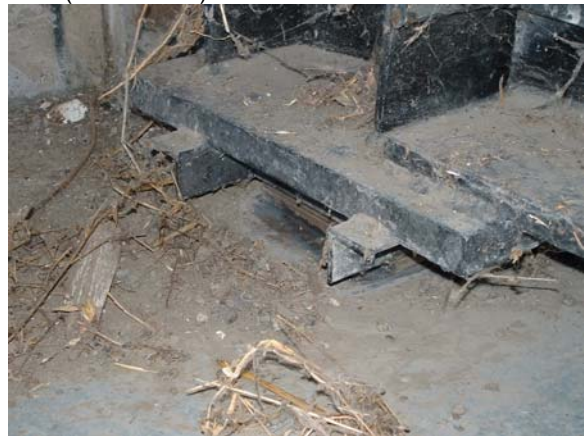
Figure 28. Movement at the bridge bearing (Photo: Chadwell).
