STRUCTURAL RECONNAISSANCE FINDINGS OF
THE 2017 MEXICO CITY EARTHQUAKE

BY
RACHEL G. CHANDLER

SENIOR PROJECT REPORT

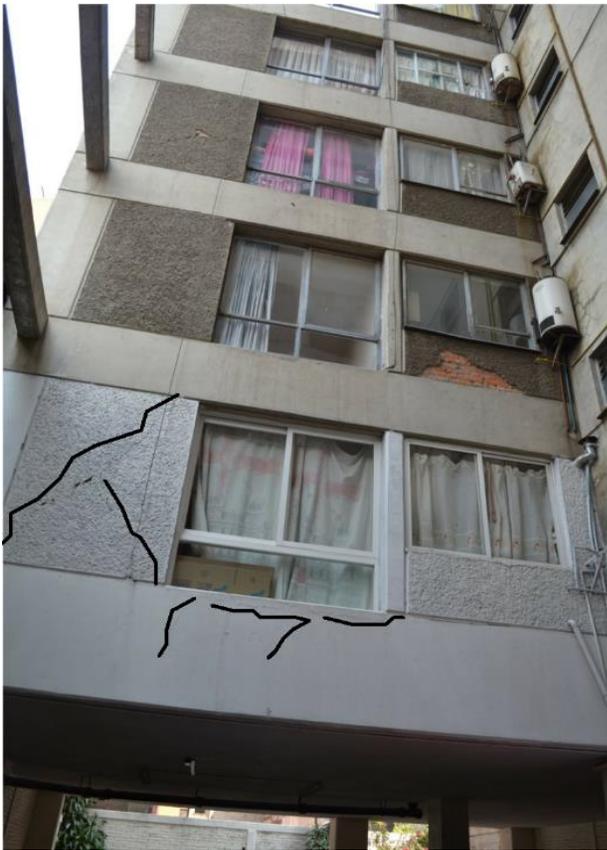
The damage after the 2017 earthquake was, like the 1985 earthquake, concentrated primarily in the masonry walls on all levels. The unreinforced masonry saw moderate shear cracking and spalling, shown in Figure 15. There was no pounding damage with adjacent buildings. The frame of the structure appeared to have a ductile response based on the numerous flexural cracks in all first-floor columns shown in Figure 16. Through their exterior evaluation of the building, the reconnaissance team noted that the foundation had experienced uplift seen in Figure 17. Due to movement of the exterior masonry walls perpendicular to the reinforced concrete frame on line A, columns experienced significant cracking from the rocking motion of the building. Repeated rocking of the building – uplift and impact with the ground – resulted in significant cracking to the concrete columns. Specifically, there were flexural cracks at the top and bottom of N-S faces of columns indicative of plastic hinging. On the E-W faces there were flexural cracks on N-S faces and tension-shear cracks of columns highlighted in Figure 18 and 19. Further inspection of the columns yielded a typical crack width measurement of 0.30 mm (0.013 in) for columns on lines 2-4. Like in the 1985 earthquake, the N-S direction had a more ductile response due to the continuous walls on lines A and C in Figure 12.

Figure 15: Shear Cracks through Masonry Infill Walls and Beam

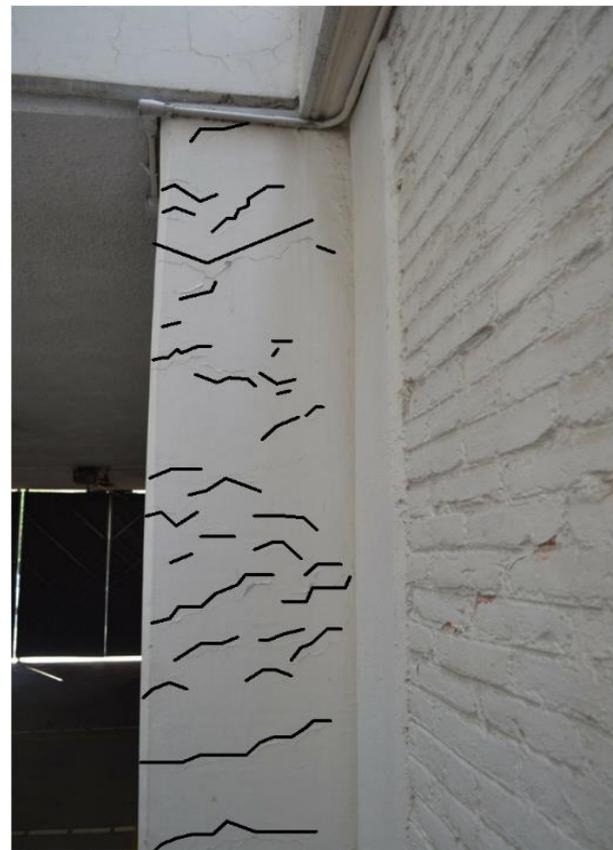
Figure 16: Column Damage Seen on Line 5 in Figure 12

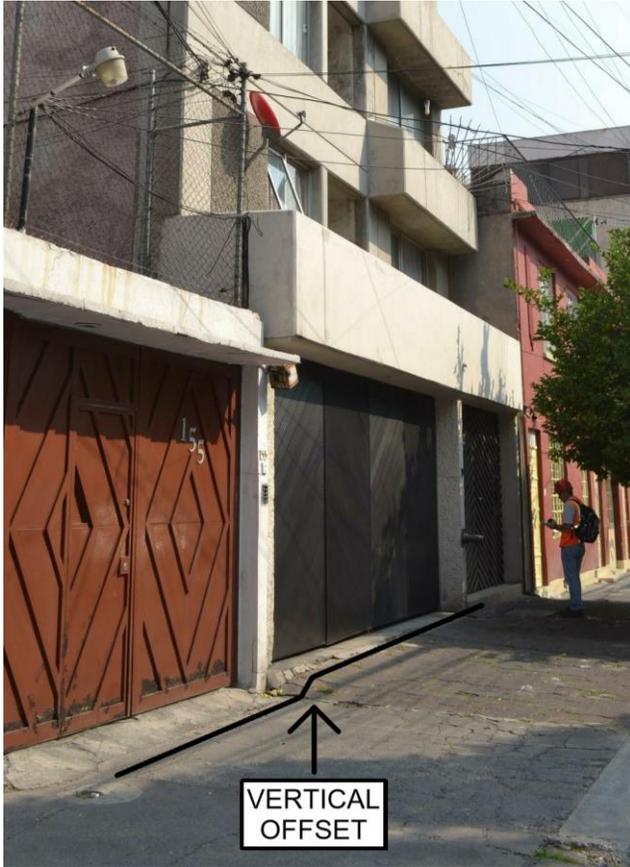
Figure 17: Vertical Offset of Foundation

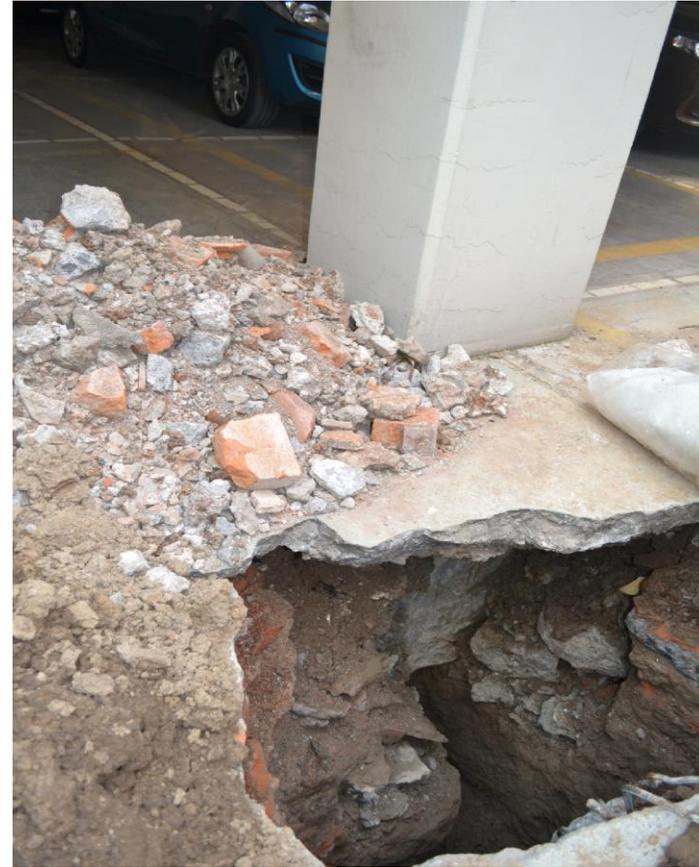
Figure 18: Exposed Foundation Damage

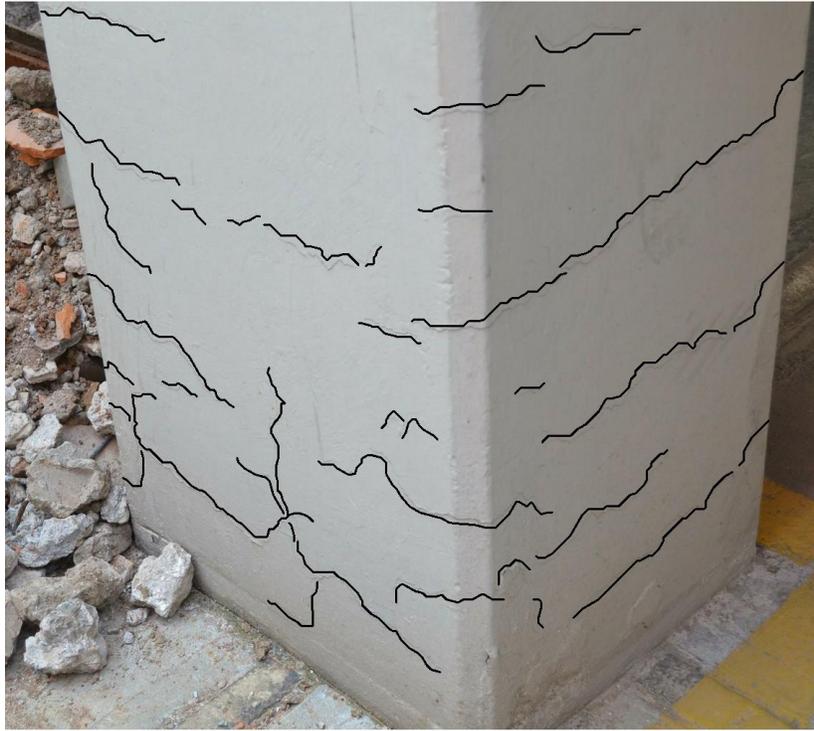
Figure 19: Column Damage Seen on Lines 2, 3, and 4 in Figure 12

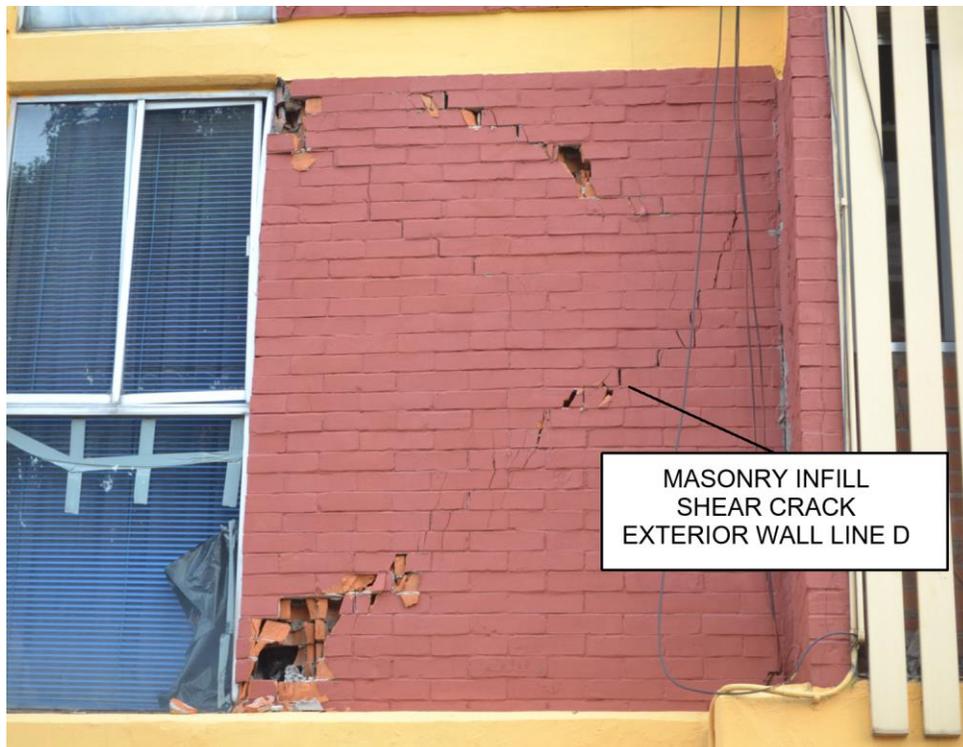
The damage after the 2017 earthquake was concentrated primarily in the masonry walls on all levels as highlighted in Figure 25 and 26. There was no pounding damage with adjacent buildings that could be observed. The deep spandrel beams experienced spalling of concrete and the rebar was exposed as shown in Figure 27. In addition, the frame of the structure appeared to have shear cracking damage on the E-W faces of columns at the first-floor level, as seen in Figure 28. There was also shear damage to the columns on the outside frame at floor level 2 as seen in Figure 29. Further inspection of the columns on the first floor yielded a typical crack width measurement of 0.10 mm (0.004 in) for columns on lines 3, 6, and 8. These cracks were thought to have occurred due to the soft story irregularity and insufficient ties within the column. The overall performance of the building was poor. Visual inspection of one of the first-floor apartments led to the cataloging of severe masonry infill damage in the apartment walls as shown in Figure 25 and 26. Severe damage to all masonry walls and shear damage to columns has made the building unfit to occupy for the time being until a retrofit has been performed.

Figure 25: Shear Cracks through Masonry Infill Walls Exterior View

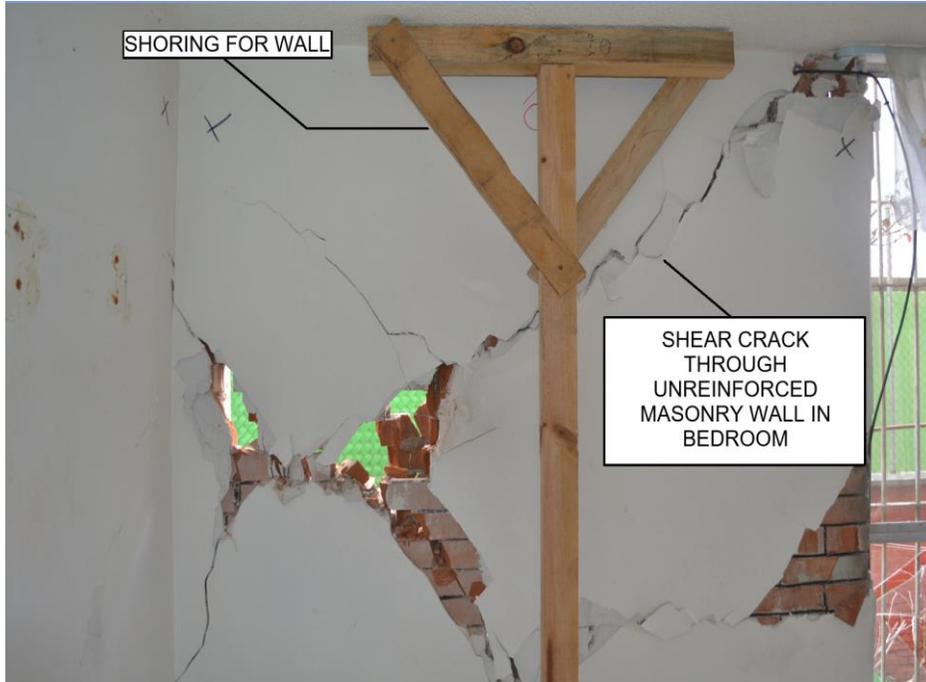
Figure 26: Shear Cracks through Masonry Infill Walls inside Apartment

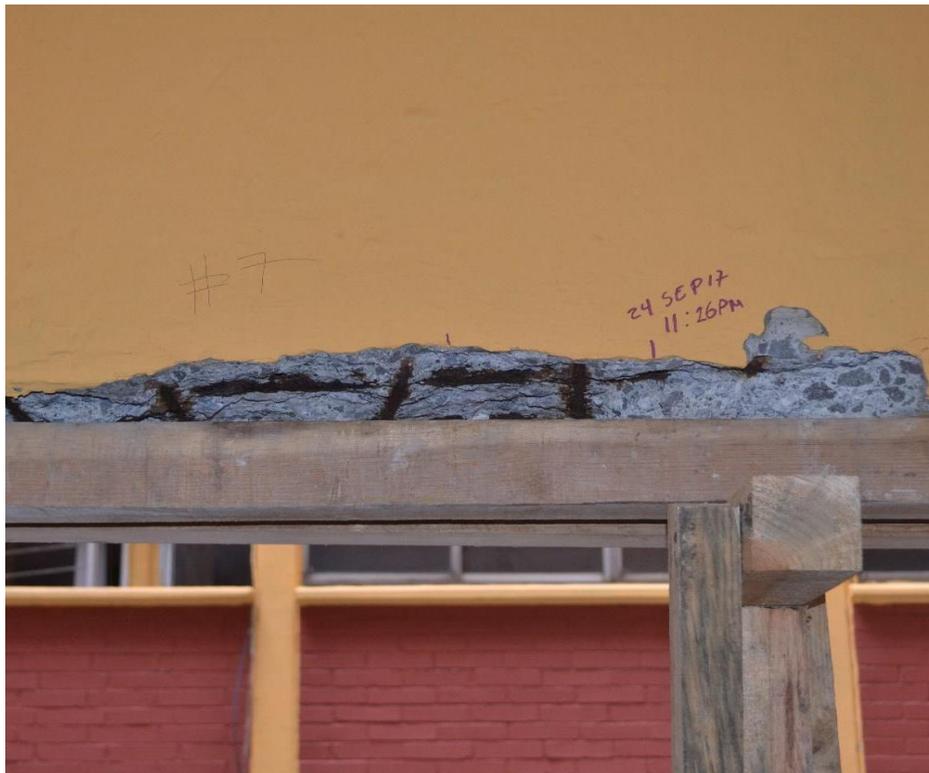
Figure 27: Exposed Rebar from Concrete Spalling in Deep Spandrel Beam (Located on line A in Figure 12)

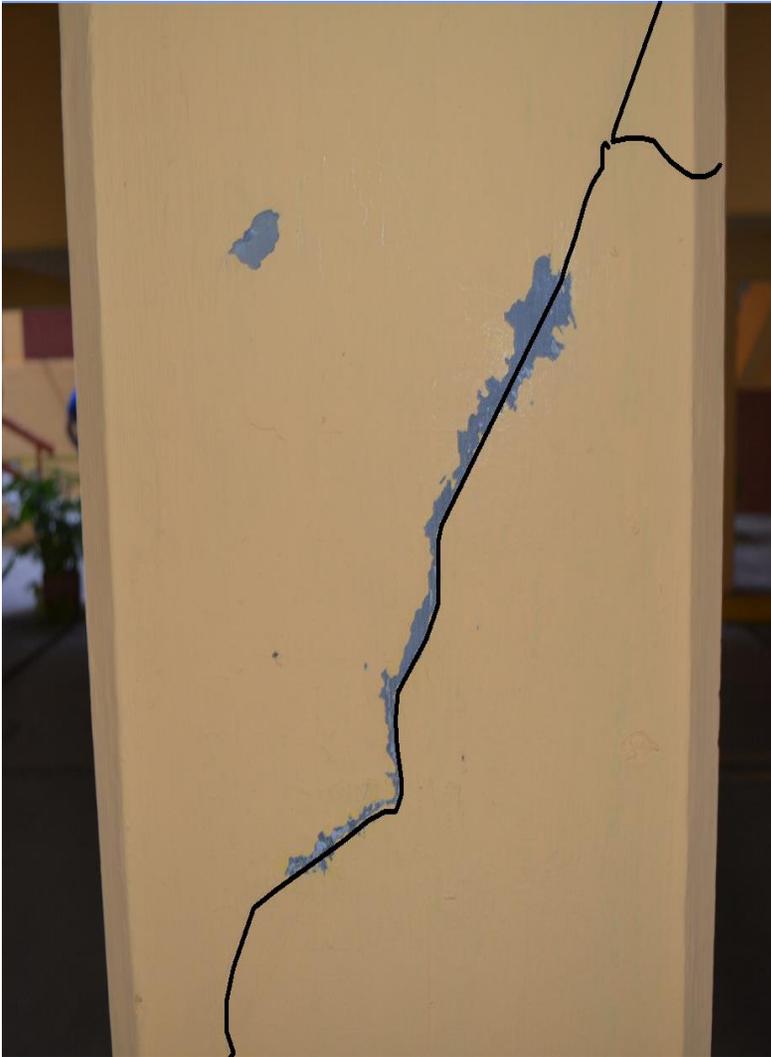
Figure 28: Shear Cracking on First Floor Columns

The team concluded that the overall performance of Rancho de Lorenzo 54 was poor. The nonstructural damage to the masonry infill walls throughout the building was severe. The shear cracks on the columns observed make this building an unsafe structure. The primary lesson learned with Rancho de Lorenzo 54 is that a building with soft story and reentrant corner, can experience severe damage to the structure if not sufficiently designed.

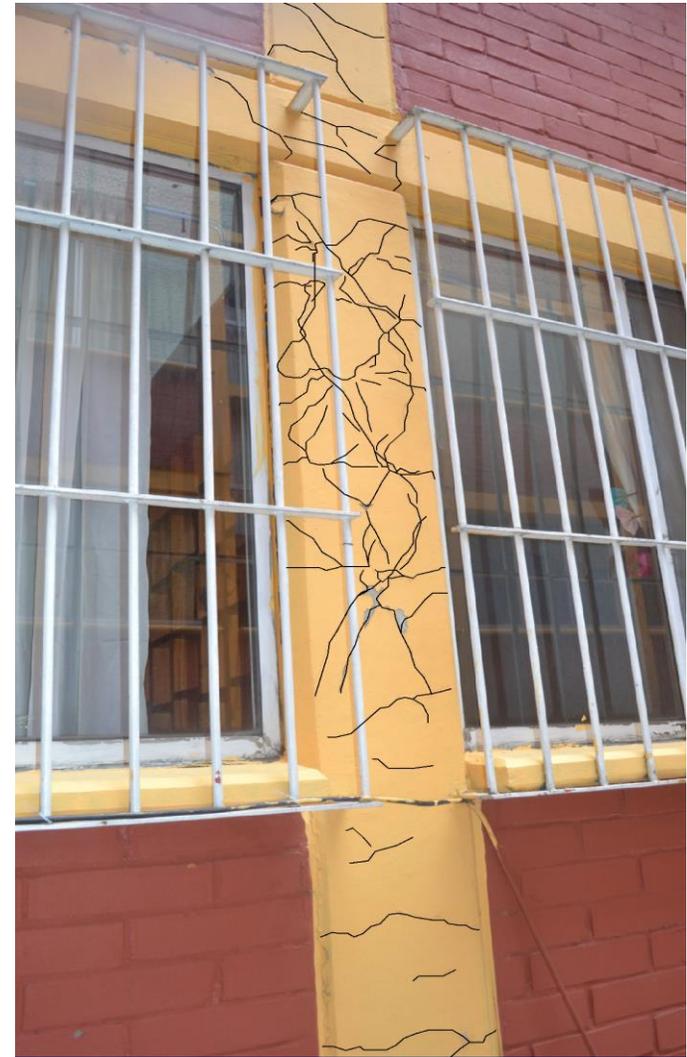
Figure 29: Shear Cracking in Columns (Typical on Exterior Line D)

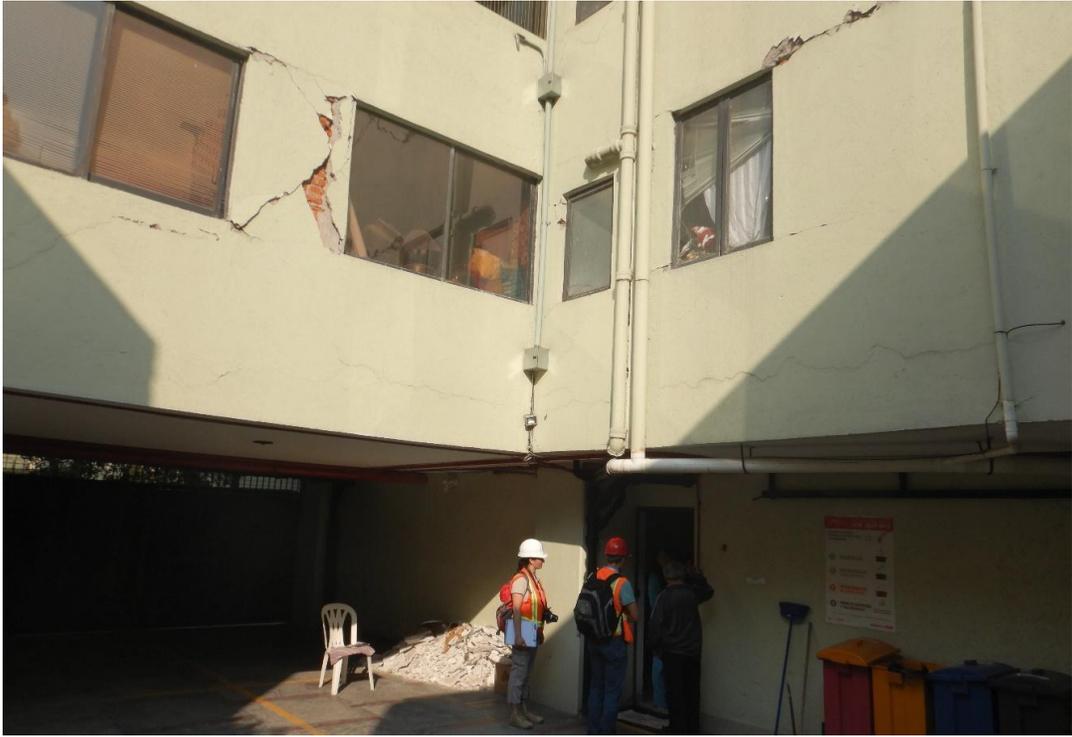
The major vulnerabilities identified in this structure were vertical irregularity at the first floor and torsional irregularity continuous along height of the building. The vertical irregularity at the first floor is created by discontinuous walls and columns at the first floor in between lines 3 and 4 in Figure 32 that results in the soft story shown in Figure 33. The reentrant corner in the top left of the building's floor plan seen in Figure 36 creates a torsional irregularity.

Figure 33: Exterior View of Soft Story Irregularity

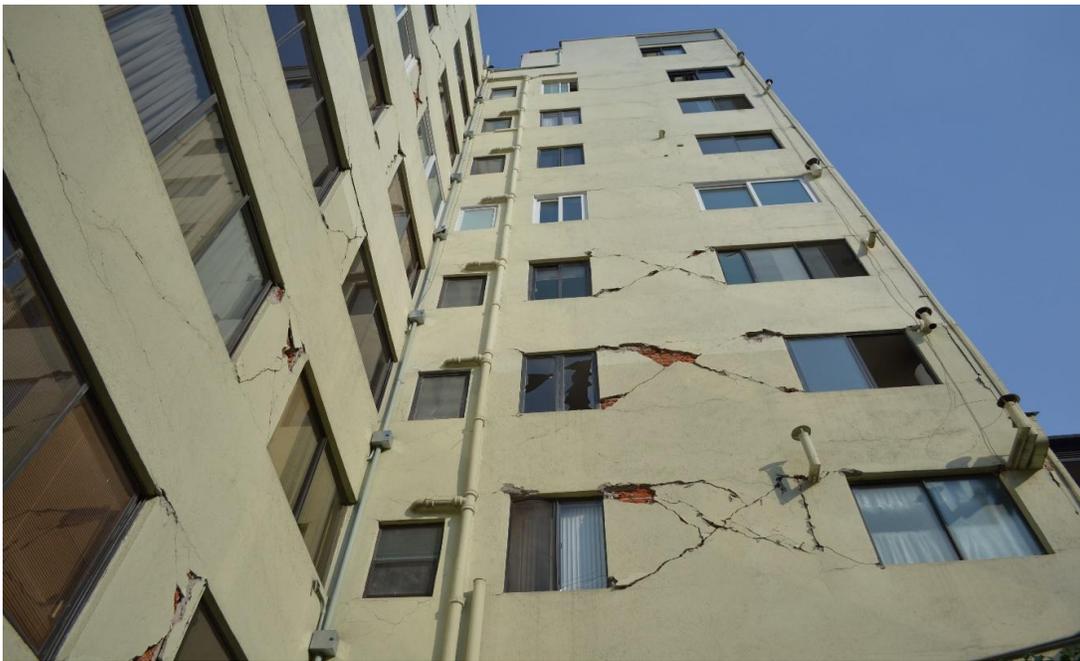
Figure 34: Reentrant Corner Torsional Irregularity

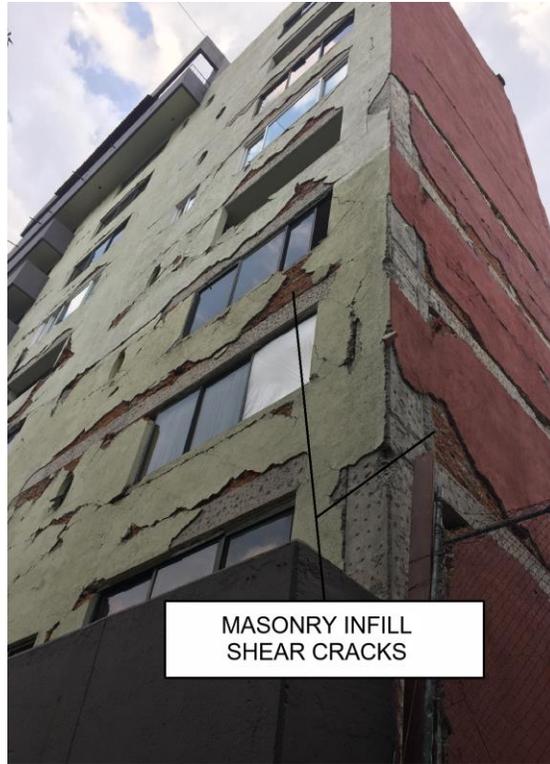
The damage after the 2017 earthquake was concentrated primarily in the masonry walls on all levels as highlighted in Figure 35 and 36. This was a result of the epoxy injected concrete core being weakened from the previous 1985 earthquake. As shown in Figure 37, the epoxy injections were along significant lengths of the wall. With the concrete core weakened, the reinforced concrete frame experienced greater torsion and pounding forces from neighboring buildings as seen in Figure 38. The deep spandrel beams experienced shear cracking as highlighted in Figure 39. The frame of the structure saw a shear crack to the bottom column on line 3-D as shown in Figure 40. This shear crack was not present in the same column on 3rd or 5th floor. This shear crack formed due to the story forces being increased with the torsional movement of the frame. Visual inspection of 3rd and 5th floor apartments led to the cataloging of severe masonry infill damage in the apartment walls as seen in Figures 40 and 41. Severe damage to all masonry walls and shear damage to columns has made the building unfit to occupy for the time being until a retrofit has been performed. The overall performance of the building was poor.

Figure 35: Masonry Infill Exterior Wall Damage (Line 1)

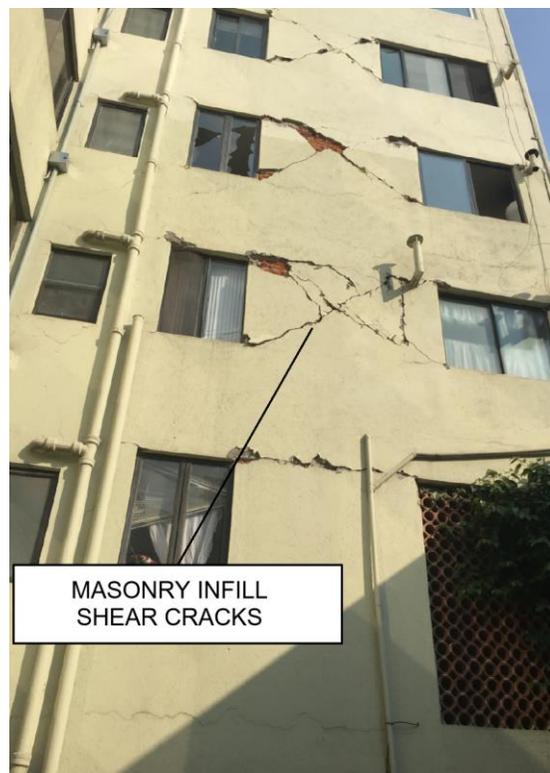
Figure 36: Masonry Infill Exterior Wall Damage (Line 3)

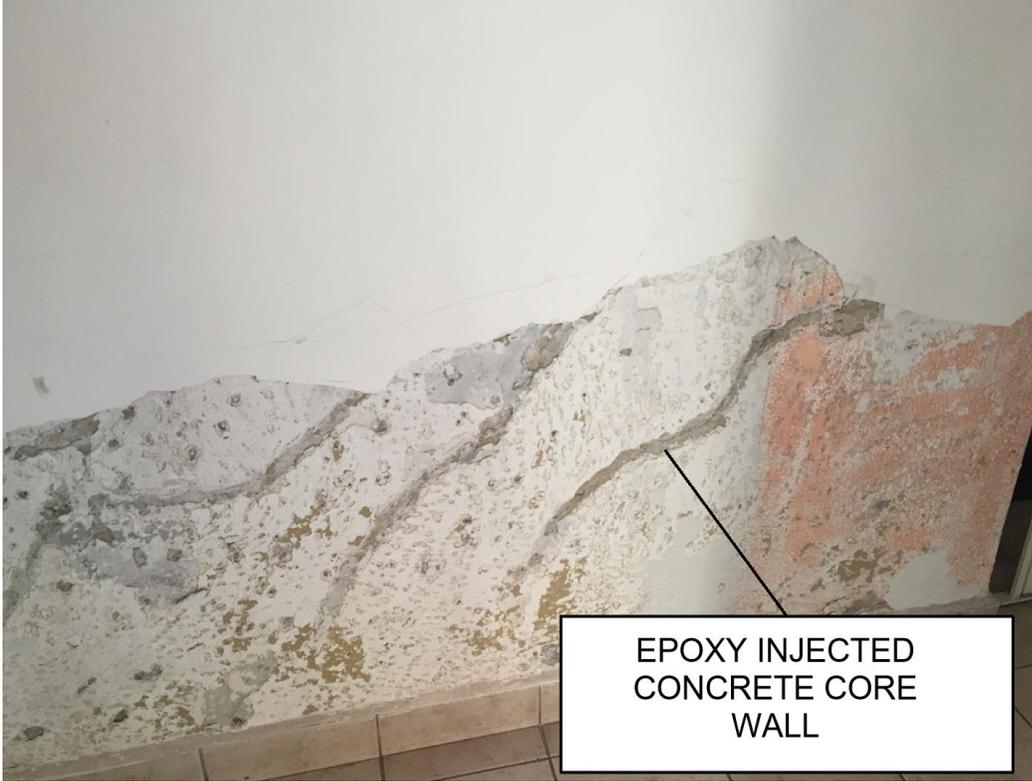
The reconnaissance team interviewed the apartment owner who indicated that after the 1985 earthquake the only damage to the structure was to the concrete core in the center of the buildings – repaired by epoxy injecting all cracks.

Figure 37: Epoxy Injections for Concrete Core (Line B1)

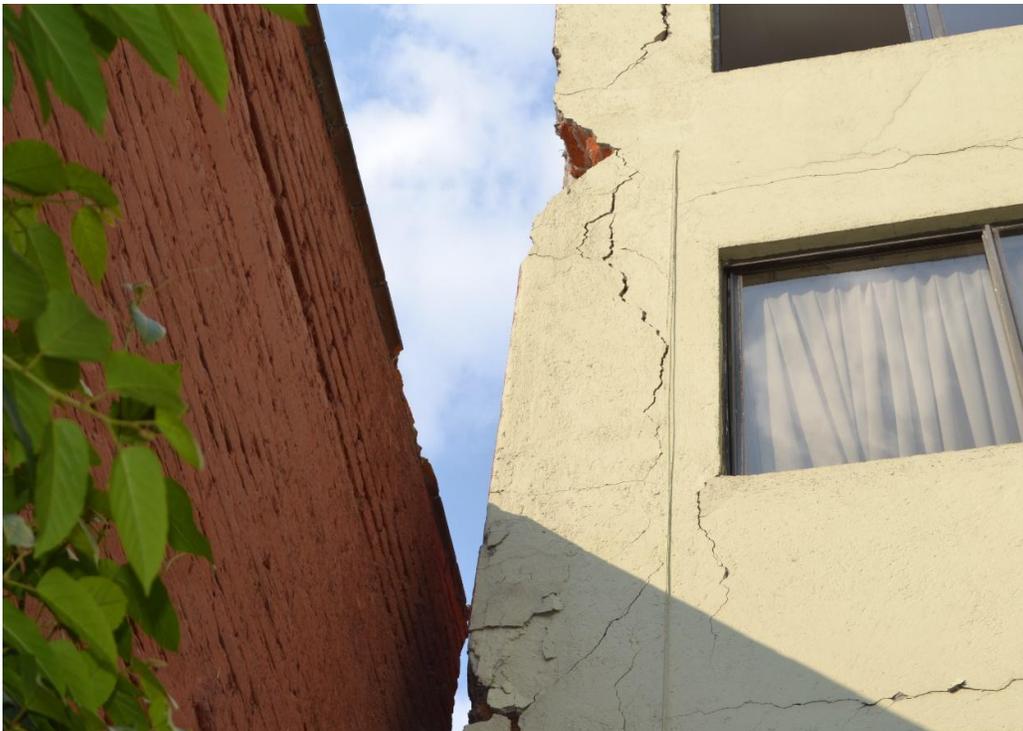
Figure 38: Pounding Damage (Line B)

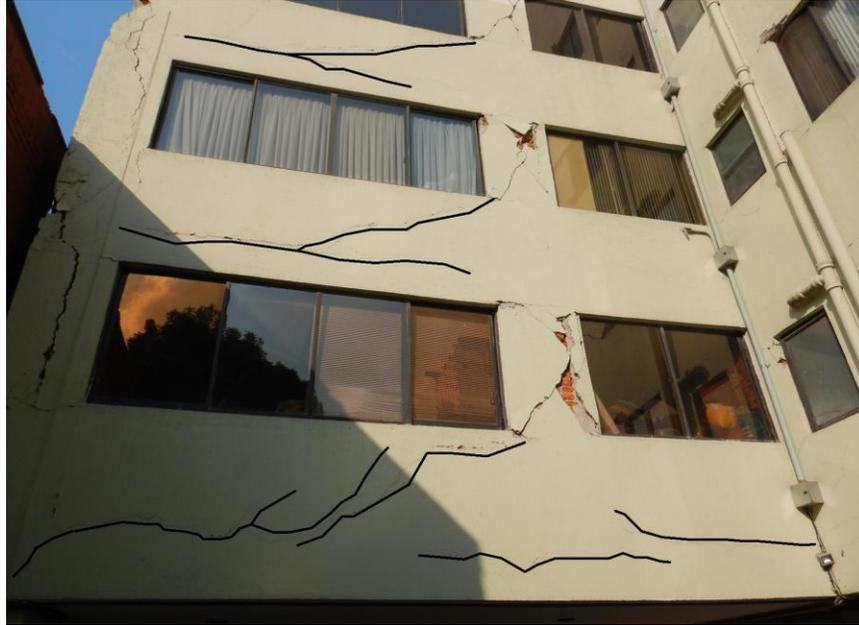
Figure 39: Beam Cracking (Line B)

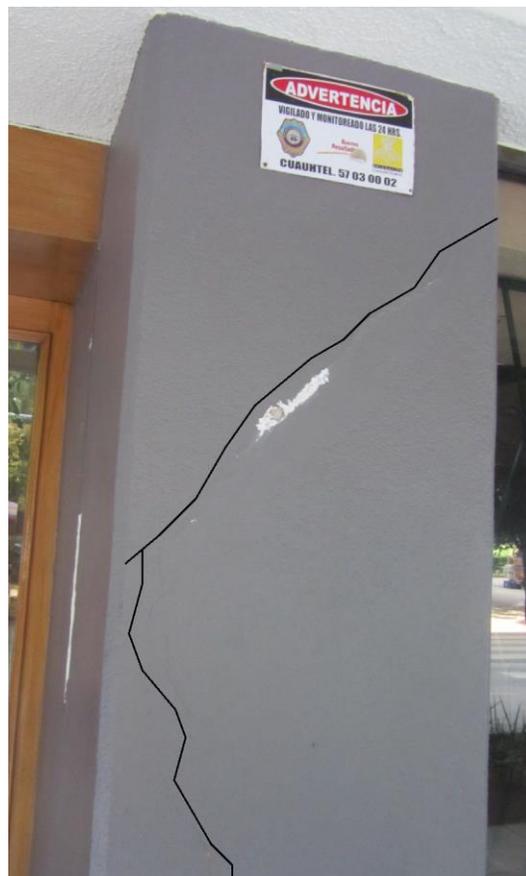
Figure 40: Column Shear Crack (Line 3-D)

The team concluded that the overall performance of Avenida México 55 was poor. The nonstructural damage to the masonry infill walls throughout the building was severe. The shear crack on the column on line 3-D, highlighted in Figure 40, would need further investigation to determine if it affects the strength of the column. The amount of structural damage to the reinforced concrete frame observed suggests this building is an unsafe structure. The primary lesson learned with Avenida México 55 is that when designing a soft story with a reentrant corner, there will be severe damage to the structure if not sufficiently designed.

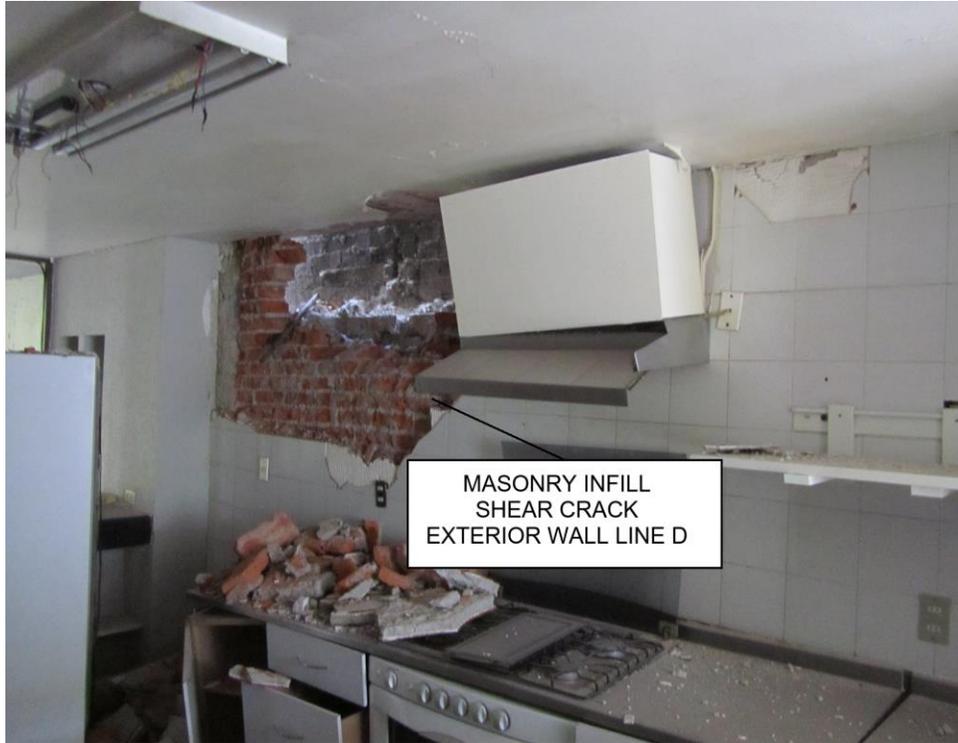
Figure 41: Shear Cracks through Masonry Infill Walls in Kitchen 3rd Floor

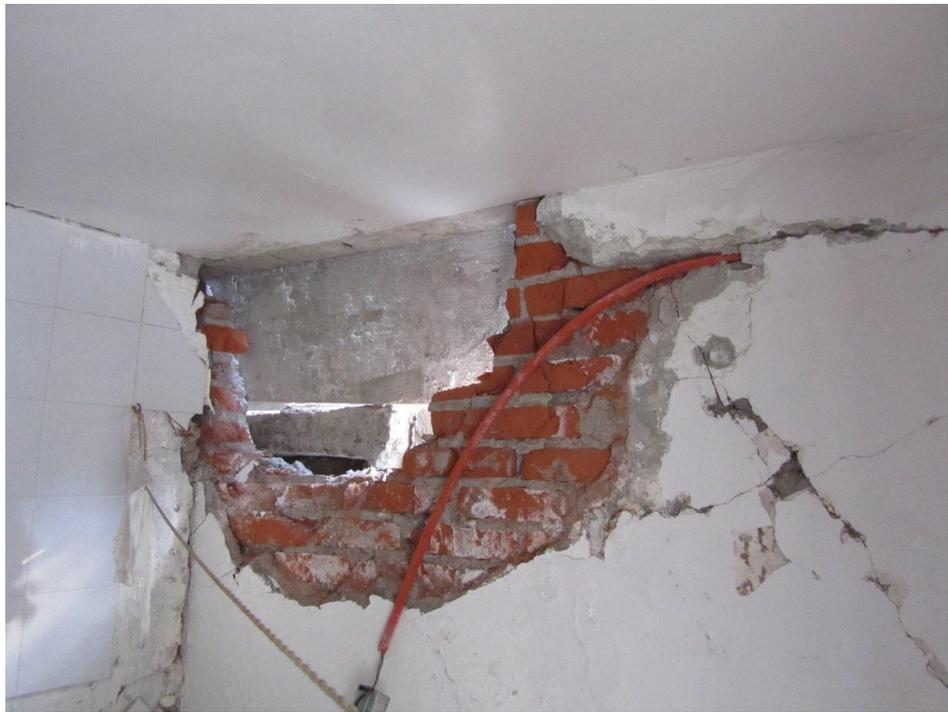
Figure 42: Boundary Element Exposure due to Masonry Infill Wall Spalling in Bathroom 5th Floor

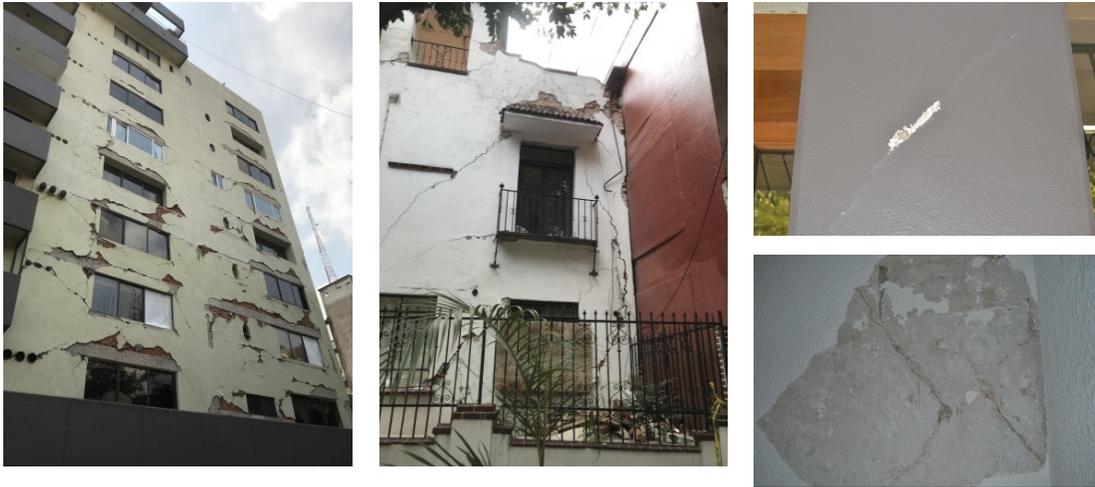
Much of the external damage to buildings was horizontal and diagonal cracking to unreinforced masonry infill, clearly visible in the images shown below (top row). Another common damage type was spalling along beams and columns that were subjected to significant stresses during the earthquake shown below (bottom row). Further investigation will be necessary to determine if repairs could be made using epoxy injection of cracks or strengthening of column members via jacketing.

CRACKING TO MASONRY INFILL(LEFT) AND CRACKING AND SPALLING OF BEAMS/COLUMNS(RIGHT)

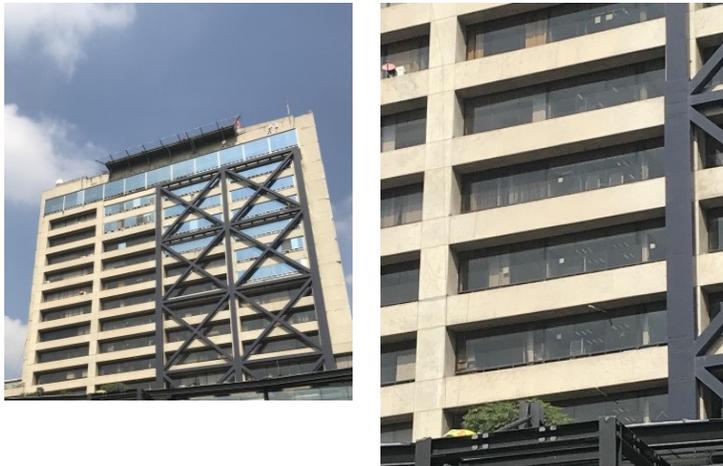
The first retrofitted building we investigated was the local police station which performed rather well with the addition of external steel bracing (shown in the images below). Still, the interaction between the original concrete structure and steel frame was apparent in hairline cracking in concrete beams/ columns where steel bracing was introduced. Based on our observations, we concluded that: (1) the location of more numerous or wider concrete cracks in the columns indicated which member (beams vs. columns) controlled in the concrete system, and that (2) connections between the concrete and steel systems at every other floor created a collector in the concrete beam on the intermediate story that was not tied into the steel bracing (as evidenced with the lack of visible cracking in these beams).

LOCAL POLICE OFFICE: RETROFIT WITH EXTERNAL STEEL FRAME

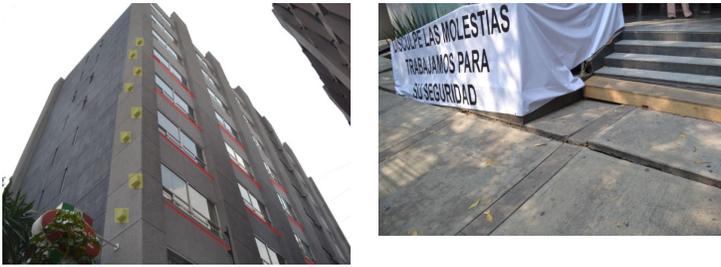
We also visited a local hospital building retrofitted with the addition of steel rods/anchorage for the beams up to the 6th floor and widening of columns to result in strong column behavior, per the strong column-weak beam seismic design approach. In the images shown below, the thin line (highlighted in red) are the steel rods and the end anchorage of these rods are housed in square box (highlighted in yellow) on the exterior face of columns. This building performed exceptionally well. The on-duty security guard informed us that during the earthquake there was some shaking of the building and slight uplift in the foundation shifting; however, overall the columns exhibited no visible signs of damage. This was probably the most successful retrofit seen today.

ABOVE: PERFORMANCE OF STEEL ROD/ANCHORAGE RETROFIT BETWEEN BEAMS AND COLUMNS (LEFT) & SLIGHT UPLIFT OF FOUNDATION (RIGHT)

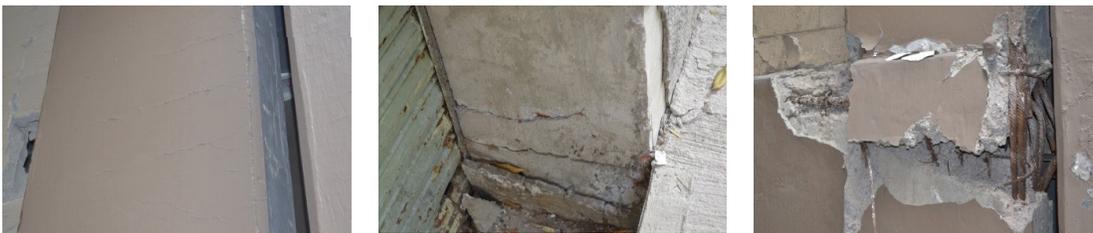
EXAMPLES OF COLUMN DAMAGE : CONCRETE CRACKING AND SPALLING

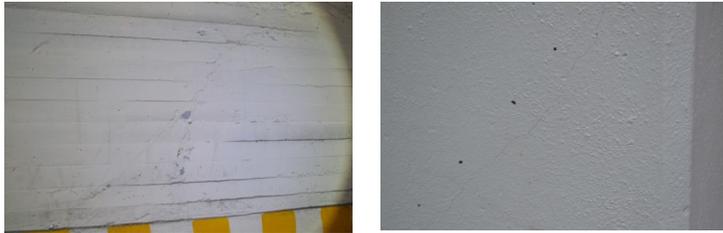
Additionally, a crack can be pre-existing from a past earthquake, these are normally epoxy injected and painted over. The following images show the difference between a large pre-existing crack that has been epoxy injected (left) and new crack which occurred on a similar wall (right, note black dots placed along crack).

EXAMPLES OF PRE-EXISTING EPOXY INJECTED CRACKS AND NEW CRACKS

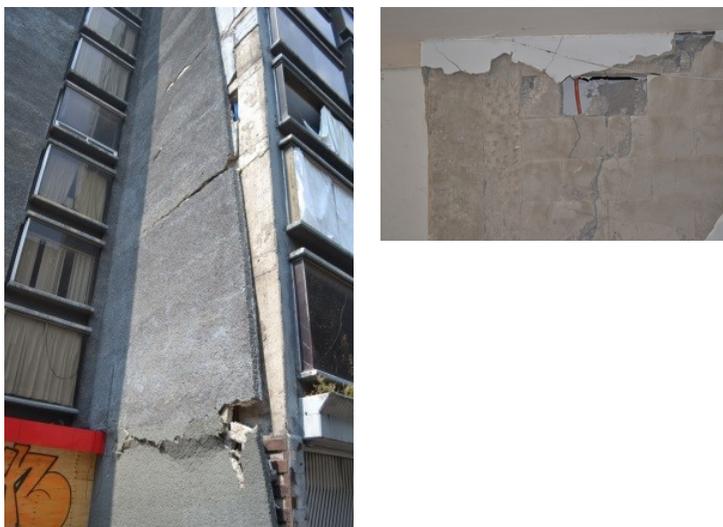
EXAMPLES OF DAMAGE TO CONCRETE WALL (LEFT) AND URM INFILL WALL (RIGHT)

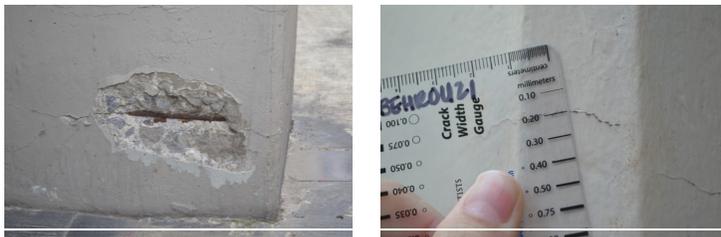
CHARACTERISTIC EXAMPLES OF CONCRETE DAMAGE

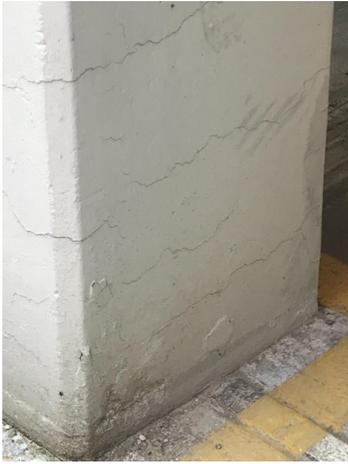
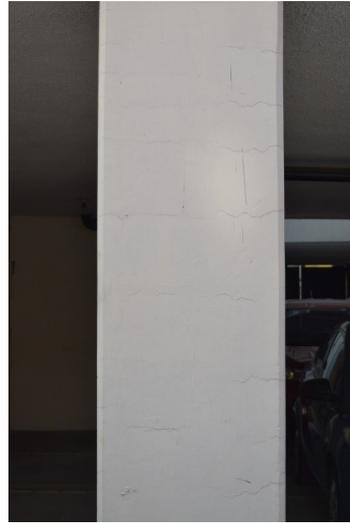
TEHUANTEPEC 153: VARIATION OF COLUMN CRACK PATTERNS BASED ON DIRECTION OF LOADING

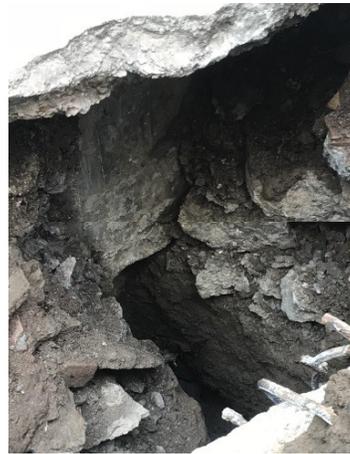
TEHUANTEPEC 153: FIRST-FLOOR COLUMN AND UNDERLYING EXPOSED FOUNDATION SYSTEM

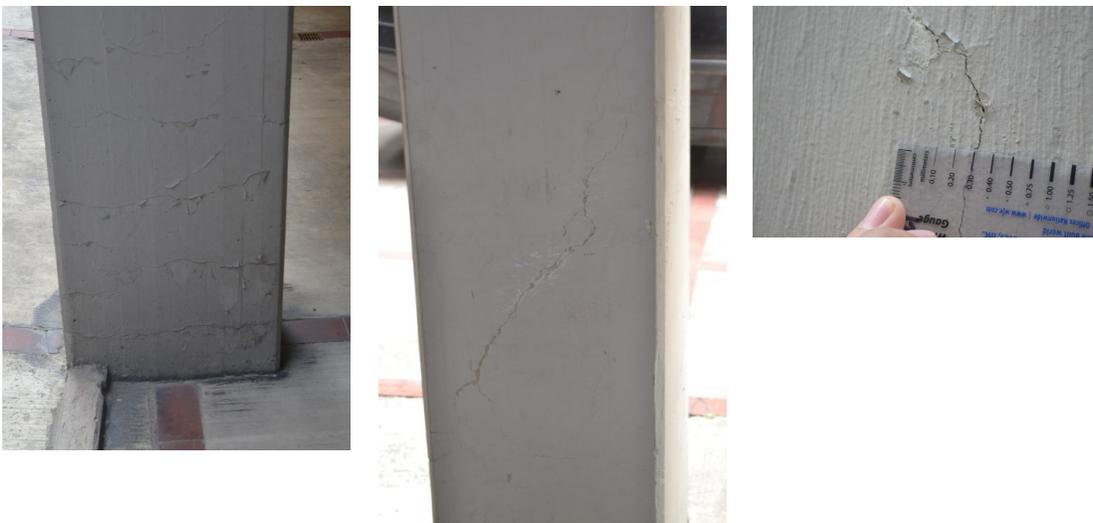
MANZANILLO 114: (LEFT) COLUMN HINGING AT ENDS, (CENTER) SHEAR CRACKING, (RIGHT) COLLECTING CRACK WIDTH DATA(0.30MM)

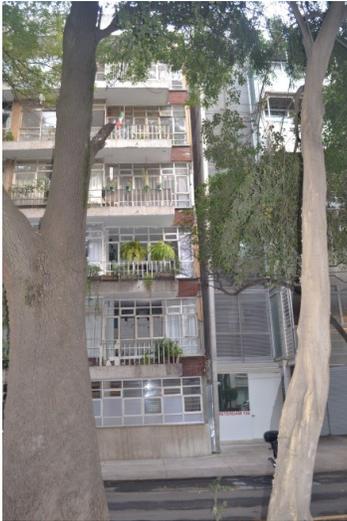
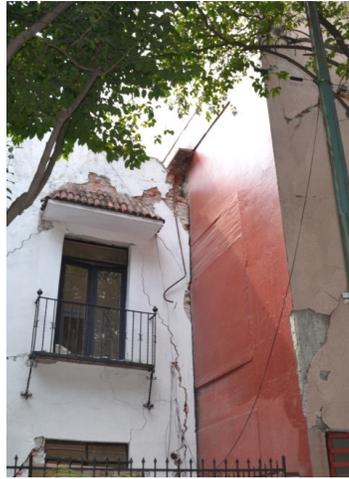
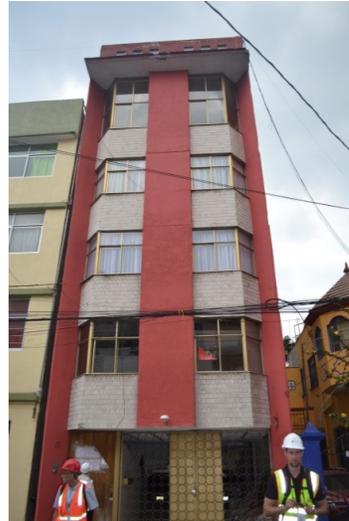
OBSERVATIONS OF POUNDING BETWEEN BUILDINGS

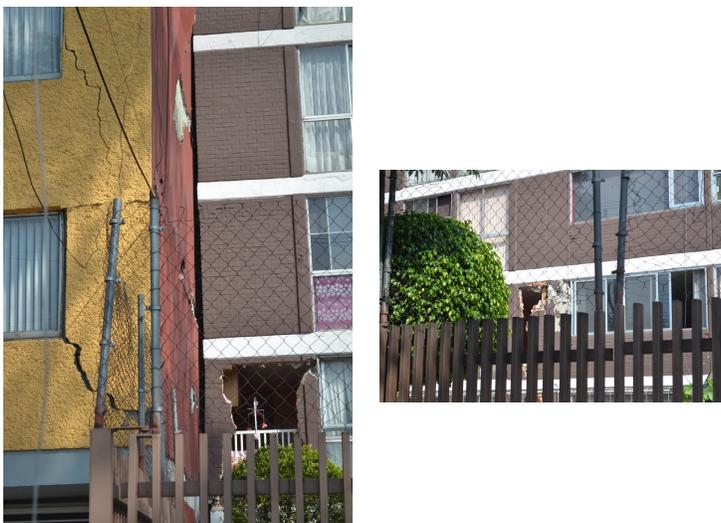
Further down the street we saw families moving out of a six story apartment building where columns had severe cracks and partial/complete collapse of masonry infill wall panels.

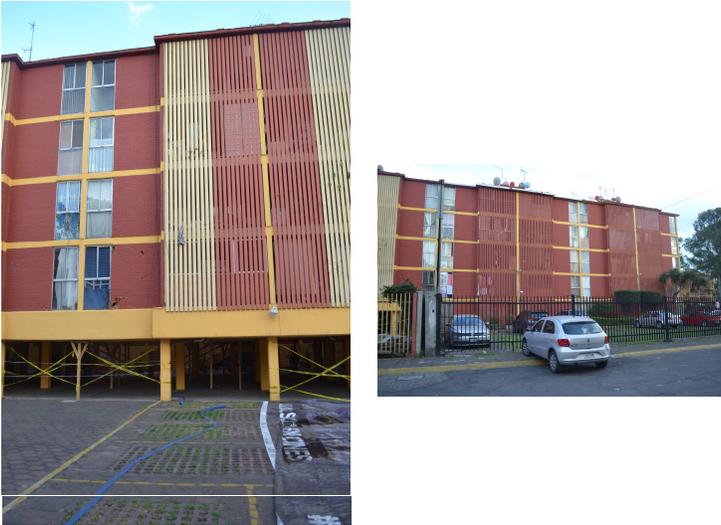
On the adjacent street, we found two nearly identical apartment complexes, differing only by the first floor design. The building shown on the right had continuous masonry walls, while that shown on the left had an open garage making it susceptible to soft-story behavior.

The apartment building, shown above on the left, exhibited shear and flexural cracks on columns and exposed rebar on its deep spandrel beams. The most important thing I learned from this case was that open first-floor garages have a tendency to reduce the building stiffness at this level where the shear force is the greatest.

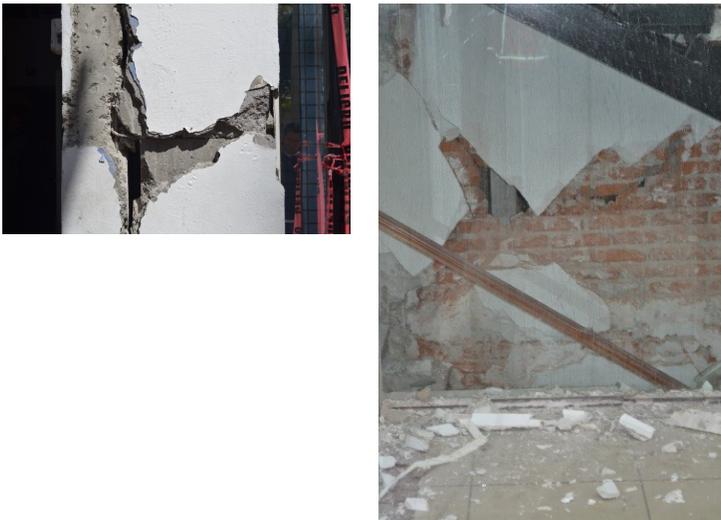
ZAPATA 285: (LEFT) SEPARATION CRACK IN COLUMN, (RIGHT) TYPICAL DAMAGE TO MASONRY INFILL WALL

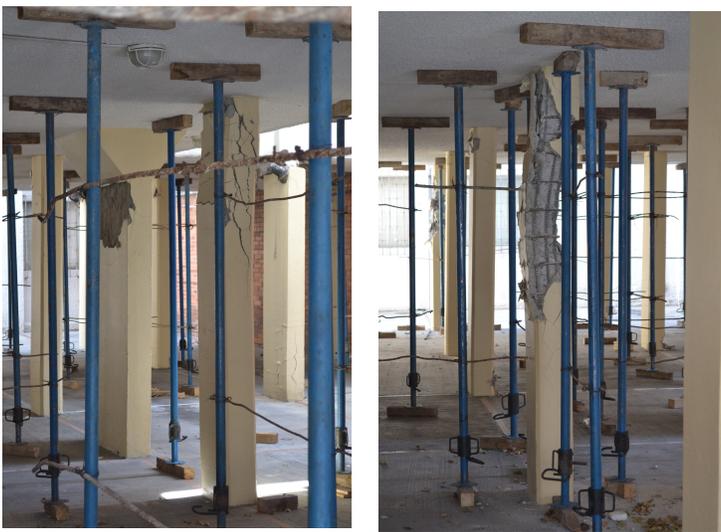
AZORES 609: EXTENSIVE COLUMN DAMAGE REQUIRING SHORING (LEFT) SHEAR AND (RIGHT) GLOBAL BUCKLING
