The Institute's Team for Damage Investigations

Lessons learned from field deployments

by Lucas A. Laughery, Aishwarya Y. Puranam, Christopher L. Segura Jr., and Anahid A. Behrouzi

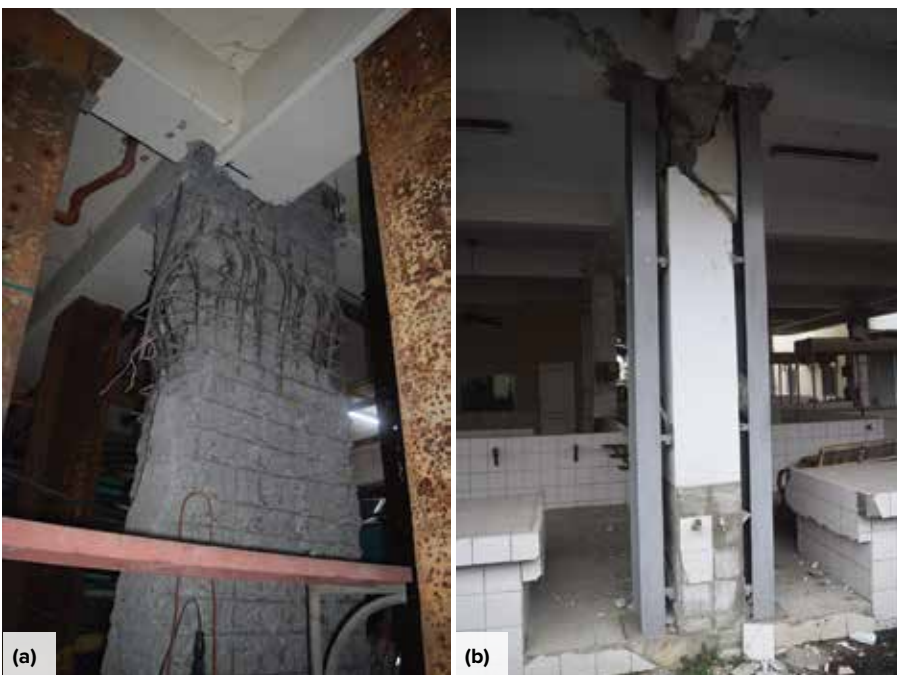
Much damage was observed in Tainan City, approximately 40 km (25 miles) from the epicenter. Reports suggested that most fatalities resulted from the collapse of a 14-story residential building. ACI Committee 133 deployed a team in March 2016, supported in part by the National Science Foundation (NSF), to join researchers from the Taiwanese National Center for Research on Earthquake Engineering (NCREE) to investigate the effects of the earthquake on RC structures. Over 12 days, 119 low-rise school, residential, and government buildings and 11 structures between eight and 23 stories tall were surveyed around Tainan City. In addition to conventional techniques, teams used aerial drones to collect videos of structures. Members of the ACI team investigated the failure of a corner column in a 14-story building in Tainan City, and they concluded that the failure was the result of axial demands imposed from discontinuous RC walls intended to function as partitions.²¹ The team also conducted an evaluation of four different seismic vulnerability screening indices, including that proposed by Hassan and Sozen¹⁶ and another then used in Taiwan. Figure 4 shows damage that was observed in columns in two different buildings.²²

Fig. 4: Damage to columns in the 2016 Taiwan Earthquake: (a) axial compression failure; and (b) shear failure (after Reference 22, licensed under CC BY-NC-SA 4.0)

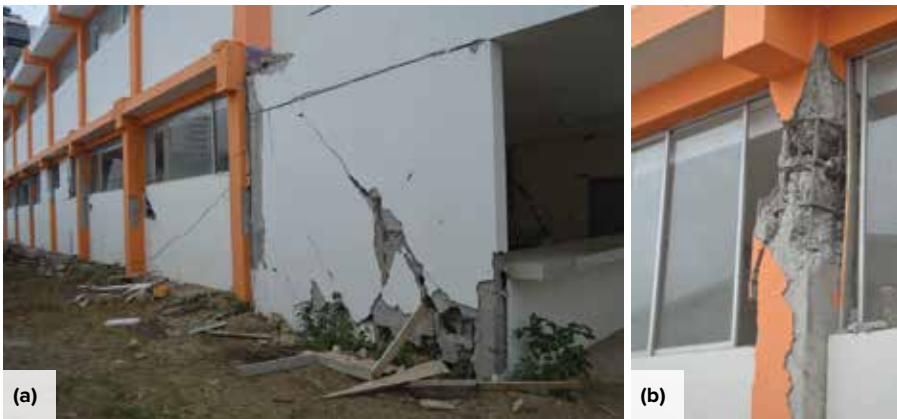
On April 16, 2016, a M_w 7.8 earthquake shook coastal Ecuador, causing severe damage to and collapse of structures, particularly around the coastal province of Manabí. Thousands of aftershocks were reported in the following months. In July 2016, ACI Committee 133 deployed a team that, together with faculty and students from Escuela Superior Politécnica del Litoral (ESPOL), surveyed RC buildings over a period of 8 days. The buildings ranged from one to six stories in height. Most of the buildings had masonry infill walls. Figure 5 shows examples of damage observed in RC frame buildings.²³

Fig. 5: Damage caused in two buildings by the 2016 Ecuador Earthquake: (a) shear failures in masonry infill walls; and (b) shear failure in a short, ground-level column above infill walls (after Reference 23, licensed under CC BY-SA 3.0)

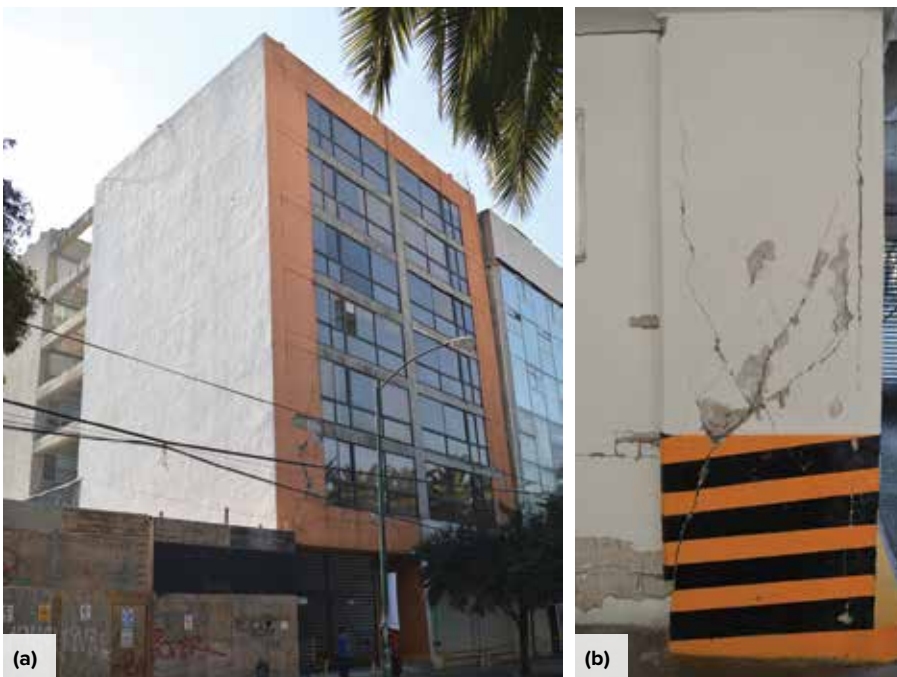
Two major earthquakes occurred in Mexico during September 2017: a M_w 8.1 on September 7 off the southern coast of Chiapas and a M_w 7.1 on September 19 about 55 km (34 miles) south of the city of Puebla. The second event caused significant loss of life and damage in Mexico City, including the collapse of more than 40 buildings.²⁵ In mid-October 2017, ACI Committee 133 deployed a team with funding support from the NSF. With the assistance of faculty from Universidad Nacional Autónoma de México (UNAM) and Colegio de Ingenieros Civiles de México (CICM), the team surveyed RC buildings located in Mexico City. Most of the buildings surveyed were constructed prior to 1985, were five to 10 stories, and were comprised of RC framing with masonry infill. The most salient observation was that the affected structures were too flexible. Flexible RC frames without adequate transverse reinforcement lack the deformability to cope with large lateral drift demands. Continuous grade-to-roof infill walls were observed to increase stiffness and reduce drift, but these walls were seldom distributed in two directions on the floor plan. In most cases, continuous infill was present only along floor plan edges perpendicular to the street. In this direction, damage to the frame was infrequent and relatively minor. Continuous infill walls were rarely present parallel to the street, and in this direction building damage tended to be much more severe (Fig. 6).

Fig. 6: A typical residential building affected by the 2017 Puebla Earthquake: (a) edge frames oriented perpendicular to the street had continuous infill walls and exhibited no significant damage; and (b) edge frames oriented parallel to the street had infill walls and fenestration and exhibited shear failure in first-story columns (after Reference 26, licensed under CC BY-NC-SA 4.0)

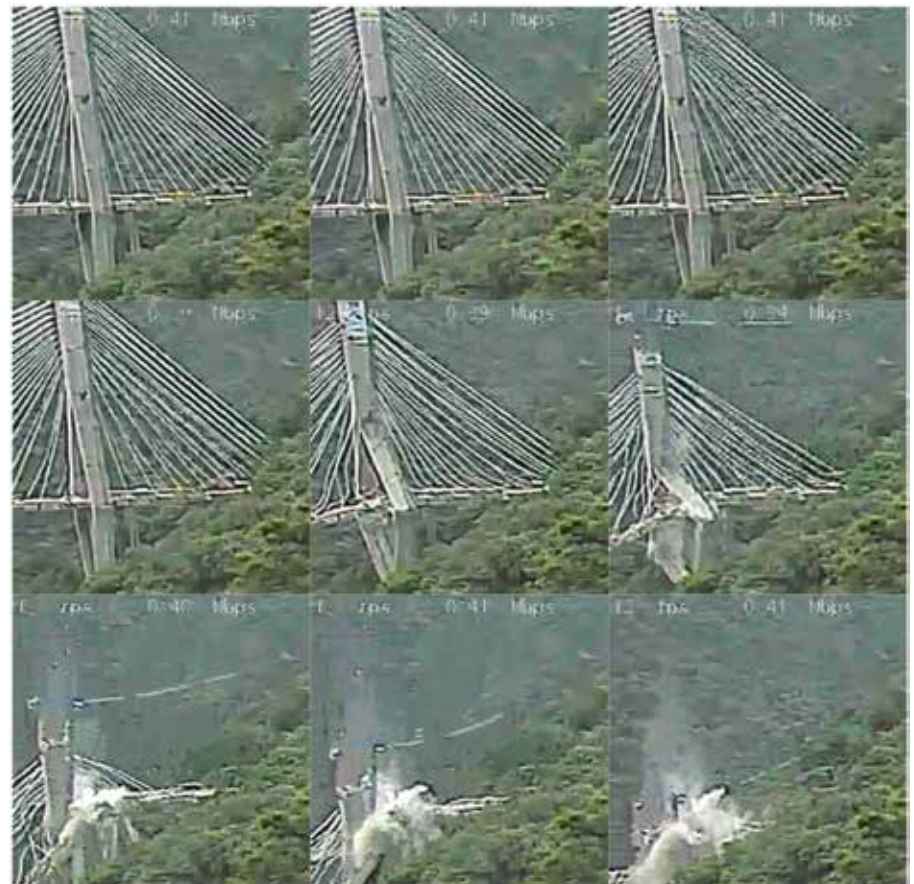
(UAS). A review of the design drawings revealed that the tower slab, which was apparently intended to act as a tie midway up the diamond-shape support

towers, had insufficient longitudinal reinforcement to support the gravity loading condition estimated on the tower at the time of the collapse. Findings

Fig. 8: Chirajara Bridge west tower failure sequence (after Reference 29)

from the ACI Committee 133 team's investigation illustrate the importance of: 1) exceeding Code minimum reinforcement ratios in critical members to allow spread of inelastic deformations, thus avoiding brittle behavior as a result of strain concentrations; and 2) the peer-review process, specifically for complex structures. Details of the investigation can be found in Pujol et al.²⁹
