The Institute's Team for Damage Investigations

Lessons learned from field deployments

by Lucas A. Laughery, Aishwarya Y. Puranam, Christopher L. Segura Jr., and Anahid A. Behrouzi

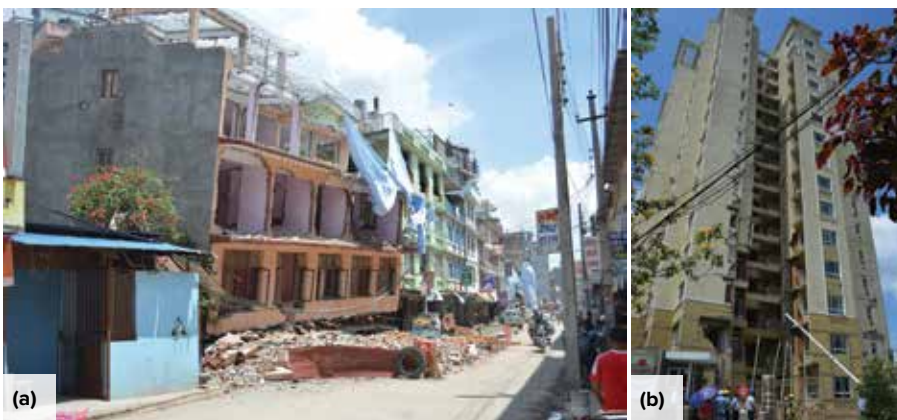
partition walls. Figure 3 shows severe damage to unreinforced masonry infill in low-rise and high-rise buildings.^{18,19} Collapse of the first story in the low-rise building (left) demonstrates the soft-story vulnerability. More information about the reconnaissance can be found in Shah et al.²⁰

Fig. 3: Buildings damaged in the 2015 Nepal Earthquake: (a) low-rise building (after Reference 18, licensed under CC BY-SA 3.0); and (b) high-rise building (after Reference 19, licensed under CC BY-SA 3.0)

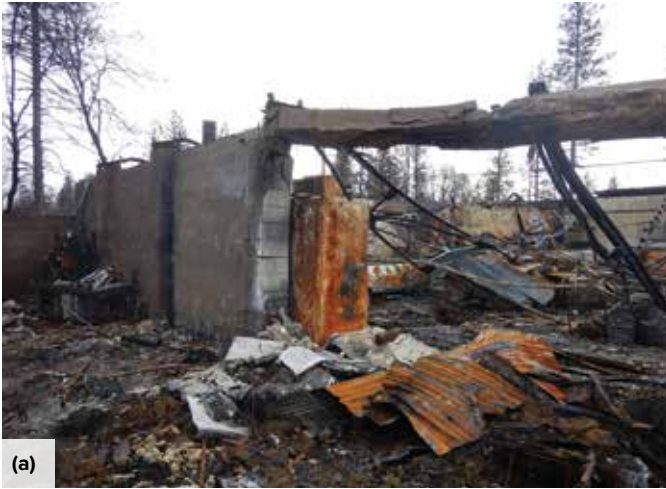
Typical commercial facilities consisted of RC or masonry wall structures with light-gauge steel joist roofs. One example was the Stratton Market, which collapsed due to the fire

Fig. 9: Remains of buildings destroyed in the Camp Fire: (a) Stratton Market; and (b) Paradise Elementary School (photos courtesy of Erica Fischer)

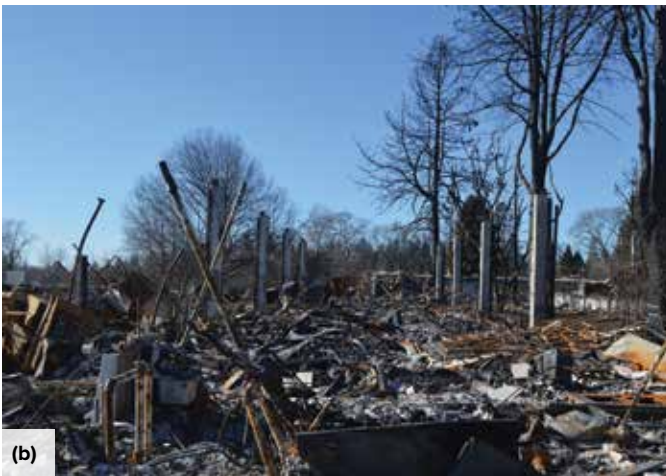
(Fig. 9(a)). One school building, Paradise Elementary School, had RC columns and timber framing. It also completely collapsed due to the fire (Fig. 9(b)). The ACI team also documented damage to a three-story residential building with RC framing. The fire caused buckling of the building's corrugated metal roof, cracking and spalling around flexural reinforcement in RC roof beams, and vertical splitting and spalling of third-story columns.
