**IRRIGATION ENGINEERING IN SEISMIC ZONES – MEXICALI VALLEY, MEXICO**

USCID Sixth International Conference on Irrigation and Drainage

Alan Dennis Gracia, P.E.<sup>1</sup>  
Charles M. Burt, Ph.D., P.E.<sup>2</sup>  
Mario Paredes Vallejo<sup>3</sup>

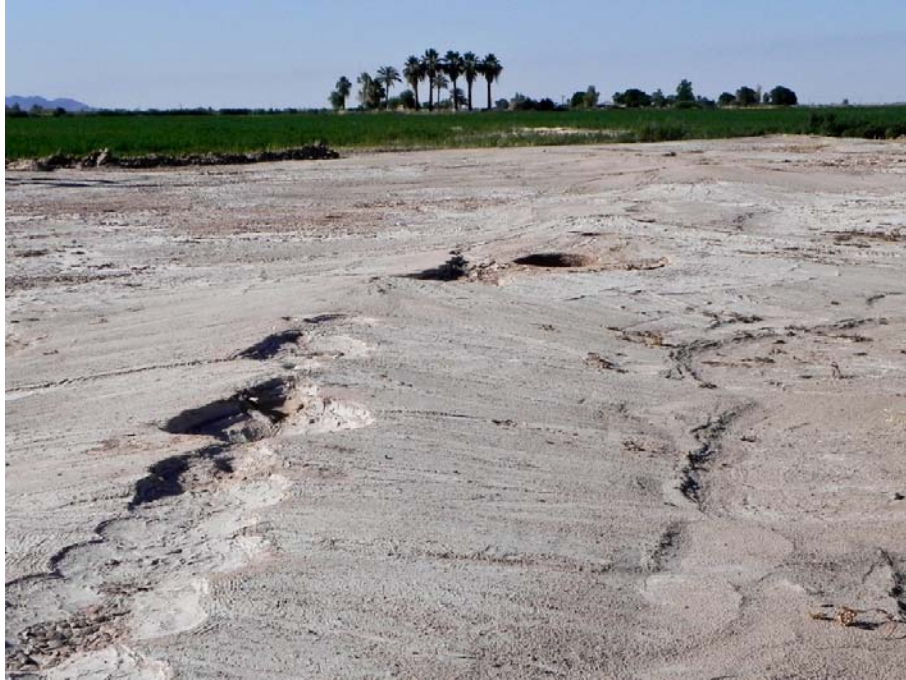
The agricultural fields suffered substantial damage due to a combination of subsidence and liquefaction in the subsurface. Small “volcanoes” appeared in fields across a huge area – where water flowed up from the saturated subsurface and discharged large amounts of sand plus salty water across the soil surface. Figure 5 illustrates this phenomenon.

Figure 5. Sand volcanos that arose from subsurface liquefaction.

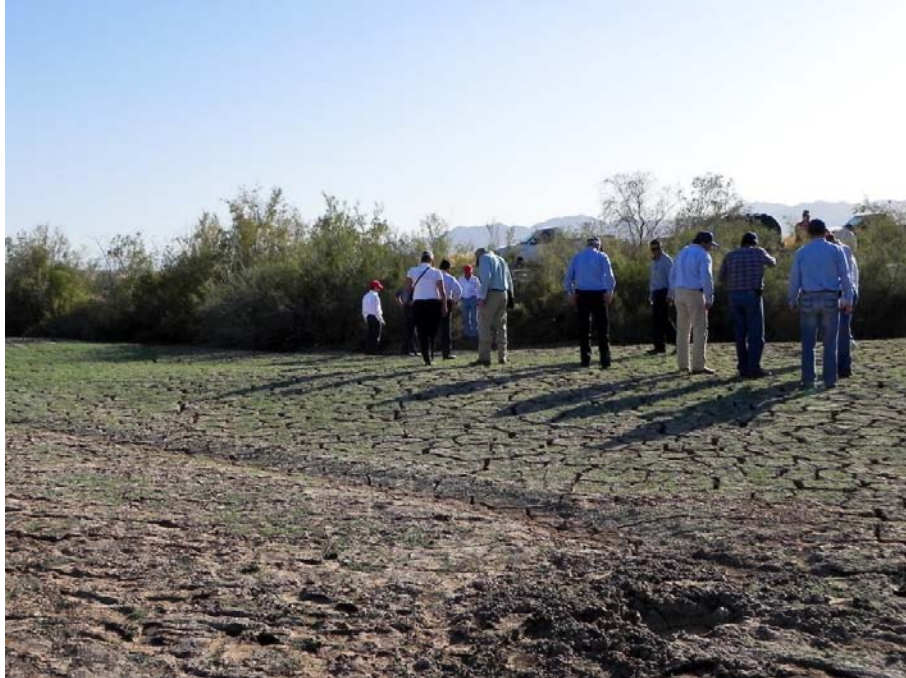
The canals and drains suffered considerable damage. Drain embankments sloughed in, as did canal embankments.

Figure 6. Remnants of a large drain channel that completely filled in during the earthquake.

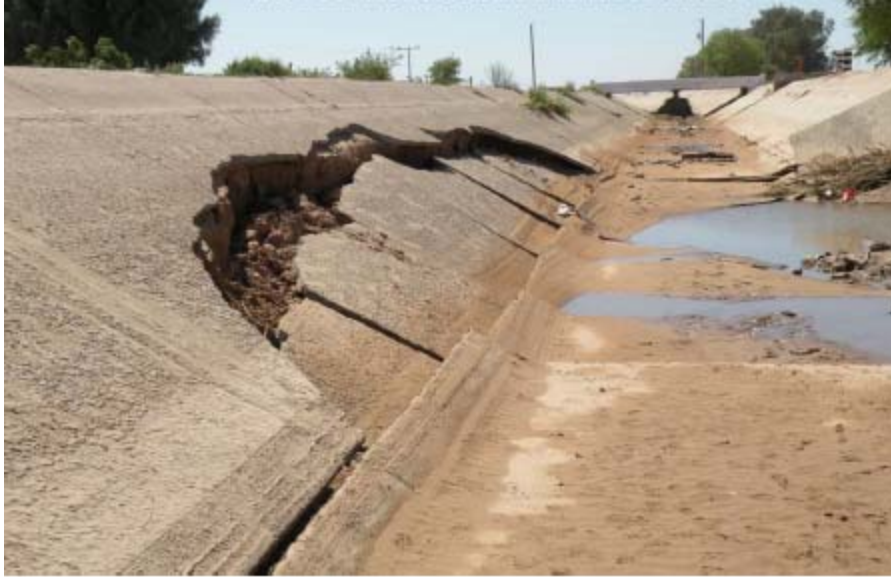
Figure 7. Slumping of embankment into the canal. Photo courtesy of CONAGUA.

1. The canal banks were constructed of native materials, with a high silt percentage, that were not well compacted.
2. There was high seepage loss from the canals prior to the earthquake – indicating that the canal embankments under the cracked concrete lining, at least in many areas, were saturated.
3. A high water table existed, indicating that the soil immediately under the base of the canal and its embankment were saturated.

With the exception of localized shear caused by displacement of soil along/crossing a fault line, the damage exhibited classic symptoms of slope instability. This type of embankment failure is sometimes associated with a different manifestation of liquefaction than was mentioned earlier (sand volcanoes in fields due to subsurface liquefaction). For canal bank failure, the embankment becomes more “slippery” due to the rapid buildup of high pore pressures during cyclic shear of saturated soils. If the pore pressure builds up on uncompacted soil, the potential for slippage (shear failure) increases as compared to on compacted soils.

1. The soil will be over-excavated, filled with compacted soil, and then the cross section for the new canal will be cut from the compacted soil.
2. The canal embankments and the “footing” of the canal itself will be kept dry by preventing moisture from entering from above and below. The two solutions will be:

- a. The canal will be lined with a geomembrane to prevent seepage from “above”. That geomembrane is equipped with a fuzzy material on its surface so that concrete will adhere to it. Concrete will be applied with a 3” thickness over the geomembrane. The concrete will provide mechanical protection from cleaning operations and other physical damage that might occur.

- b. A tile drain will be installed approximately 6’ below the bottom of the canal, and to the side, to help lower the water table immediately under the canal. This will help minimize moisture from entering the embankment from below, and will possibly provide a more stable footing for the whole structure.

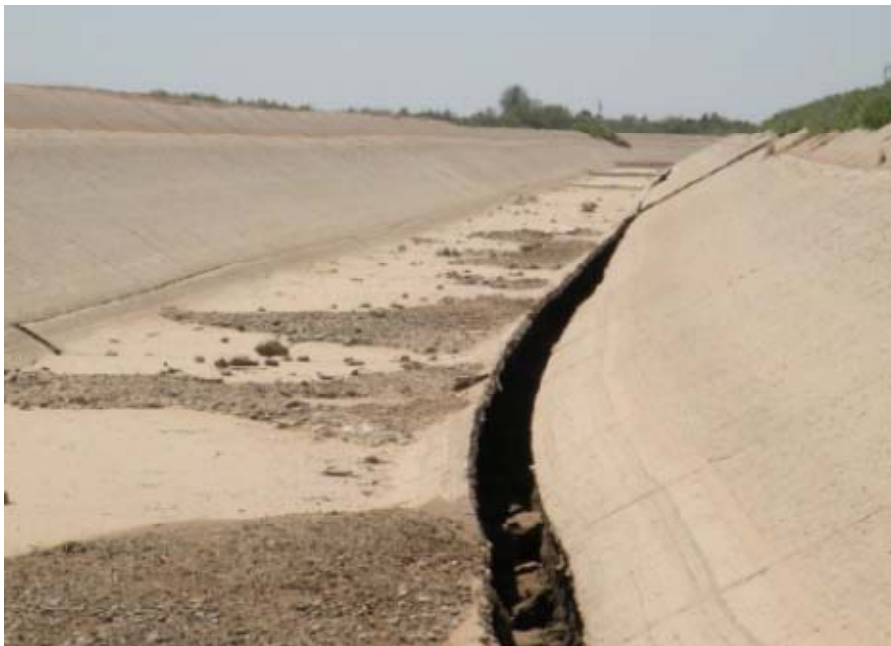
Figure 8. Movement of the entire canal embankment away from the canal. Photo courtesy of CONAGUA.

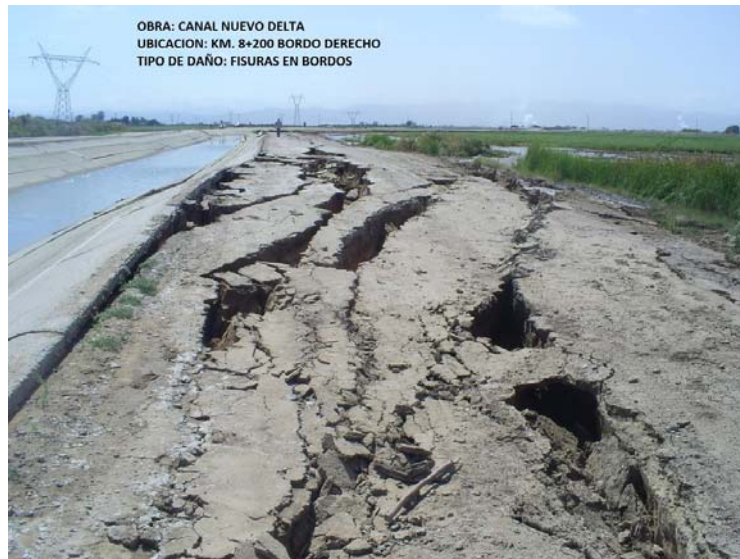
Figure 9. Fissures in the embankment road. Photo courtesy of CONAGUA.
