Failure Analysis of Variably Sized 4340 Steel Mandrels Utilized in the Production of Seamless Superalloy Rings through the Vertical Ring Rolling Process

A Senior Project

Joshua Venz & Mikhail Vasilyev

Sponsor: Carlton Forge Works

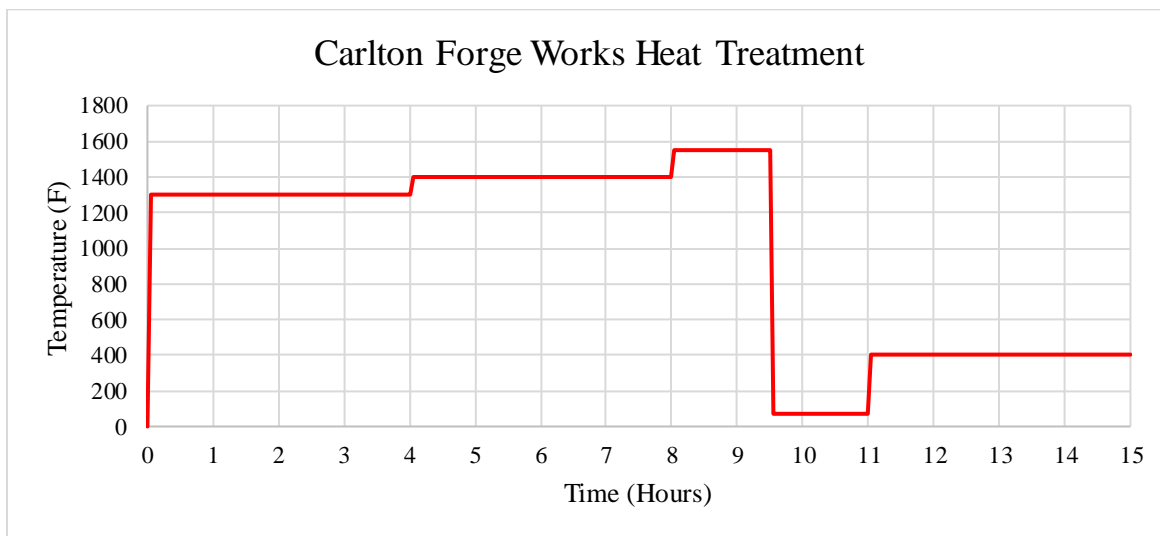
Figure 9 shows the current mandrel heat treatment for CFW, which is a common quench and temper procedure used on low alloy steels. The CFW Heat Treatment produces tempered Martensite, the desirable microstructure for the mandrel application due to high strength and toughness. The heat treatment begins with a step Austenitization of 4-hrs at 1300°F 4-hrs and 1400°F and 1.5-hrs at 1550°F. This is performed to ensure homogenous distribution of heat in an attempt to account for component size. Following Austenitization a 1.5-hr water quench is performed, followed by a 4-hr temper at 400°F and an air cool to room temperature.

Figure 9: Heat Treatment graph of the current mandrel treatment for CFW last amended in 2004.

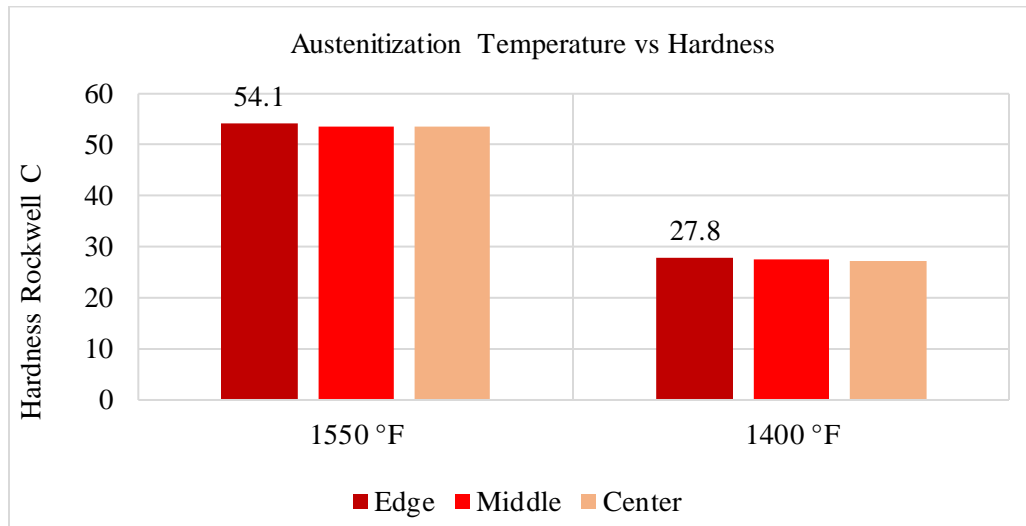
HRC. Consequently, the incompletely Austenitized sample (1400°F) possessed an HRC of half the previous, only around 28 HRC. These results are also supported by metallography performed on the samples, the microstructures of which are shown in *Figure 18*. The fully Austenitized microstructure shows tempered Martensite, whereas the incompletely Austenitized sample shows the presence of proeutectoid ferrite and pearlite. These are microstructural artifacts from the annealing stage performed prior to the heat treatment (and the condition mandrels arrive in), a fact supported by it possessing a hardness typical of pearlite (HRC 28).

Figure 17: HRC of samples Austenitized at 1550 and 1400°F.

Analysis of the results from both the Austenitization and Quench experiments is relatively straightforward. The Austenitization experiment stressed the importance of accounting for the overcrowding of the furnaces, as mandrels which are not austenitized completely possess a microstructure lacking Martensite which handicaps the properties of the component prior to further heat treating. A simple solution to the problem of overcrowded Austenitizing is raising the furnace temperature from 1550°F to 1750°F. The higher austenitization temperature will produce a buffer zone within the heat treatment and ensure that the mandrels homogeneously reach 1550°F at a minimum.

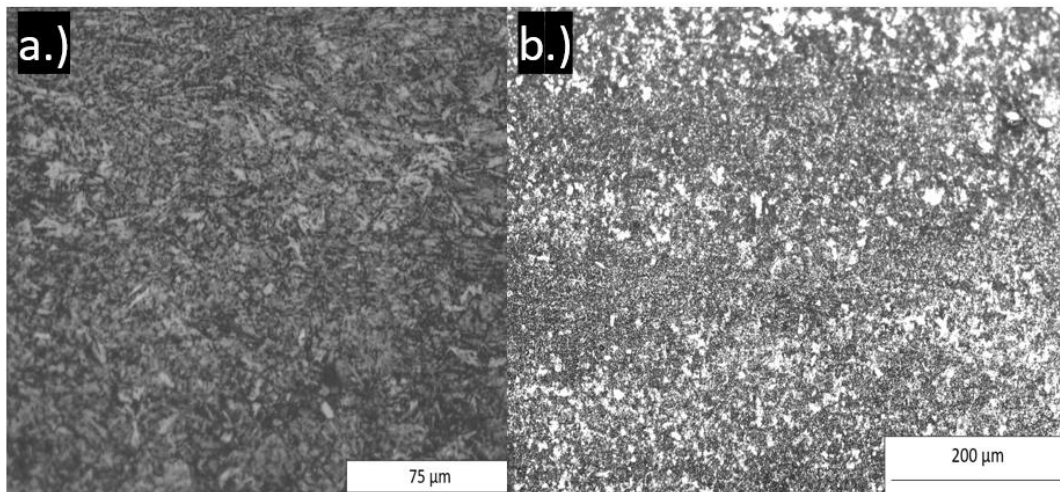
Figure 18: Microstructure of Martensite post complete Austenitization and Quench at a.) 1550°F b.) 1400°F.

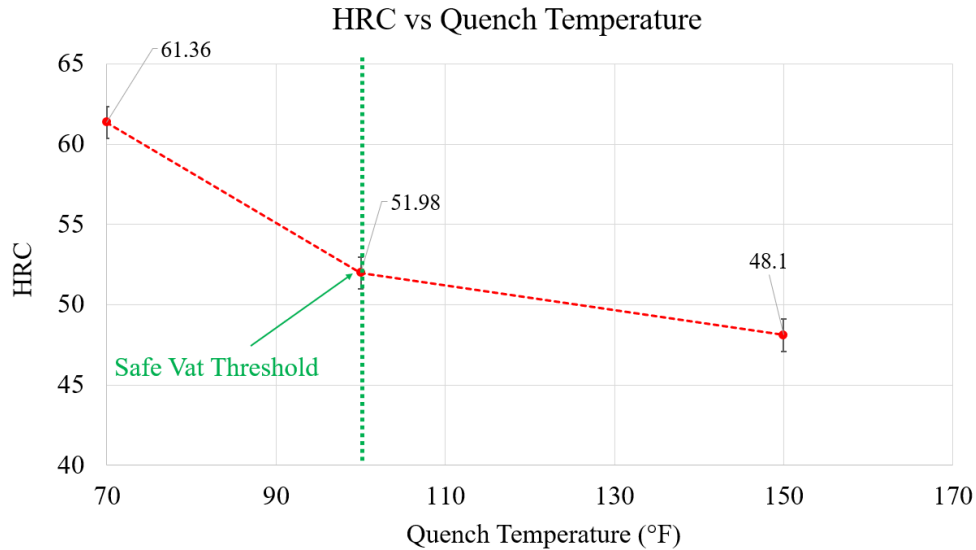
Results of the quench experiment are shown in *Figure 19*. As the temperature of the quenching vat is raised from 70°F to 100°F to 150°F, the HRC of the steel samples drops. At a proper room temperature quench the HRC is indicative of a fully Martensitic structure, while at 100°F the structure resembles the hardness of a 50% Martensitic structure. Past water temperatures of 150°F, HRC degrades below 50 which indicates the presence of large amounts of retained austenite and other slower cooling phases. Metallography was not performed on the quenched samples due to the inability to decipher retained Austenite through optical microscopy.

Figure 19: Safe quench vat range identified between 70°F and 100°F.

The sponsors at CFW desired a safe vat range, or upper maximum water temperature which the quench solution could sit at to ensure proper quenching of the mandrels. That threshold was decided at 100 °F due to its HRC being that of 52. This value ensures that the HRC of the mandrel and minimum rests at the HRC of the mandrel post its initial temper. While not ideal, due to the scale of the facilities at CFW 100°F quench vat temperature is a far more reasonable threshold than true room temperature quenching. Results from the over tempering experiment are given in *Figure 20*.

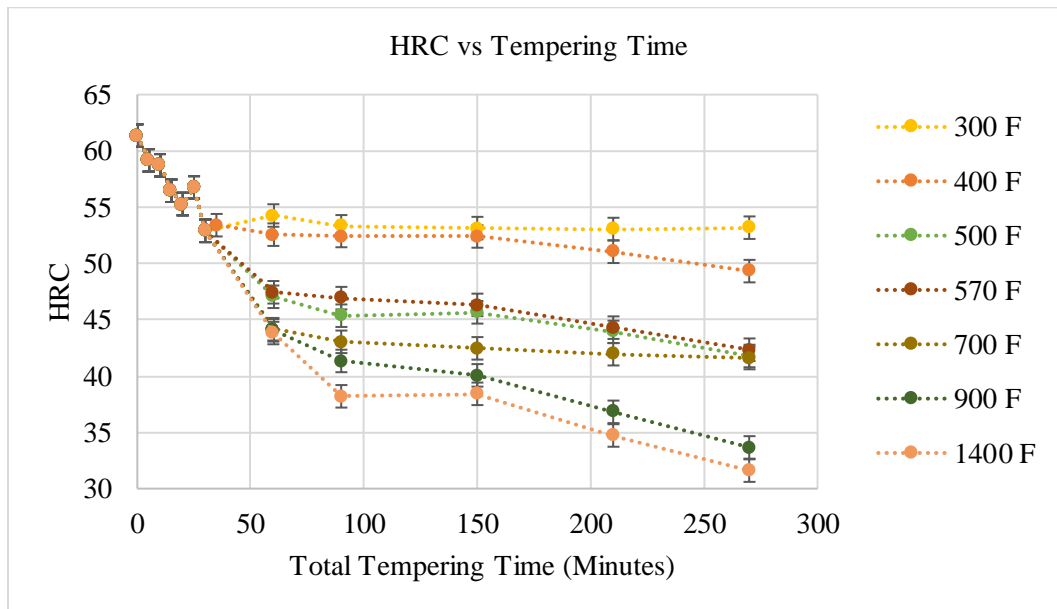
Figure 20: Over Tempering estimated through degradation in HRC at exposure to elevated temperatures. Heat Treatments begin with the 400°F temper followed by more tempering at separate temperatures.

The trends that emerge from the over-tempering experiment fit expected results. At low temperatures such as 300°F and 400°F prolonged exposure post the initial temper see plateaus in hardness around 52 HRC. This plateau effect is expected in low alloy steels, as the diffusion of carbon from Martensite during the tempering process is limited over time. It should be noted that the 300°F over

tempered sample emerged harder than the 400°F sample, which illuminates 4340 steel's propensity for air hardening. Once the exposure temperature is raised to 500°F, however, hardness immediately degrades, in the case of the experiment by around 10 HRC. All samples over tempered between 500-700°F plateaued in hardness at around 45 HRC. Exposure to extreme temperatures such as 900 and 1400°F (forging temperature of INCO718 and 718Plus) led to extreme degradations in hardness, reaching a low of 33 HRC. This over tempering stresses the necessity of cooling the mandrels, as over tempering is accelerated by elevated temperatures.

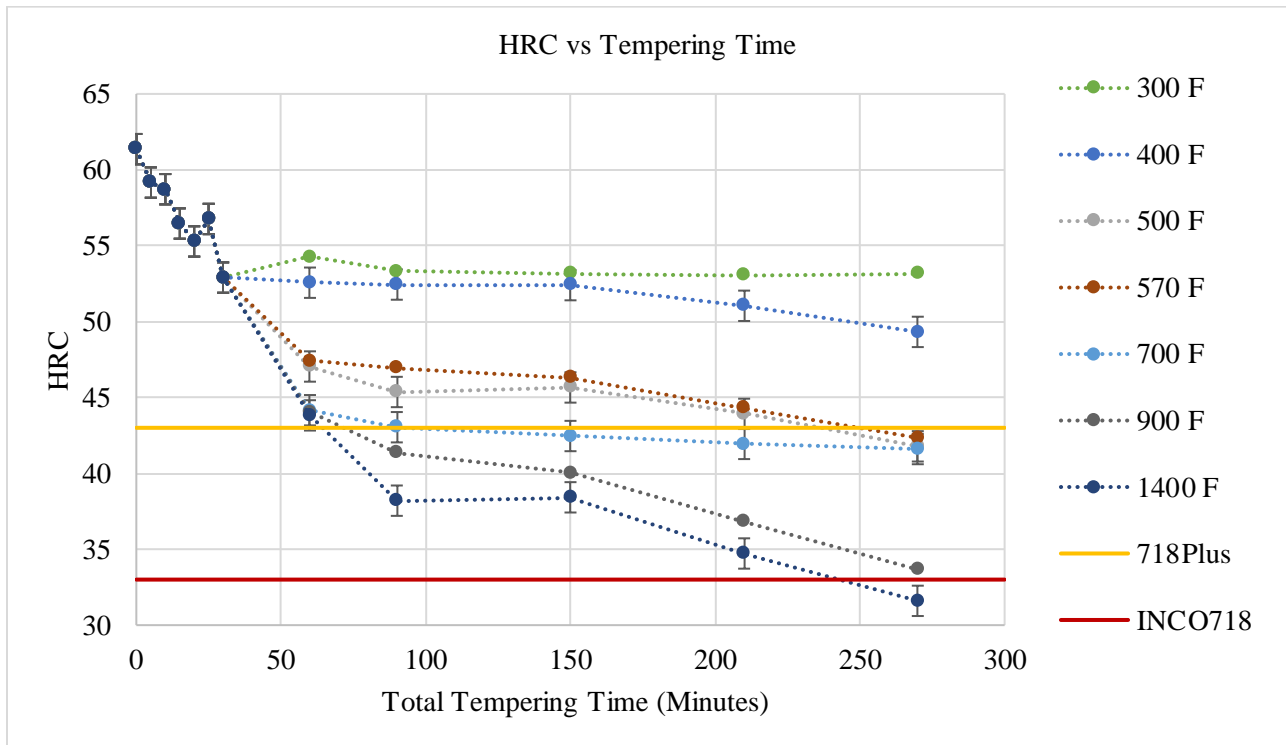
Figure 21: Hardness Degradation for Over tempering Experiment following initial CFW Heat Treatment. Values for the maximum HRC of 718Plus and minimum HRC of INCO718 plotted as constants.

The results of the over tempering experiment, however, produce a more interesting analysis in terms of quantifying and offsetting mandrel failure. With the HRC values of INCONEL components plotted on the hardness degradation charts from the over tempering experiment, a region for scarring of the mandrels could be identified between 33-43 HRC. The degradation charts also allow for temperature and time to be correlated to mandrel failure, with elevated temperatures sending steel samples into the scarring region faster. From this scarring region, the project has identified other regions which could be equated to a mandrel's lifetime. These regions are given in *Table V*.

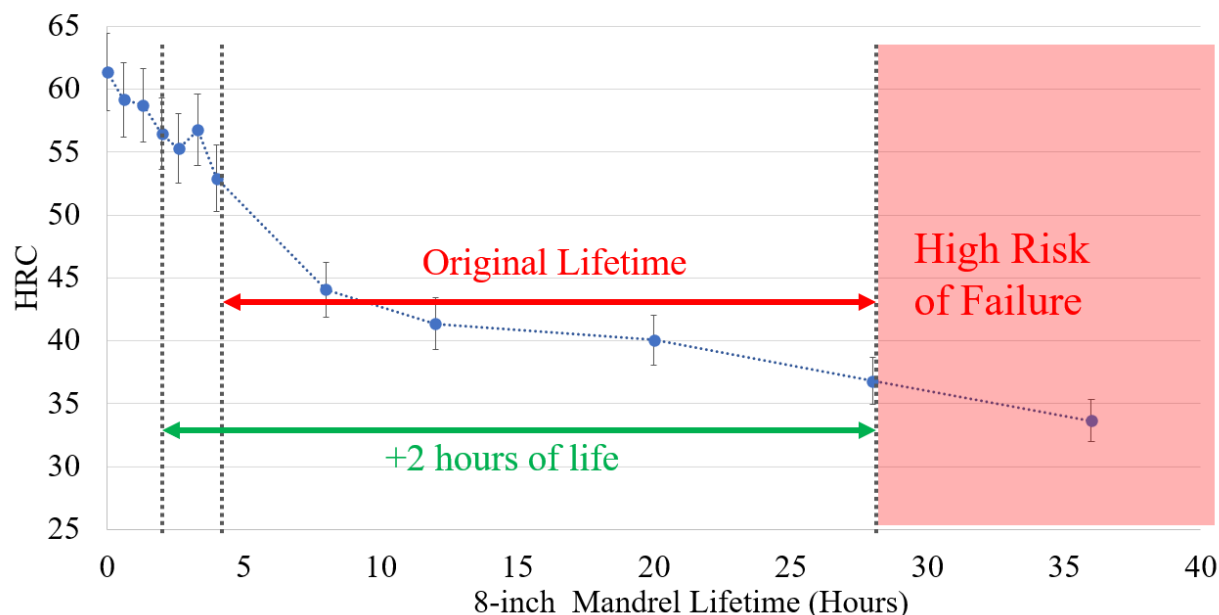
Figure 22: Estimated Lifetime of Mandrel (at 900°F) using the inch-per-hour standard. Shown in green is a reduction in initial temper increasing the overall lifetime of the component.

From the figure a means by which mandrel failure can be offset can be identified. If the CFW heat treatment is reduced from 4-hours to 2-hours, two hours of mandrel lifetime can be added. A 2-hour temper is more than sufficient to form tempered Martensite 2-inches into the bulk of a mandrel, but more importantly the offset in HRC degradation by 2-hours would give at minimum 2-hours of life back to the mandrel, which on the floor at CFW could save the company 4 to 5 batches of components.
