Executive Summary

The April 25, 2015 Gorkha (Nepal) Earthquake and its related aftershocks had a devastating impact on Nepal. The earthquake sequence resulted in nearly 9,000 deaths, tens of thousands of injuries, and has left hundreds of thousands of inhabitants homeless. With economic losses estimated at several billion US dollars, the financial impact to Nepal is severe and the rebuilding phase will likely span many years.

The Geotechnical Extreme Events Reconnaissance (GEER) Association assembled a reconnaissance team under the leadership of D. Scott Kieffer, Binod Tiwari and Youssef M.A. Hashash to evaluate geotechnical impacts of the April 25, 2015 Gorkha Earthquake and its related aftershocks. The focus of the reconnaissance was on time-sensitive (perishable) data, and the GEER team included a large group of experts in the areas of Geology, Engineering Geology, Seismology, Tectonics, Geotechnical Engineering, Geotechnical Earthquake Engineering, and Civil and Environmental Engineering. The GEER team worked in close collaboration with local and international organizations to document earthquake damage and identify targets for detailed follow up investigations.

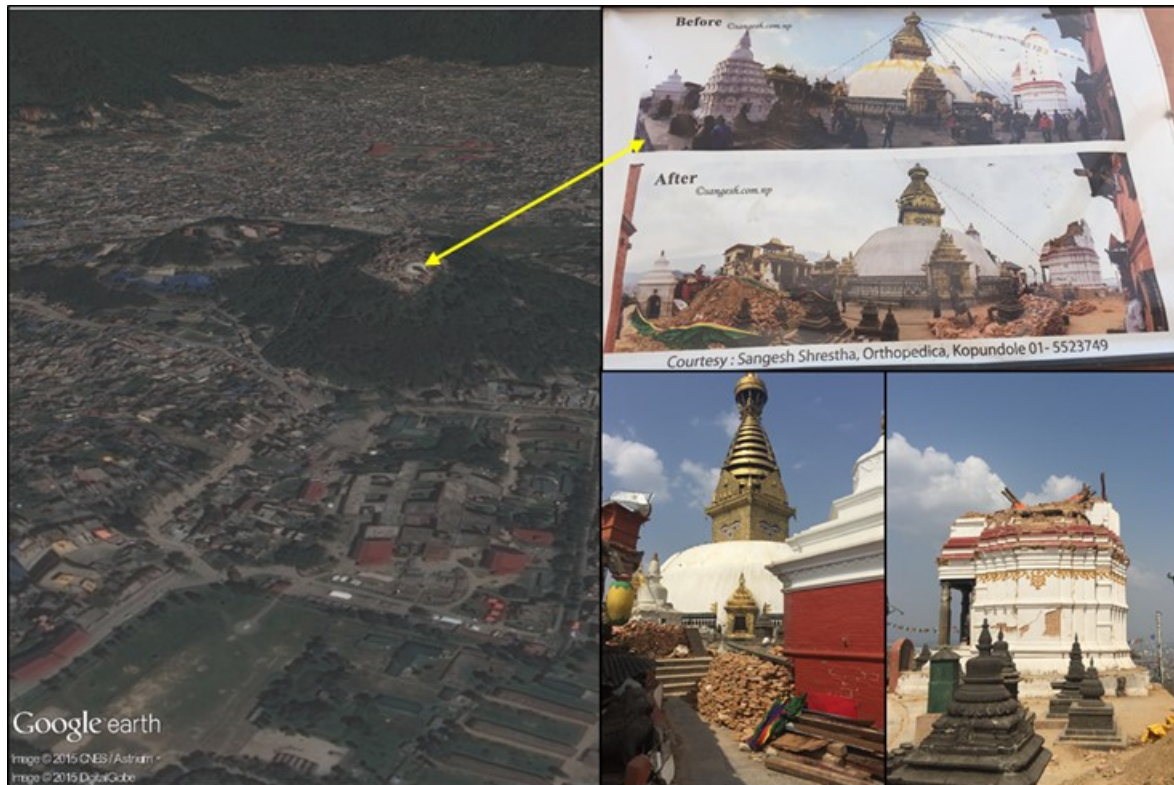
Figure 4-19 Damage in Swayambhu (Monkey) Temple (27.715270 N, 85.290231 E).

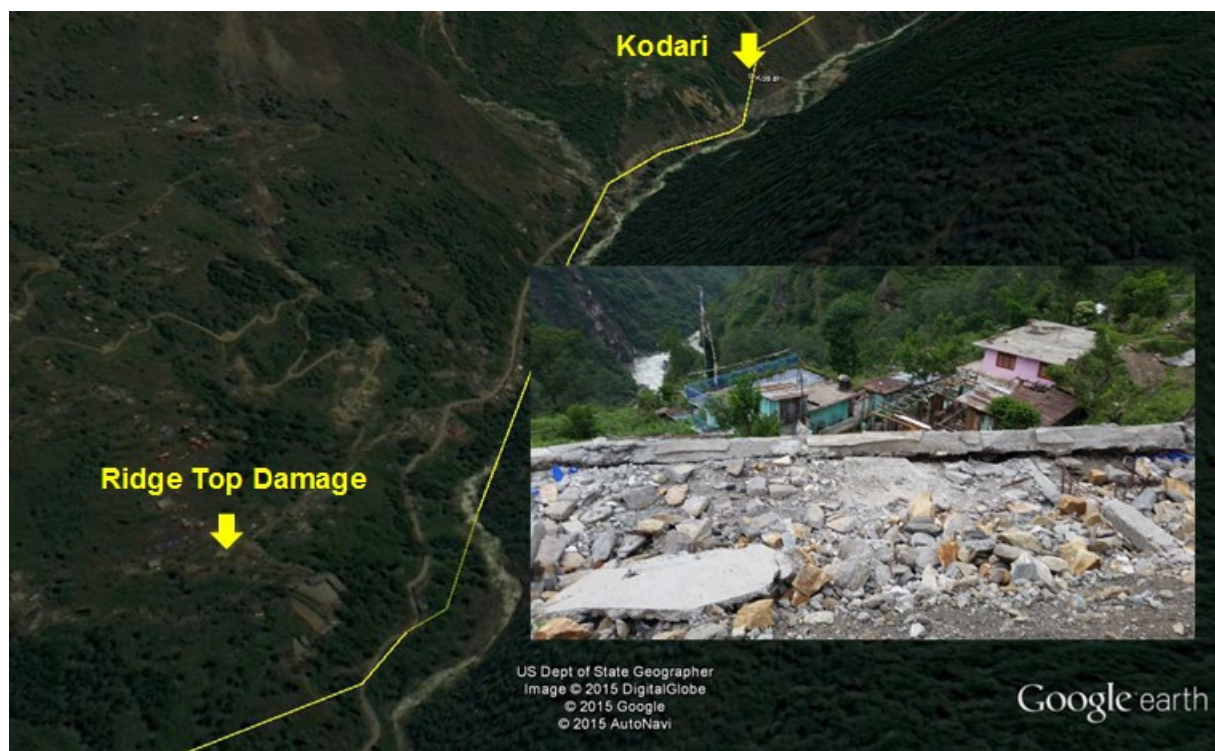
Figure 4-22 Ridge top damage and structure collapse, south of Kodari, near Chinese border (27 57' 31.9" N, 85 57' 17.7" E).

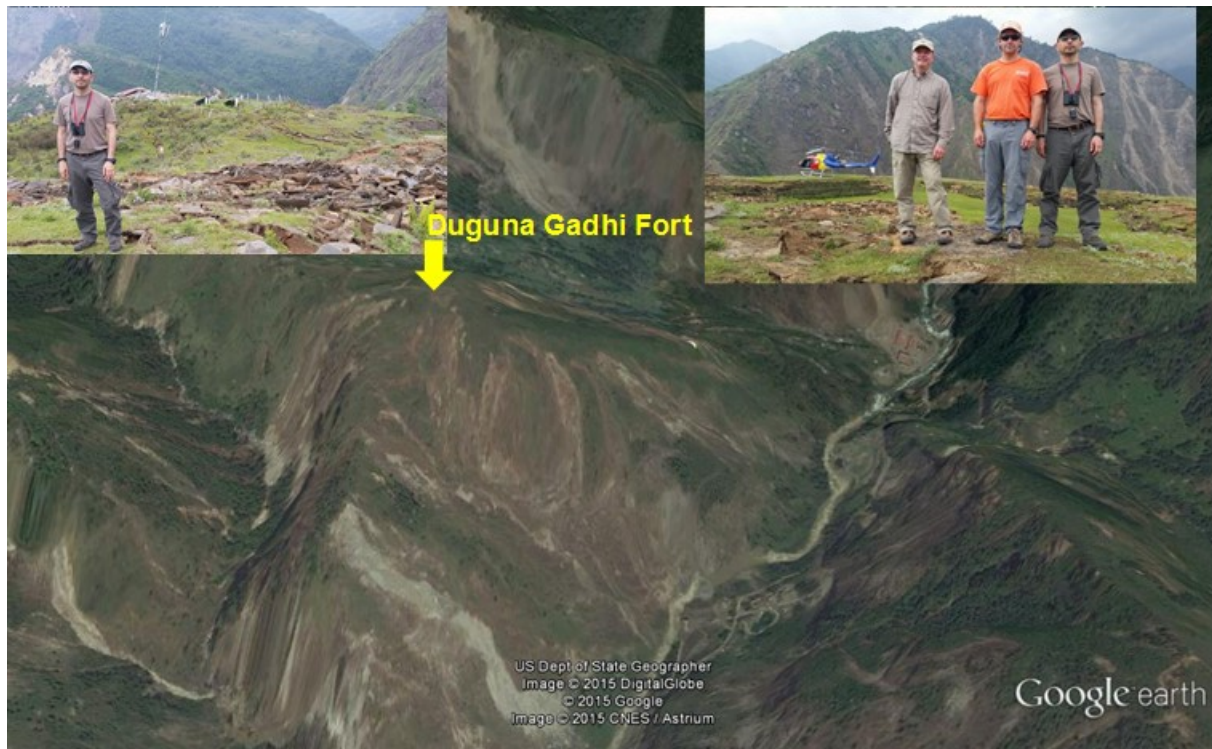
Figure 4-23 Shattered Ridge, Duguna Gadhi Fort (27 54' 59.4" N, 85 55' 2.38" E).

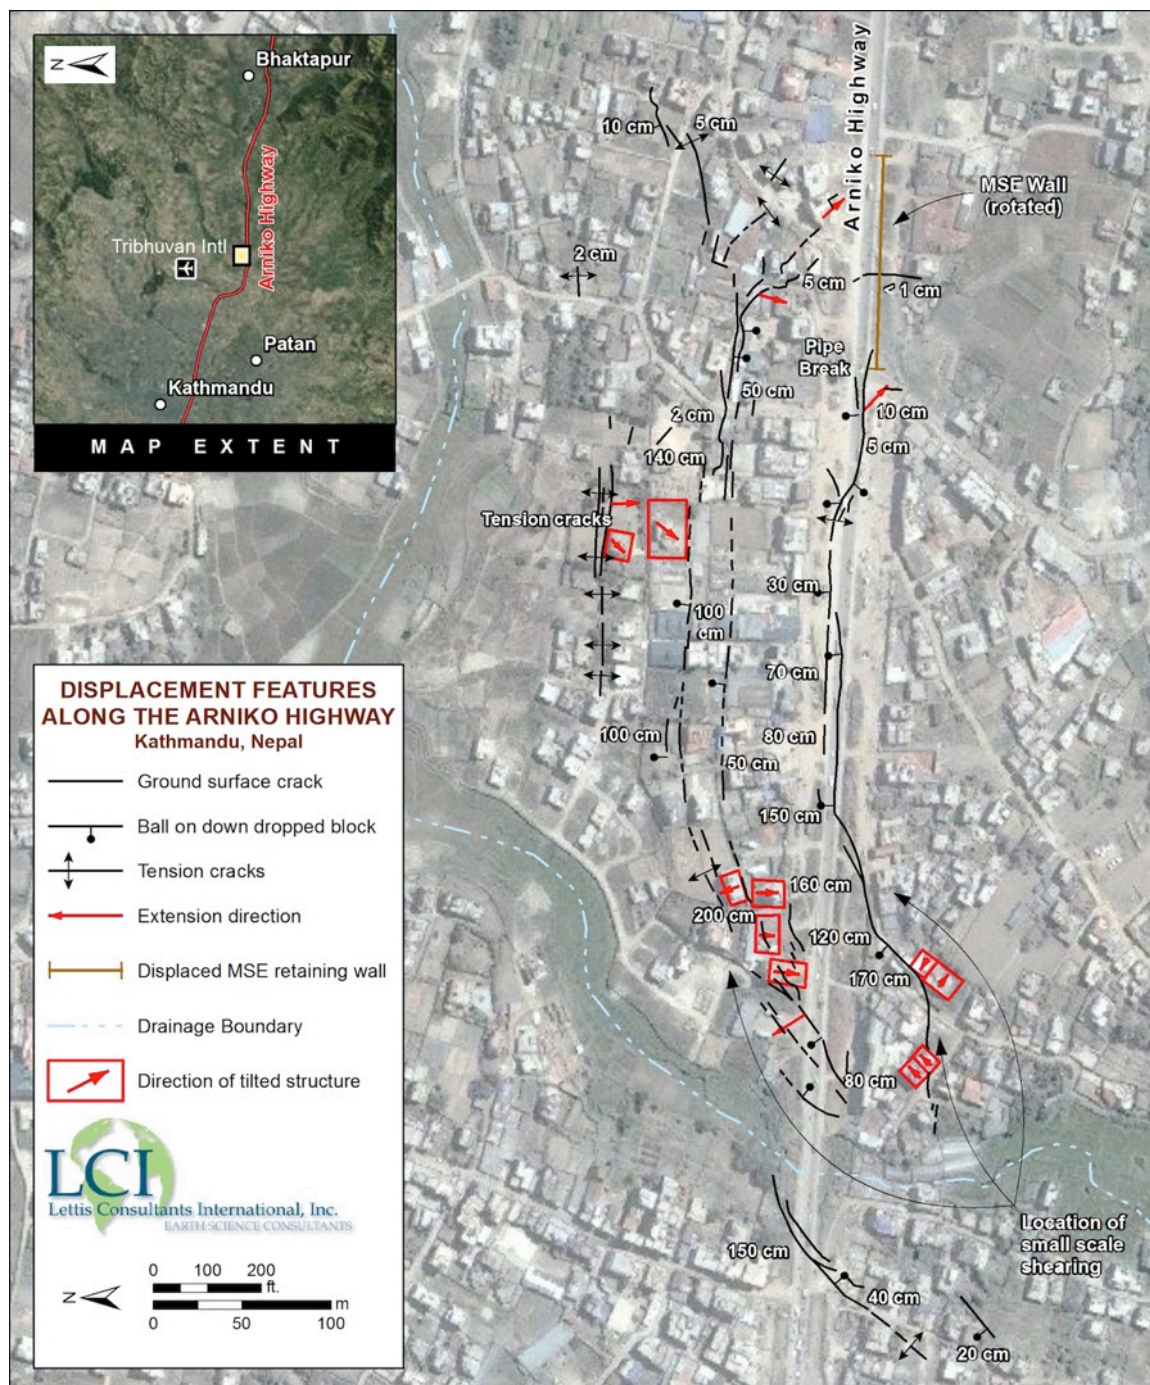
Figure 6-14. Cracks mapped at Lokanthali site (27.674816° 85.362646° and surrounding region). Vertical displacements on the order of 1m, horizontal displacements on the order of 0.5m, with fissure roughly 2 m deep.

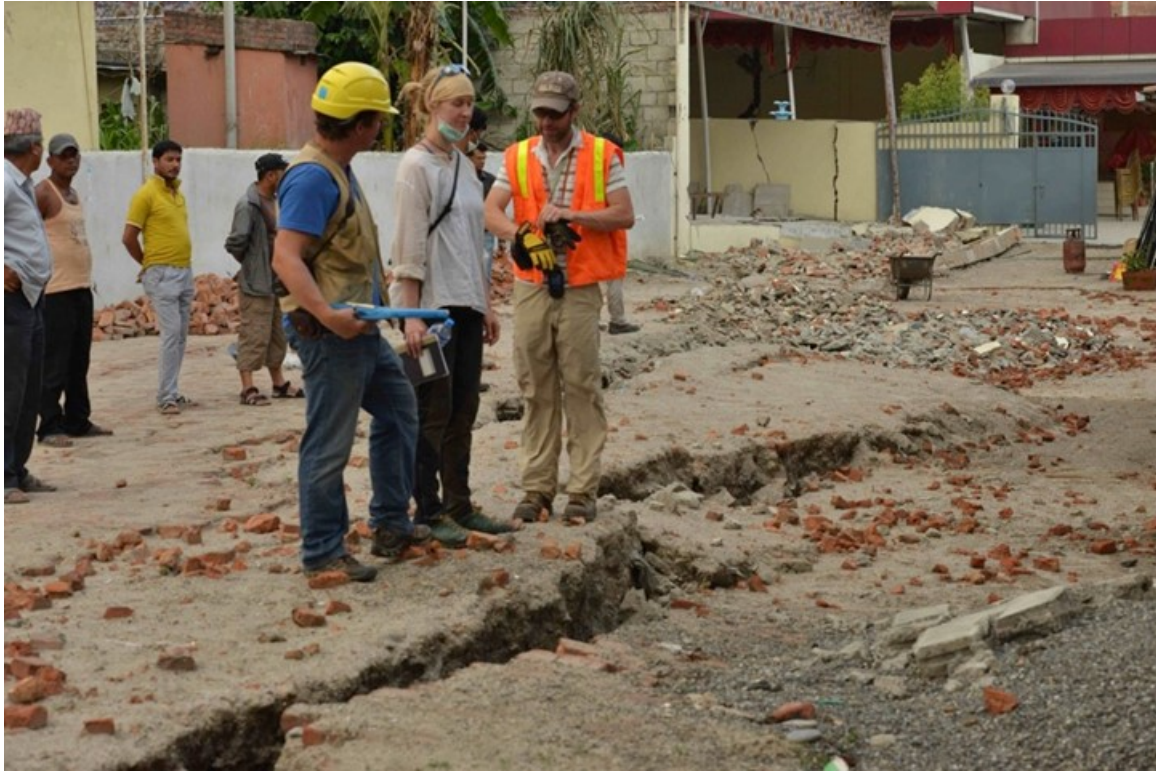
Figure 6-15 Cracks near the top of the rise in Lokanthali (27.674816° 85.362646° and surrounding region). Depth of cracks 2 to 3 m deep. Most of the deformation was reported to have occurred during the first aftershock, with only a small amount of deformation from the mainshock.

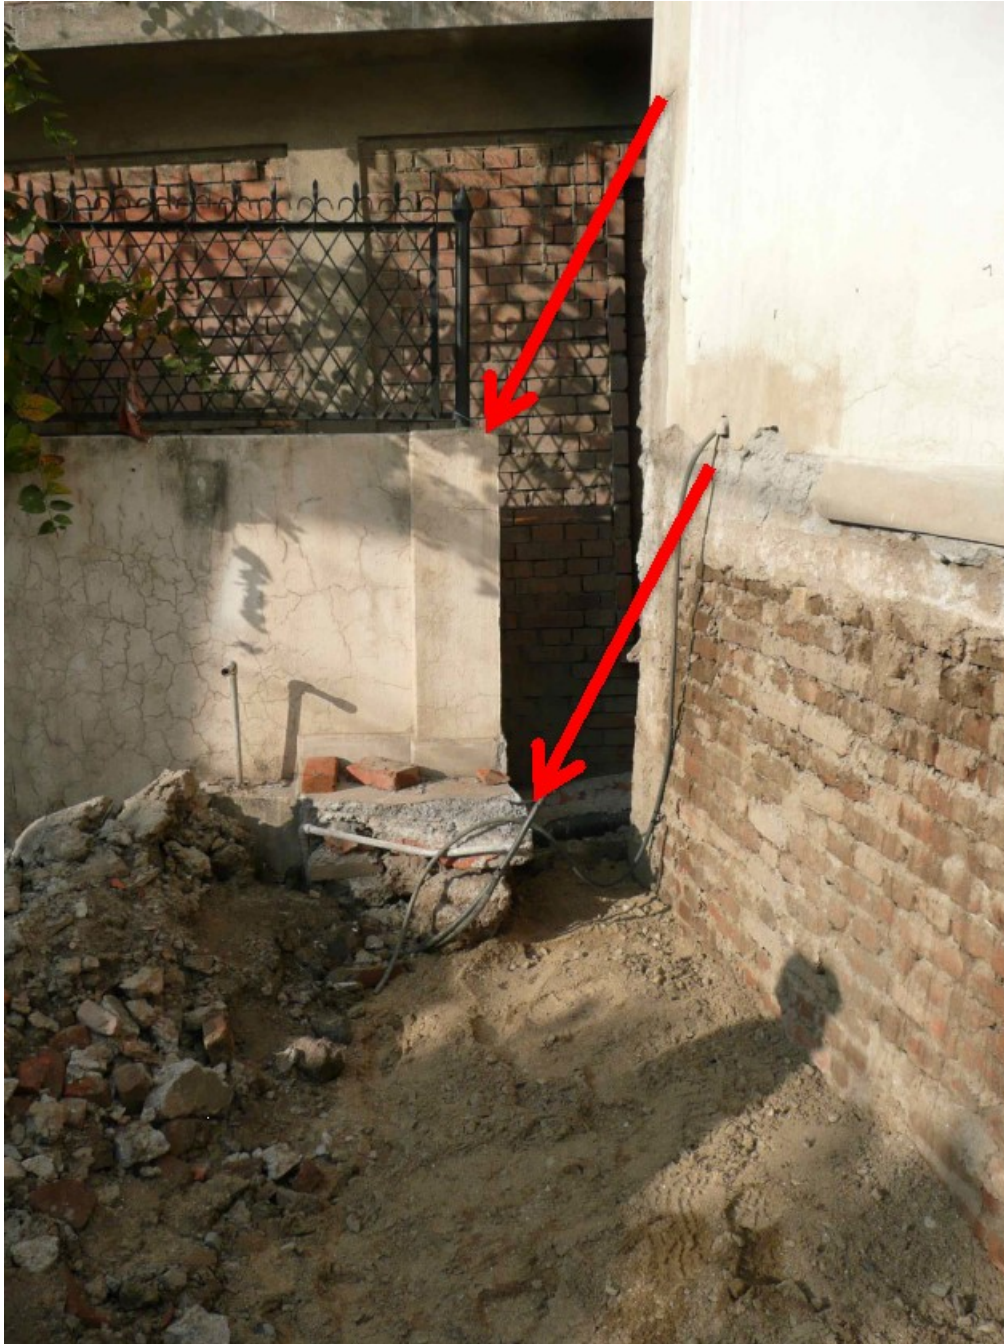
Figure 6-19. House on the hanging wall of the crack. The ground pulled away from the structure dropping upwards of 3/4 m and moving laterally 1/2 m. Before the earthquake the brick foundation was completely below the ground surface.

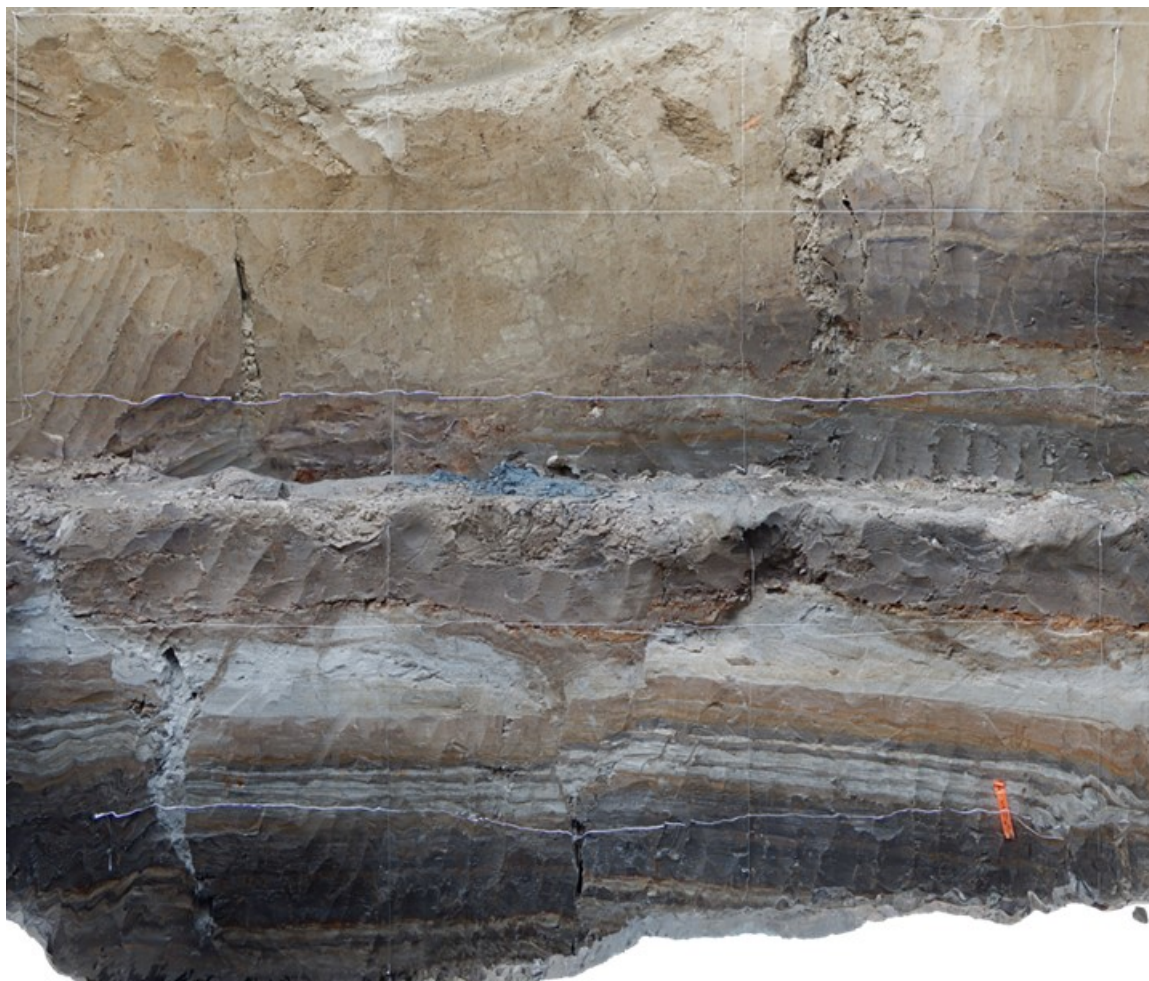
Figure 6-21. Cross section perpendicular to scarp at EMT09. Horizontal and vertical spacing of the string is 0.5 m and 1.0 m, respectively (27.675524 N, 85.363083 E).

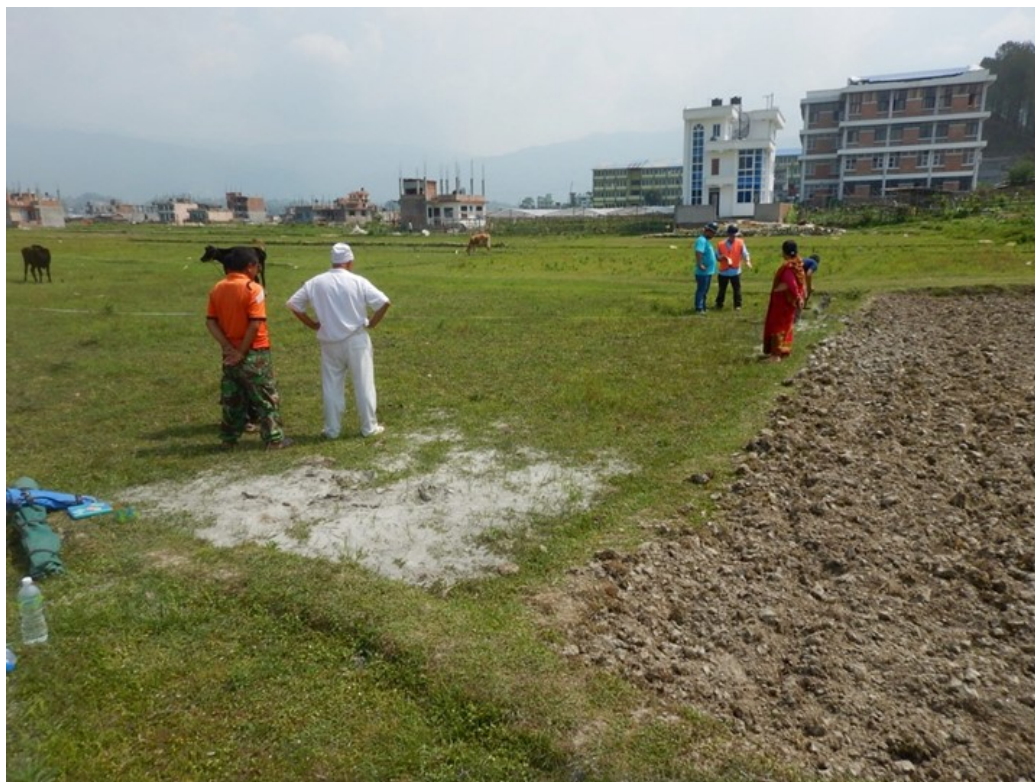
Figure 6-24. Sand boils in Changu Narayan (27.70943 N, 85.41397 E).

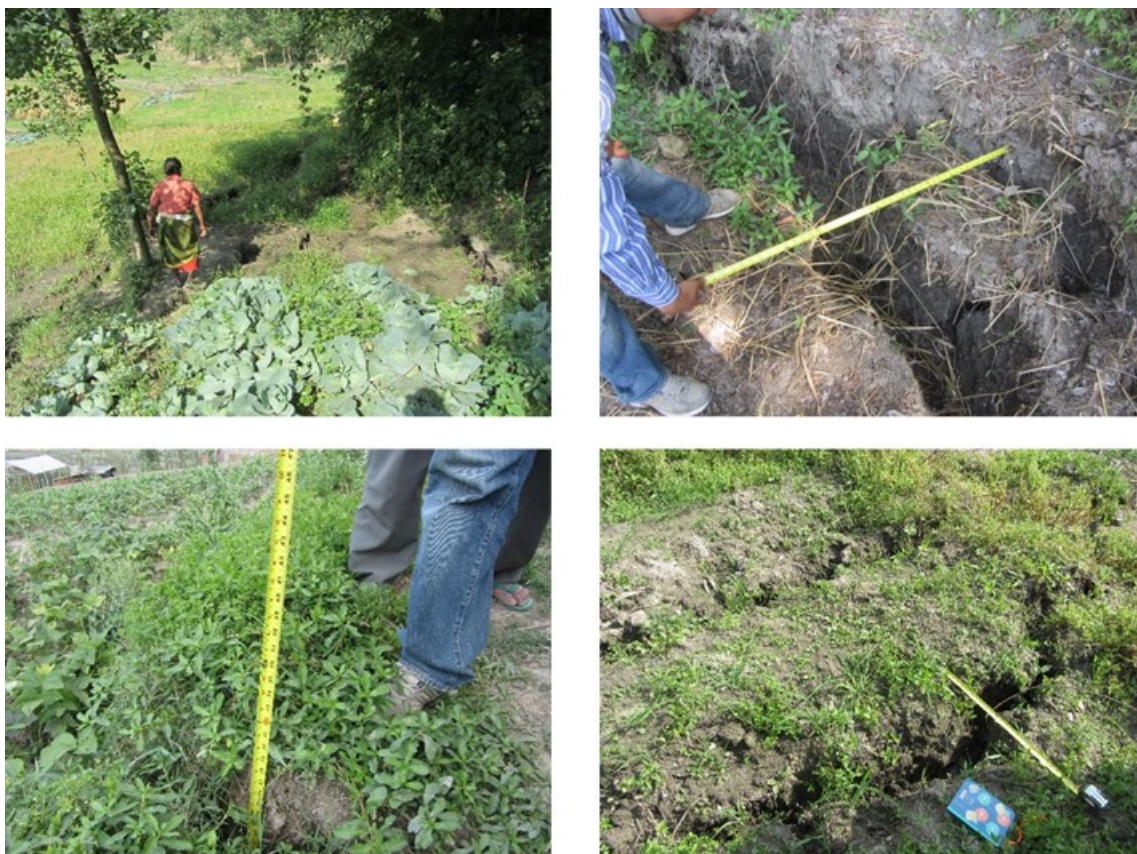
Figure 6-30 Observed surface cracks ~250m long, up to 0.8m wide, and up to 1.5m deep
(Location: 27°40'42.20" N, 85°26'13.12" E)

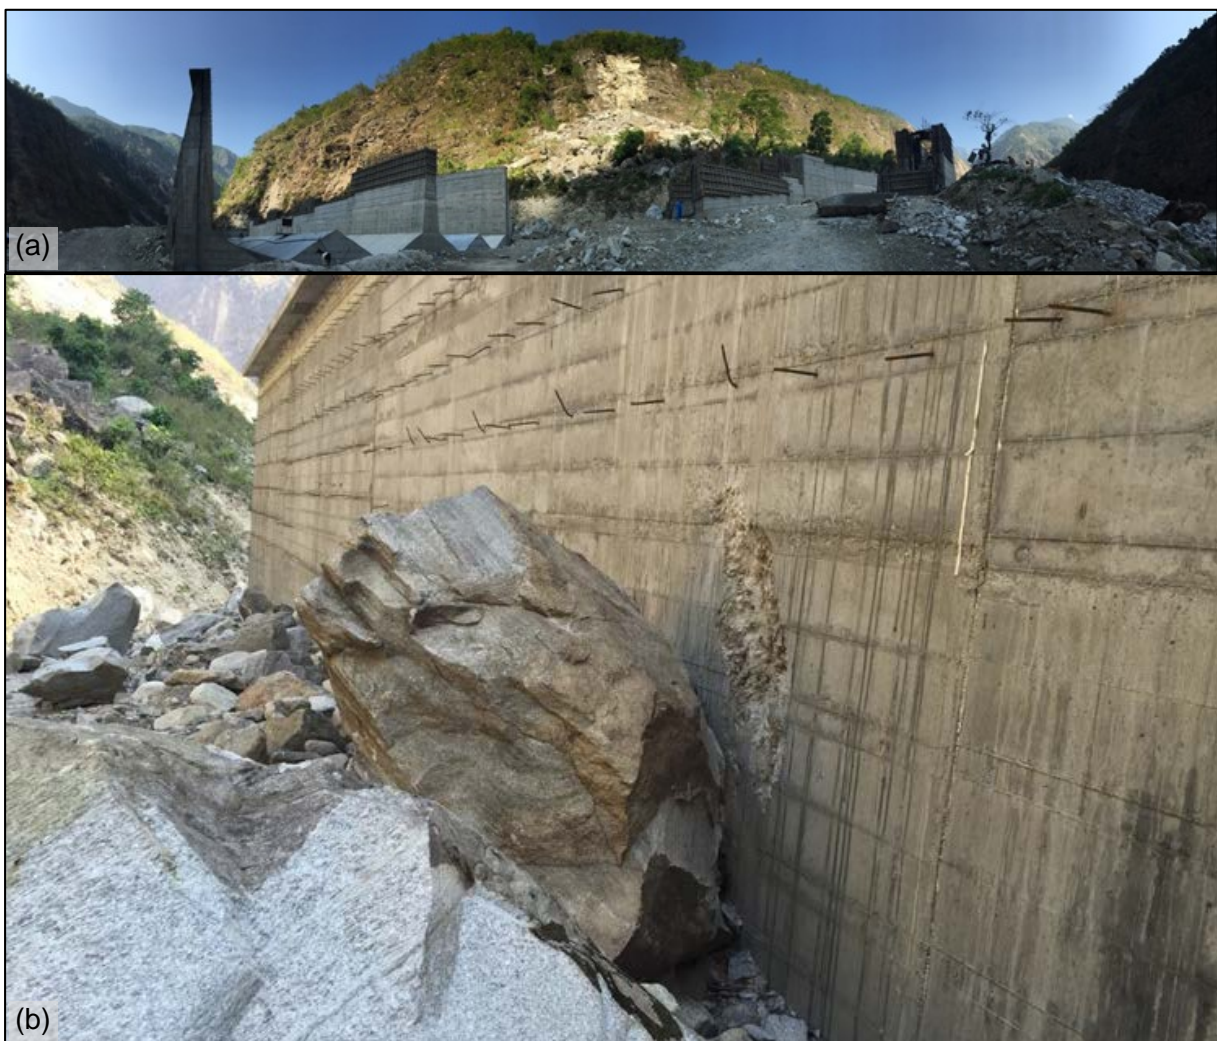
Figure 7-9 Sand trap under construction downstream of the headworks diversion dam were impacted by rockfall from above. Damaged observed was not consequential. (a) 28°3'41.77" N, 85°12'24.74" E, (b) 28°3'40.03" N, 85°12'23.69" E

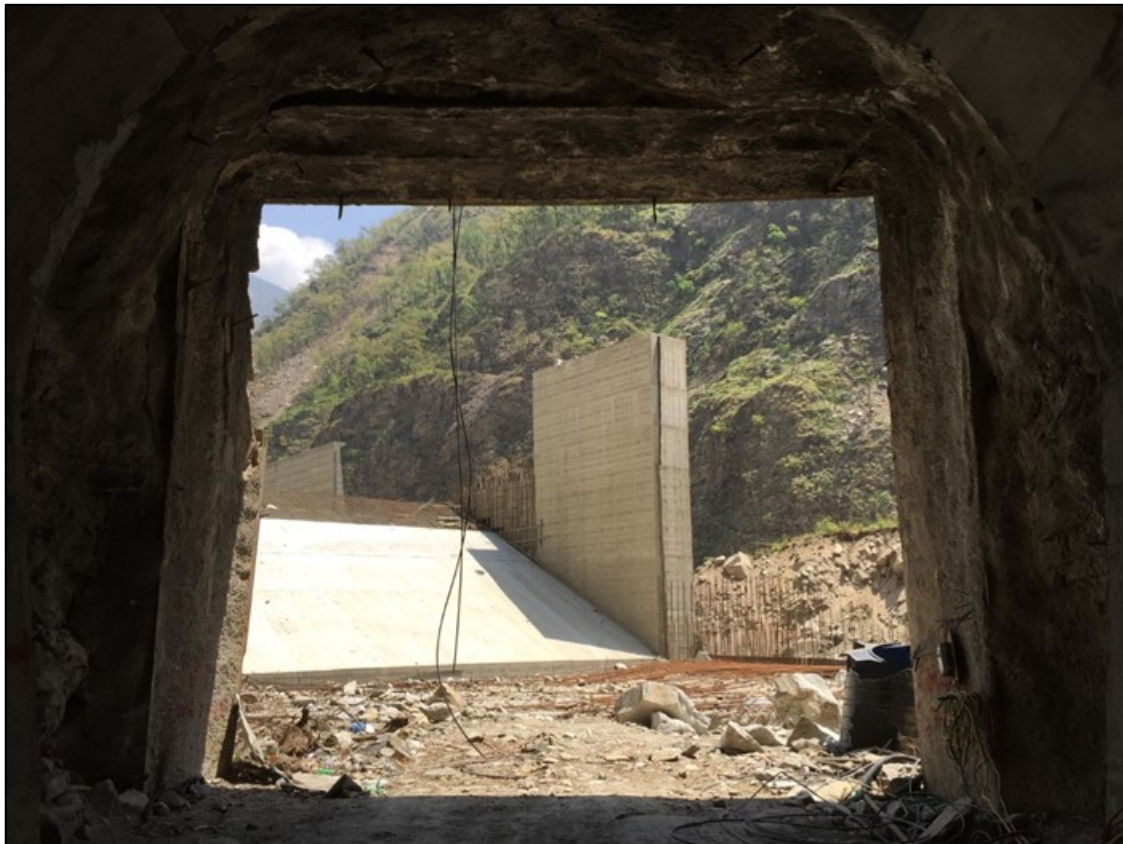
Figure 7-10 Scattered rockfall debris observed outside portal entrance with risk of continued rock fall evident. View is upstream toward dam (not shown) (28°3'36.20" N, 85°12'24.21" E).

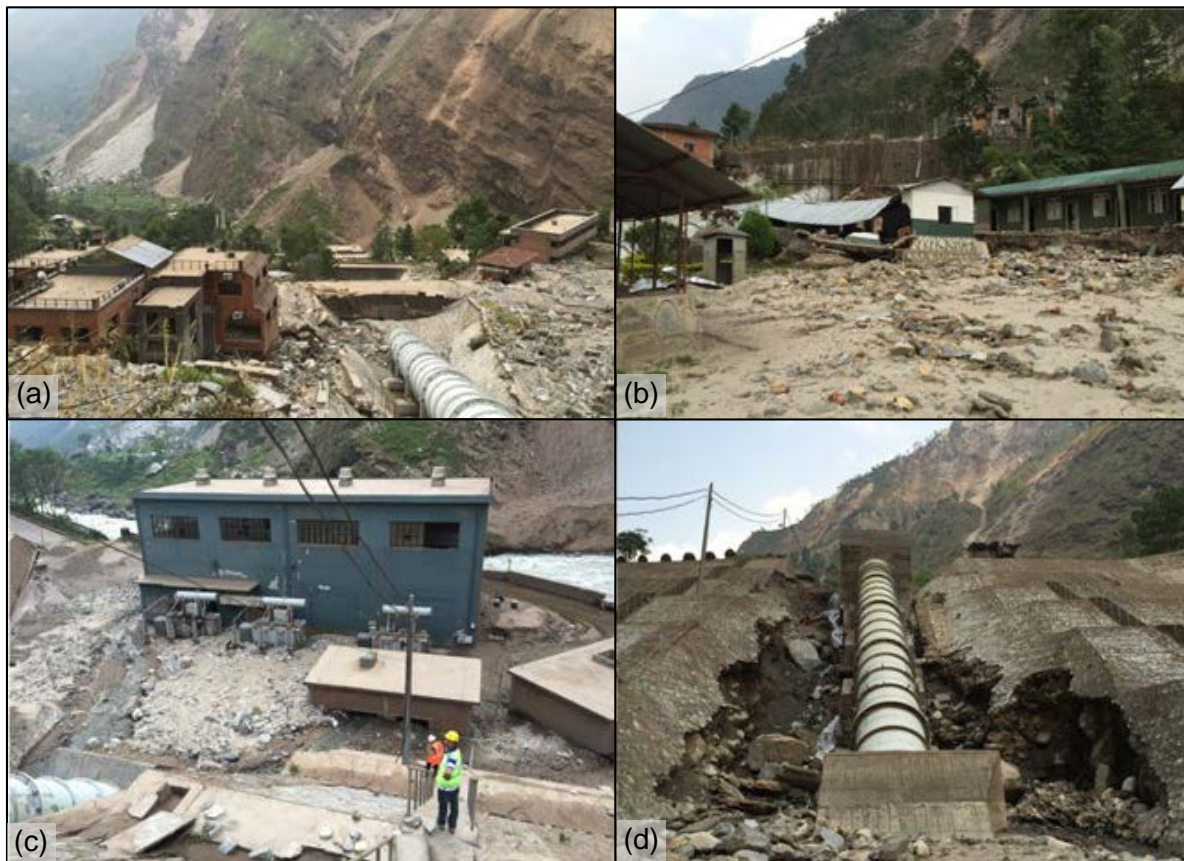
Figure 7-17 (a) Debris flow damage (27°54'45.77" N, 85°55'38.00" E), (b) Debris flow damage the workers colony (27°54'44.47" N, 85°55'32.87" E), (c) powerhouse, showing debris that has accumulated to the top of doorways in the powerhouse area (27°54'45.67"N, 85°55'28.23"E), (d) penstock liner (27°54'45.32" N, 85°55'27.15" E)

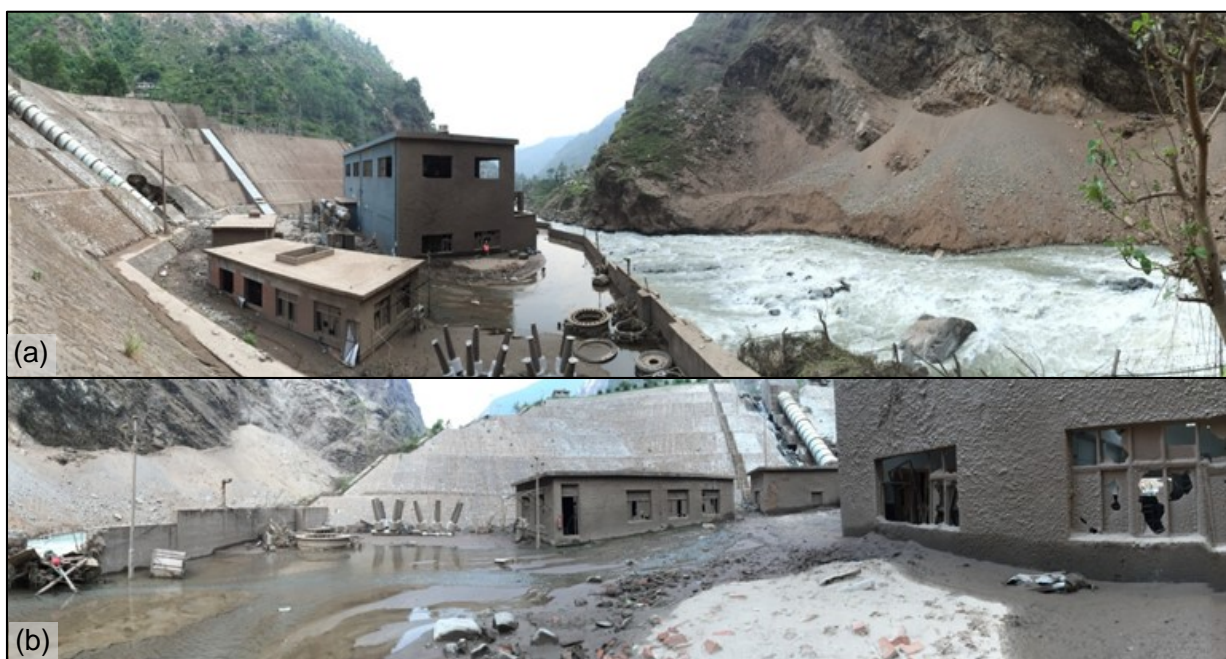
Figure 7-18 A debris plume and water from the impact of the rock fall across the river is hypothesized to have broken windows and resulted in the silt coating on river-facing walls of the powerhouse (contrast blue walls facing away from river with brown, silt coated walls)

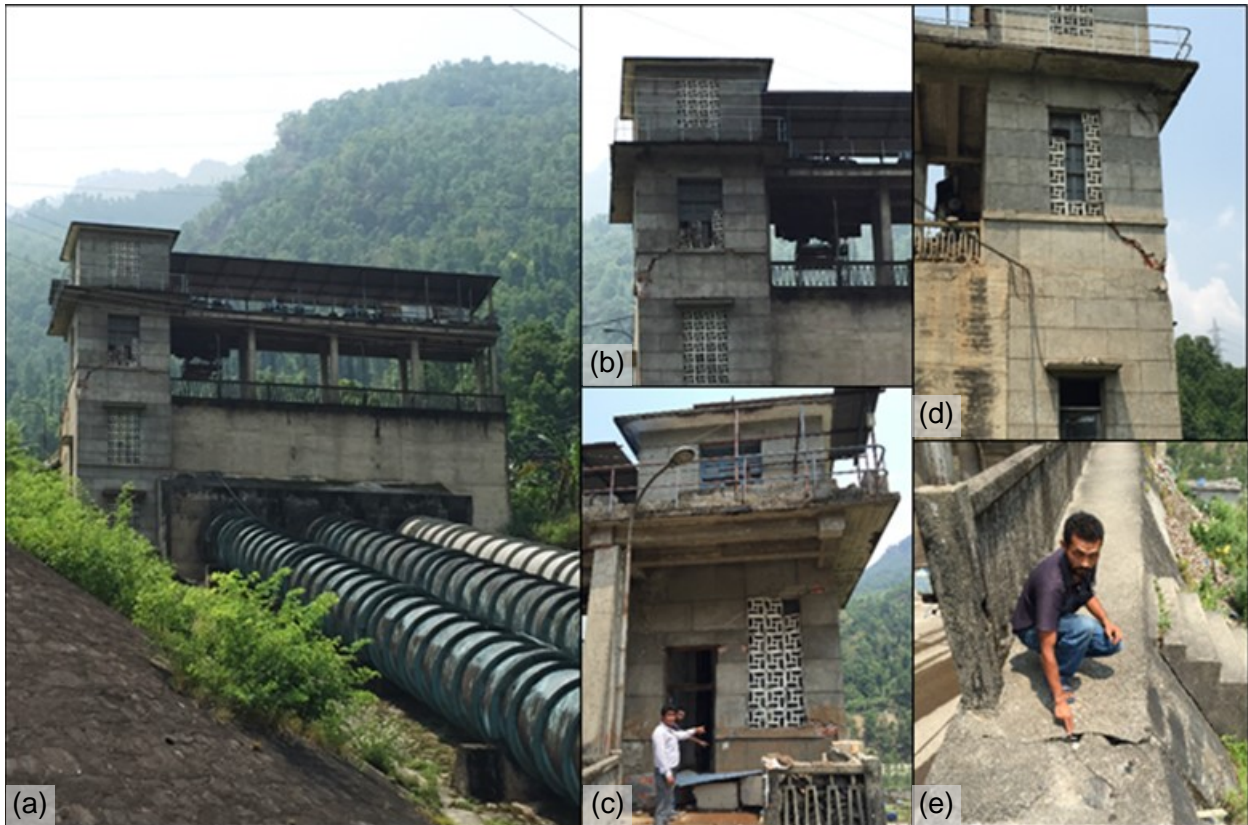
Figure 7-21 Structural damage observed in the intake structure of Sunkoshi powerhouse. Significant shear cracks were observed in the upper structure after the May 12th M 7.3 aftershocks. No significant damage was observed in the penstock (27°45'10.66" N, 85°50'17.70" E).

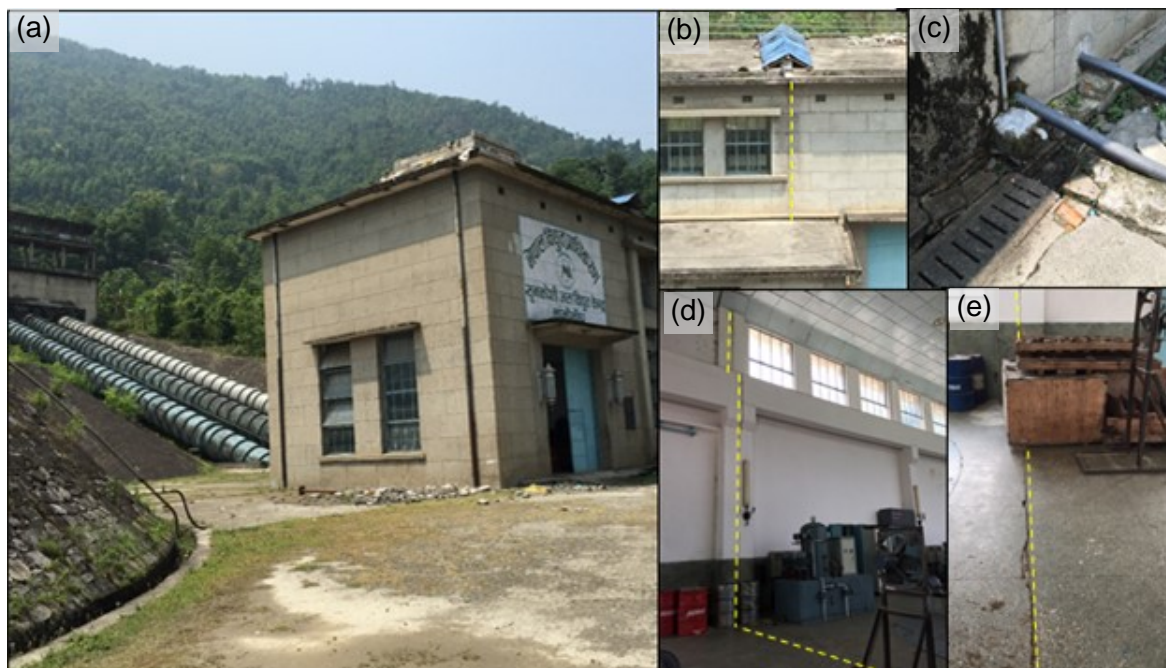
Figure 7-22 A continuous crack running through the walls and the floor is observed in the powerhouse structure. This observed crack can be potentially due to the differential settlement across the power plant structure, which can be further supported by the cracks and slight vertical offset observed in the pavement shown on the upper left side (7-21 $27^{\circ}45'13.96''\text{N}$, $85^{\circ}50'17.26''\text{E}$).

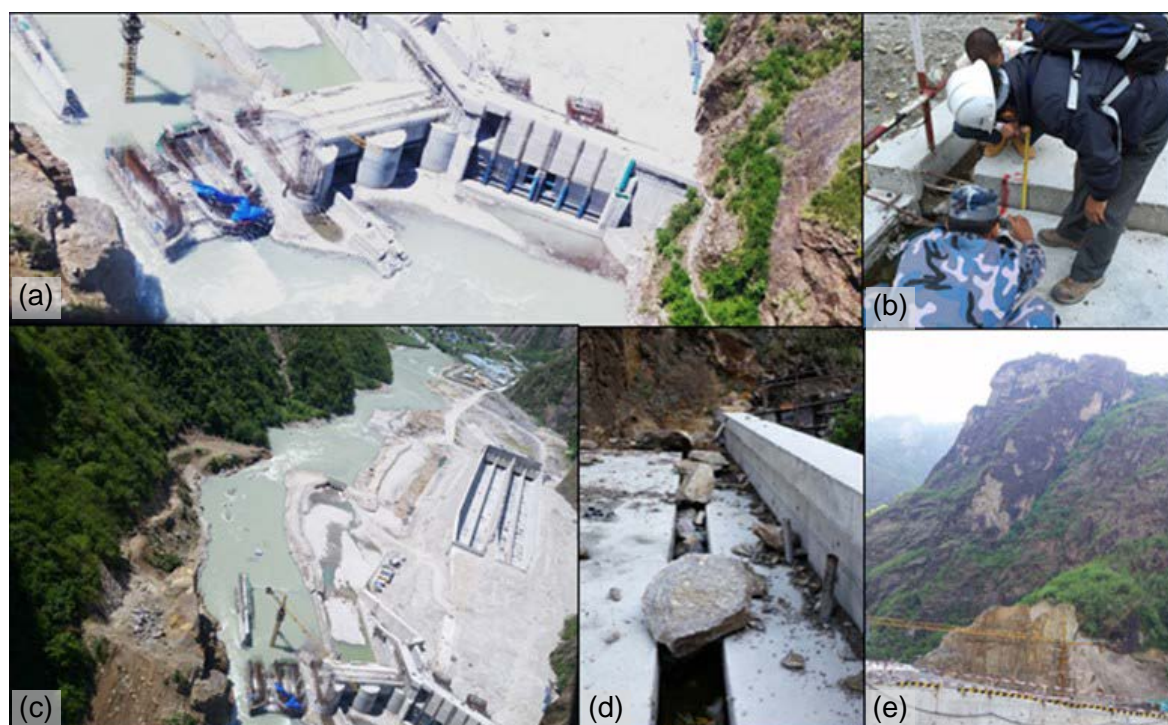
Figure 7-24 Damages observed at the Upper Tamakoshi Powerplant. (a) Aerial image of the headworks, (b) the settlement at the headworks, (c) breached cofferdam, (d) rockfalls, (e) steep slopes at the abutments.(27 55' 29.8" N, 86 12' 46.4" E)

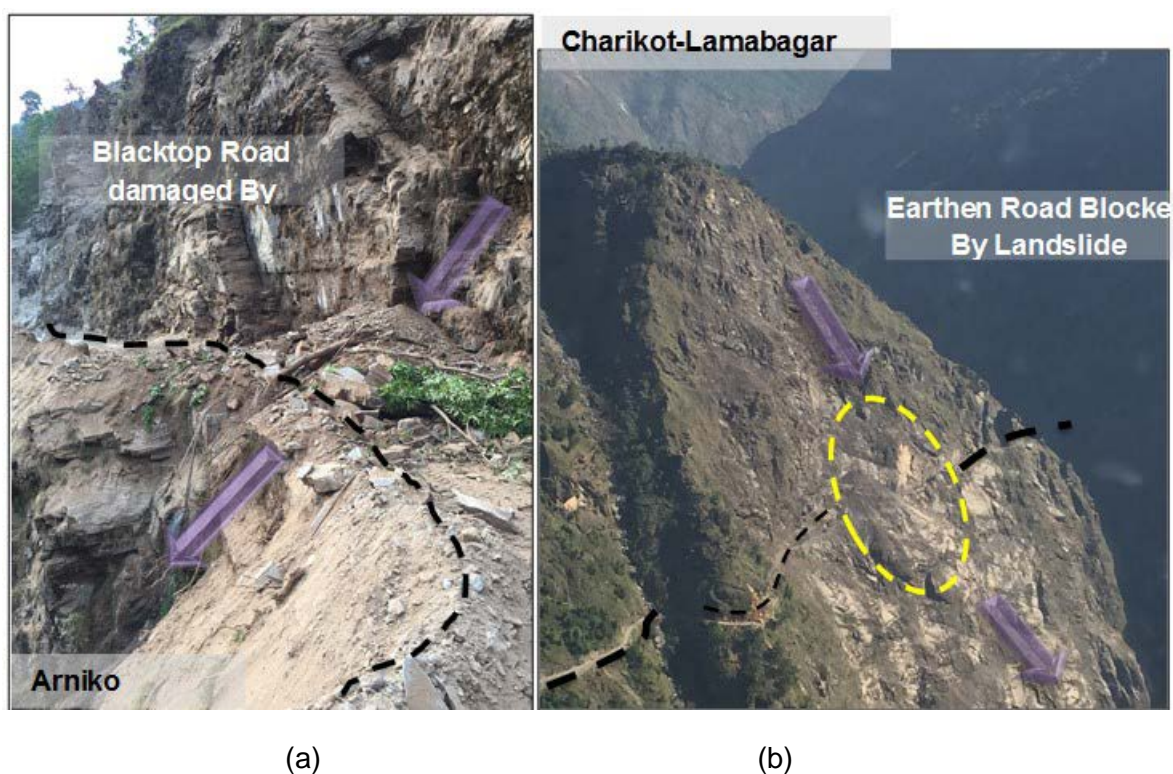
Figure 8-2 Interruptions and damage on roadways caused by the earthquake-induced landslides, (a) 27 52' 15.9"N 85 53' 15.9"E, (b) 27 52' 19.1"N 86 13' 20.7"E.

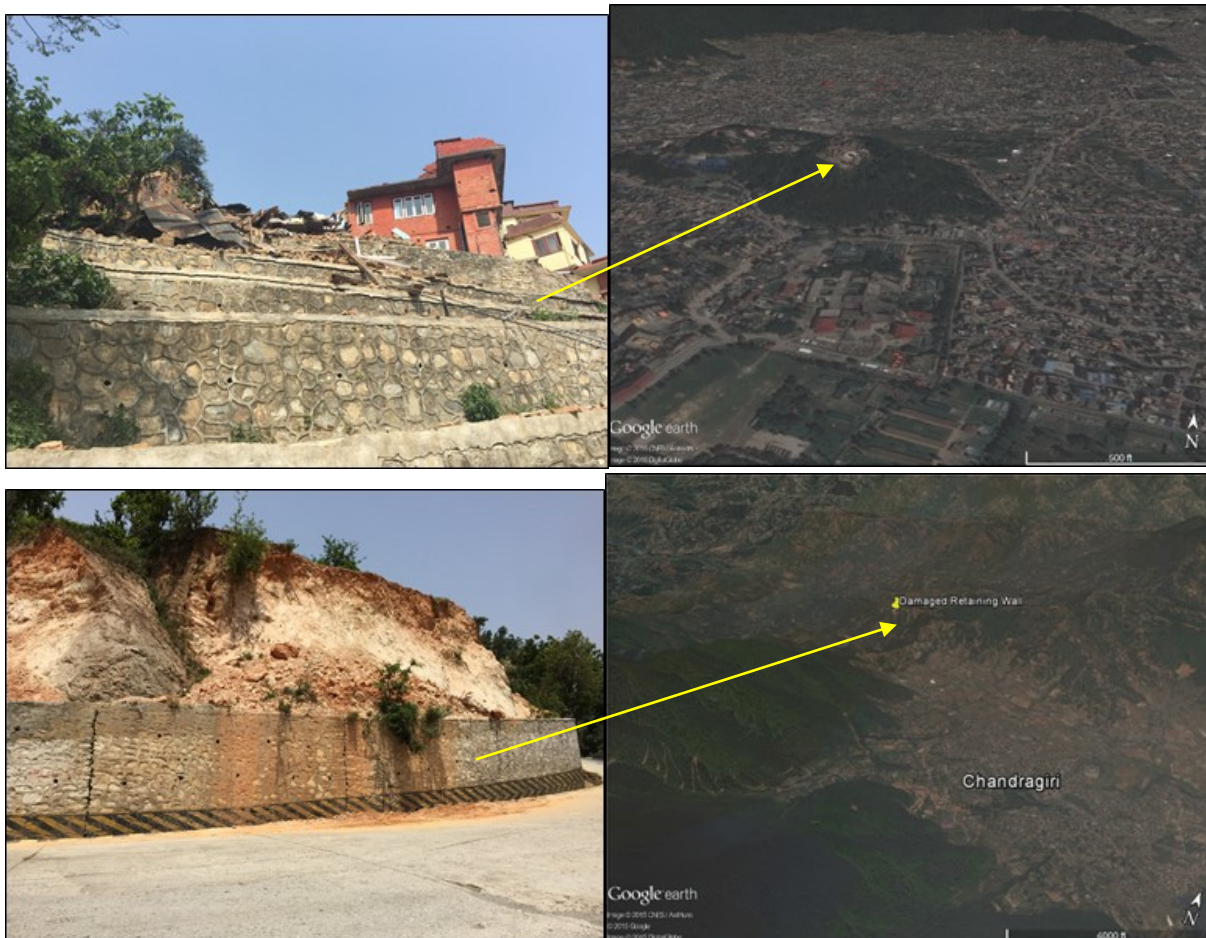
Figure 8-17 Retaining wall damage observed at the ridges (a) around Monkey Temple, Kathmandu (27 42' 54"N 85 17' 23.5"E) (b) around western basin edge of Kathmandu valley (27 42' 51.5"N, 85 11' 59.7"E).

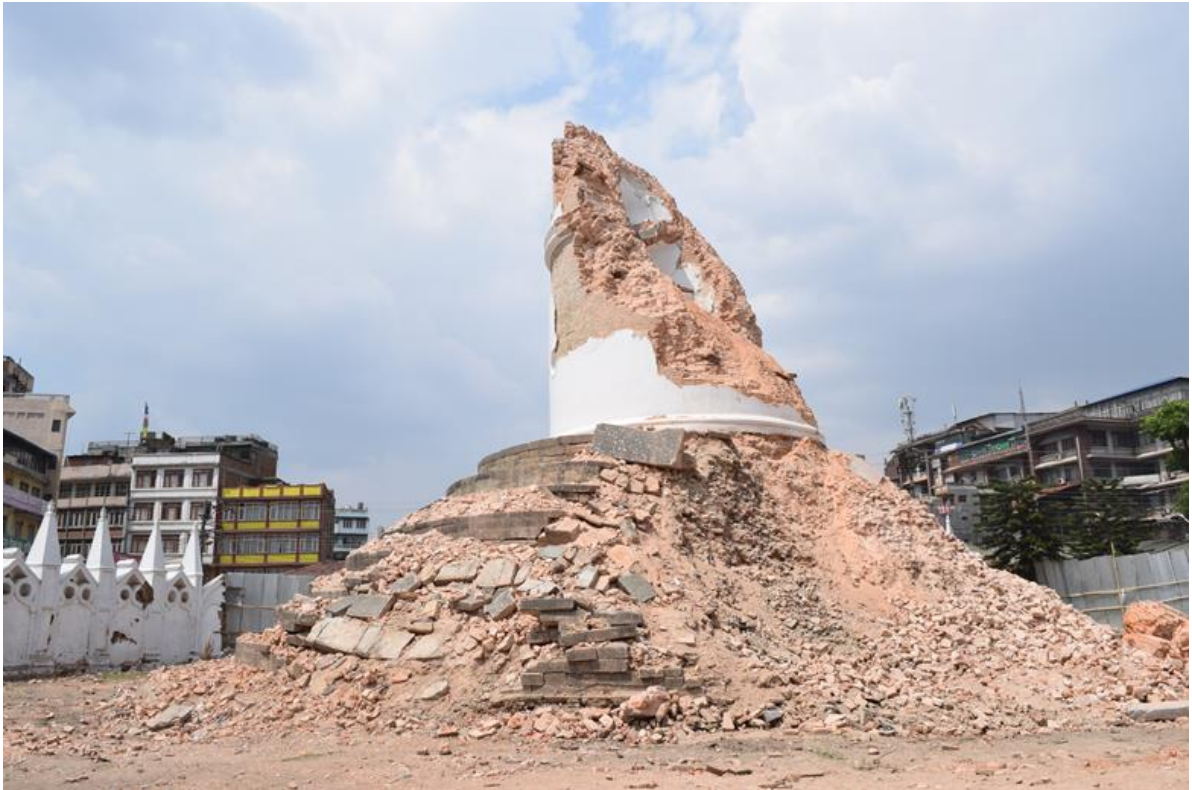
Figure 9-1 Seven story tall Bhimshen Tower collapsed due to earthquake shaking ($27^{\circ}42' 2.23''$ N, $85^{\circ}18'43.11''$ E).

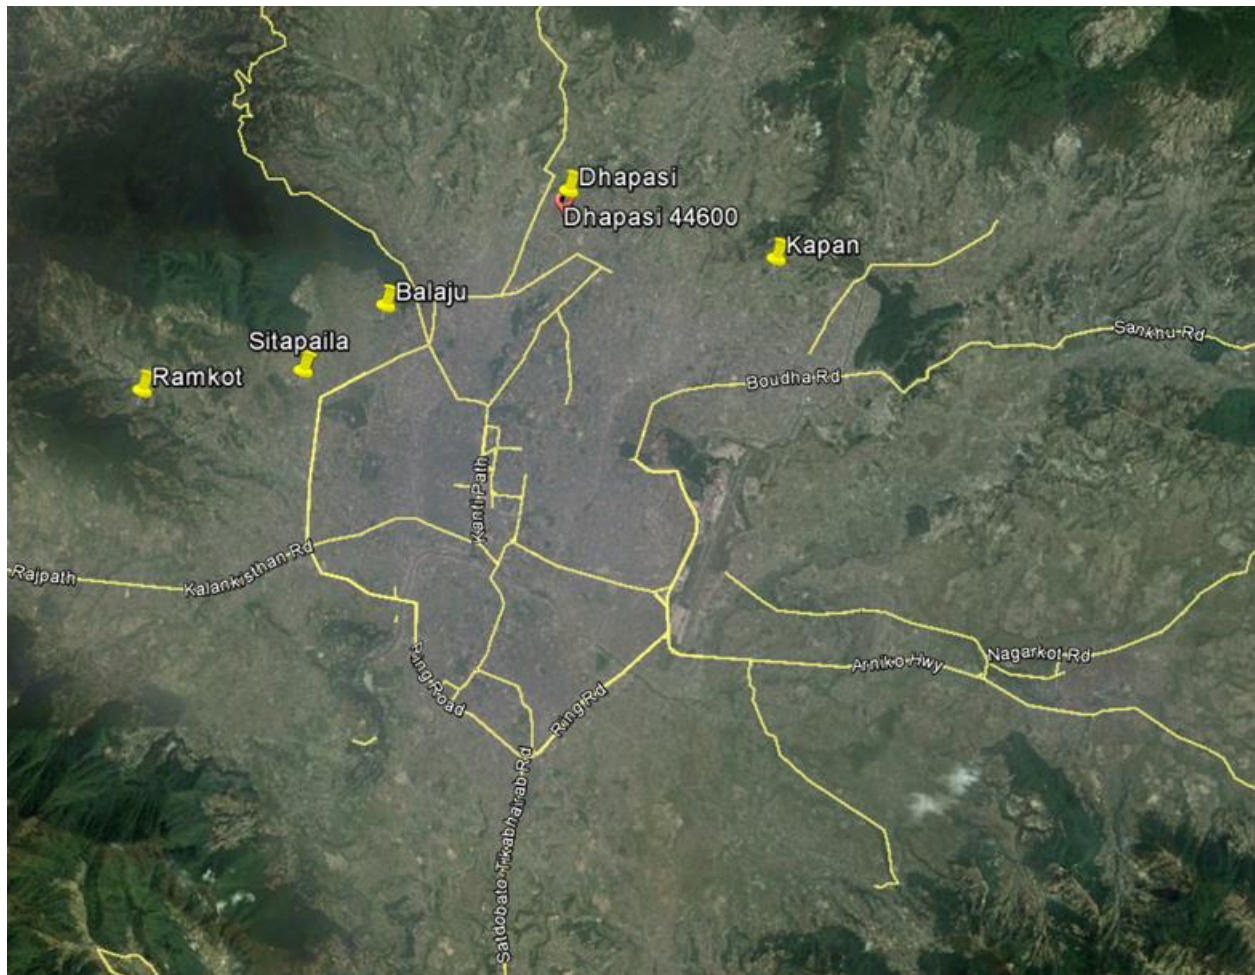
Figure 9-2 Major structural damage observed at Kathmandu Valley

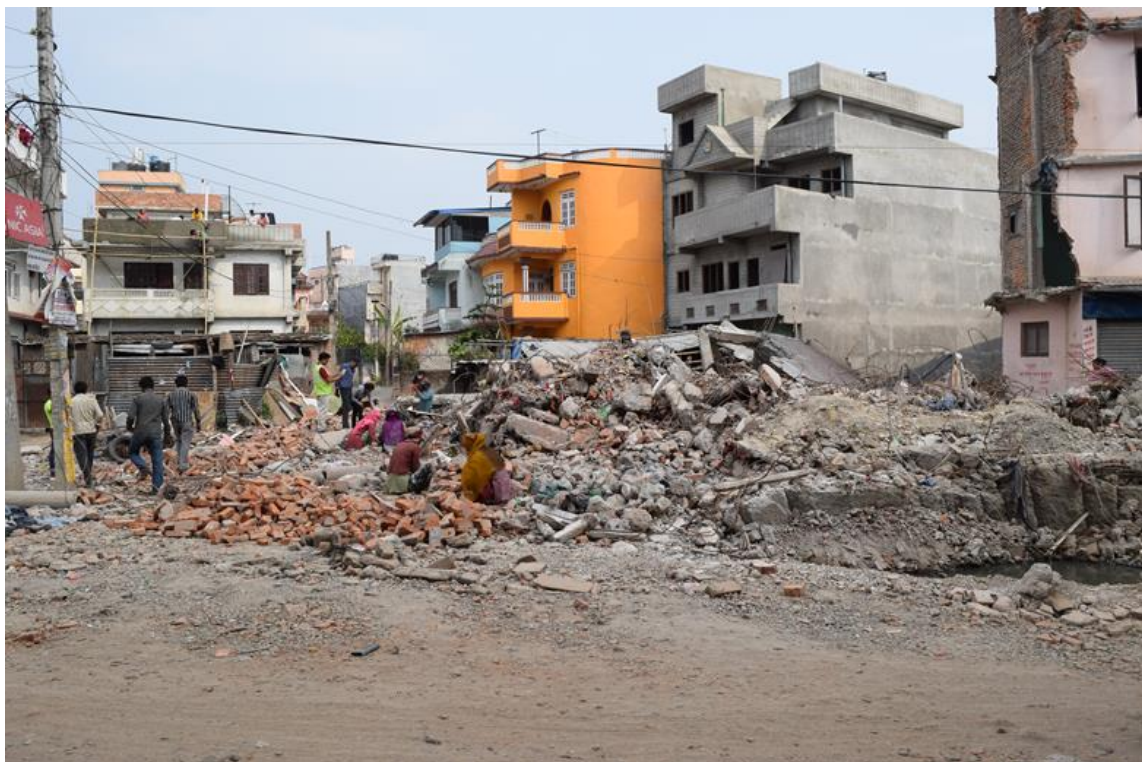
Figure 9-4 A 7 story building collapsed at Kapan after the ground shaking due to the M_w 7.8 Gorkha Earthquake. A total of 40 people died at this building ($27^{\circ}43'26.15''$ N, $85^{\circ}21'30.75''$ E).
