Executive Summary

The April 25, 2015 Gorkha (Nepal) Earthquake and its related aftershocks had a devastating impact on Nepal. The earthquake sequence resulted in nearly 9,000 deaths, tens of thousands of injuries, and has left hundreds of thousands of inhabitants homeless. With economic losses estimated at several billion US dollars, the financial impact to Nepal is severe and the rebuilding phase will likely span many years.

The Geotechnical Extreme Events Reconnaissance (GEER) Association assembled a reconnaissance team under the leadership of D. Scott Kieffer, Binod Tiwari and Youssef M.A. Hashash to evaluate geotechnical impacts of the April 25, 2015 Gorkha Earthquake and its related aftershocks. The focus of the reconnaissance was on time-sensitive (perishable) data, and the GEER team included a large group of experts in the areas of Geology, Engineering Geology, Seismology, Tectonics, Geotechnical Engineering, Geotechnical Earthquake Engineering, and Civil and Environmental Engineering. The GEER team worked in close collaboration with local and international organizations to document earthquake damage and identify targets for detailed follow up investigations.

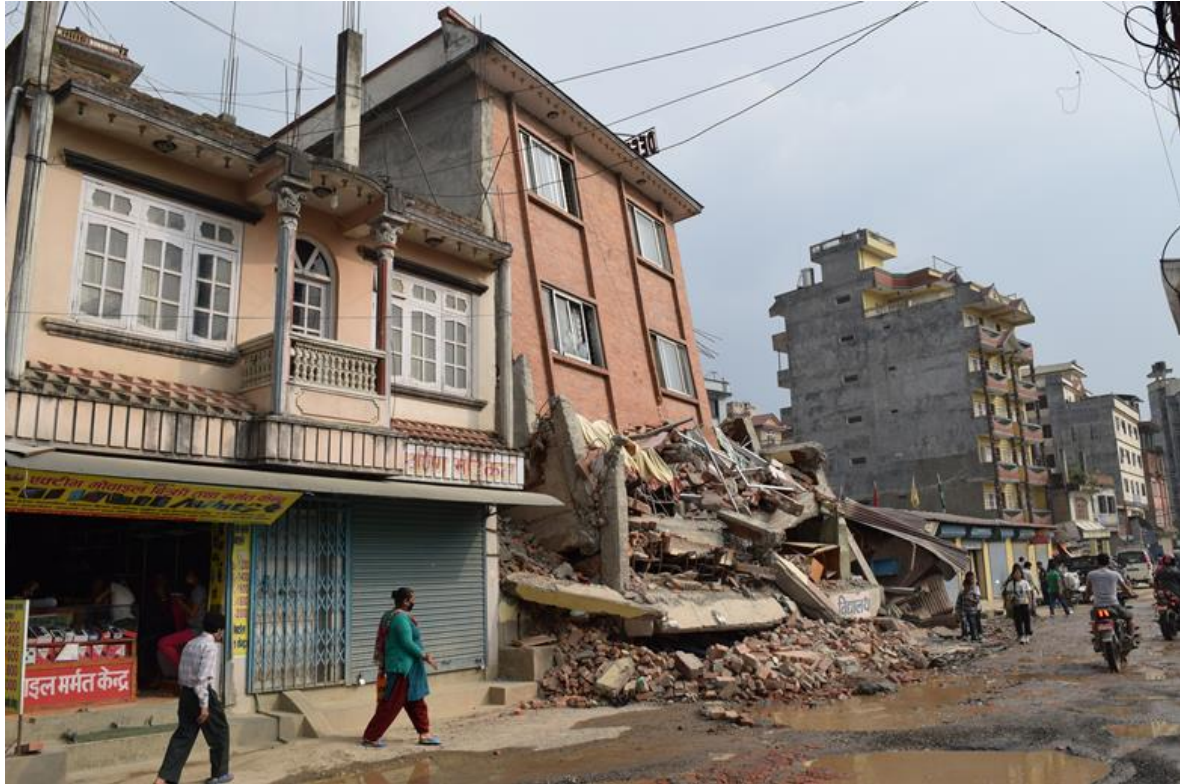
Figure 9-7 Structural damage of a RCC frame structure at Gogabu Bus Park near Balaju ($27^{\circ}44'7''$ N, $85^{\circ}18'29''$ E).

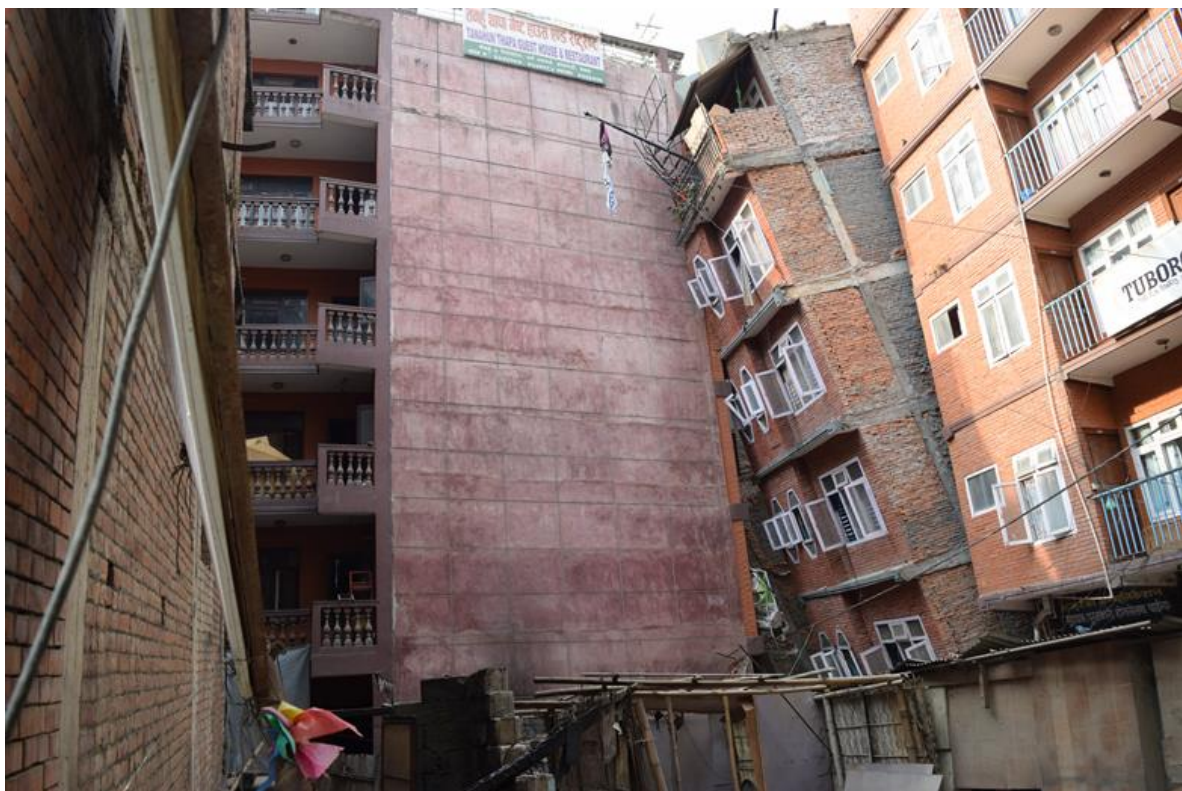
Figure 9-8 Soft story collapse of a six story building near Gogabu Bus Park. Three buildings were completely damaged in the neighborhood that killed over 20 people ($27^{\circ}44'06''$ N, $85^{\circ}18'32''$ E).

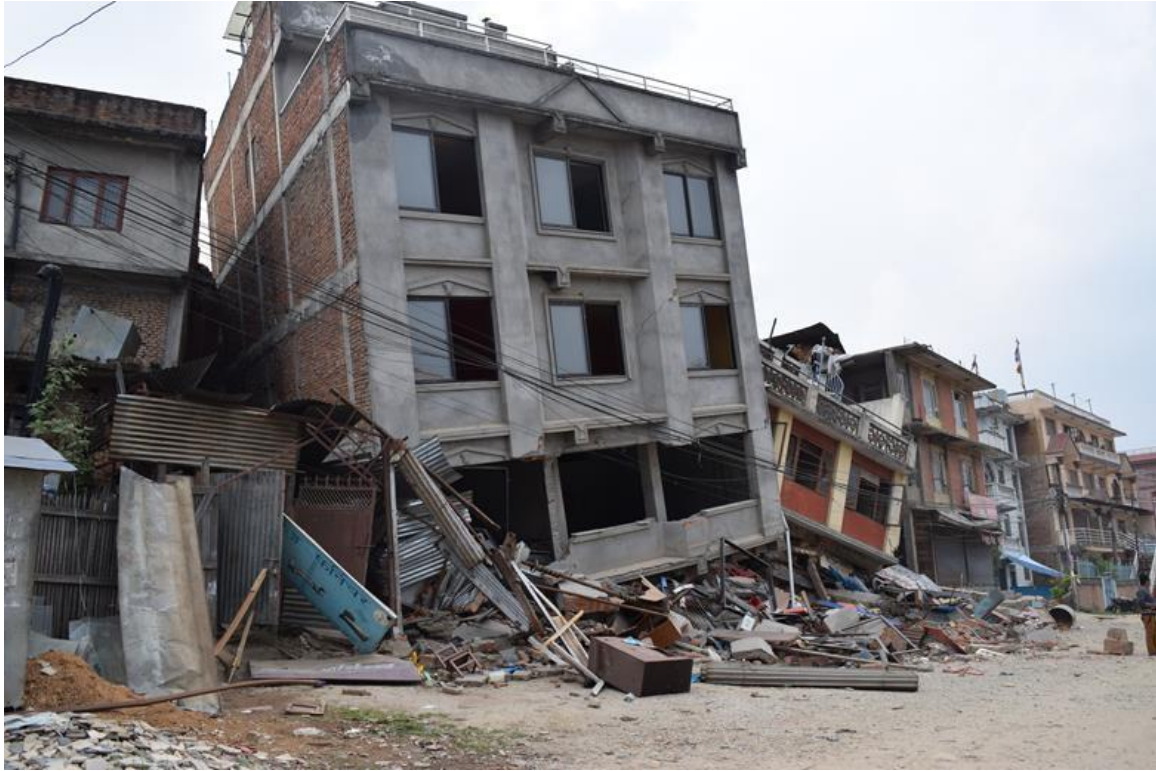
Figure 9-13 Five buildings collapsed along the ridge line at Sitapaila area near Ring Road at Swayambhunath. One building at the rightmost part of the picture was not damaged ($27^{\circ}42.7'0''$ N, $85^{\circ}17'0''$ E).

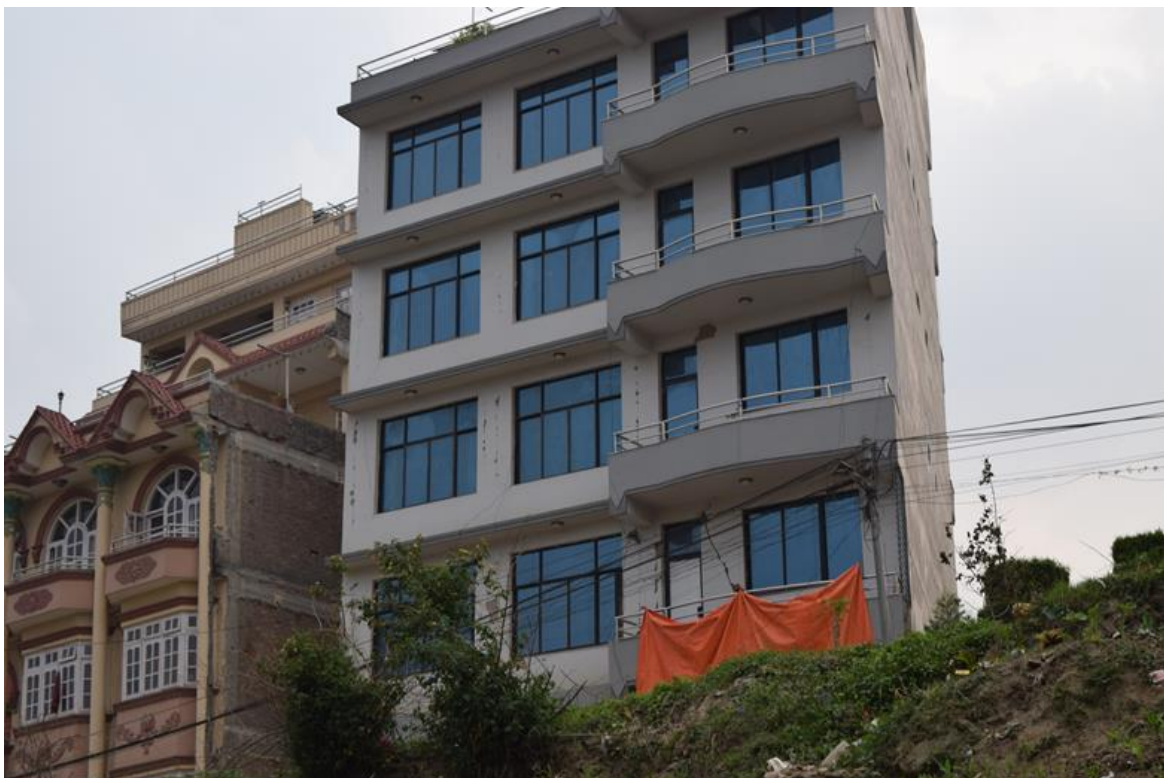
Figure 9-14 Recently constructed buildings at Sitapaila height also sustained significant damage although did not collapse ($27^{\circ}42'51''$ N, $85^{\circ}16'58''$ E).

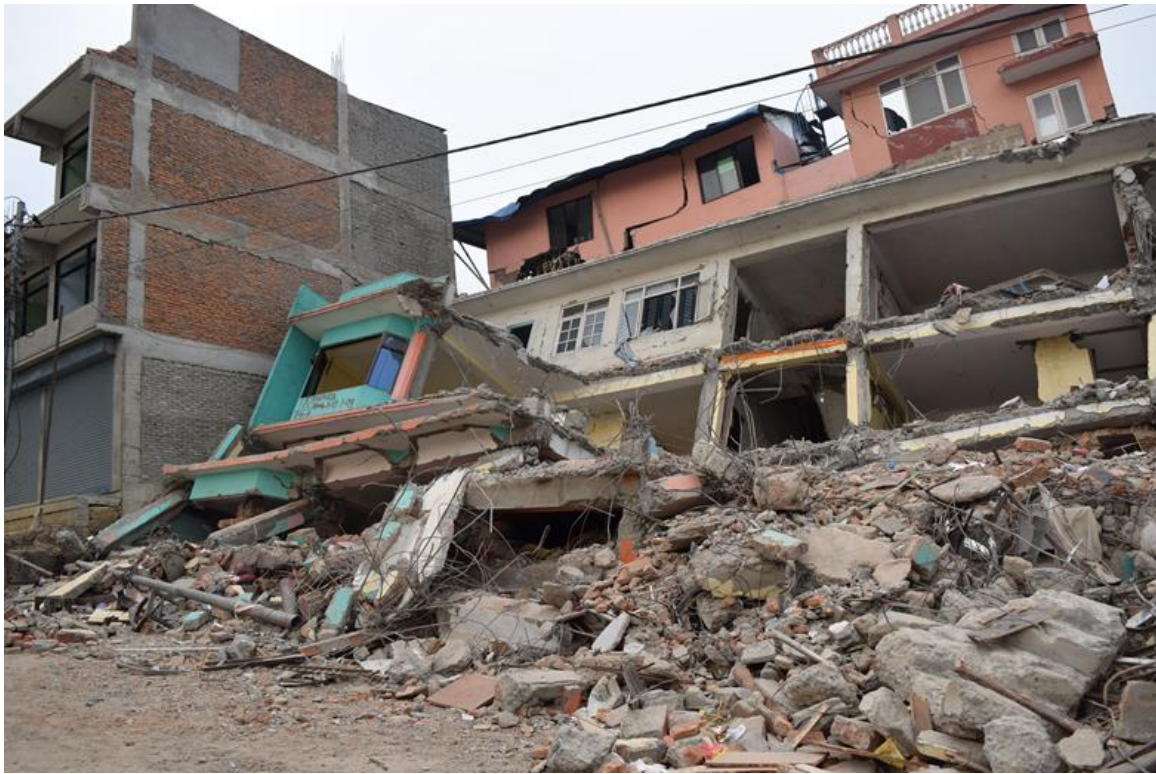
Figure 9-15 Collapse of two multi story buildings at Sitapaila killed over 20 people (27°42.7'0"N, 85°17'0"E).

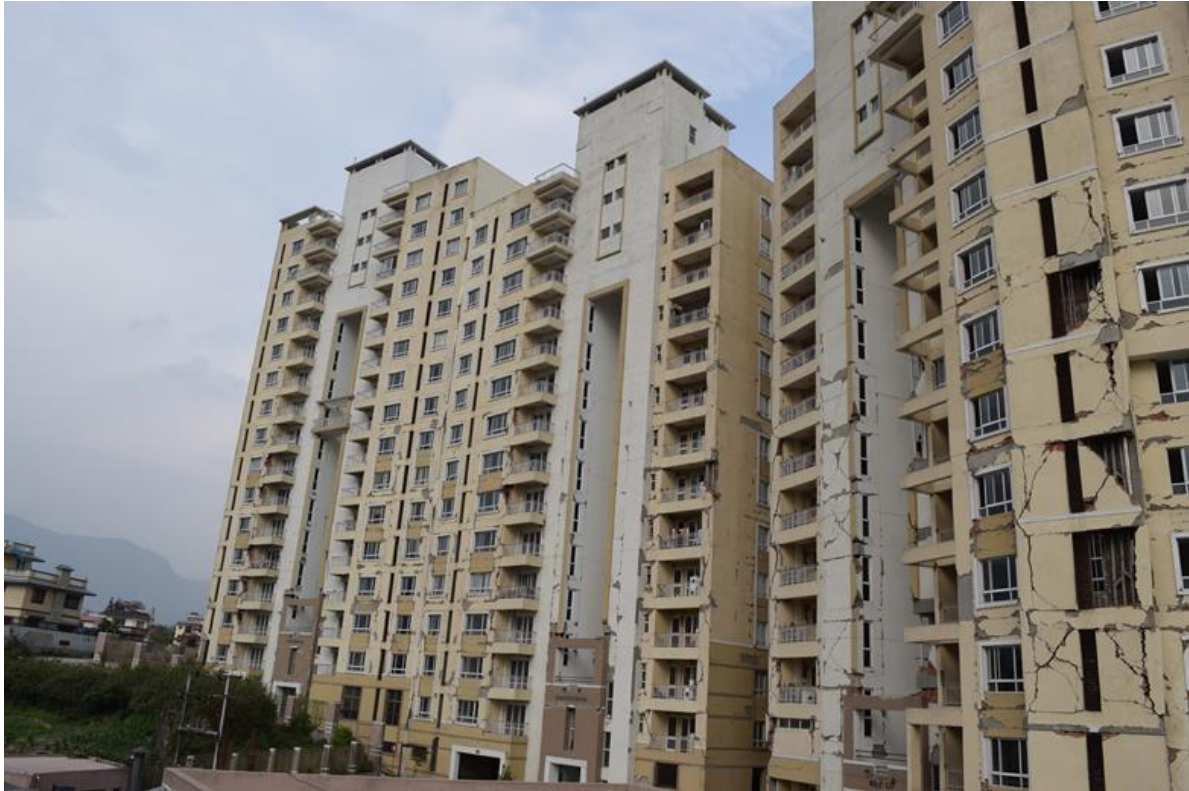
Figure 9-18 Structural damage to the park Horizon Apartment Building at Dhapasi due to the strong ground motion. Eye witness said that the buildings were pounding due to story drift due to ground shaking.

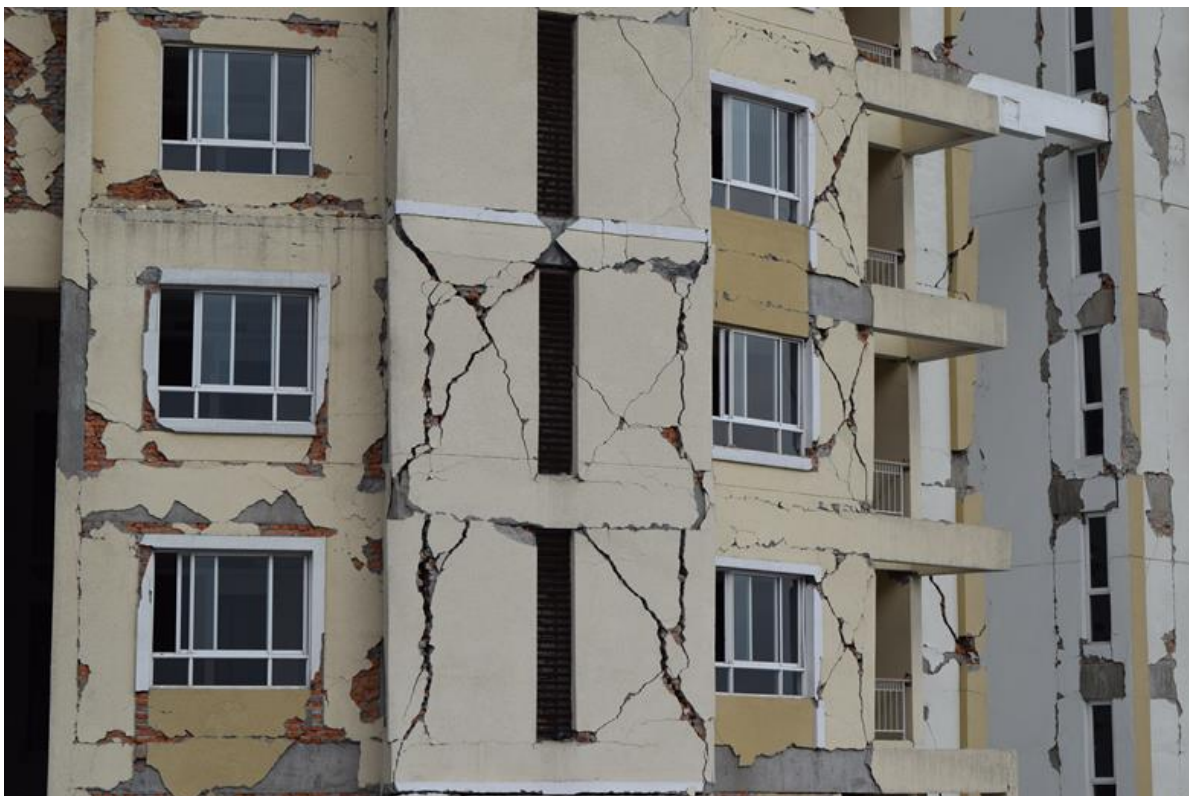
Figure 9-19 Close view of the structural damage (27°44.4'0"N, 85°19.4'0"E).

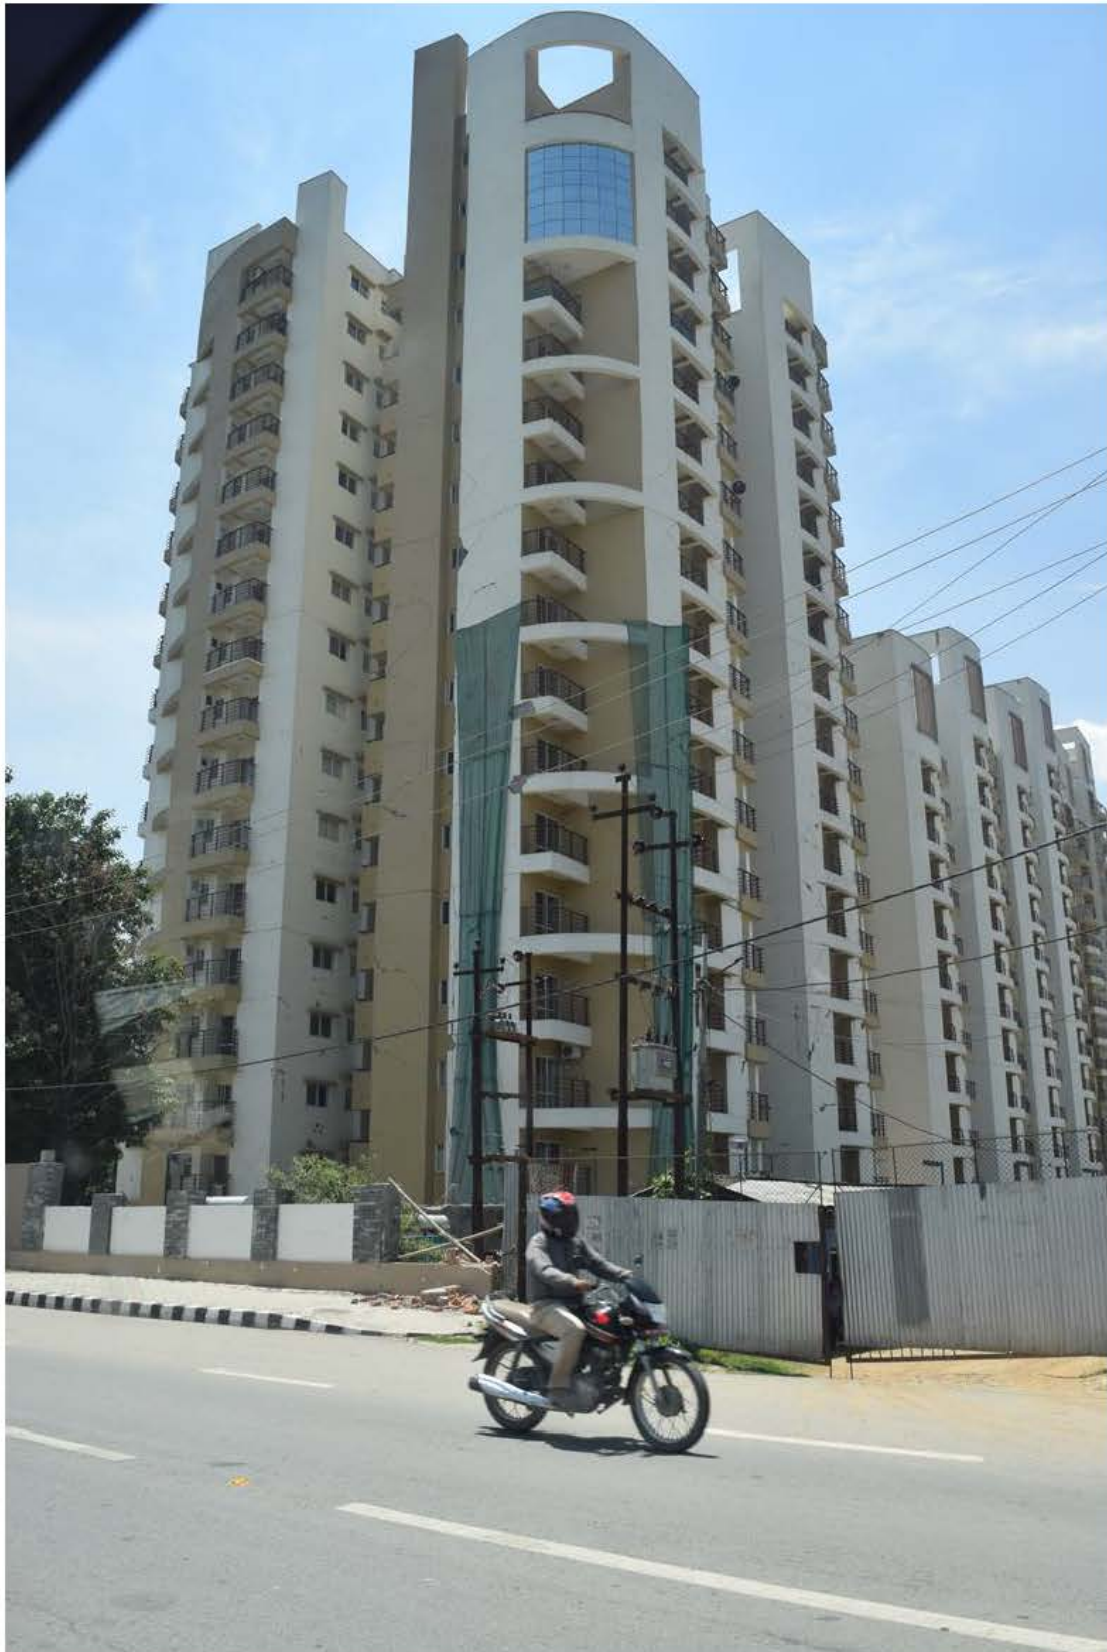
Figure 9-22 A high rise apartment building at Hattiban, Lalitpur. This building also sustained some major damage due to the earthquake.

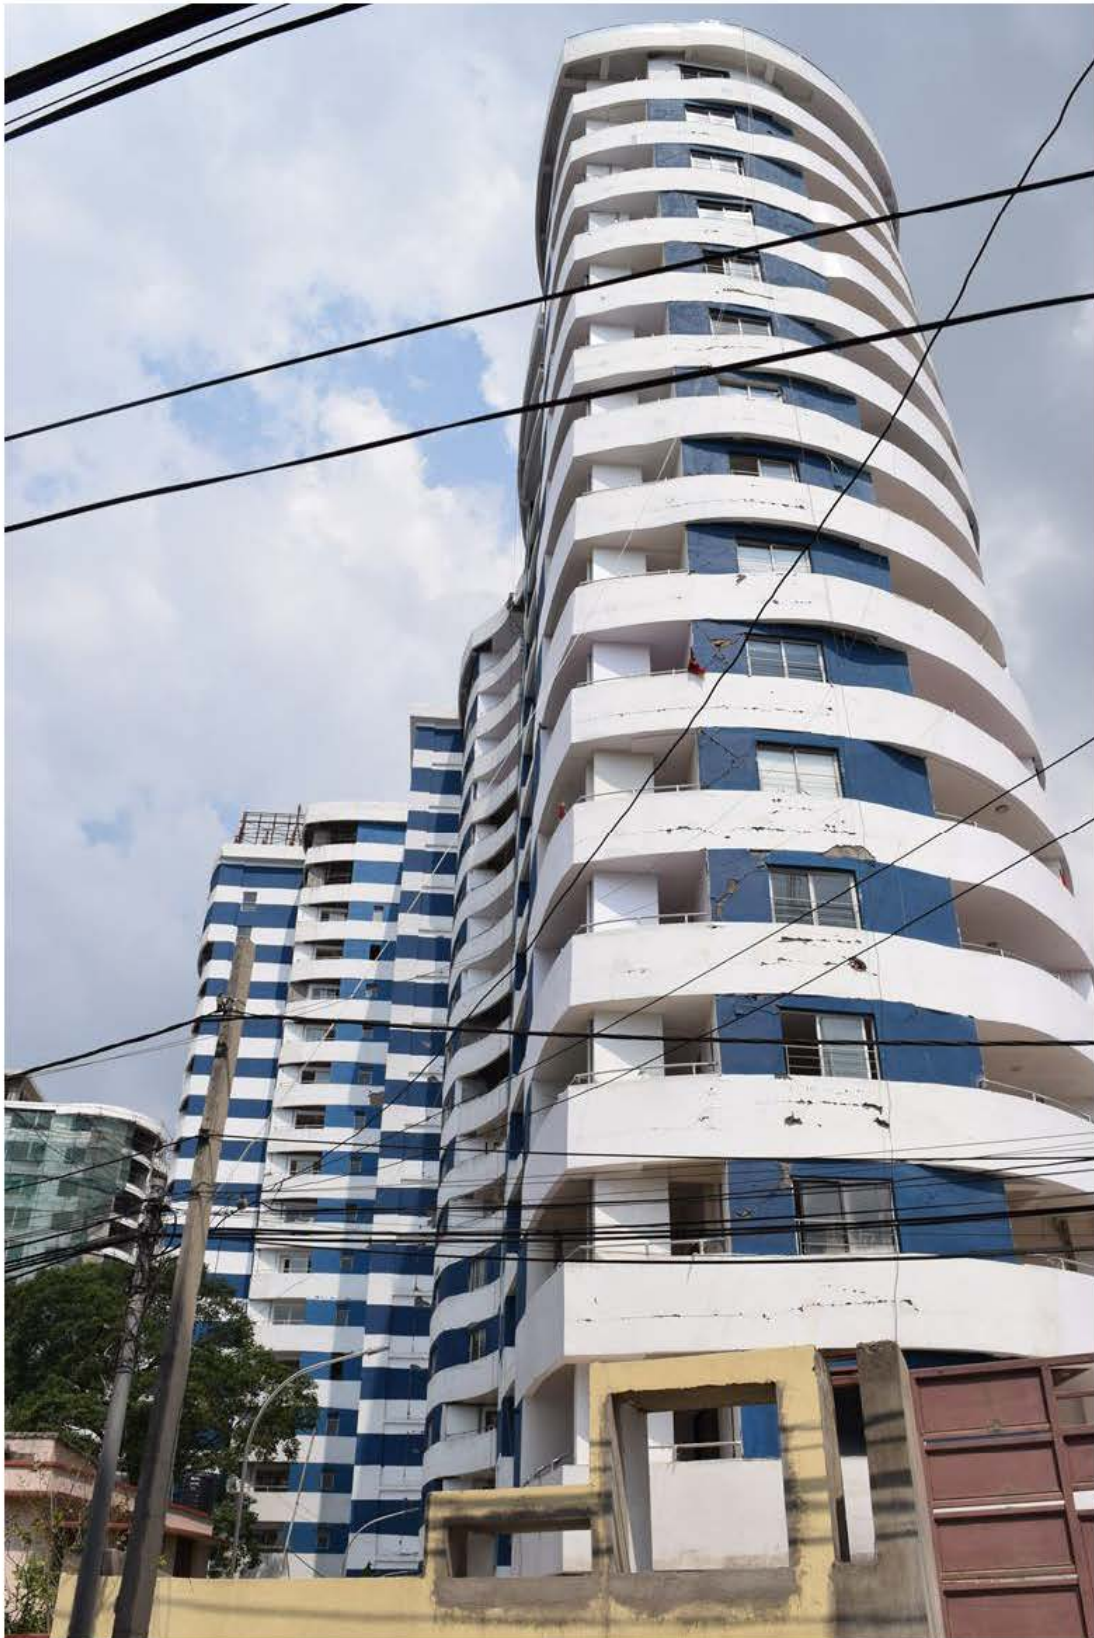
Figure 9-25 Damage observed at an apartment complex in Kalikasthan ($27^{\circ}42'13''$ N, $85^{\circ}19'38.3''$ E).

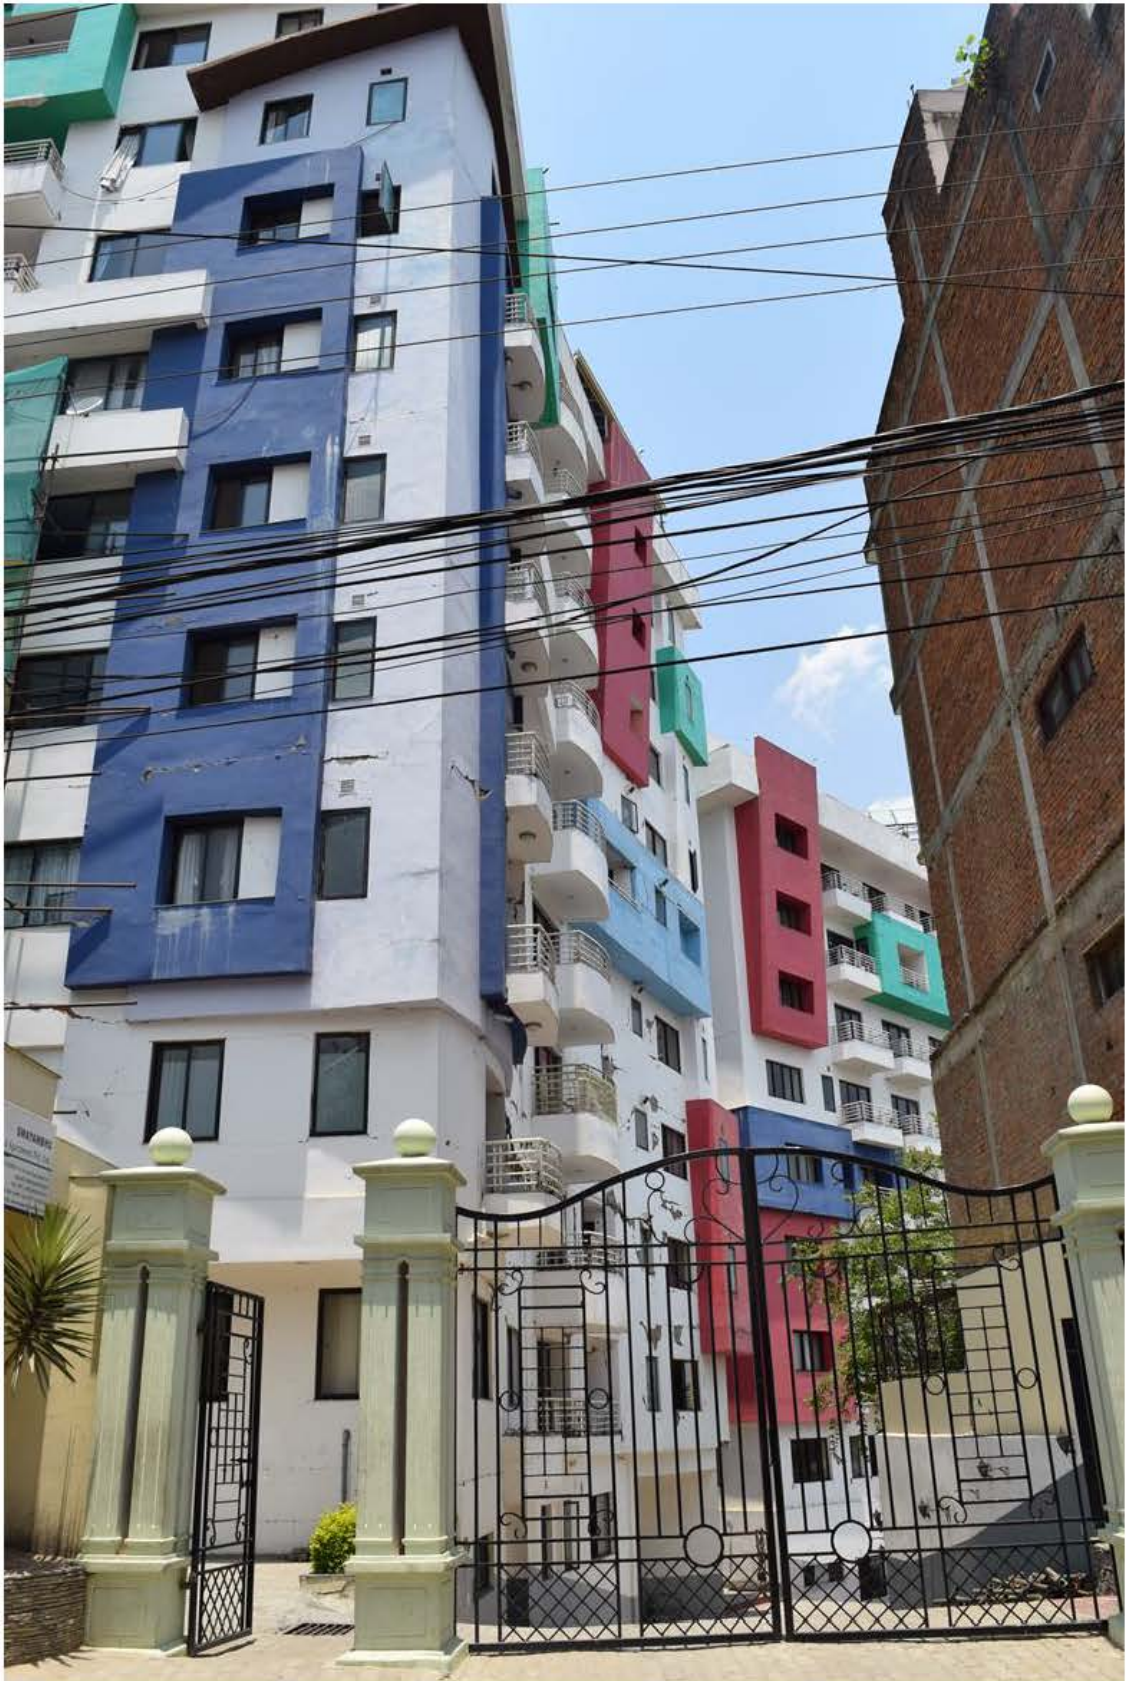
Figure 9-26 Damage observed at an apartment complex in Sitapaila

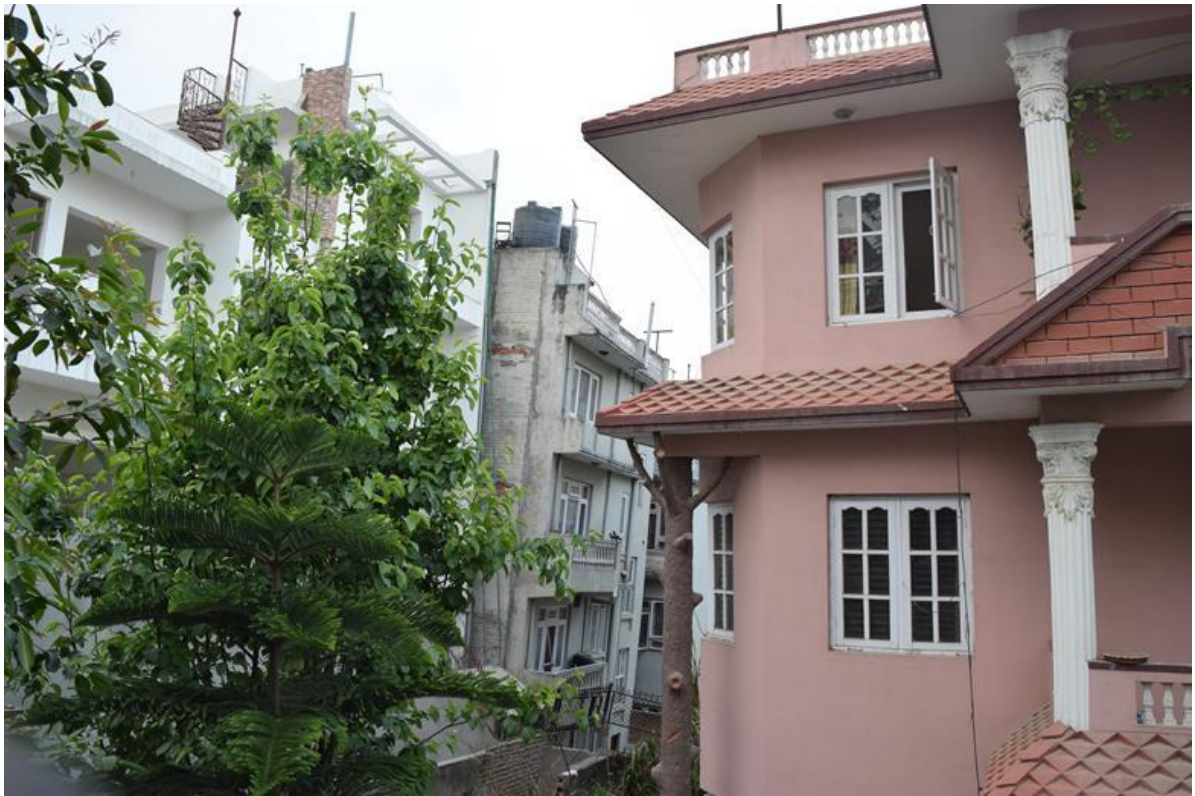
Figure 9-29 Buildings tilted at Lokanthali area (opposite side of the one presented in Figure 9-28) due to ground failure (27°40'25.83" N, 85°21'44.3" E).

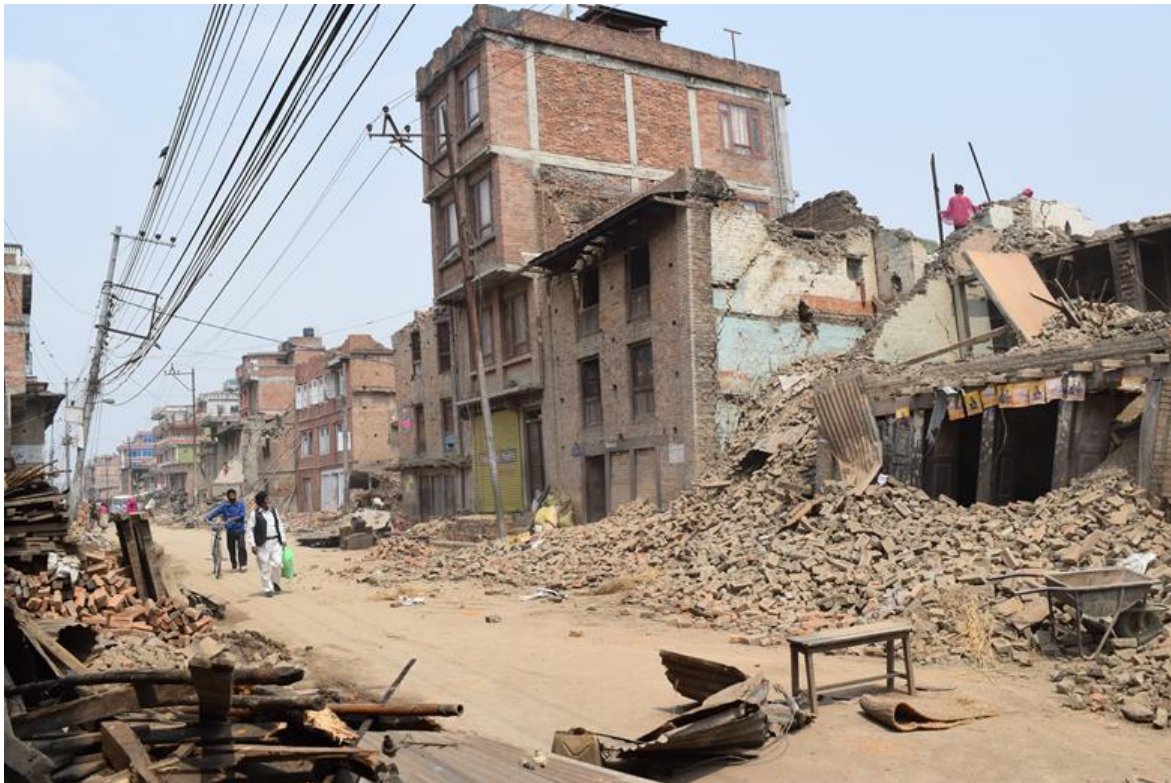
Figure 9-32 Unreinforced brick masonry in mud mortar at Bhaktapur collapsed due to ground shaking whereas the modern RCC structures did not sustain much damage (27°40'33.64" N, 85°24'26.18" E).

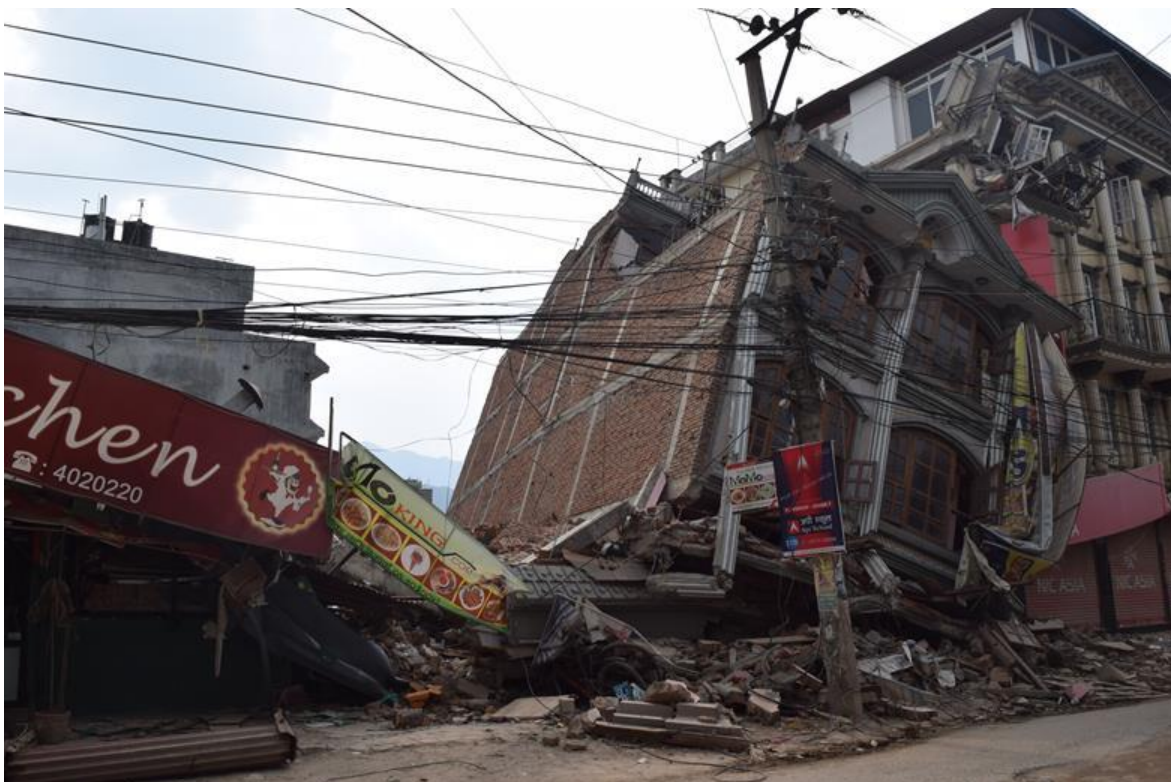
Figure 9-33 A four and half story RCC frame structure collapsed at Samakoshi, Kathmandu (27°43'49" N, 85°18'52" E).

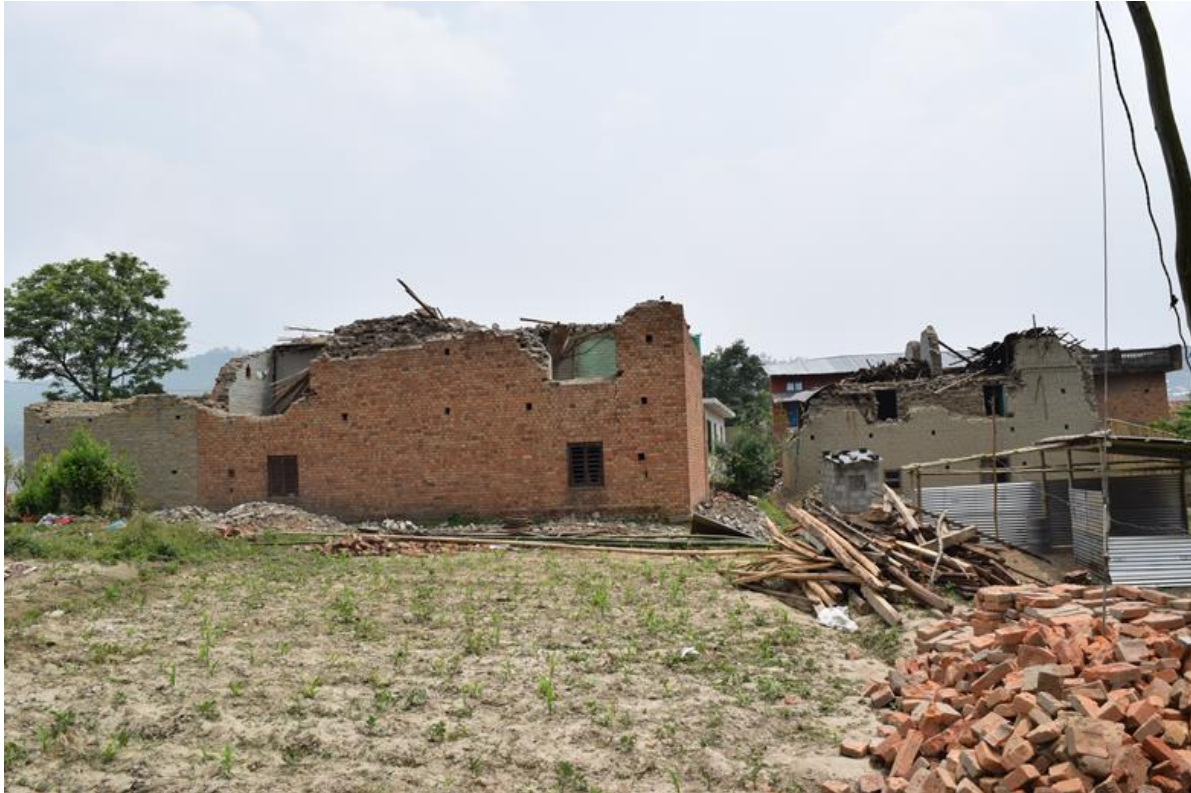
Figure 9-34 Old buildings with unreinforced brick masonry at Indrayeni Village got damaged due to ground shaking (27°43.7'0" N, 85°26.2'0" E).

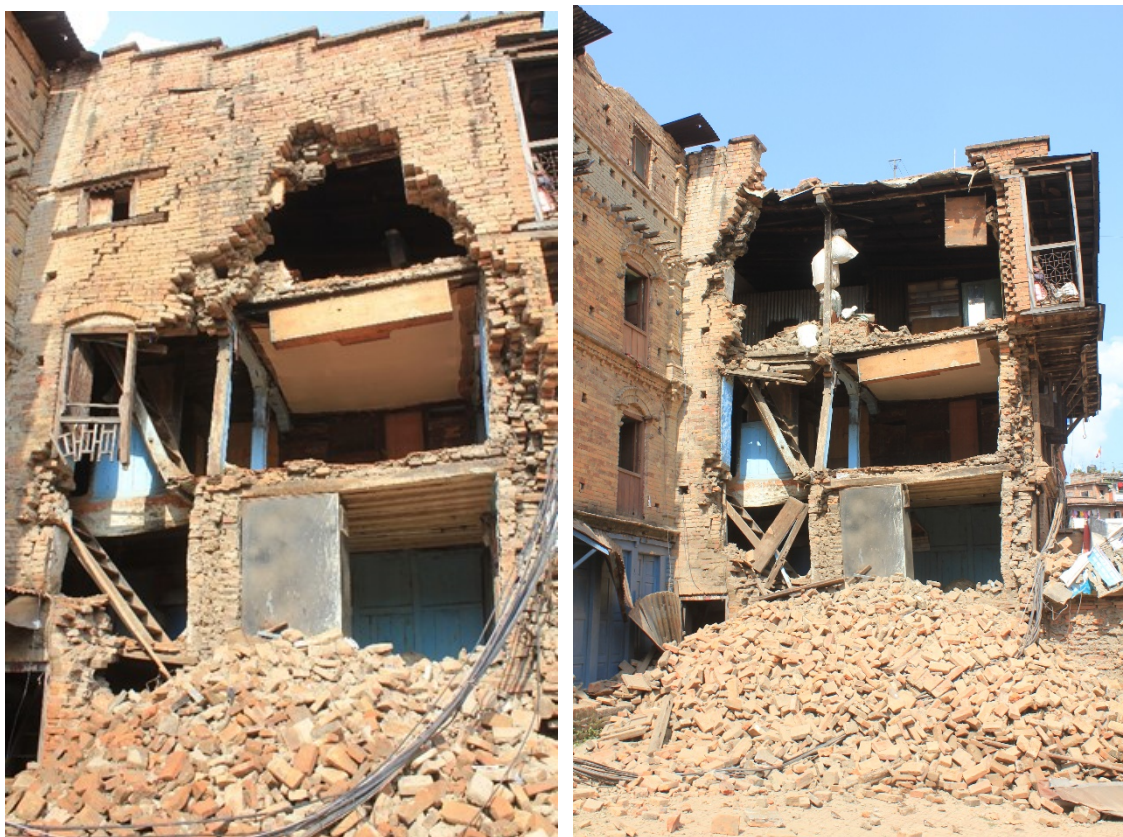
Figure 9-37 Photos on left taken May 11, 2015 and photo on right taken after the May 12, 2015 M_w 7.3 aftershock. Already damaged unreinforced masonry building experienced additional collapse ($27^\circ 40' 21.15''$ N; $85^\circ 25' 56.23''$ E).

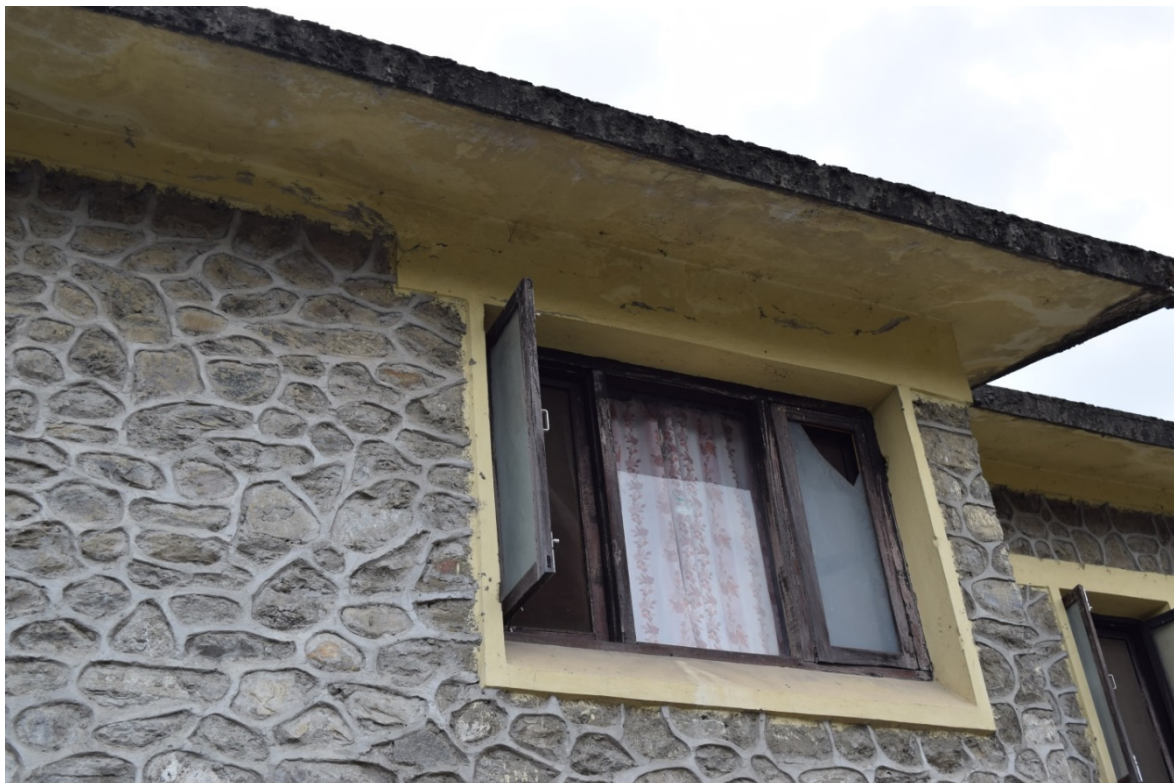
Figure 9-40 Damage to stone masonry walls under heavy roof at the staff quarter of Western Region Campus of the Institute of Engineering.

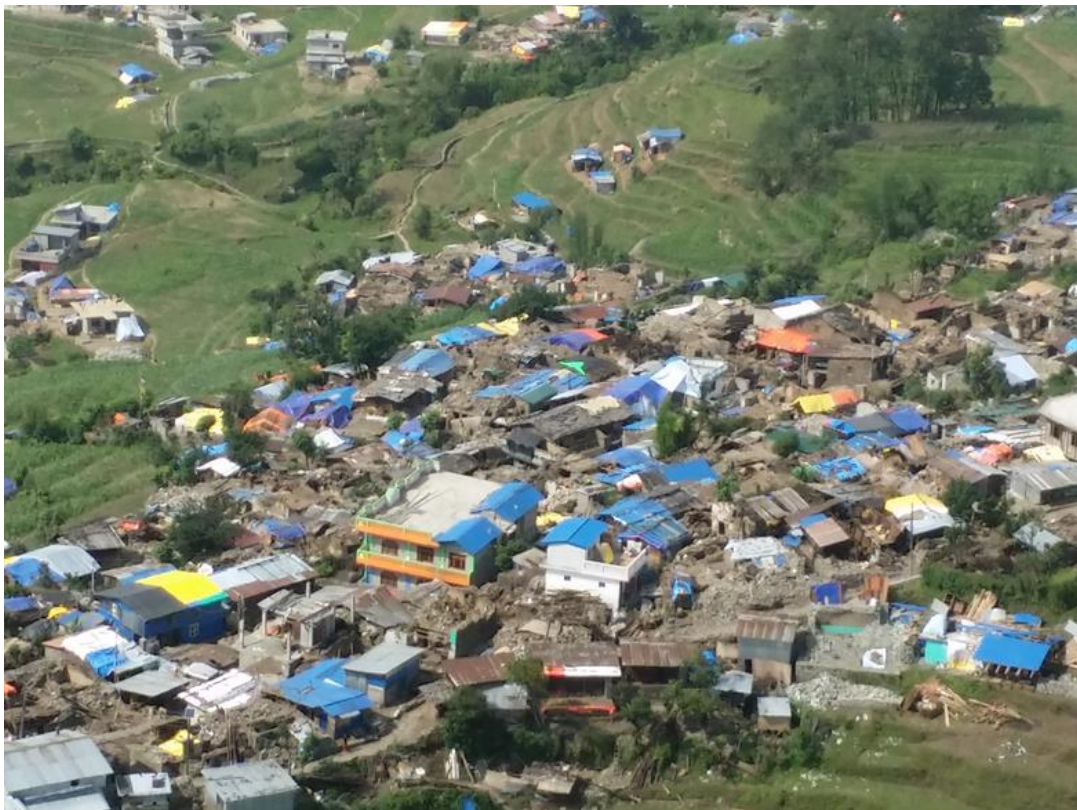
Figure 9-48 Closer look at the earthquake damage to stone masonry and RCC buildings.

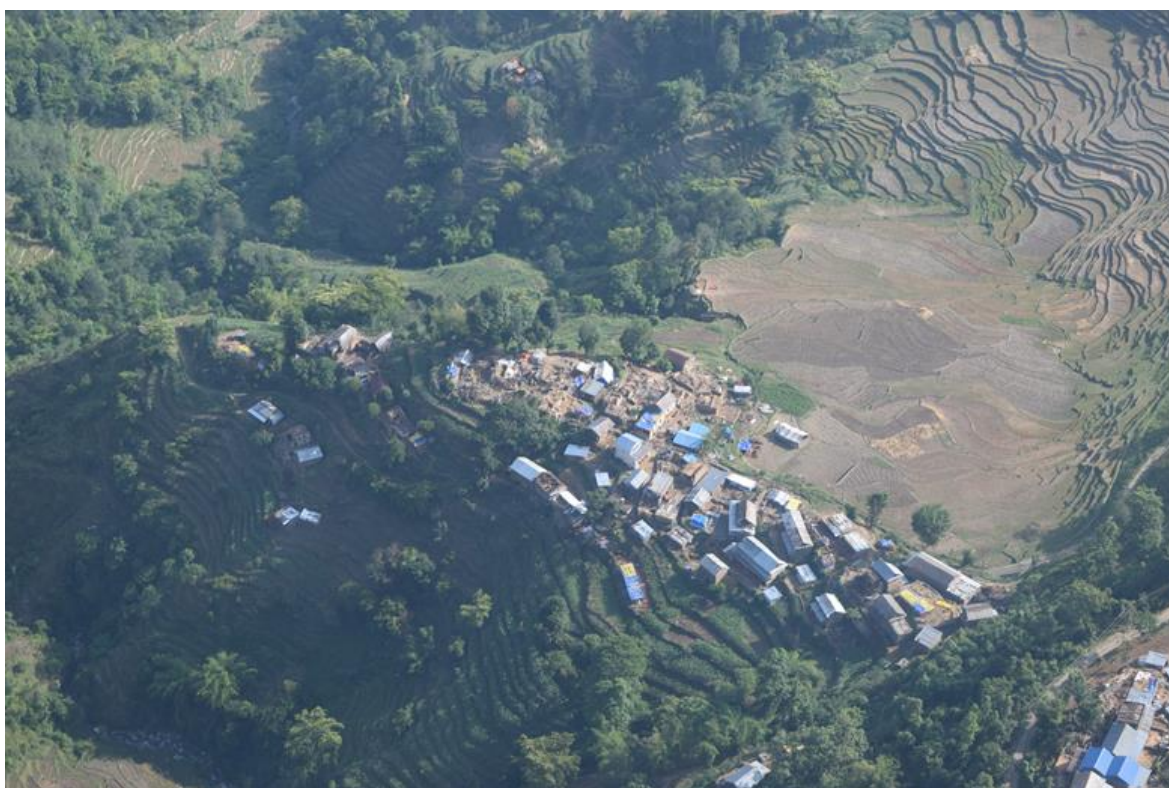
Figure 9-57 Aerial view of building damage at a ridge in Sindhupalchowk – aerial way to Lamabagar.

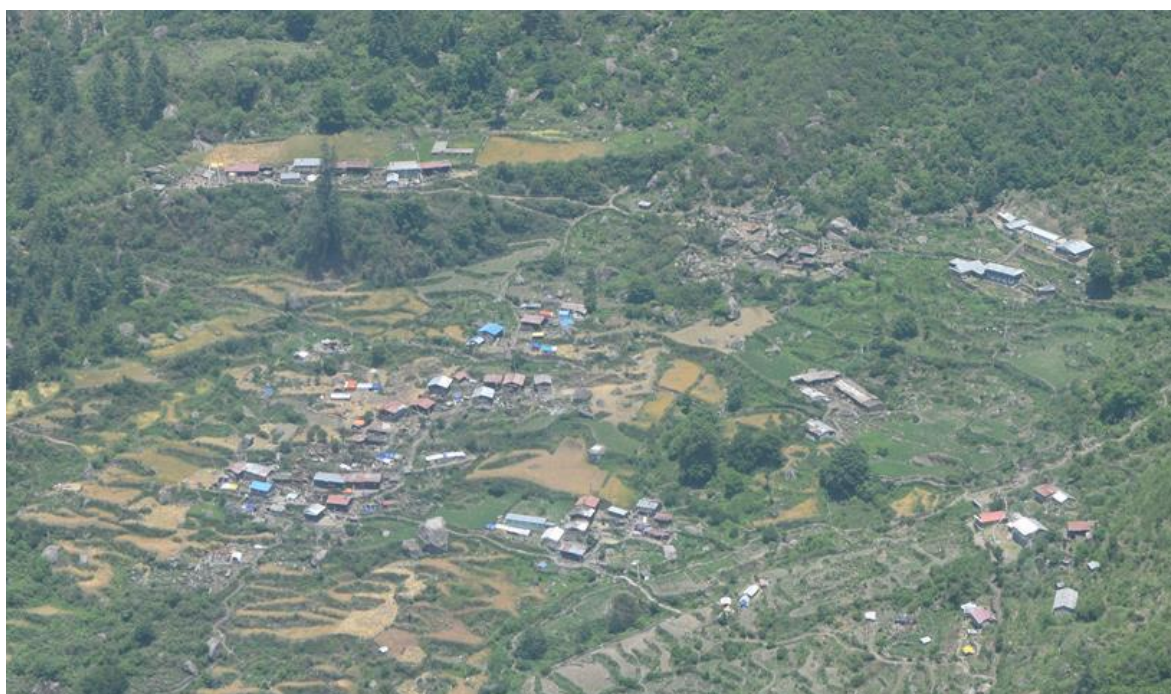
Figure 9-61 Building damage due to seismic shaking near Rasuwagadi of Rasuwa district.

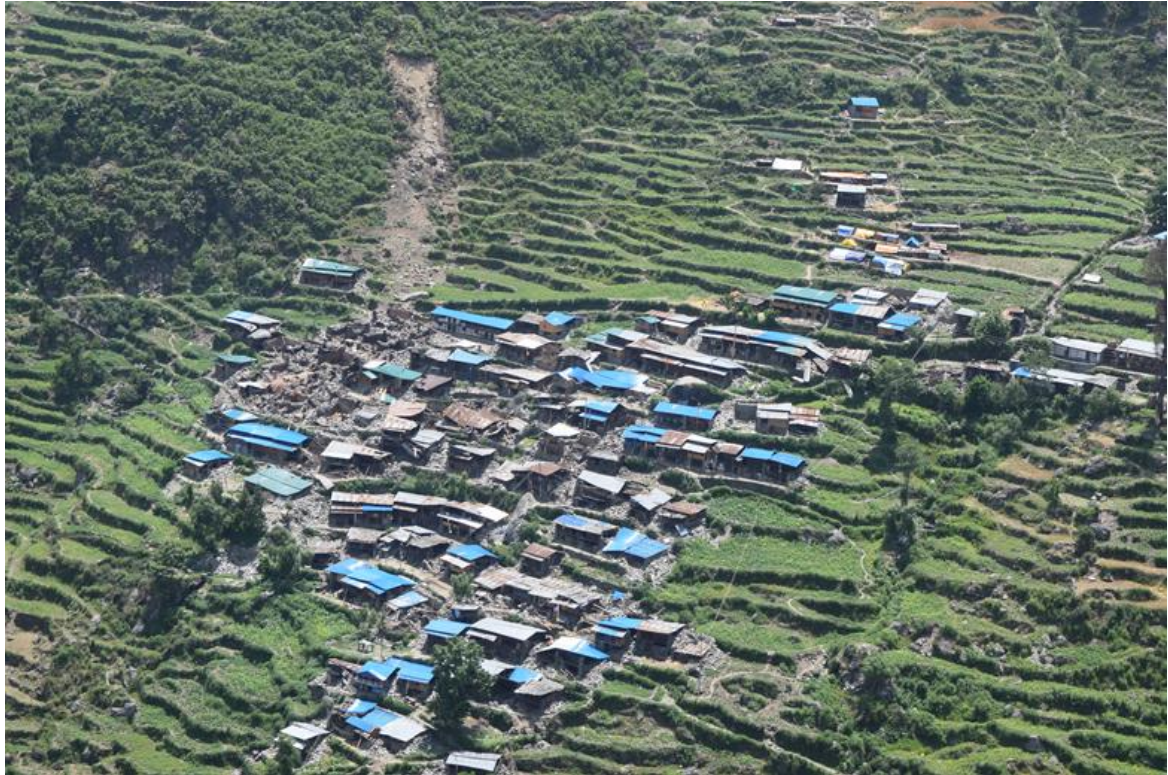
Figure 9-62 Building damage at a village near Rasuwagadi in Rasuwa District due to earthquake shaking and earthquake induced landslides.

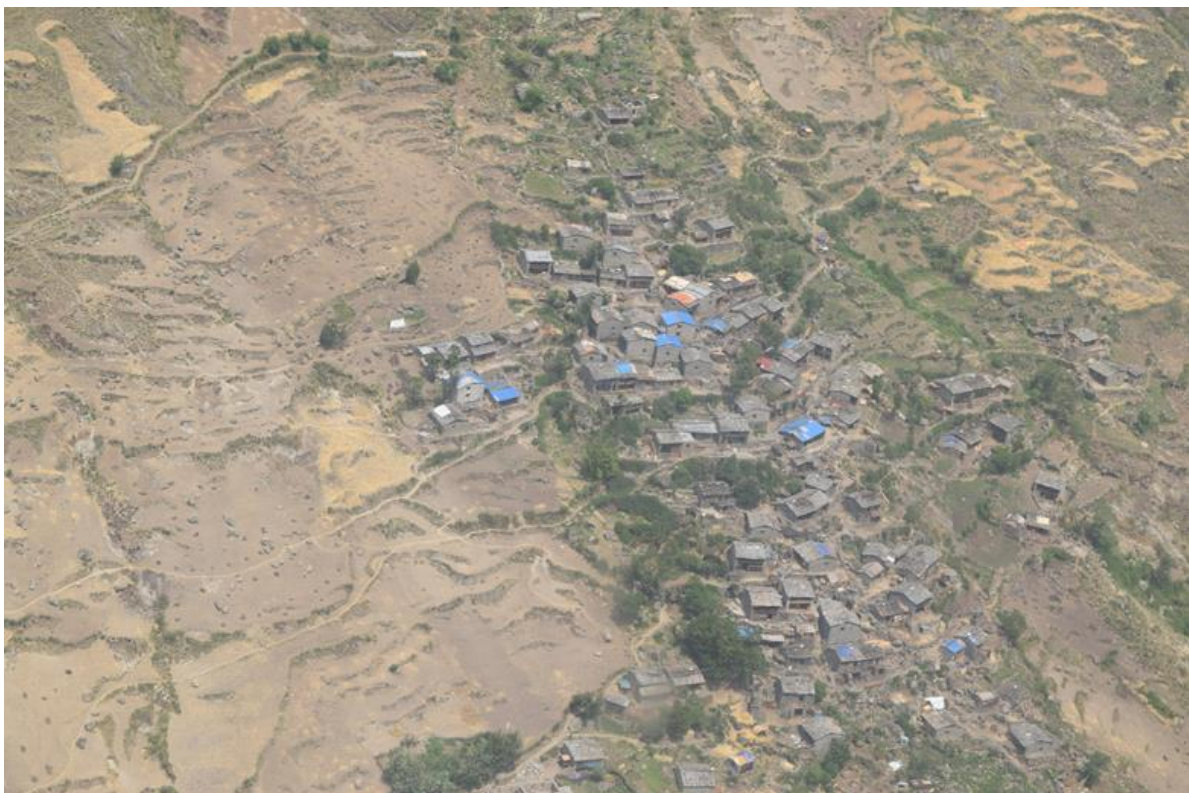
Figure 9-69 A village near Prok of Gorkha was devastated due to the seismic induced damage of unreinforced masonry structures.
