# INSTRUMENTATION AND EVALUATION OF DISTRICT 10 CALTRANS AUTOMATED WARNING SYSTEM (CAWS)

## Technical and Operational Assessment

Prepared for the California Dept. of Transportation and California Office of Traffic Safety  
by Loragen Corporation, San Luis Obispo, California

Document No. L-D10-FR-03

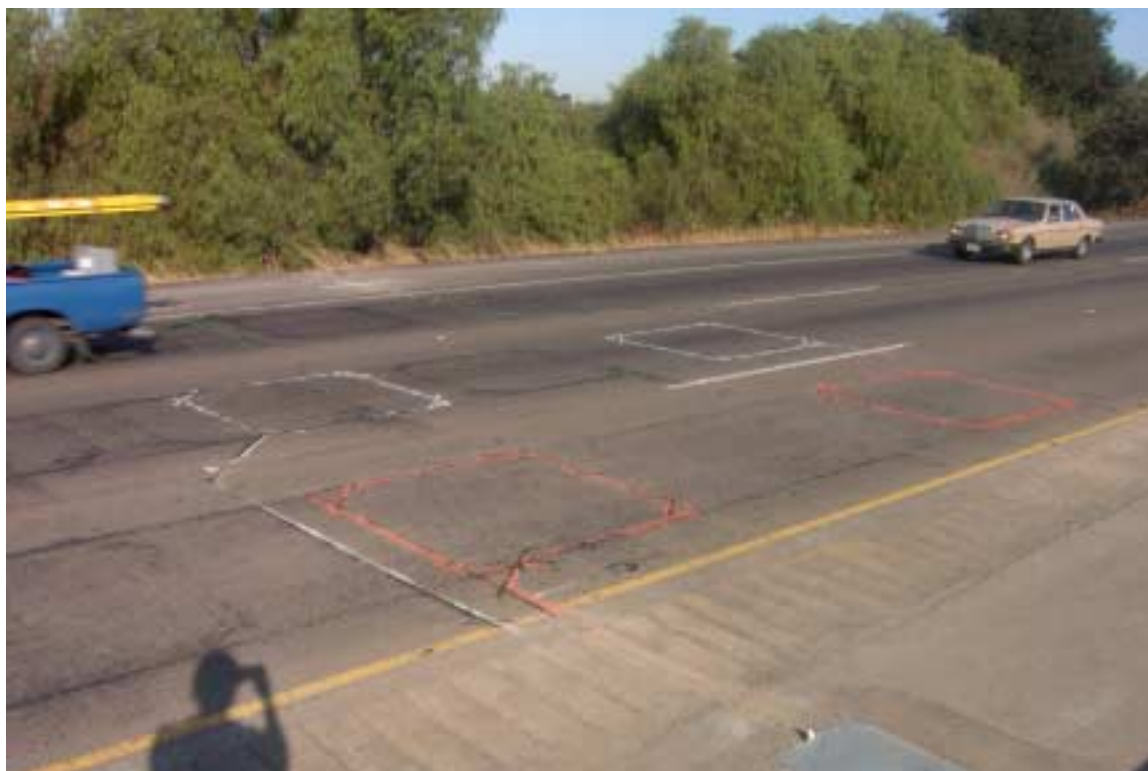
The sole speed measurement mechanism used in the CAWS are duplex inductive loops installed in each lane. Site monitored between one and five lanes, with three being the norm on I-5. A total of 216 inductive loops are connected to the CAWS. 8'x8' rectangular loops are used, as highlighted in Figure 3.2.3.2. The usual separation of the duplex loops is 20 feet, although variations from 16 to 30 feet were observed at various locations in the CAWS. It was not possible to verify if the loop separation distances has been correctly calibrated at individual traffic monitoring sites. However, speeds reported by the TMS computer as recorded in the TMS log files usually seemed reasonable. At the French Camp Slough count station that we used as a Before-CMS monitoring site, the loops had been incorrectly connected in series and the separation distance was much different than had been assumed (16 feet).

**Figure 3.2.3.2. Duplex inductive loops installed in each lane for speed measurement at each traffic monitoring station.**

In our experience during this study, the loop detectors were the most problematic of all sensors, both for the evaluation system and the CAWS itself. Loops were found to be susceptible to occasional false triggering from adjacent lanes, or failures to trigger. Sensitivities were usually set to 5 as the default value recommended by the loop detector card manufacturer, but in our experience, much lower sensitivity settings were required to prevent false triggering, typically 2 or 3. Problems with the loops including failures of Type 222 detector cards at the evaluation test sites were common, and became a source of our frequent requests for assistance from district maintenance personnel (which diligently responded). But this suggests that similar problems were being encountered throughout the CAWS, with or without the immediate knowledge of the CAWS system operators, since partial failures or calibration drift can go unnoticed in the period average speed data reported by the traffic monitoring sites.

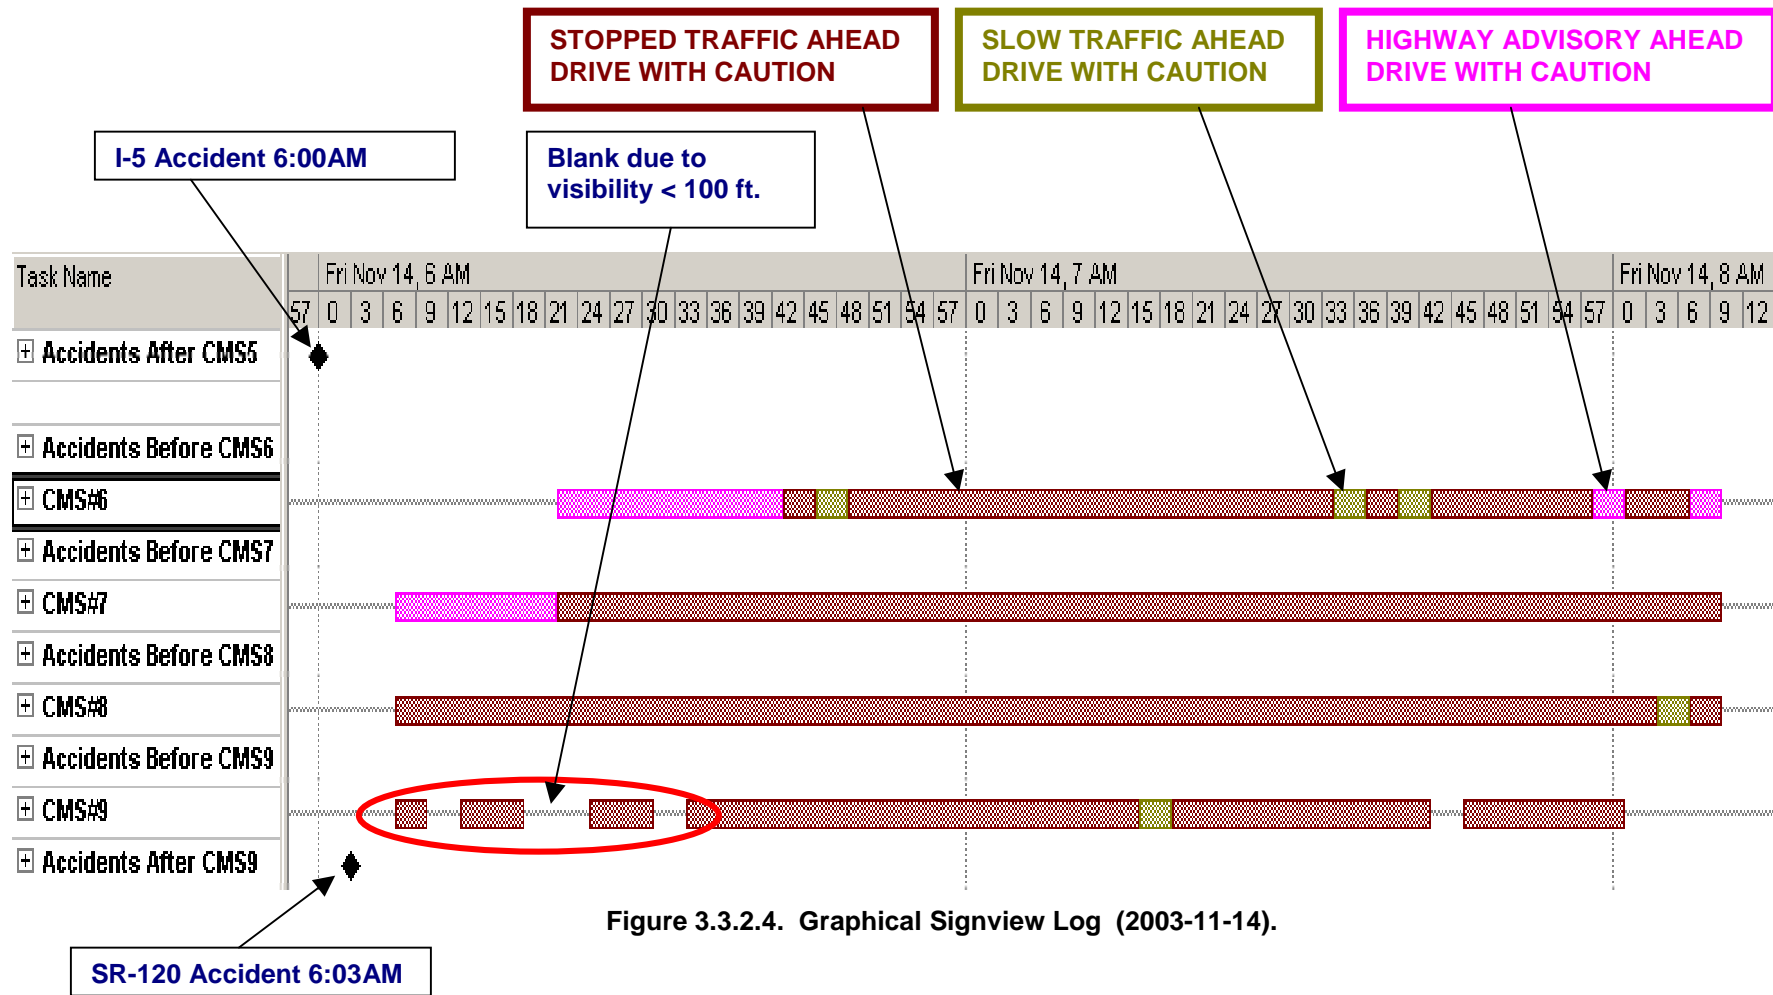
Figure 3.3.2.4. Graphical Signview Log (2003-11-14).

The Signview log file, shown graphically in Figure 3.3.2.4, indicates that no messages were activated for any of the Changeable Message Signs (CMS) on I-5 (CMS 1 through CMS 5). This lack of message activation is consistent with the TMS speed data log file. Speed stations 9A and 9B were capable of activating CMS 9 during this period. CMS 9 should have activated due to the station 9A condition, but was apparently inhibited by the "no warning if any lane over 55" algorithm. Figure 3.3.2.2 shows that speeds at station 9A fell to 0 mph, well under the 11 mph or below threshold used to activate the "STOPPED TRAFFIC AHEAD" message.

As shown in Figure 3.3.2.4, there are several breaks in the activation of CMS 9. The "STOPPED TRAFFIC AHEAD" message was issued by CMS 9 several times in succession with interruptions between each issue. This intermittency was attributed to erroneous speed data sent from 170 controller. As stated earlier, the TMS software inhibits activation from a loop site if it receives a speed report of 50 mph or greater in any lane at that site. The "STOPPED TRAFFIC" message was interrupted during this period because of intermittent erroneous readings of 117 mph in lane 1 at 6:31 am.

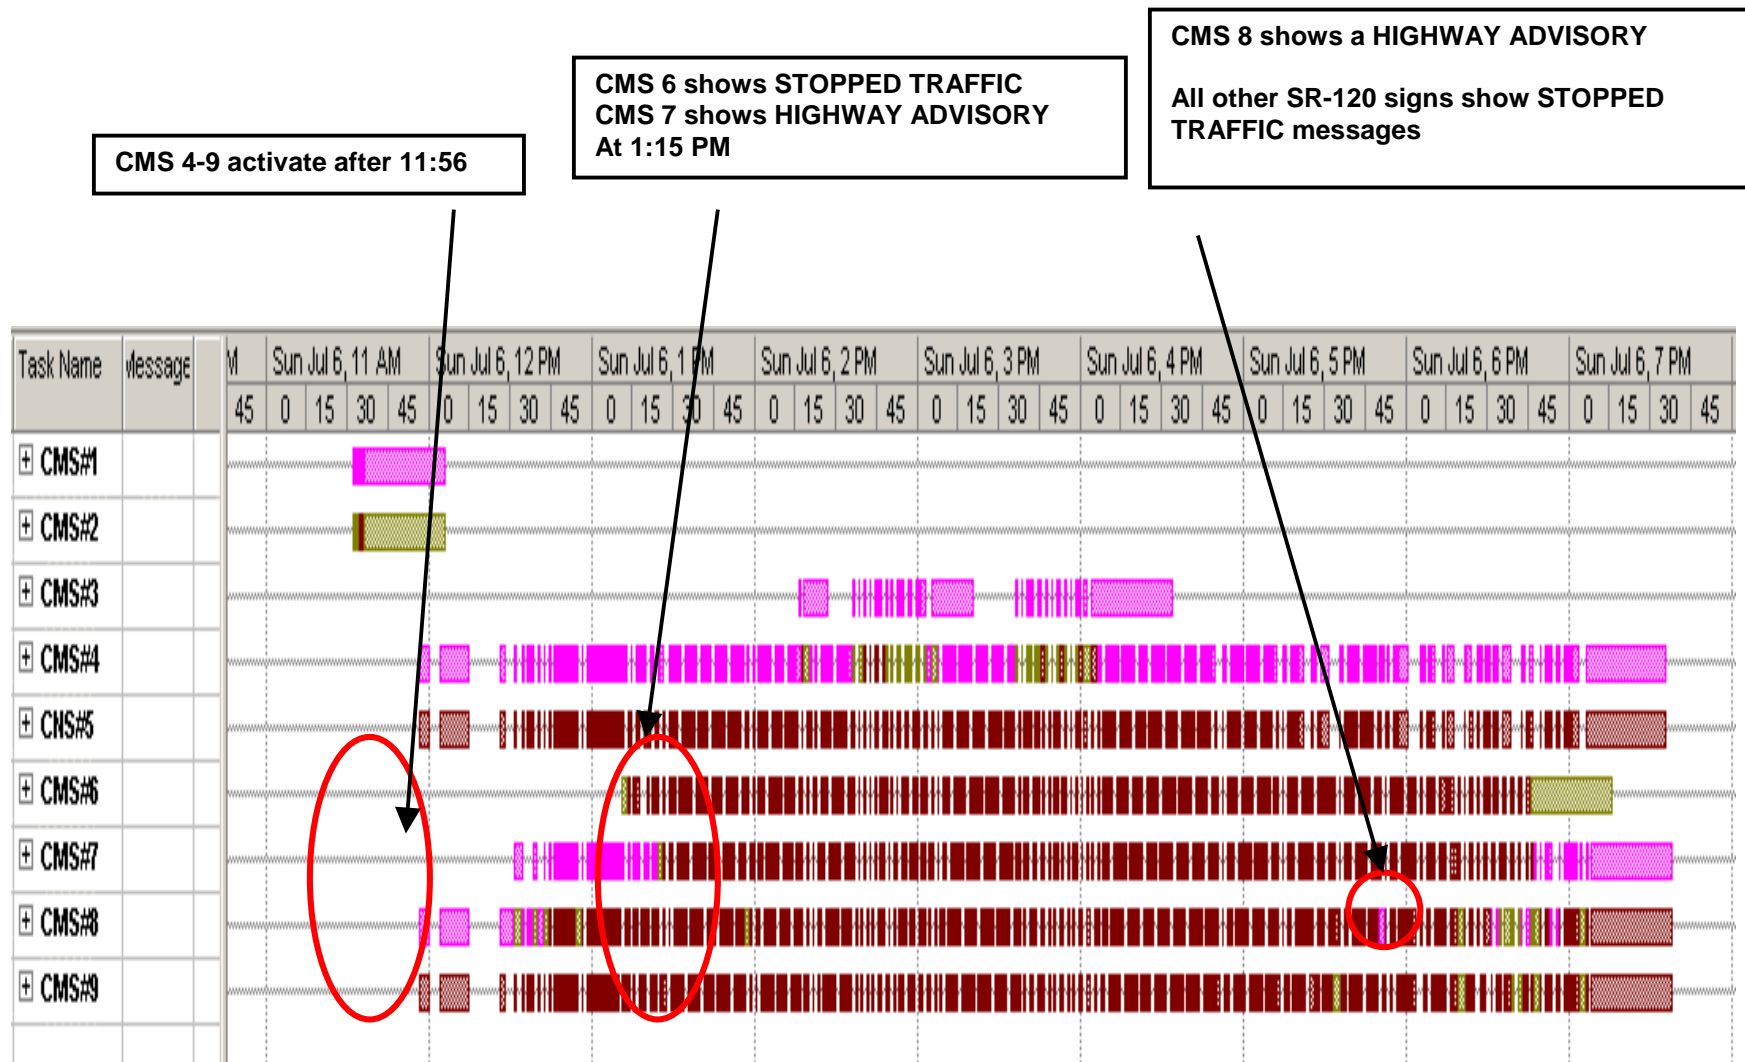
Figure 3.3.2.5. Graphical Signview Log File (1997-07-06).

The unusual response of the system in this and similar cases observed during the first year of CAWS operations motivated us to more closely investigate the actual system control strategy by examination of the Signview software source code<sup>2</sup>. We discovered that the observed incorrect relationship between speed sites and CMS sites was due to the use of an incorrect version of the TMS mapping table, which

incorrectly associated speed monitoring sites with CMS's. This error was eventually found to be due to a change in the site numbering convention incorporated in the final system, but the retention of the old mapping table. The error was corrected during a system software update September 29, 1997, approximately eleven months after the start of CAWS operation. A derived complete diagram of the original version of the CMS-speed station mapping is shown and described later in Figure 3.8.1.2. Figure 3.3.2.6 is a subset of this diagram which provides a close-up of the activation path for CMS 6 and 1:15 pm. The speed log files for this event show that speed station 8E delivered data to Signview at 1:15 pm which triggered the stopped traffic message on CMS 6. The corresponding data from speed site 8E is shown in Figure 3.3.2.7.

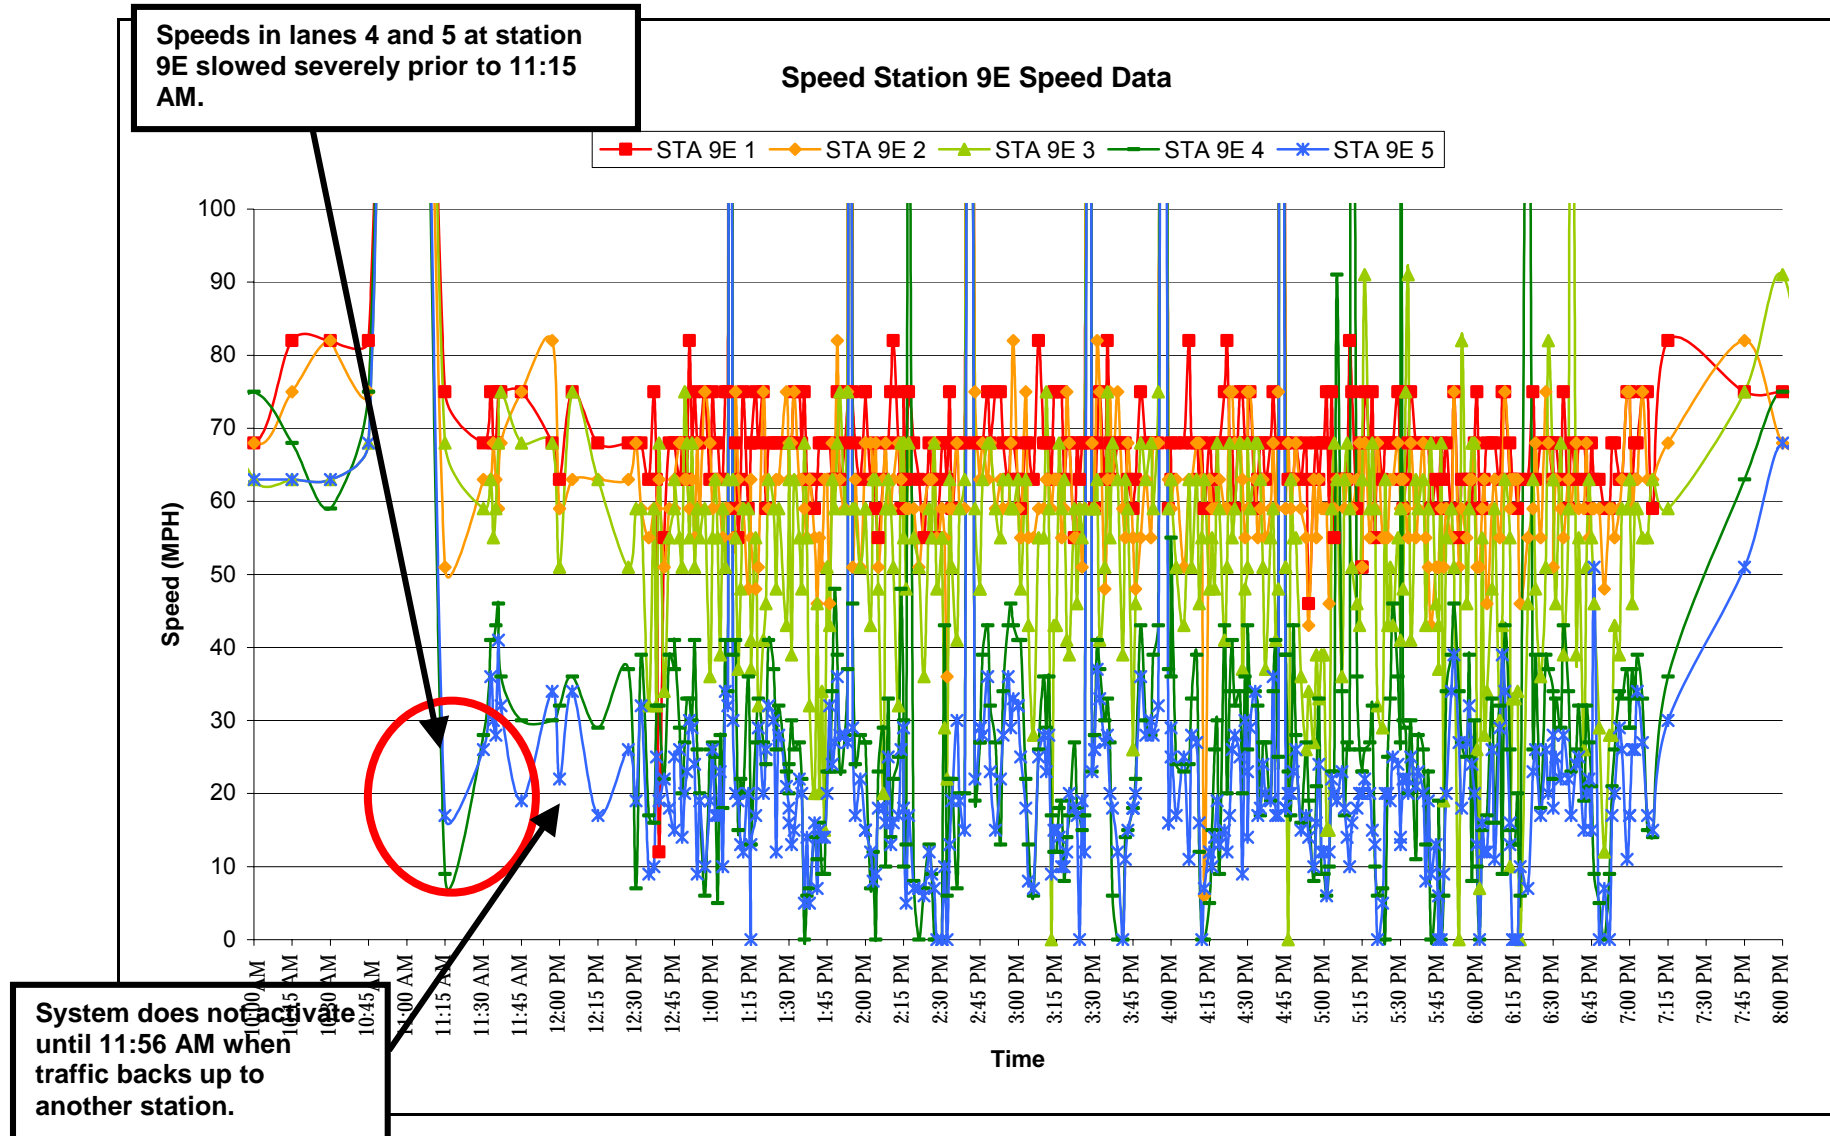
Figure 3.3.2.8. Speed Station 9E Data Plot.

Also of note during this event was the lack of response from conditions in lanes 4 and 5 (slow lanes in merge section) at speed station 9E. This station appeared to be reporting data only from the three fastest lanes. This could have resulted from malfunctioning 222 loop detector cards, but is more likely due to the five-lane speed monitoring station 9E being configured the same as other sites which monitored only three lanes. The TMS algorithm does not distinguish between two, three or five lane sites. The zero values reported by the 170 controller in lanes 4 and 5 at station 9E could have caused a false activation of the CMS. However, it is unknown what volume (or count) data the 170 controller was reporting during this period. Since the TMS software invalidates speed data for a particular lane if the associated volume data is read as zero, it was possible that the speed data for Lanes 4 and 5 were completely ignored. Moreover, the 5-lane speed site 9E seldom causes a CMS activation since the fast lanes are through lanes, not merging with I-205, which rarely slow below 50 mph even when traffic in lanes 1 and 2 is stopped (frequently).

On this same day, speed monitoring site 9E (the closest to the I-205 and I-5 split) showed signs of stopped traffic in lanes 4 and 5 prior to 11:15 am. This data is shown in Figure 3.3.2.8. But the system activated at 11:56 am, 41 minutes later. This delay occurred despite the stopped traffic condition in 4 and 5 at 5-lane Site 9E because lanes 1 and 2 were above 50 mph. Activation did not occur until traffic had backed up all the way to Y junction, and a slow traffic condition was detected by Site 8E.

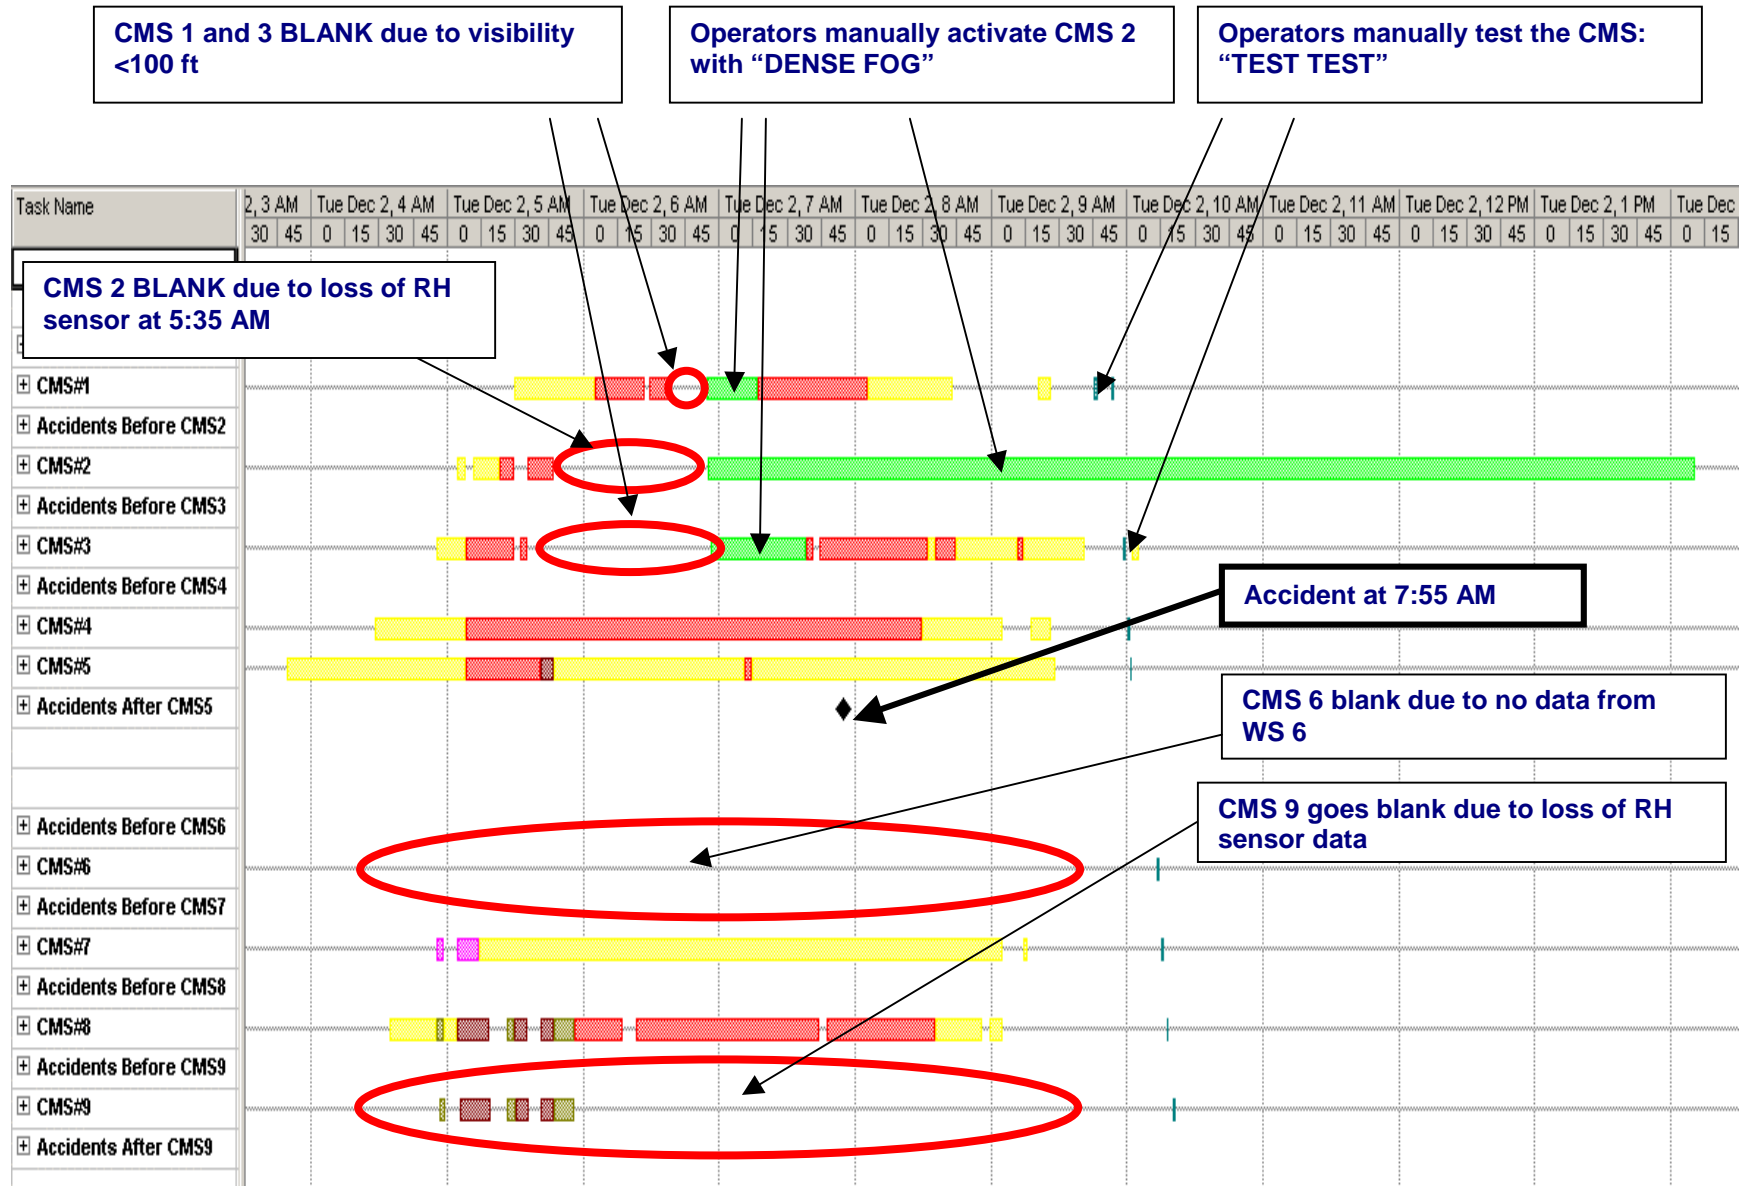
Figure 3.3.3.1. Graphical Signview Log File (2003-12-02).

Despite very low visibility, a failed relative humidity (RH) sensor at Weather Station 9 prevented interpretation as fog, so no message was displayed on CMS 9 located immediately prior to the Y on SR-120. The actual text string sent by the QCMS computer to the Signview/CAWS computer was:

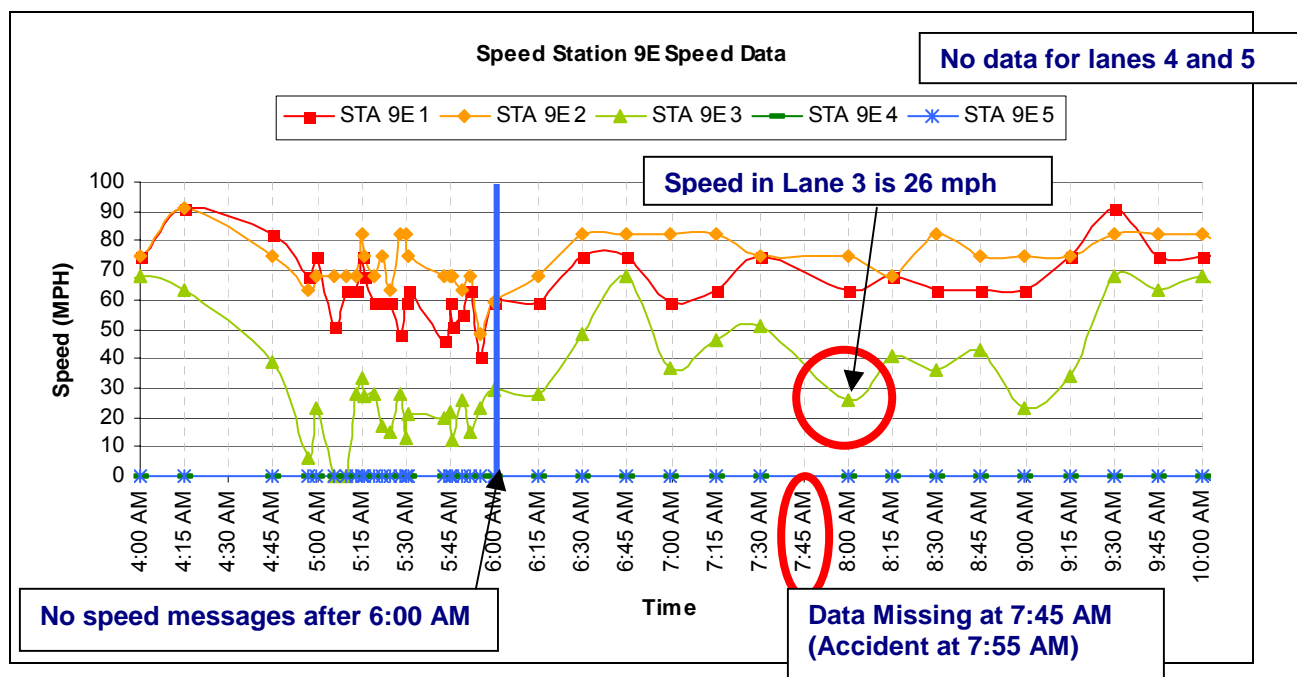
**Figure 3.3.3.3. Speed Site 9E Speed Data.**

Constant zeros were reported for the two slow lanes (Lanes 4 and 5) at the southernmost speed site 9E. Because volume information is not logged by the TMS software, there is no way to tell if ‘0’ meant 0 mph or no vehicles had been detected. The system failsafe assumption in the event of no data is zero volume, which inhibits the TMS from generating a speed alarm for these lanes, despite the obviously slow or stopped traffic condition in lanes 4 and 5 due to the accident at this location.

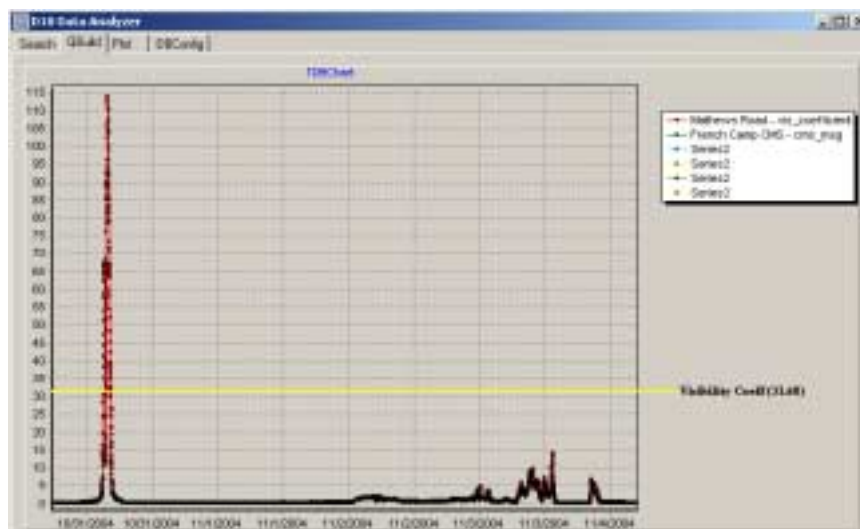
**Figure 3.3.4.1. D10 Analyzer Screenshot**

- All weather stations from 9-15-04 1:00 pm to 9-16-04 1:55 pm. Examining the CAWS-evaluation data indicates that there were no visibility activations generated by weather station 1 which leads to the assumption that there was a communication error during this time.
- Weather station 7 from 9-23-04 11:20 to 10-01-04 2:20 but communication problems started again on 10-01-04 8:40 to 11-03-04 14:45.
- All weather stations from 10-30-04 17:45 to 11-03-04 14:45. Examining the CAWS-evaluation data indicates that there was one visibility event missed. Figure 3.3.4.1 shows the D10 Analyzer output for this time period.

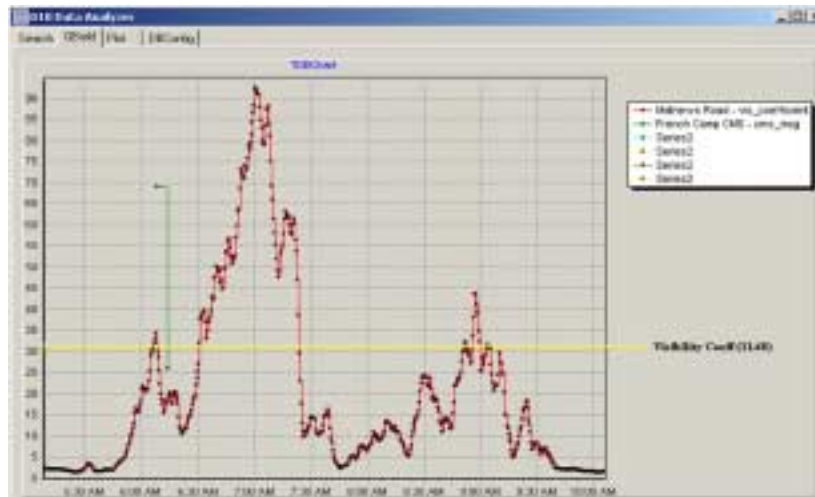
- Weather Station 7 from 11-07-04 6:35 to 11-21-04 21:35.
- All weather stations from 11-07-04 6:35 am to 11-10-04 10:05 am. Due to a communications failure, fog level flags of 2 and 3 were being sent to the Signview computer for weather stations 2, 3, 7 and 8. These flags were sent until 11-08-04 12:46:54 pm when a 'SYSTEM INIT' was sent which reset all flags to 0. Examining the CAWS-evaluation data indicates that two fog events were missed on 11-07-04. Figure 3.3.4.2 shows the D10 Analyzer output for this time period.

**Figure 3.3.4.2. D10 Analyzer Screenshot, showing graphical depiction of fog over the course of an activation event, 11-07-04.**

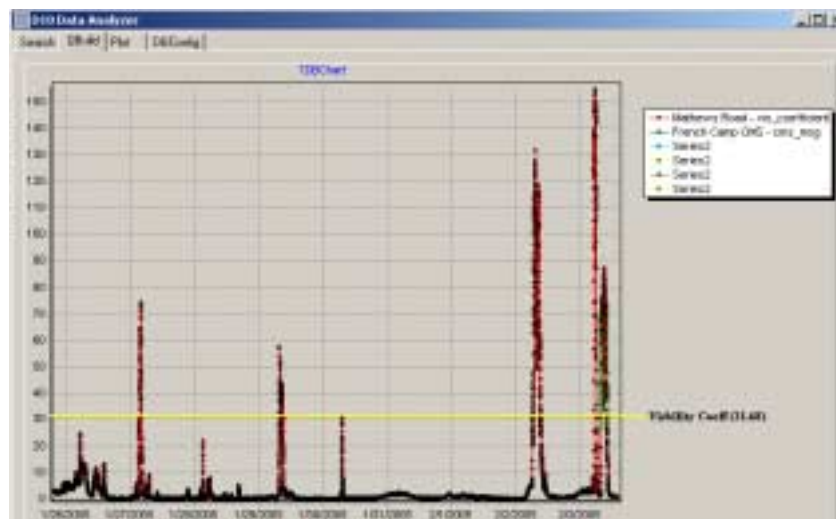
- Weather station 7 from 11-25-04 9:15 to 11-28-04 18:40.
- Weather station 7 from 12-01-04 9:30 to 2-02-05 10:05.
- All weather stations from 1-26-05 7:20 pm to 2-02-05 10:05 am. CAWS-evaluation data system data from this site (at Mathews Road) indicated that there should have been three visibility activations. Figure 3.3.4.3 shows a graphical depiction of the visibility levels for this time period. Dense fog periods are indicated by the peaks in the plot of the extinction coefficient from the visibility sensor at this station.

**Figure 3.3.4.3. Visibility at WS 1, 9-day profile starting 1-26-05, from D10 Analyzer.**

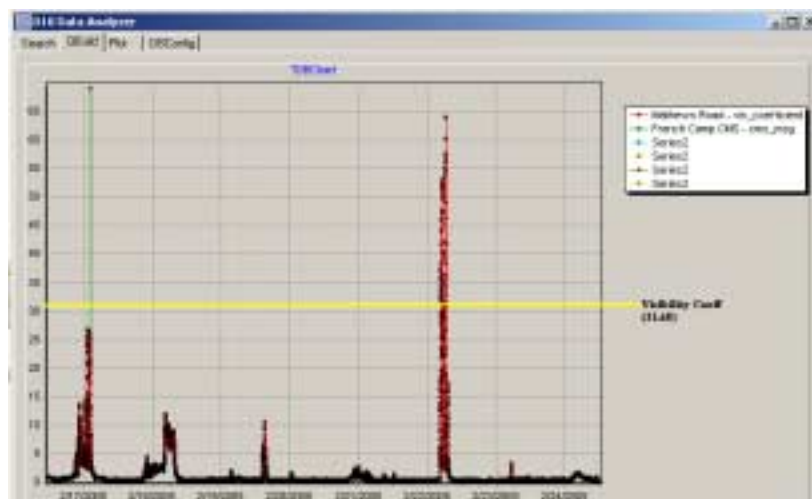
**Figure 3.3.4.4. D10 Analyzer Screenshot, 2-17-05 through 2-24-05.**

- Body Weather station 2 from 1-26-05 7:20 pm to later then 3-22-05 11:55 pm (Logs were only available through 3-22-05).
- All weather stations from 2-17-05 11:05 pm to 2-23-05 8:25 am. CAWS-evaluation system visibility data is shown in Figure 3.3.4.4 indicating the missed fog activation.

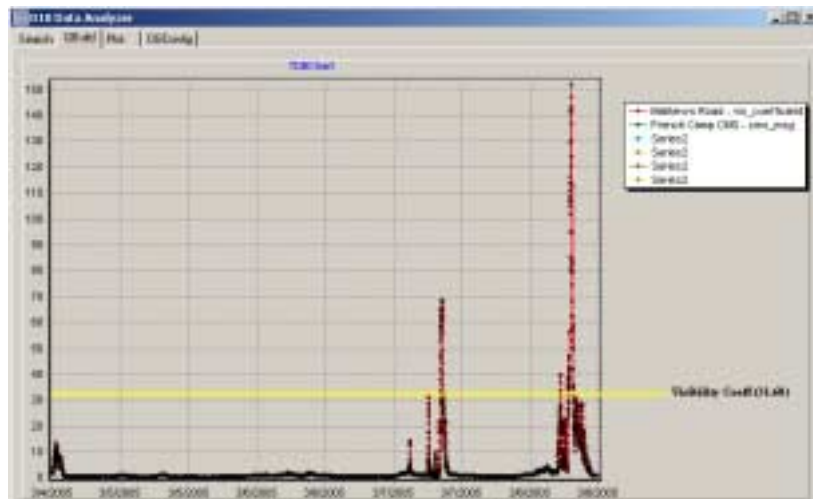
Figure 3.3.4.5. D10 Analyzer Screenshot.

- All weather stations from 3-05-05 4:05 am to 3-0-05 8:55 am. CAWS-evaluation data represented in Figure 3.3.4.5 shows two missed fog activations.
