CHAPTER THREE

Characteristics of Housing Construction in Tecate colonias

HOUSING CHARACTERISTICS IN EL RINCON AND EL DESCANSO, TECATE

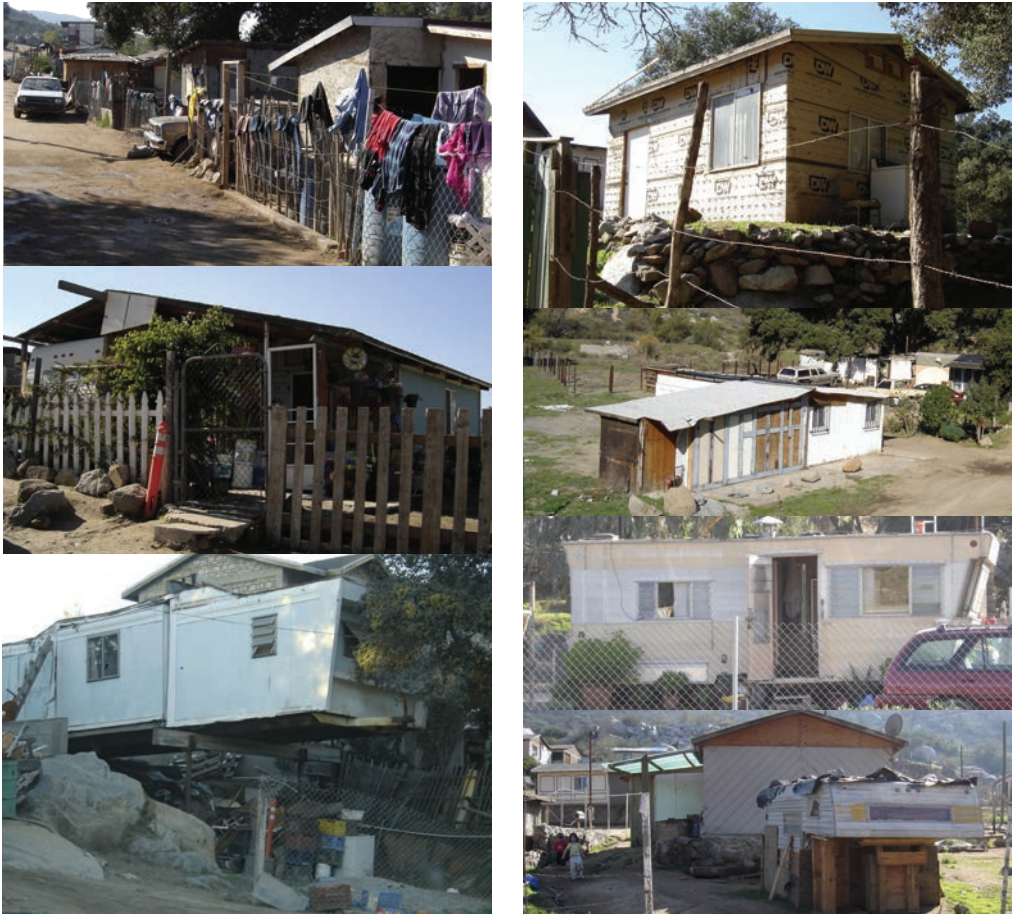
Figure 13-19: Pictures of Housing in El Rincon

CAMERA 10	Place	Time	Comment
1		2:10 PM	Anabel Valdez. She does not like from her house that it does not have floor or light
2		2:10 PM	Anabel Valdez. She does not like from her house that water leaks through the roof and walls
3		2:15 PM	María Felicita Moreno. She does not like from her house that it leaks
4		2:18 PM	María Felicita Moreno. She does not like that water runs through her land when it rains

A pilot study to capture the sensibilities of El Rincon residents was made by distributing disposable cameras to ten residents and asking them to take pictures of the home and surroundings to document what they liked, were concerned about, and would like to change, in their immediate neighborhoods (Figure 21). This study indicated that 68% of residents placed a high priority on improving their dwellings, while 20% expressed a high priority for improved services. Other wishes were more parks and playgrounds (5%), more schools or churches (3%), and cleaning up the Tecate River (3%).
