CHAPTER THREE

Characteristics of Housing Construction in Tecate colonias

HOUSING CHARACTERISTICS IN EL RINCON AND EL DESCANSO, TECATE

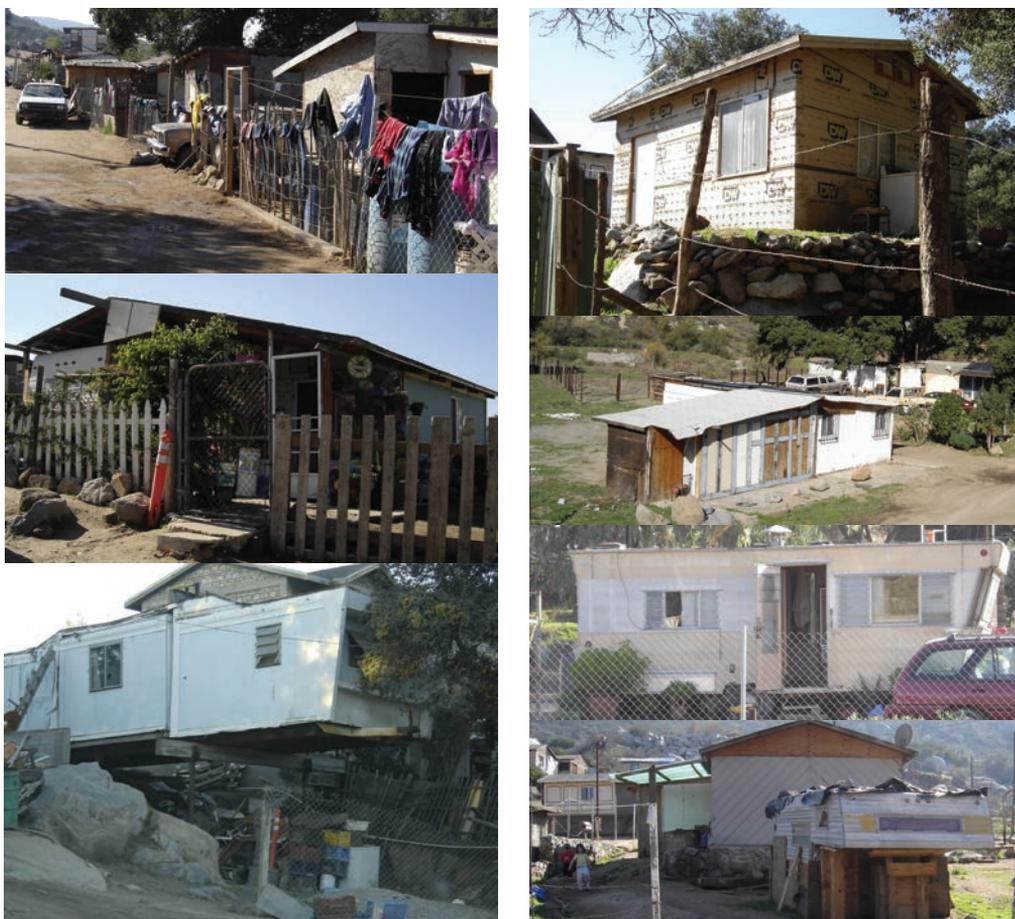
Figure 13-19: Pictures of Housing in El Rincon

2:10 PM	Anabel Valdez. She does not like from her house that it does not have floor or light
2

2:10 PM	Anabel Valdez. She does not like from her house that water leaks through the roof and walls
3

2:15 PM	María Felicitas Moreno. She does not like from her house that it leaks
4

2:18 PM	María Felicitas Moreno. She does not like that water runs through her land when it rains
