Effects of Habitat Restoration on Soil Retention on Santa Rosa Island

Michael Perez¹, Kathryn McEachern², Ken Niessen³

Sato Academy of Math and Science¹, U.S. Geological Survey², Mountains Restoration Trust³

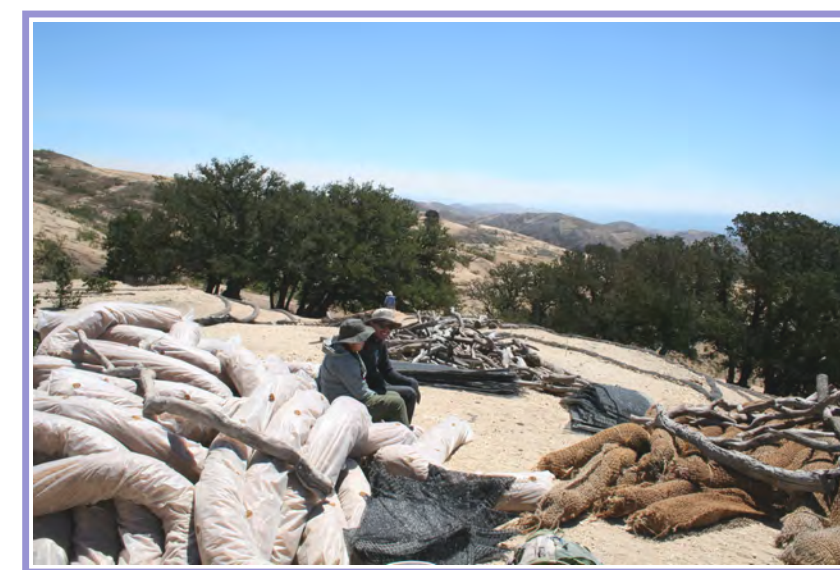
The restoration site, with erosion control structures that will be installed on the slope to slow or reverse sediment erosion.

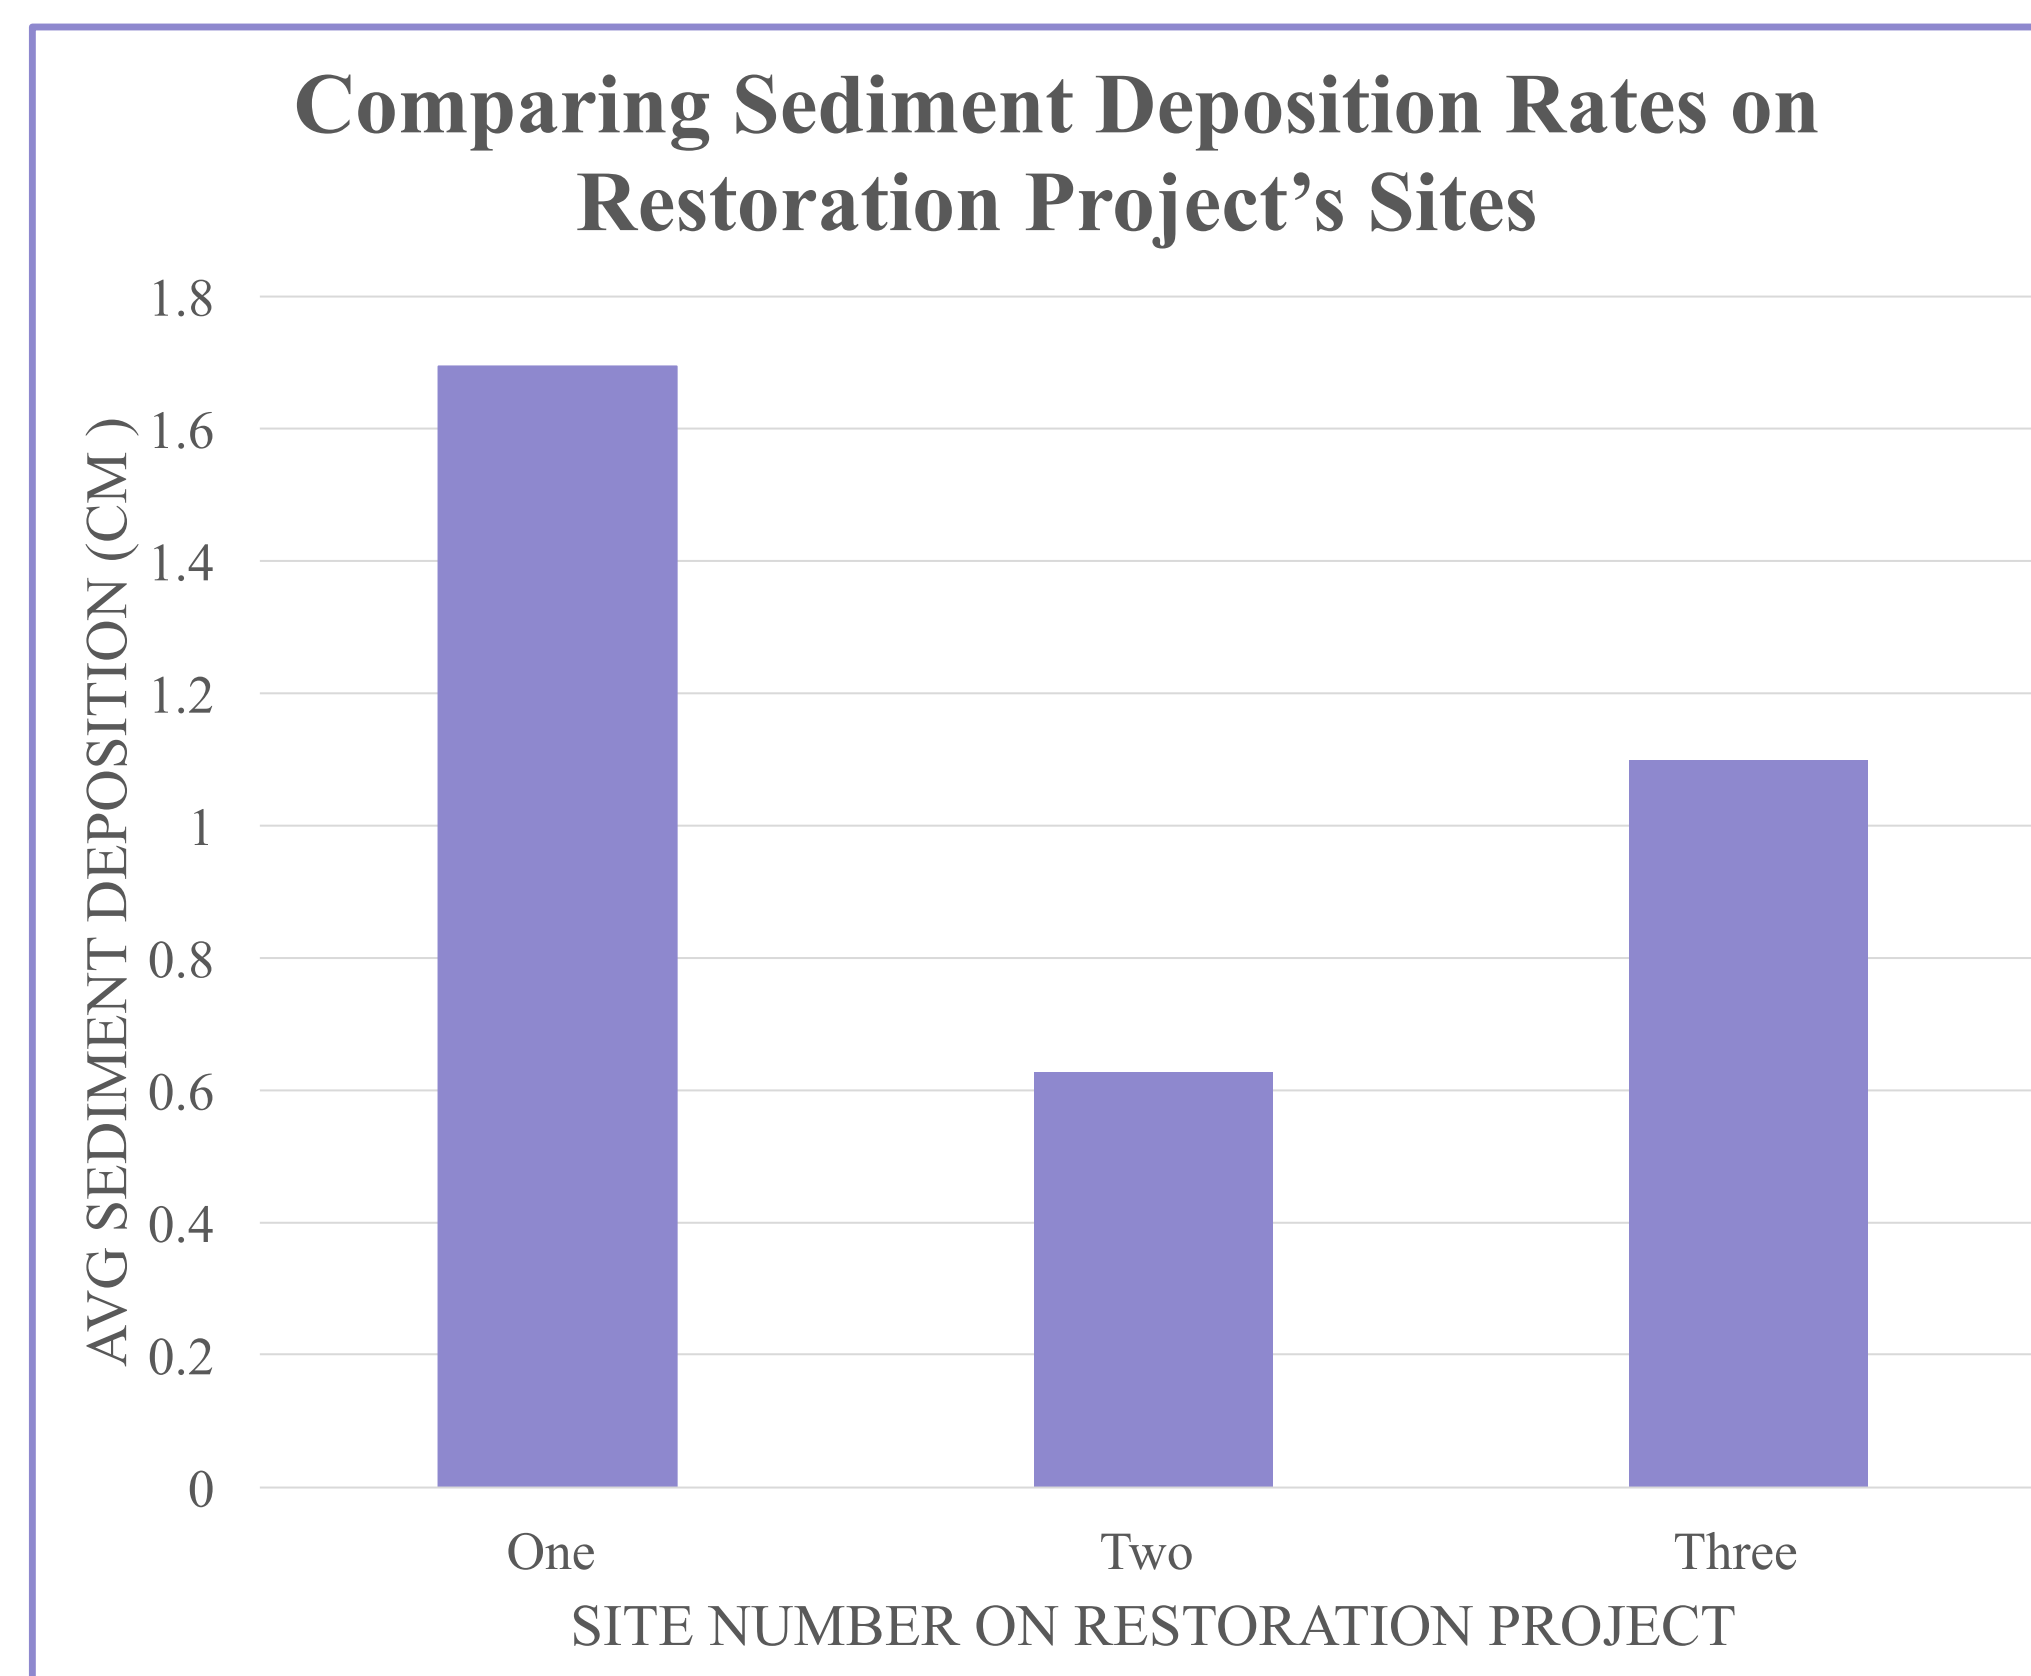
Figure 1 : Sediment deposition was measured at three different locations at the restoration site. Each site had three 60-meter transect lines placed going downhill. The results show that among the three different sites, Site One seemed to have had the highest average sediment deposition but there was a lot of variation in the measurements. p-value = 0.2373, f-value = 1.46, df = 2.

- All sites experienced sediment deposition. There is not a significant difference in the sediment deposition rates among the three sites where transects were placed on Soledad Ridge.
- Areas immediately upslope of soil erosion barriers have significantly greater sediment deposition with an average of 2.11 centimeters.

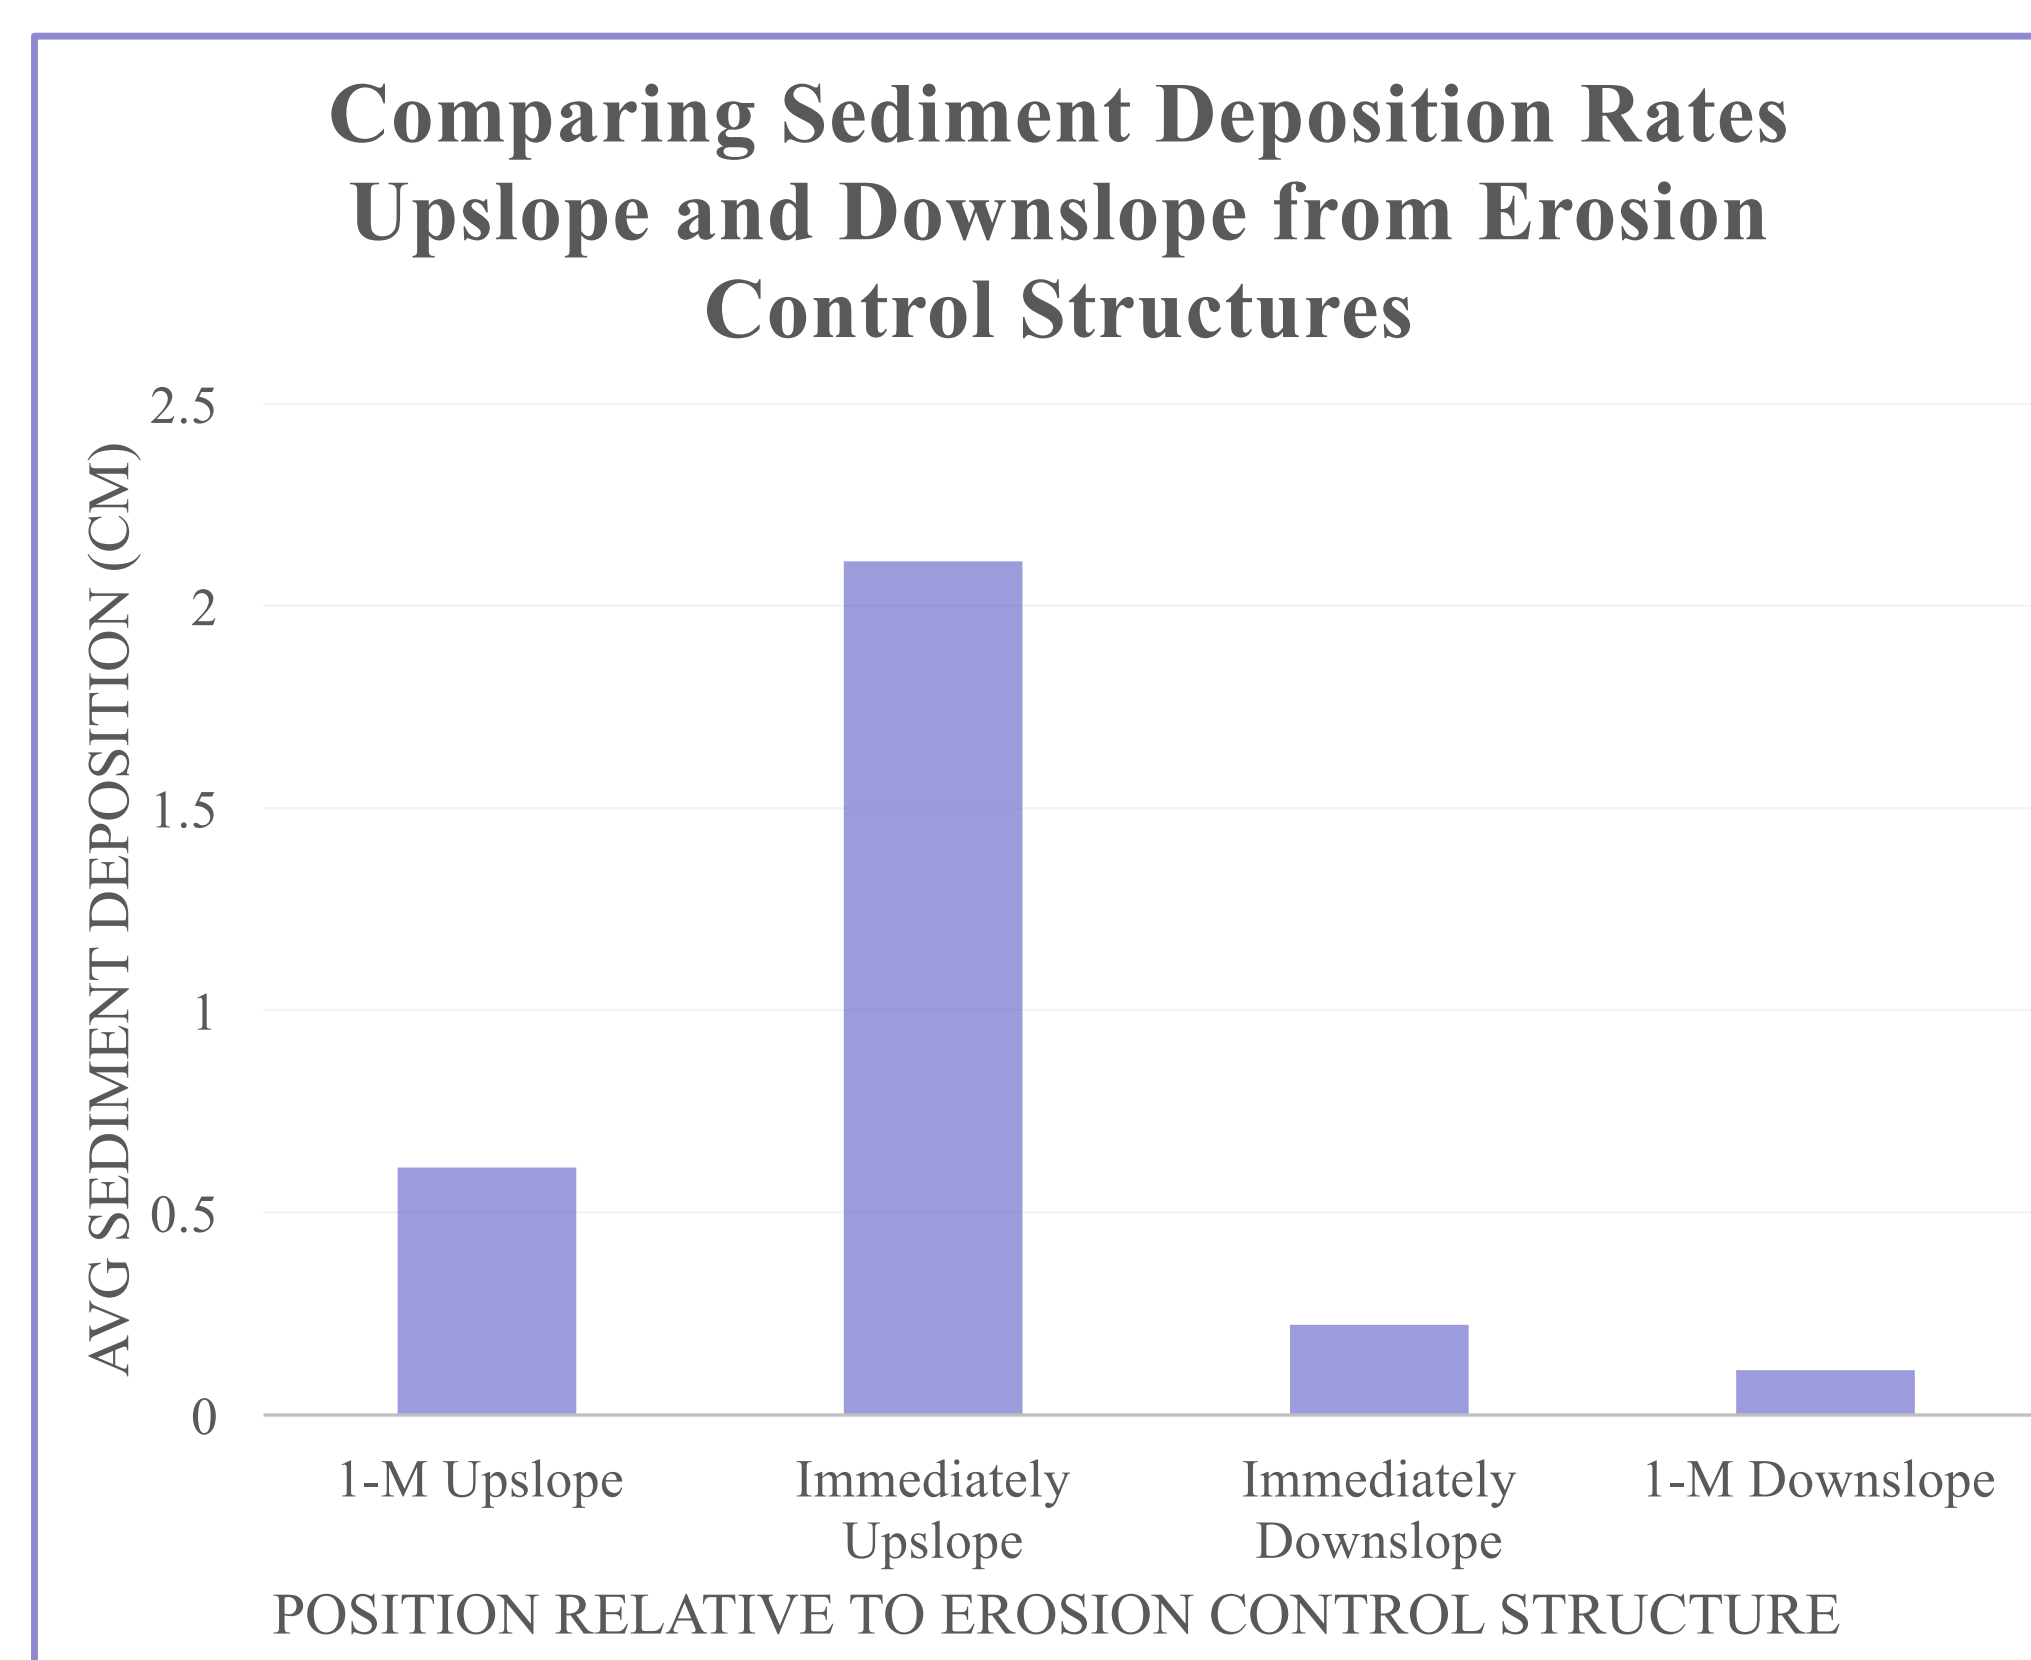
Figure 2 : Sediment deposition was measured both upslope and downslope from wattles, which are soil erosion structures installed at the restoration site. The results show that among the four different locations, immediately upslope of the structure experienced the highest average sediment deposition of 2.11 cm. p-value = 0.0105, f-value = 4.41, df = 3.

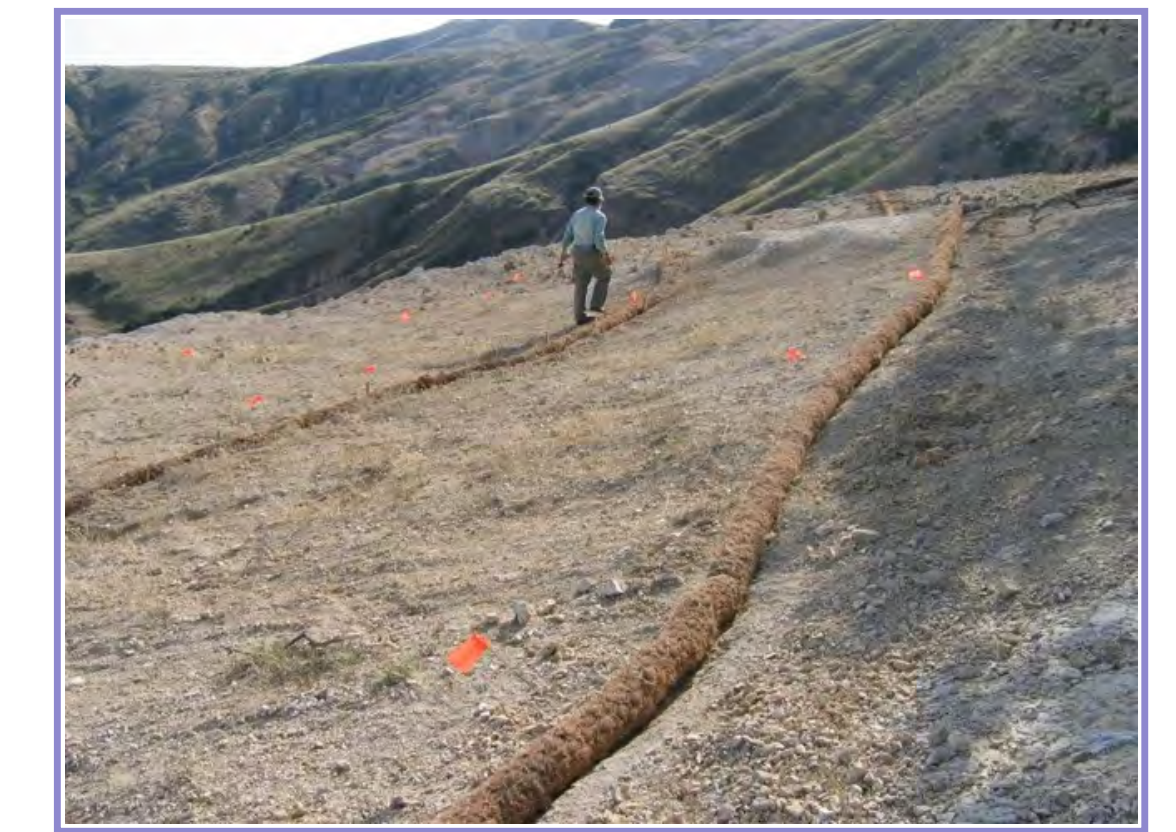
An example of wattles, soil erosion control structures

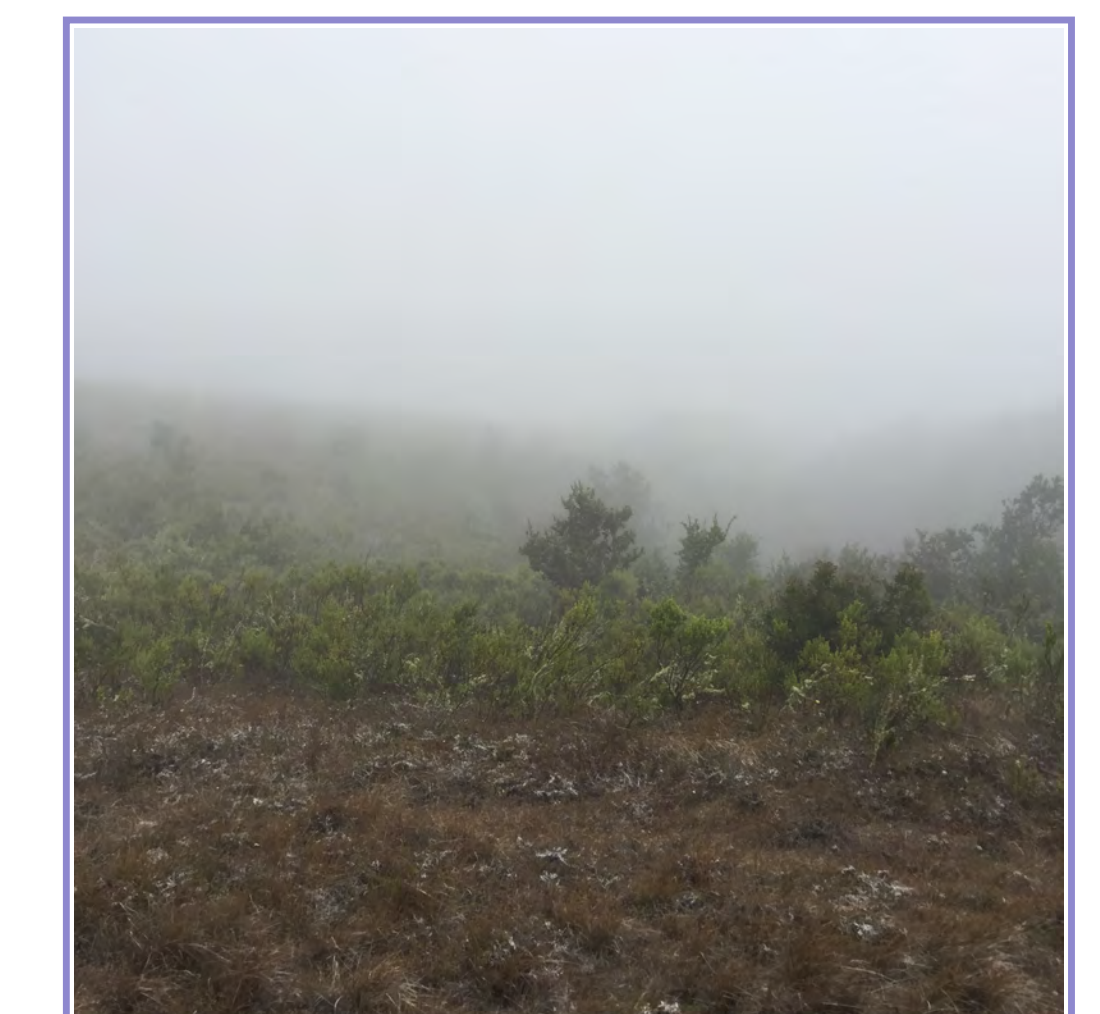
An example of vegetation naturally stabilizing sediment
