Corrosion of Stainless Steel 316L and ASTM F75 Cobalt Chromium Alloy during Immersion Testing in Silver Salt Solutions

California Polytechnic State University, San Luis Obispo

Materials Engineering Department

June 1st, 2012

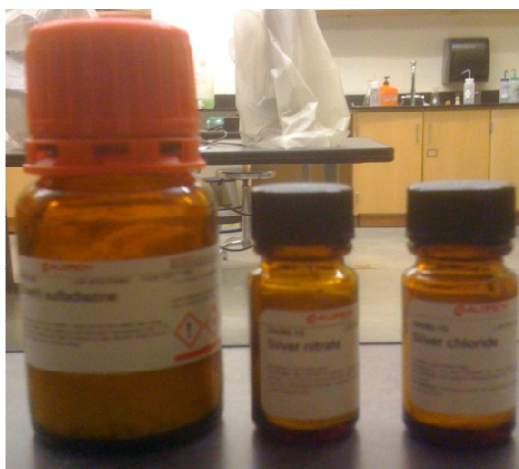
Figure 1: The three silver salts that were used from left to right are silver sulfadiazine, silver nitrate, and silver chloride.

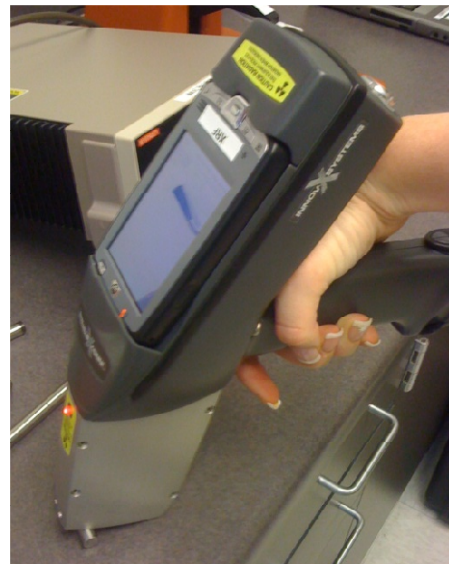
Figure 2: XRF was used to determine the composition of the stainless steel and cobalt chromium alloys.

When the cobalt chromium samples and stainless steel samples were obtained, it was unknown what the exact alloys were. To determine the chemical composition, a handheld Innov-X Systems X-Ray Fluorescence (XRF) Spectrometer was used, as shown in Figure 2. The data obtained for the cobalt chromium alloy and stainless steel alloy are shown below in Table I and Table II.

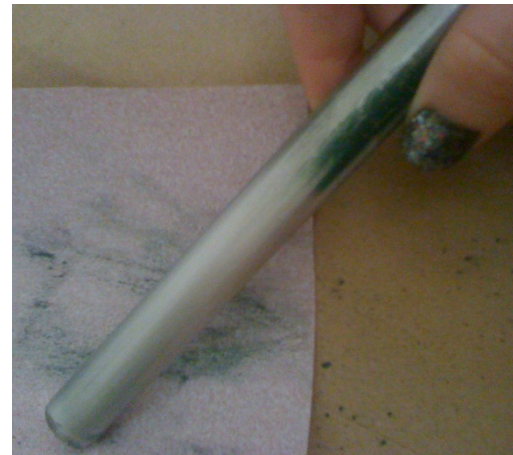
Figure 4: Paint and dirt was removed from the samples using fine grain sand paper.

Before cutting the samples, they had to be cleaned. The outside was covered in paint and dirt, so the outside of the rods were rubbed smooth with 150 grain, fine surface preparation sand paper, as seen in Figure 3. The stainless steel 316L rods and the ASTM F75 cobalt chromium alloy rods had different diameters. To compensate for this, we cut the samples

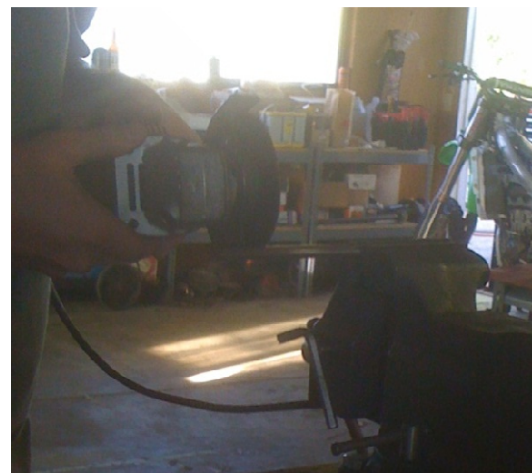
Figure 3: The metal alloy samples were cut using a cut off wheel attached to an angle grinder.

to ensure they each had the same surface area, and therefore the same amount of area exposed to the silver salt solution. The samples were cut using a 4-1/2 inch aluminum oxide, 40 grit, cut off wheel for metal. It was attached to a Dewalt Angle Grinder, as seen in Figure 4. The stainless steel samples had a diameter of 16 mm and a length of 2 cm. The cobalt chromium rods have a smaller diameter, so they were

cut to a longer length. These samples had a diameter

of 10 mm and a length of 4 cm. This gave the stainless steel and cobalt chromium samples similar surface areas, 1407.4 mm² and 1413.7 mm² respectively.

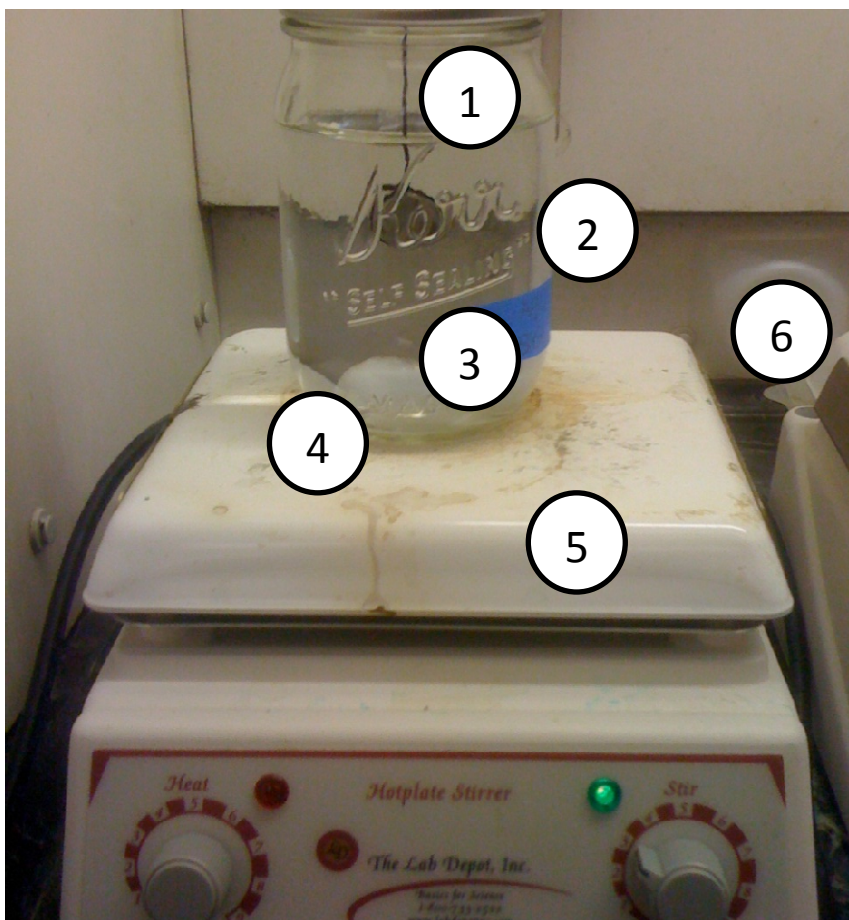
Figure 5: Testing set-up for one metal and silver salt combination.

The picture below shows the testing arrangement for one metal alloy and silver salt combination. ASTM G31-72 Standard Practice for Laboratory Immersion Corrosion Testing of Metals was taken into account while developing this test. The different aspects are discussed further below.

1. **Suspension:** To keep the metal sample suspended in the solution, a popsicle stick was laid across the top of the container. Hemp string was tied around the popsicle stick and then around the sample. This held the sample above the stirring rod and below the solution surface.
2. **Container:** 16 oz (473 mL) Mason Jars were used to hold the solution, samples, and stirring rods. These worked just as well as a beaker would have.
3. **Sample:** The samples were Stainless Steel 316L and ASTM F75 Cobalt Chromium Alloys. These are discussed in detail in the Introduction.
4. **Solution:** The solution consisted of silver salt and deionized water. The three silver salts that were used, silver nitrate, silver chloride, and silver sulfadiazine, are discussed in

detail in the Introduction. To make each test consistent, all of the deionized water for all tests done at each concentration came from the same batch. The solutions being tested are discussed in detail in the Tests Performed section.

5. **Stirring:** To keep the silver salts from settling on the bottom of the container, a stirring rod was placed in the container and the container was placed on a stir plate. Prior to testing, the stirring rods were coordinated to the same speed by counting the number of turns per minute. This helped ensure the speed of the solution in each container would be similar. The heating capabilities of the stirring plates were not utilized.
6. **Environment:** As an added safety precaution, all testing was done under a fume hood.

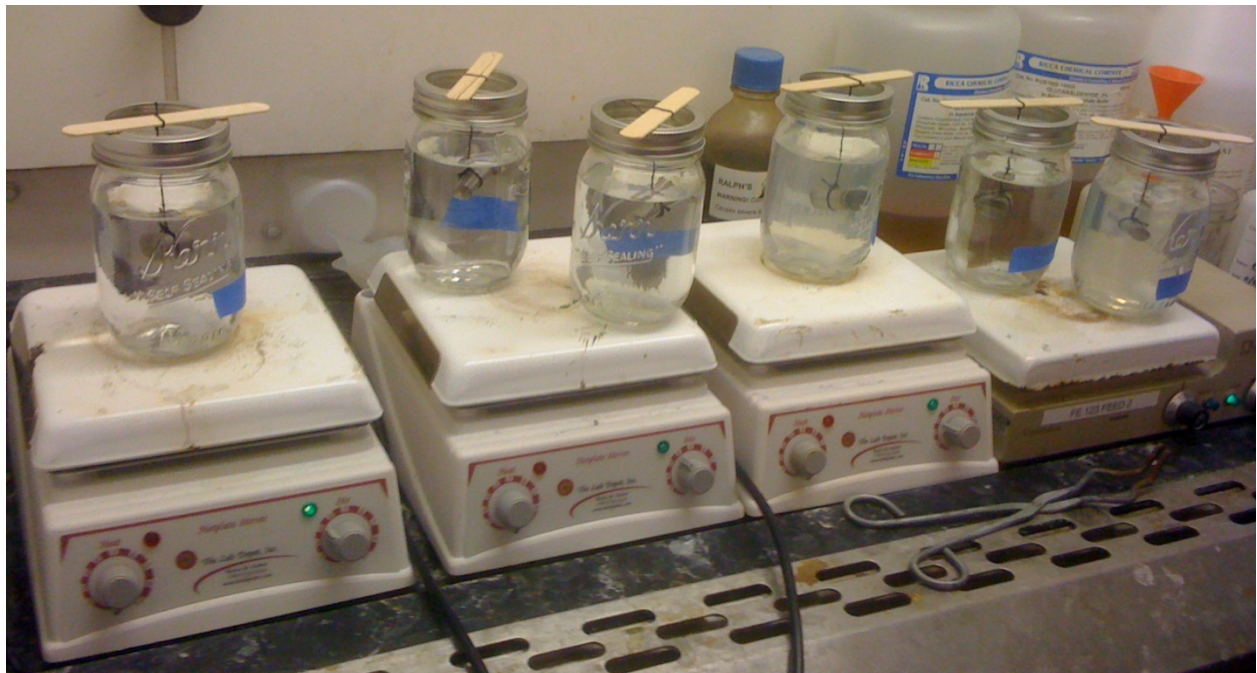
Figure 6: All of the tests at each solution were performed at the same time.

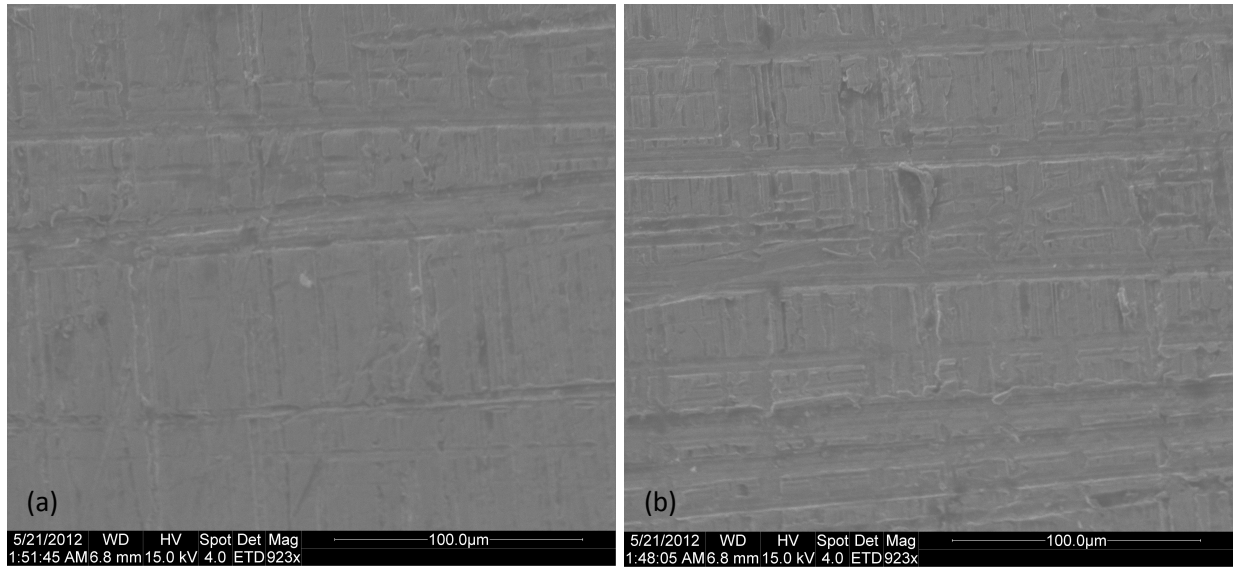
Figure 7(a),(b): Images of the surface of the control samples.

The first images that were taken were of the surface of the control samples of Stainless Steel 316L, which were not exposed to Concentration 1 or Concentration 2. In Figure 7(a), you can see the average area of the control samples. You can see the striations from sanding the surface, but there is no pitting or evidence of corrosion. Sporadically, small depressions were observed in the surface, as seen Figure 7(b).

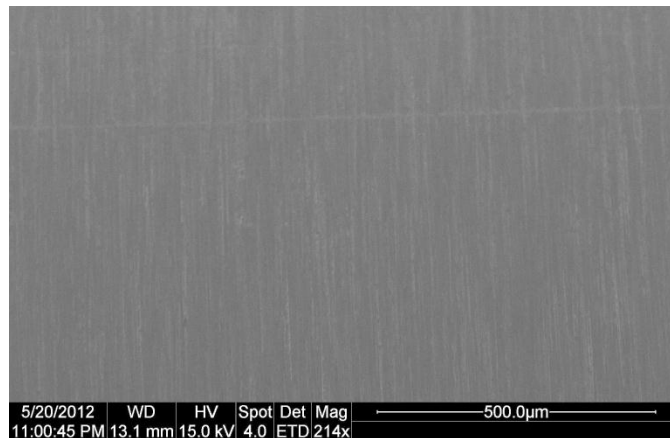
Figure 8: Cobalt chromium alloy surface after exposure to Concentration 1 showing no apparent corrosion.

Next, the samples that were exposed to Concentration 1 were observed. There was not a significant difference between the control samples and the samples from Concentration 1. The majority of the area was clear, as was the case with the control samples, as seen in Figure 8. Figure 8 is an image of the surface of ASTM F75 Cobalt Chromium Alloy which was exposed to silver sulfadiazine, Concentration 1. The same striations from the sand paper are visible but there are no noticeable pits. There were still intermittent areas in which indents in the surface were found. However, these indentations did not appear to be the same as in the control samples. Figure 9 is an image of the surface of ASTM F75 Cobalt Chromium Alloy which was exposed to silver chloride, Concentration 1. The indent appears to be deeper than the depressions found in the control samples. These pits were found on the surfaces of both the Stainless Steel 316L and the ASTM F75 Cobalt Chromium Alloy samples. Figure 10 shows a more magnified image of a pit in the surface of Stainless Steel 316L exposed to silver nitrate, Concentration 1.

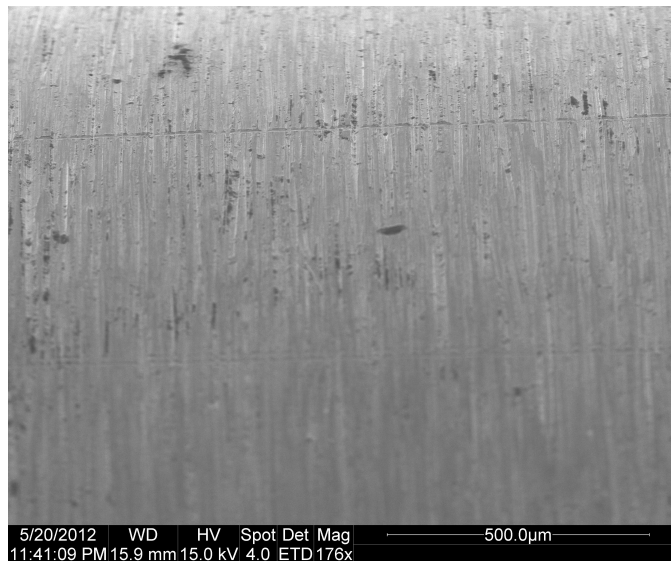
Figure 9: Cobalt chromium alloy surface after exposure to Concentration 1 showing some visible pits.

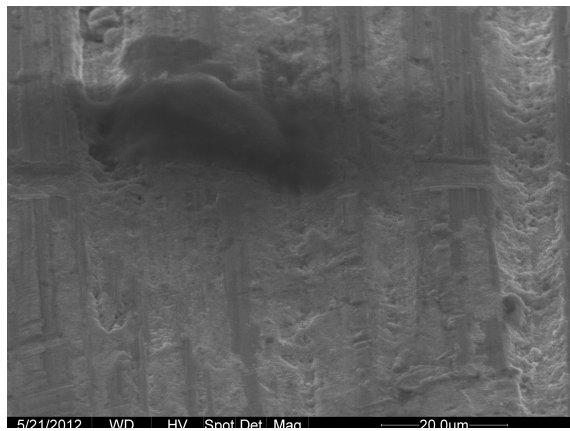
Figure 10: A pit in the Stainless Steel 316L, Concentration 1.

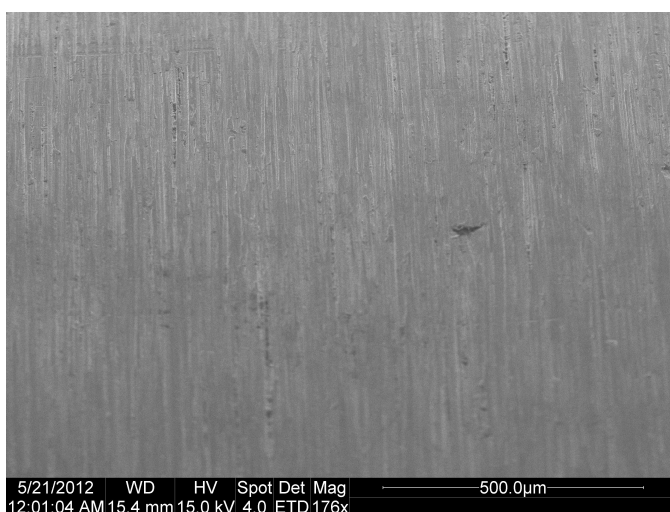
Figure 11: Surface of ASTM F75 Cobalt Chromium which displayed some pitting after exposure to Solution 2.

The surfaces of the samples that were exposed to Concentration 2 were then examined. Figure 11 shows the surface of the ASTM F75 Cobalt Chromium Alloy sample that was exposed to silver sulfadiazine, Concentration 2. The same pits were still visible, similar to the surface of ASTM F75 Cobalt Chromium Alloy which was exposed to silver chloride, Concentration 1 as seen in Figure 9. Stainless Steel 316L after exposure to silver sulfadiazine, Concentration 2 and ASTM F75 Cobalt Chromium Alloy after exposure to silver chloride, Concentration 2 showed similar pitting patterns.

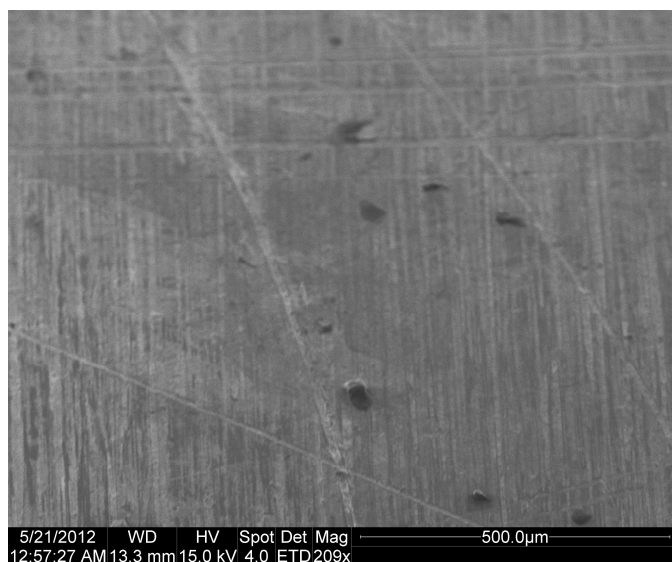
Figure 12: Cobalt chromium alloy after exposure to Concentration 2 with increased amounts of pitting.

Some differences were observed between these samples and the control samples as well as the samples from Concentration 1. In some of the silver salt and biocompatible metal combinations, the indentations in the surface appear more frequently than in the Concentration 1 samples. Figure 12 is an image of the surface of an ASTM F75 Cobalt Chromium Alloy after exposure to silver nitrate, Concentration 2. There is a noticeable increase in the amount of pits in the surface of the material.

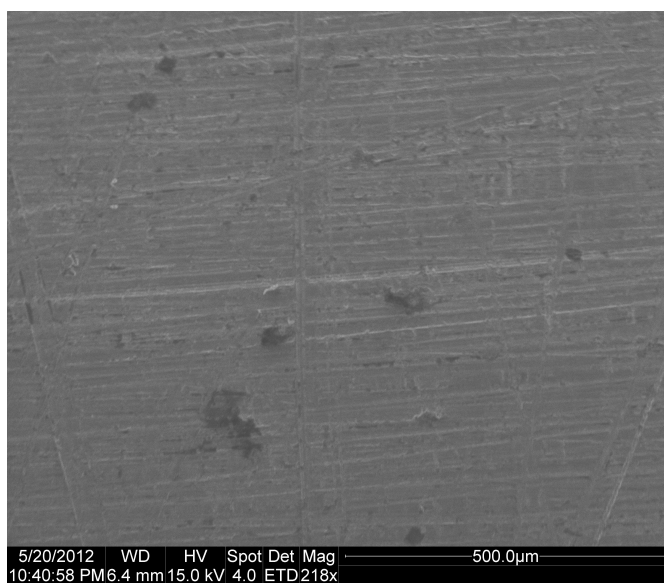
Figure 13: Stainless steel after exposure to Concentration 2 showing increased pitting.

This increase in pitting was apparent in some of the Stainless Steel 316L samples that were exposed to Concentration 2 as well. Figure 13 is an image of the surface of Stainless Steel 316L after exposure to silver nitrate, Concentration 2 and Figure 14 is an image of the surface of Stainless Steel 316L after exposure to silver chloride, Concentration 2. In this image, the pits are along striations in the surface. Both images show more pitting that was visible in the combinations at Concentration 1.

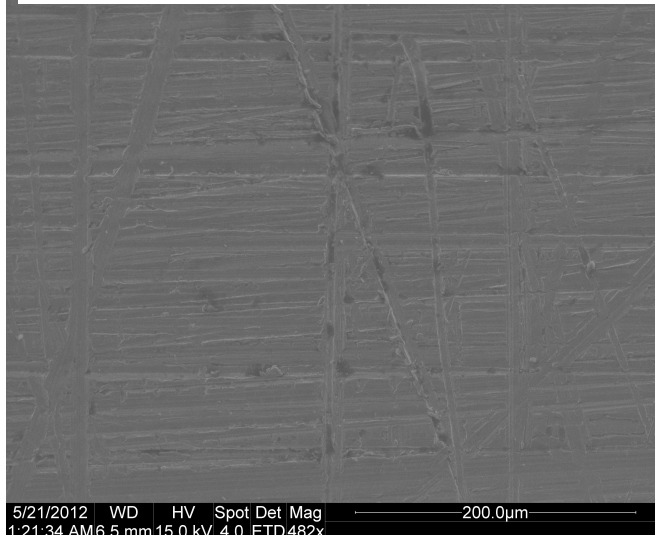
Figure 14: Stainless steel after exposure to Concentration 2 showing increased pitting.
