# Michael's Awesome Italian Adventure (With a Bit of Science, Too)

A Senior Project

Department of Physics, California Polytechnic University SLO

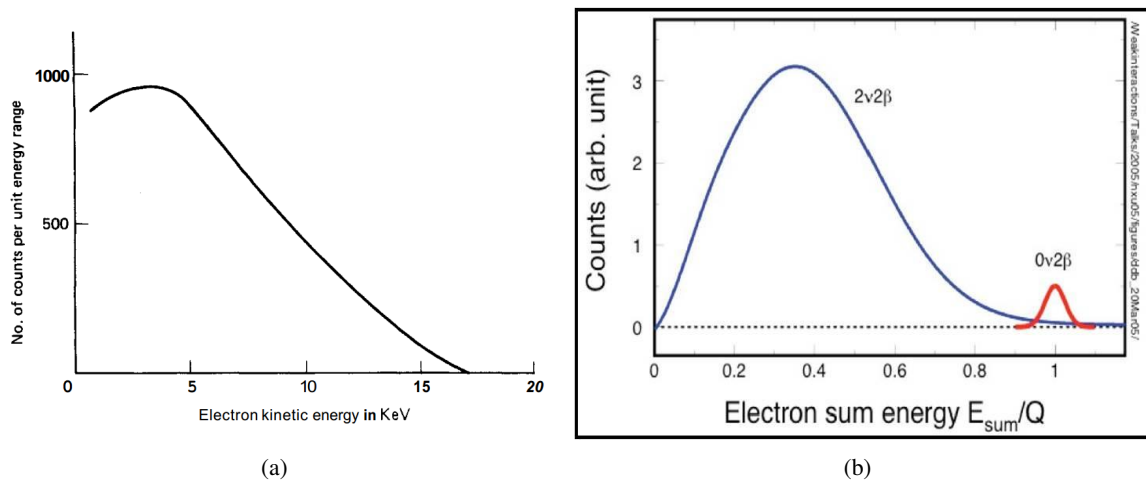
Figure 2: Energy spectrums for beta decay of tritium (a) [5] and a generalized plot of double beta decay (a).

It wasn't until 1930 when Wolfgang Pauli first predicted that there may be a third undetected particle, in addition to the proton and electron. He proposed that this particle was nearly undetectable because it was neutral of charge and interacted very weakly. In 1956 the neutrino was finally detected by Clyde Cowan and Frederick Reines [5]. Although scientists have since determined many properties about the neutrino, its weak interaction with everything makes it very difficult to study. The neutrino has some of the kinetic energy when released which gives the appearance that energy is not conserved. In Figure

2(b), normal double beta decay spectrum is shown in blue. If a peak forms similar to the red curve, the electron has received all of the energy and would suggest that no neutrinos or antineutrinos were products of the decay. This is what is expected of the theorized neutrino double beta decay, and the basis behind the CUORE experiment.

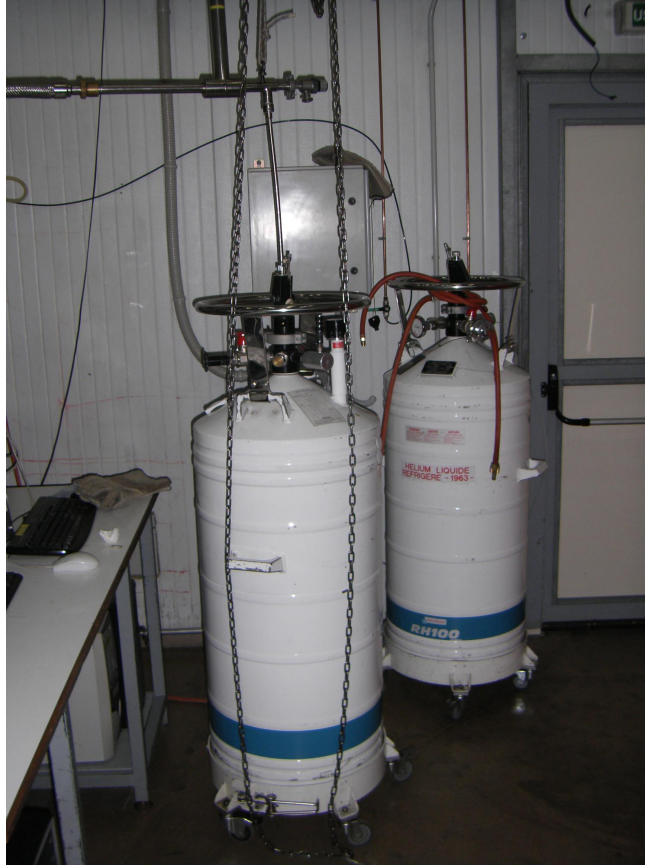
Figure 4: Liquid Helium Dewar being used to fill the main bath. The pipe coming out of the top is connected to the top of the cryostat which allows the main bath to be filled.

The Dewar has to carefully be rolled throughout the whole laboratory because liquid helium has an expansion ratio of 757:1. Every Dewar has a safety blow-out valve which can activate if the contents expand to an unsafe amount. The pressure gauge was also monitored as an extra safety precaution. A long specialized pipe is inserted into the Dewar from the top and has a pipe that runs to the top of the cryostat, which can be seen in Figure 4. The valves are opened slowly as to not shock the system, and the rate of helium entering is controlled using a pump to create suction inside the main bath tank. As previously mentioned, the liquid helium evaporates as soon as it comes in thermal contact with a warm substance, such as the inside of the main bath. In order to compensate for that, we pumped out the evaporated helium to be recycled. We aimed to pump out at a rate of 35 liters/minute but we were able to achieve 30 liters/minute which is within the acceptable range. The whole set up was left to run over

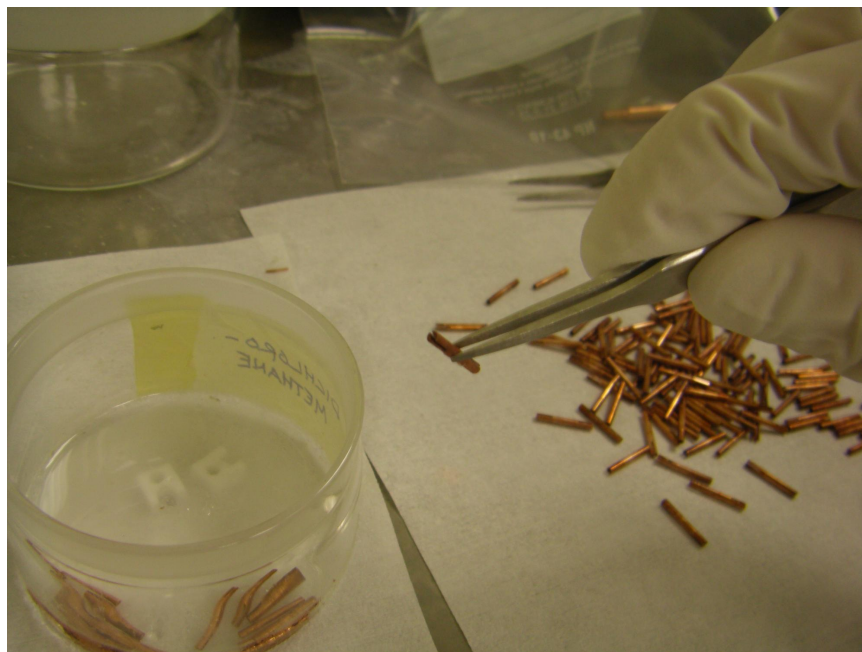
Figure 7: The set up for cleaning the epoxy off of the copper pins. The pins to be cleaned can be seen on the right, and the glass container on the left contains the pins soaking in the dichloromethane.

I was going to be using dichloromethane, which is a very strong solvent, to dissolve the epoxy from the pins. Cleaning the pins was a fairly simple but time consuming task. The pins needed to be soaked in the dichloromethane in small groups of 10-15. After about 5 minutes of soaking, each pin was removed from the bath. They then were hand cleaned and inspected to ensure all of the epoxy was removed from the center of the pin. In Figure 7 you can see part of the cleaning process. The pins on the right are waiting to be cleaning and the container on the left shows the pins being soaked. After every two rounds of pins, the dichloromethane needed to be replaced because the epoxy would start to build up. When all the pins were completed, I cleaned up the work station and the pins were taken to be put into storage until needed for the parylene project.

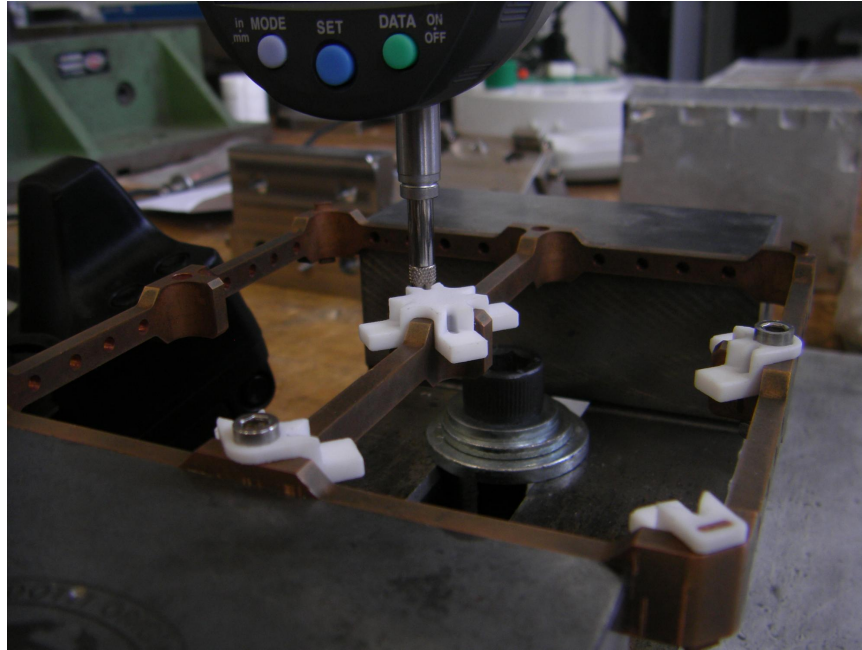
Figure 9: A full frame halfway through a cycle. The arm begins by zeroing on the raised frame next to the small spacer and working its way around the frame counterclockwise.

electronic digital indicator connected to a 6-axis robot arm. Figure 9 illustrates a full frame with a plus spacer being measured.

One full cycle for the arm is programmed to measure in the following order: small, left elbow, right elbow, all 4 sides of the plus, left elbow, and finally right elbow. Before each cycle the digital indicator touches the top of the frame to be zeroed. The process is semi-automated with human input needed after each measurement to tell the arm to move to the next piece. The digital indicator does not measure the depth of the piece, but the relative change of altitude with respect to the top of the frame. An example of a measured value on the digital indicator can be seen in Figure 10(a). To determine the depth of the piece, simply subtract the measured value by 3.0 mm. The controller is programmed to do this. It asks for the value and will return the absolute measure which tells us how deep we would like the pieces. The screen can be seen in Figure 10(b) displaying the input as well as the output.

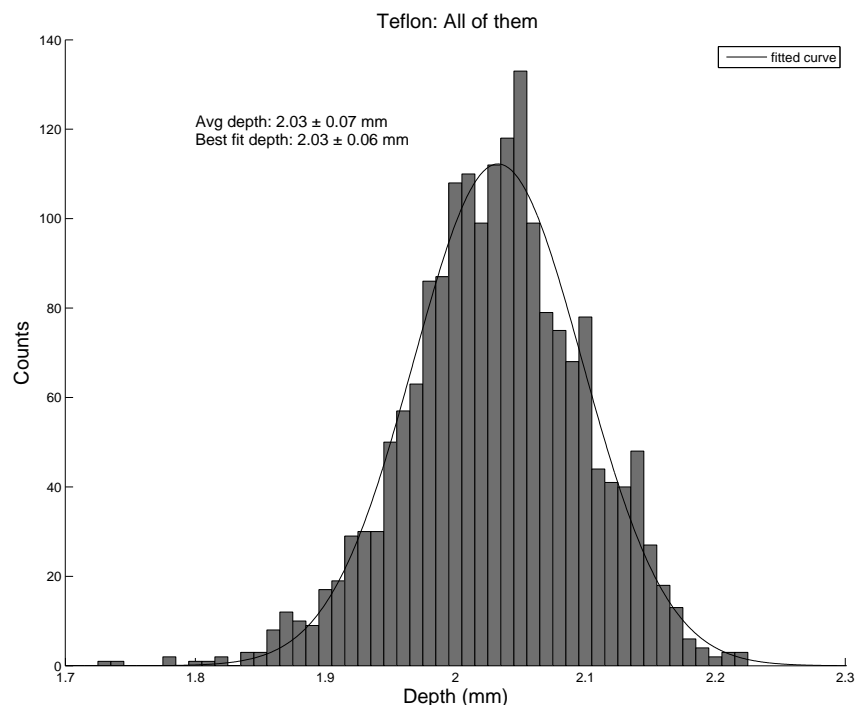
Figure 11: Histogram for all spacers measurements with a fit gaussian curve

In Figure 11 above, all of the measurements have been plotted onto one graph. Recall that the ideal spacer measurement is  $2.00 \pm 0.10$  mm. From the analysis I found that the expected mean value from the best fit is  $2.03 \pm 0.06$  mm which is acceptable within the conditions required. However, this does not tell us very much about how well each type of spacer meets these conditions. First the small Teflon spacer data was run through the code as seen in Figure 12. I found that the expected mean value from the best fit is  $2.10 \pm 0.04$  mm which is on the upper limit of the acceptable sizes. This can pose a potential problem for mounting the crystals, so many of the pieces were sorted into the rejection bag. Next, the plus Teflon spacer data was analyzed as seen in Figure 13. The expected mean value from the best fit is  $2.02 \pm 0.04$  which meets the conditions very well. There were a few outliers in the 1.70 mm range, but the majority of the spacers are within the  $2.00 \pm 0.10$  mm tolerance.

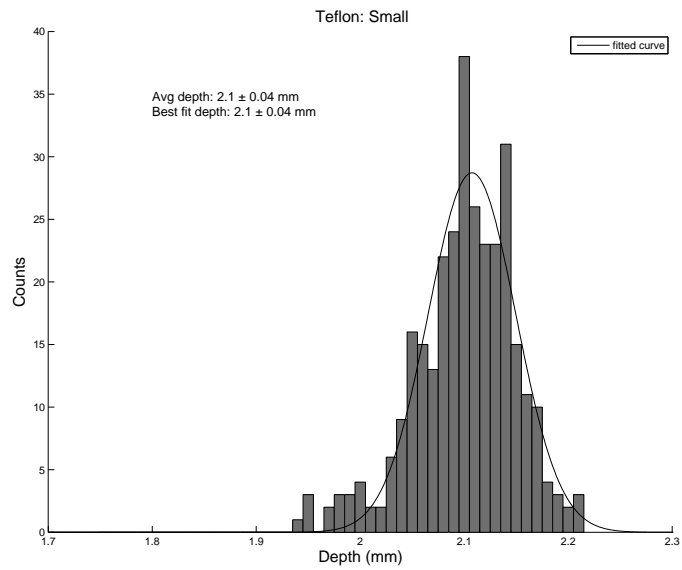
Figure 12: Histogram for the small spacers with a fit gaussian curve

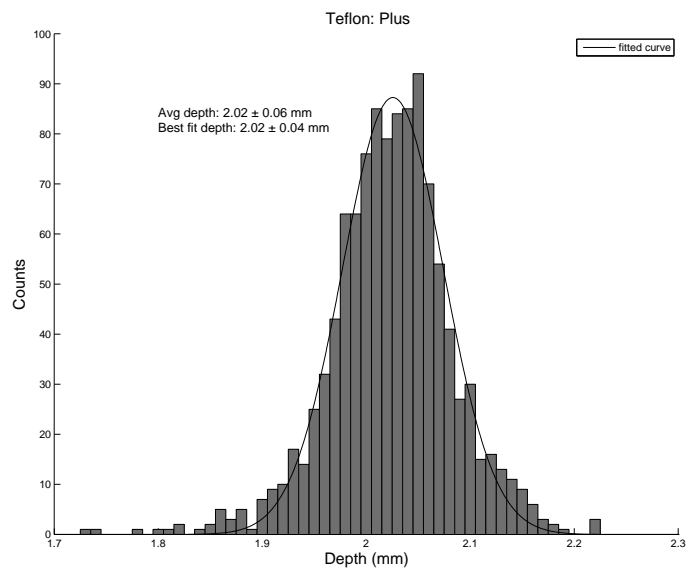
Figure 13: Histogram for all of the sides of the plus spacers with a fit gaussian curve

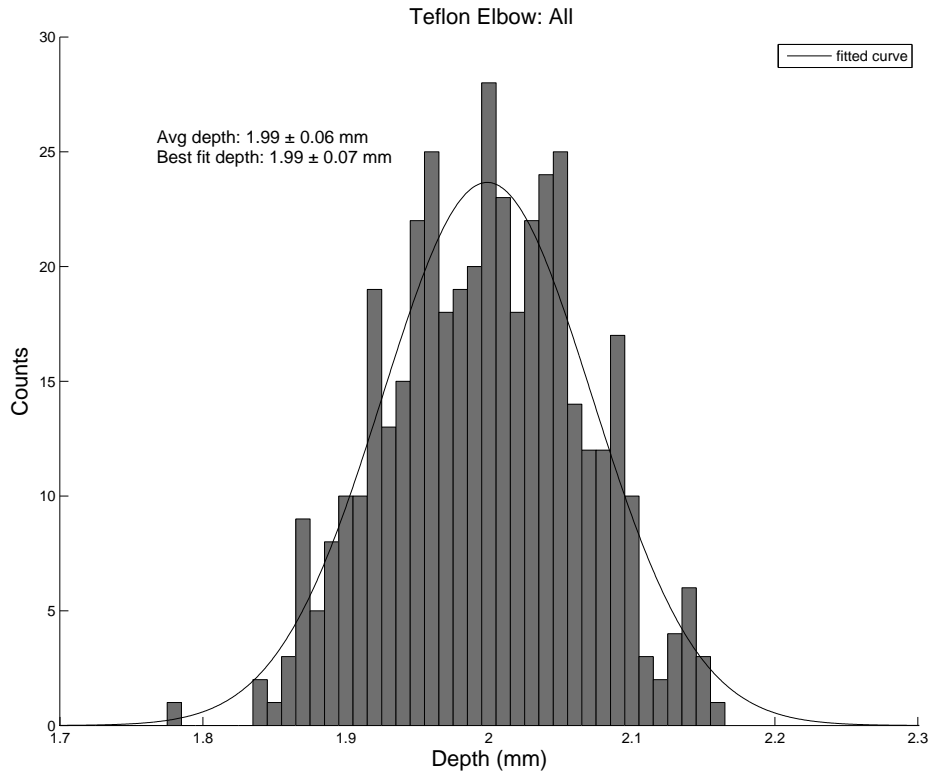
Figure 14: Histogram for the the combined right and left of the elbow spacers with a fit gaussian curve

The elbow pieces displayed some very interesting behavior. At first glance, the elbow pieces seem almost perfect because all of the measurements give us an expected mean value of  $1.99 \pm 0.07$  mm as seen in Figure 14. Most of the values are within our tolerance and the number of outliers is relatively small compared to the total measurements. However, as mentioned before, the corner of the elbow can be used as a reference point to differentiate the right and left sides. The data was then analyzed individually for the left and the right side as seen in Figure 15. The expected mean value for the left elbow is  $2.04 \pm 0.05$  mm and the expected mean value for the right elbow is  $1.95 \pm 0.05$  mm. I plotted both the left and the right elbow spacer measurements on the same graph in two colors which can be seen in Figure 16.

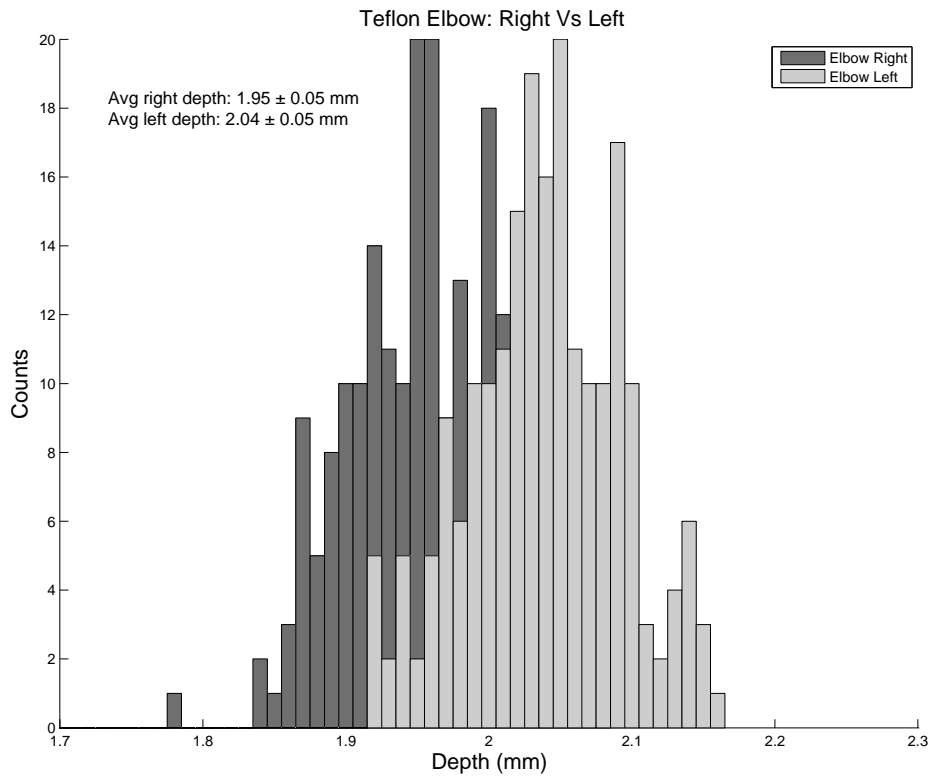
Figure 16: Side by side comparison of the right and left arms of the elbow spacers.

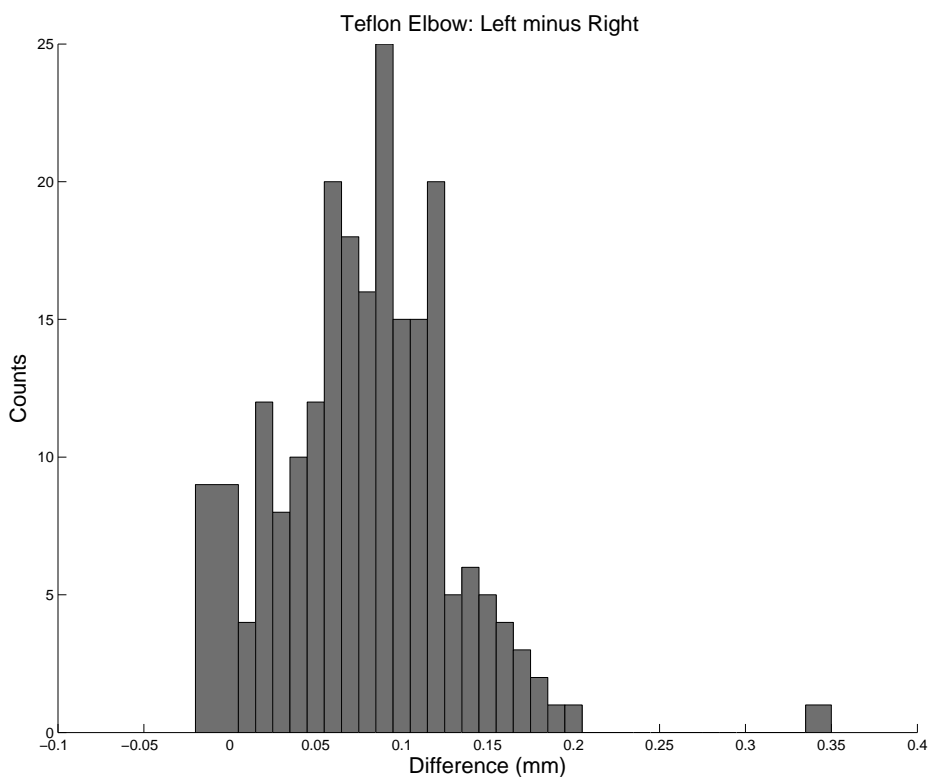
Figure 17: The difference between the right and left arms of each elbow spacers

In order to determine whether this was just an experimental coincidence, I needed to check how the right and left sides of each elbow compared. To do this I subtracted the left side from the right side within the spreadsheet. This returns the difference in depth of each spacer. In Figure 17 it is apparent that the majority of pieces have a depth difference of about or above 0.09 mm between each side. The graph has very few counts in the negative which leads to the conclusion that the left side always has a greater depth than the right.

When I first encountered this problem, I thought I might have been getting some sort of error caused by a tilting in the frame. In order to test this, the same spacer was measured in multiple elbow positions on the frame. If the frame was not level, the measurement should return values with either the right side being deeper or the two sides being equal depending on the orientation. After many tests I was

able to conclude that it was indeed the spacer, and not the apparatus, that was the problem. The data and analysis suggest that the Teflon elbow spacers were manufactured improperly and not to the specifications required by the experiment. Before anything can be said for certain, the measurements have been put on hold until it can be determined whether there is some sort of unaccounted systematic error in the data acquisition process.
