Fire & Life Safety Analysis

Orfalea College of Business

Cal Poly State University

Prepared By: Napoleon E. Nino
Fire Protection Engineering Department
California Polytechnic State University
Spring, 2017

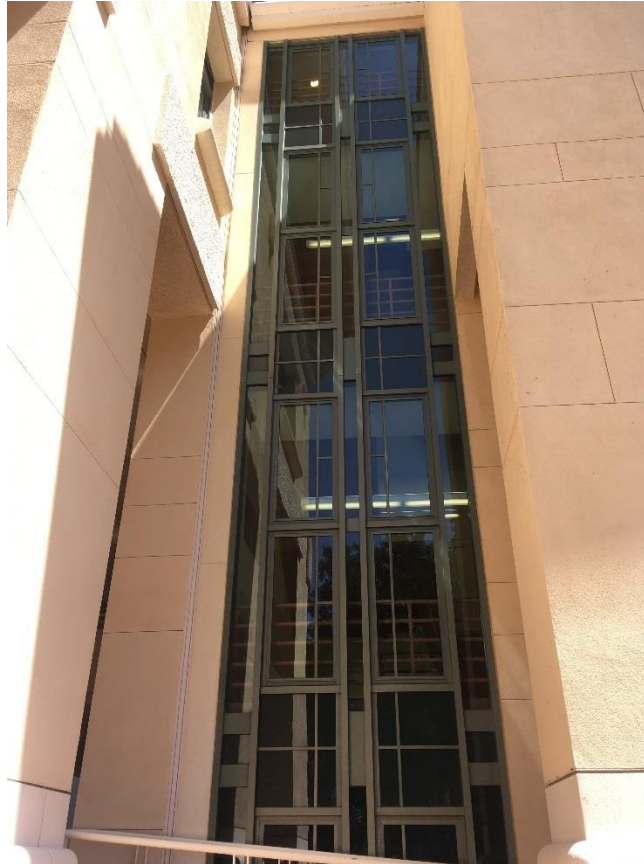
Figure 15. Enclosed Stair.

A means of egress is defined by the CBC as *continuous and unobstructed path of vertical and horizontal egress travel from any occupied portion of a building or structure to a public way*. In the Business Building, the means of egress includes both vertical and horizontal egress travel. Three enclosed stairs exist, two of which extend from the first floor to the fourth floor. One of these enclosed stairs can be seen in Figure 15.

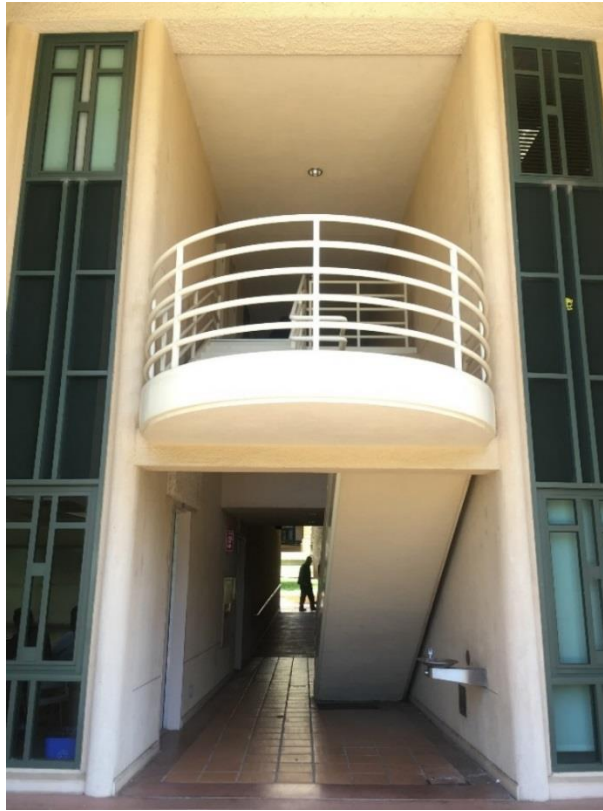
Figure 16. Open Stair.

An open stairway also exists, extending from the first to the second floor. This open stairway, seen in Figure 16, is accessed by egressing through a fire rated door that leads to a corridor which is open to the environment. It is important to note that this stair is unenclosed, and thus the stairway does not directly provide occupant fire protection. The protection is provided by the separation of the open stairway from the rest of the building by the fire rated doors.

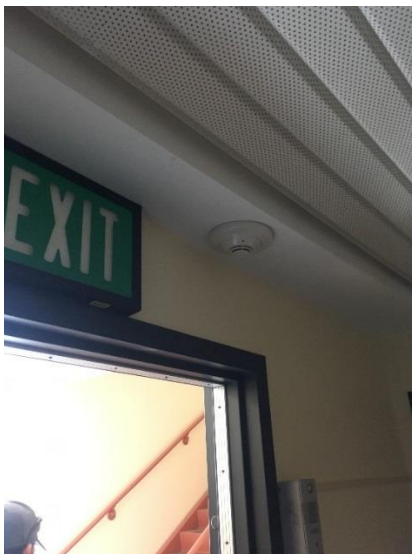
Along with violations regarding placement distance, exit signs were found throughout the building without illumination, as seen in Figures 26 and 27.

Figure 26. Darkened Exit Sign in Front of Stairway.

This lack of exit sign illumination is in direct violation of CBC Sections 1011.5 and 1011.6, which permanently require the illumination of exit signs. Violations regarding other aspects of the egress system is found in the following section.

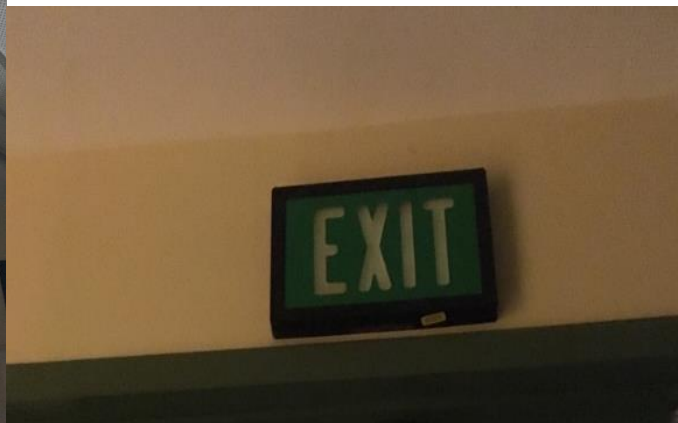
Figure 27. Exit Sign without Illumination.

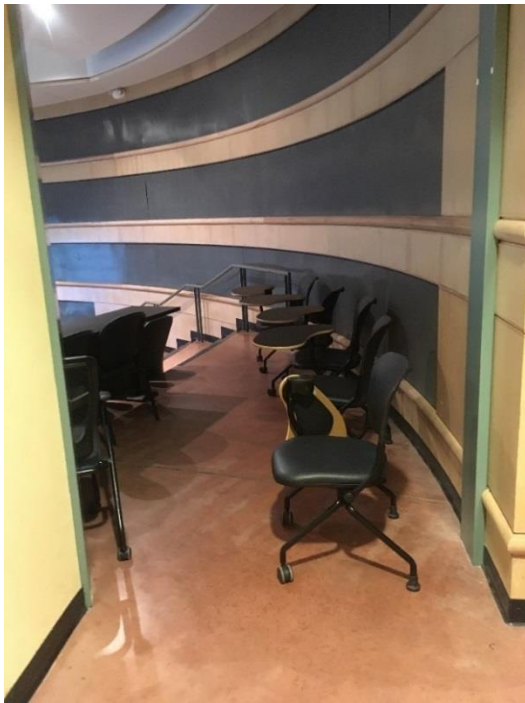
Figure 28. Obstructions in the Silo.

Obstructions in the pathway to the exit in the Silo, as seen in Figures 28 and 29, reduces the egress width below the minimum allowable width, per CBC Section 1003.6.

The building will maintain an acceptable level of protection if obstructions are removed from paths of egress and all fire and smoke doors are maintained in their proper position. The installation of sprinklers would greatly reduce the impact of a hazardous scenario, as it is nearly impossible to ensure that all doors required to be closed are closed due to the nature of the building.

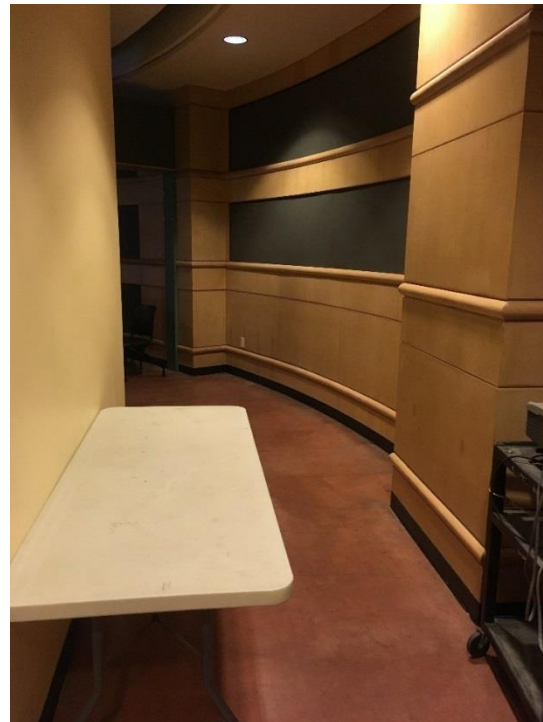
Figure 29. Obstructions in the Path of Egress in the Silo.

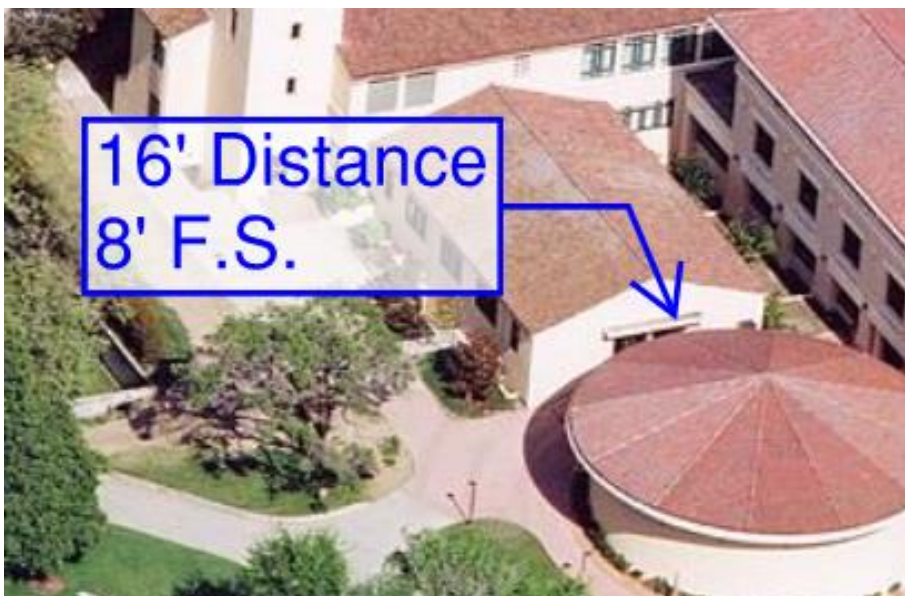
Figure 30. Fire Separation Distance – Silo and Education Building.

The fire separation distance between the silo and the Education Building can be seen in Figure 30. Using the 8' distance and using Table 8, the required exterior wall rating is 1 hour.

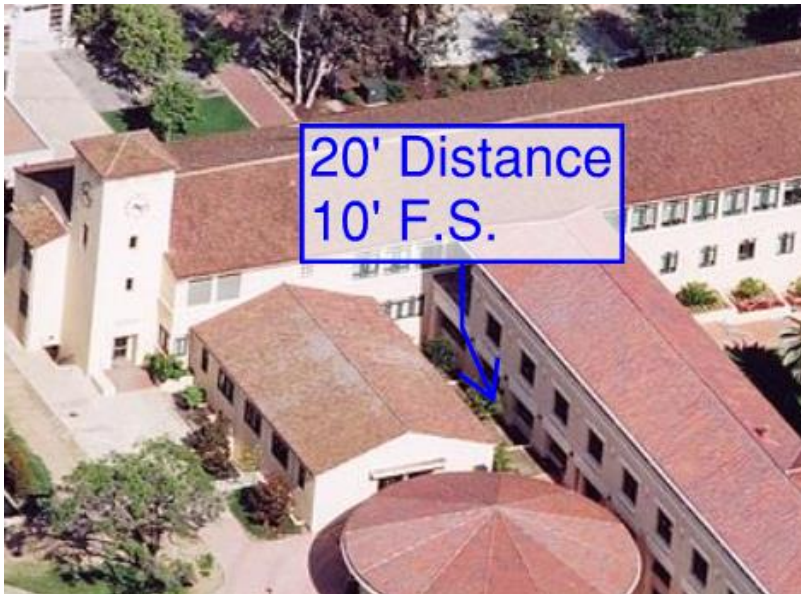
Figure 32. Fire Separation Distance – Business and Education Building.

The same process can be used for the fire separation distance between the Education Building and the Business Building. As seen in Figure 32, the fire separation distance between the two buildings are about 10'. Using Table 8 once more, it is concluded that a 1-hour exterior wall rating is sufficient for this building.

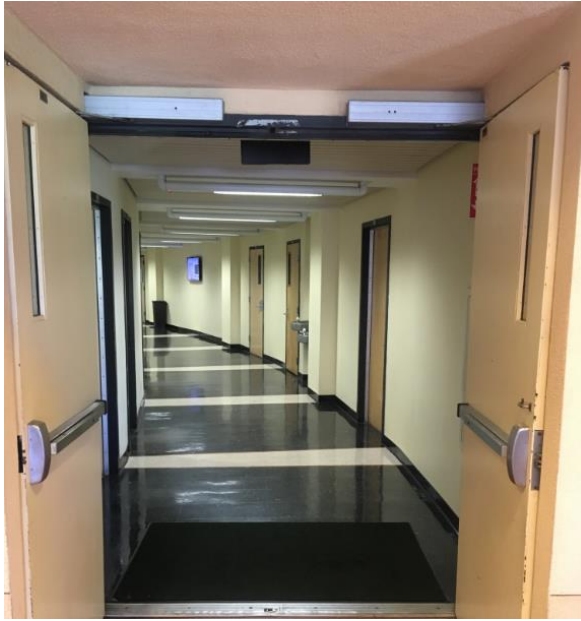
Figure 37. Doors Kept Open by Magnetic Door Holders.

When any of the activation devices are initiated, any fan programmed to be associated with the specific activation device shuts down. This shutdown is to limit smoke spread through the HVAC system. The activation devices also release doors held open by magnetic door holders, which are placed primarily on doors leading to exits. See Figures 36 and 37 for doors held open by magnetic door holders.

When these magnetic door holders are deenergized by the activation of the smoke management system, the doors are released from the magnetic door holders. All doors that are required to have fire-resistance ratings must also be self or automatic-closing in accordance with the California Fire Code (CFC) Section 715.4.8. When these doors close, they should also latch shut so that a smoke seal is created between the two sections of the building the fire doors are separating. An “S” rating on a UL listing label indicates that the door is rated for smoke protection, as seen in Figure 38. Thus, when the doors close, passive fire barriers are created throughout the building.

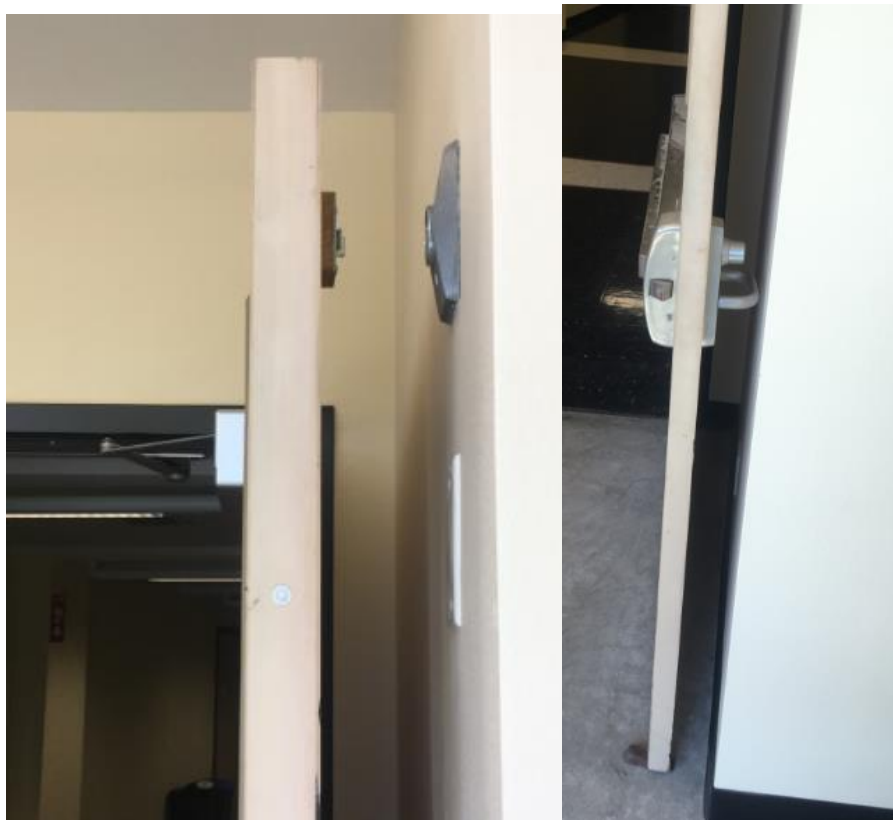
Figure 40. Propped Door with Broken Magnetic Door Holder.

Finally, any dysfunctional magnetic door holders, like the one depicted in Figure 40, must be replaced immediately. In this case, the door is propped open and leads into a stairway, which is cause for concern. The consequences of propped open fire doors will be discussed in the performance based analysis.

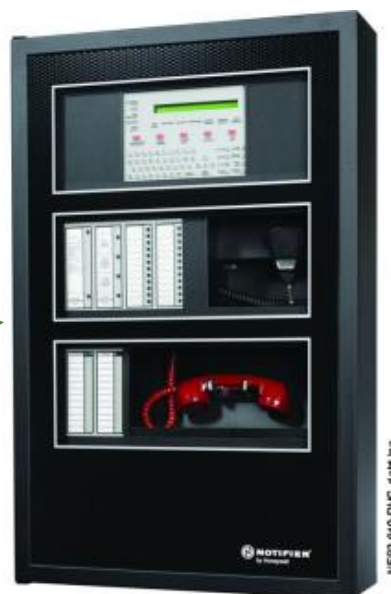
Figure 41. Notifier NFS2-640.

Original construction documents show that this building was initially installed with a Simplex 4002 Series FACU (Figure 41). However, an updated fire alarm system was added almost two decades later as a result of Cal Poly's transition to a single homologous system for the entire campus. Notifier's NFS2-640 (Figure 42) was selected as the building's fire alarm system. The Notifier System is located on the first floor on the southwest side of the building.

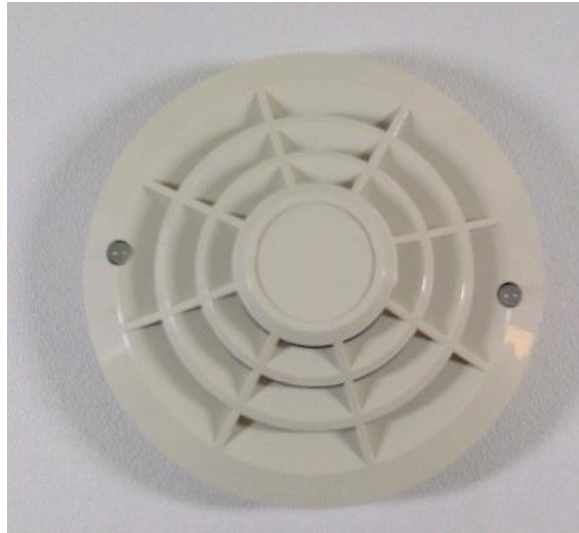
Figure 43. 5251p Heat Detector.

One model of heat detector is utilized in the Business Building. There is only one heat detector found on the fire alarm plan: a System Sensor 5251p Fixed Temperature Sensor. This sensor is used in the room containing the Fire Alarm Control Unit (FACU). The 5251p, seen in Figure 43, operates solely when its detecting element reaches a fixed temperature. The rest of the detectors in the building have smoke detecting capabilities.

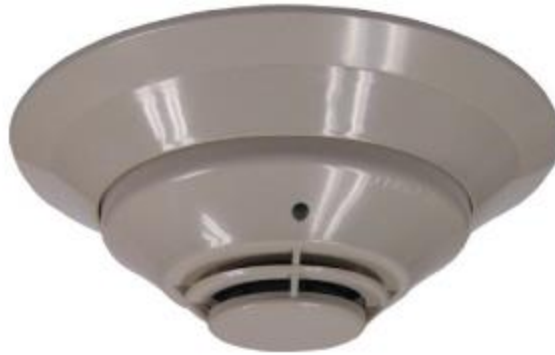
Figure 44. FSP-851 Smoke Detector.

Notifier's FSP-851 Intelligent Plug-In Photoelectric Smoke Detectors, seen in Figure 44, were utilized as a thermal and smoke detector combination and are located in the corridors of the building. These detectors operate when the temperature reaches 135 °F or when obscuration reaches the specified amount, ranging from 0.5% to 2.35% per foot obscuration.

Notifier's FSP-851 Detectors have a maximum spacing of 30' for ceiling heights of 10', but for irregular spacing, the maximum spacing from any one point to another should not exceed 21'. Analyzing the locations of detectors on the floor plans proves there is a violation of the recommended maximum spacing in the corridors. System Sensor's 5251P Detector in the FACU room provides adequate coverage, as the detectors provide 50' spacing capabilities. No detectors were noted to violate ceiling distance requirements per NFPA 72 Sections 17.6.3.1.3.1, 17.7.3.2.1. As stated in NFPA 72 Section 17.5.2.1, air duct detectors shall not be used as substitution for open area protection. A clear violation of this requirement is observed as there is a lack of smoke detectors in areas where duct detectors are located.

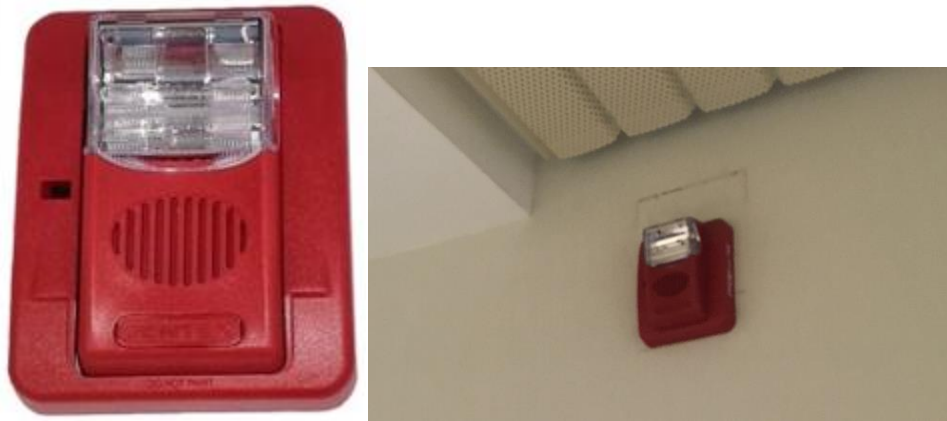
Figure 49. GEC3 Horn Strobe found in the Business Building.

All notification appliances in this building are combination audible and visible appliances. Gentex's GEC3 Selectable Candela Evacuation Signals, seen in Figure 49, are the only audible/visible appliance used in the Business Building. These devices offer a range of tamperproof field selectable candela options from 30 candela (cd) to 110 cd intensity. The horns of these devices offer selectable tones as well, producing a sound pressure level of up to 82 dBA. The catalog datasheets for this device can be found in Appendix B. These appliances are located throughout the building, and the locations can also be found in the Appendix B. 24 horn strobes exist throughout the building.

The light outputs of the GEC3's in the Business Building are on the 75 cd selection. Thus, a maximum spacing of 45' x 45' is allowable for the light intensity setting. However, there were rooms larger than this spacing that only contained one GEC3 such as room 300 on the third floor as seen on the floor plan, and thus did not meet the requirement. Also, there were rooms that did not contain any sort of visible signaling. Because these areas are occupiable spaces, the lack of visible notification appliances violates NFPA 72 Section 18.5.1.2. The corridors were noted to also exceed the spacing listed in the table above. However, Section 18.5.5.5.1 in conjunction with Section 18.5.5.5.5 allows notification appliances in corridors to be spaced no more than 15' from the end of the corridor and not more than 100' apart. After analyzing notification appliance distances on the floor plan, the corridor spacing for all four floors is deemed code compliant.

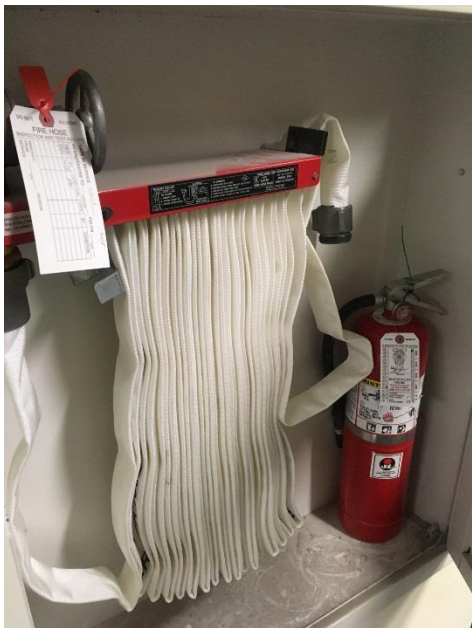
The Business Building is not equipped with a fire sprinkler system. Fire hoses located in cabinets throughout the building were designed as the primary fire suppression system implemented for this building. These fire hoses as seen in Figures 51 and 52, were previously defunct, but were recently put back in service, as attested to by the record seen in Figure 53. Appendix C contains the shop drawings for the original fire hose cabinet system.

Figure 51. Functional Fire Hose.

Although not required at the time of construction, the current edition of the CBC would require an automatic sprinkler system in this building, per CBC 903.2.1.3. Because of the lack of automatic fire suppression, a wet pipe quick response sprinkler system was designed and is presented to replace the fire hose cabinet fire suppression system.

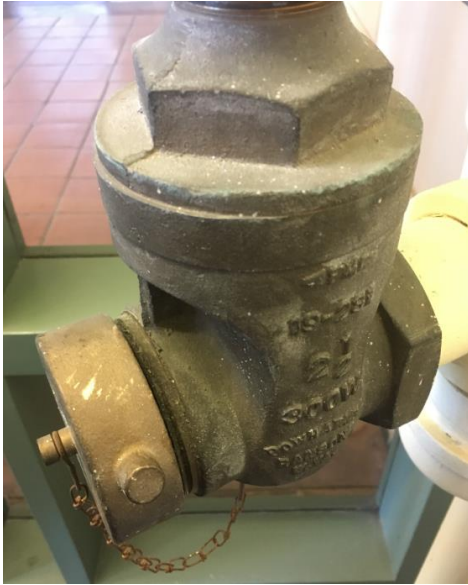
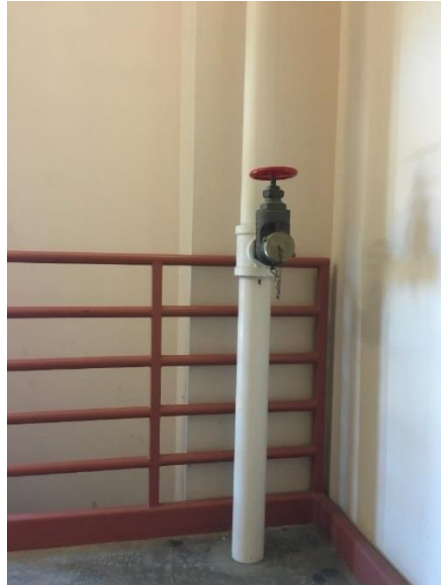
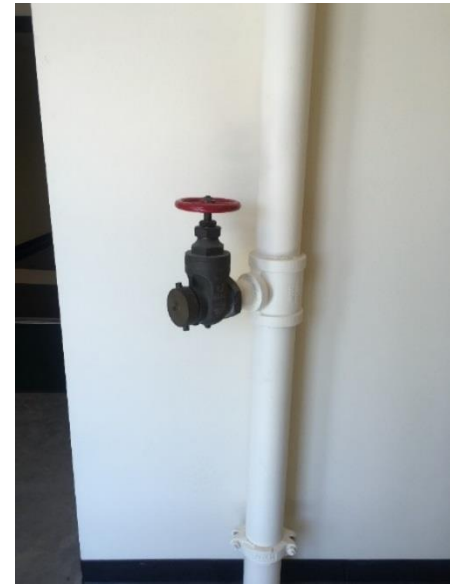
Figure 54. Dry Standpipe FDC 1/3. Figure 56. Dry Standpipe FDC 2/3. Figure 55. Dry Standpipe FDC 3/3.

Fire extinguishers also exist throughout in the fire hose cabinets as well as in specific cabinets intended for fire extinguishers. Three dry standpipes currently exist in the building, one in each of the stairways, as seen in Figures 54, 55, and 56. Each of these standpipes have 2 ½ inch fire department connections (FDC’s) so that firefighters can attach their hoses and attempt to extinguish the fire.

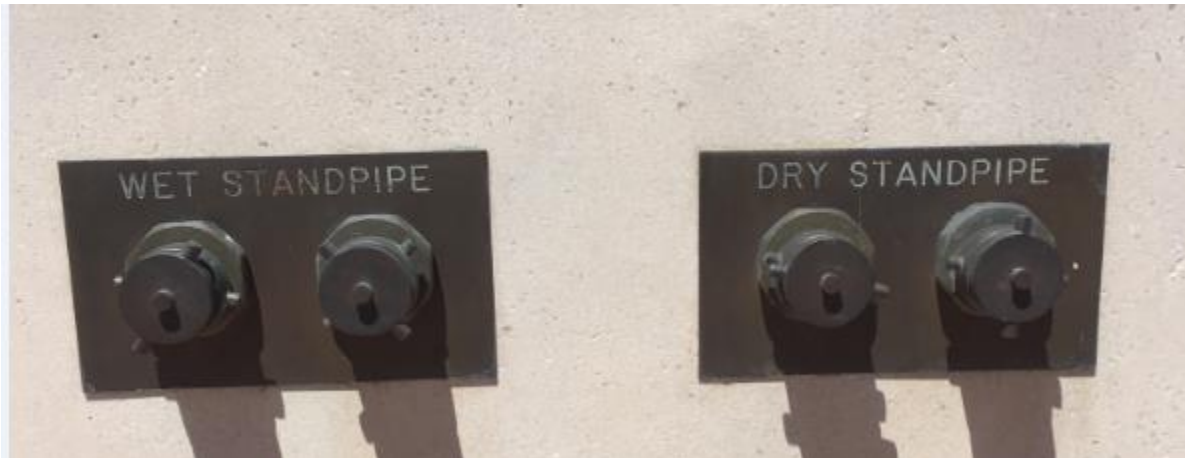
Figure 57. Siamese Connections on Exterior South Side.

2 ½ inch dry and wet standpipe FDC's were also located on the south side of the building exterior, as seen in Figure 57. The wet standpipe FDC's are intended to supplement the fire hose water demand if necessary.

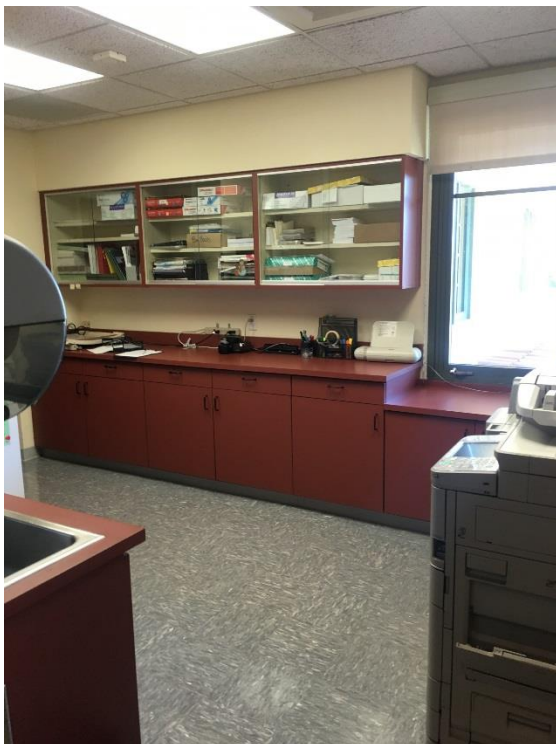
A teacher lounge exists on the fourth floor. This teacher lounge contains a large amount of combustibles throughout the room, seen in Figure 65. Ignition sources involved include electrical appliances such as the microwave, coffee maker, and refrigerator, as seen in Figure 64.

Figure 65. Teacher Lounge - Combustibles on Shelves.

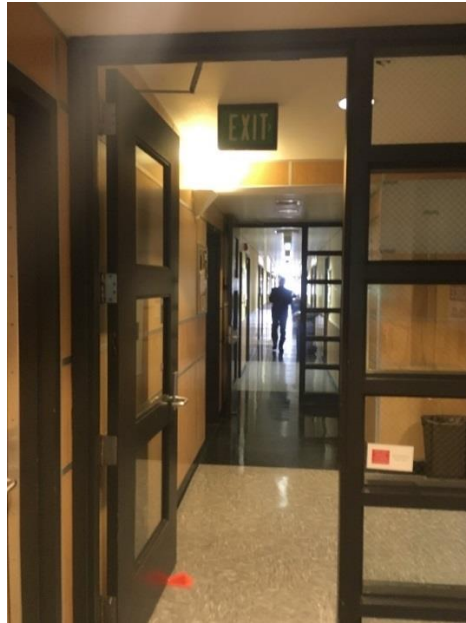
Figure 66. Propped Fire Door.

The door leading into this room is connected to an unrated corridor, but this corridor leads into the rated corridor of the fourth floor. Both the door into the teacher lounge and the door leading into the rated corridor are open. Although the door leading into the teacher lounge is not required to be self-closing, the door leading into the rated corridor needs to be self-closing, and as seen in Figure 66 it is propped open with a wedge.

This scenario was considered because fire ignition and spread is possible in the teacher lounge and the propped open door can jeopardize the safety of the occupants from other parts of the building using the rated corridor as a means of egress.

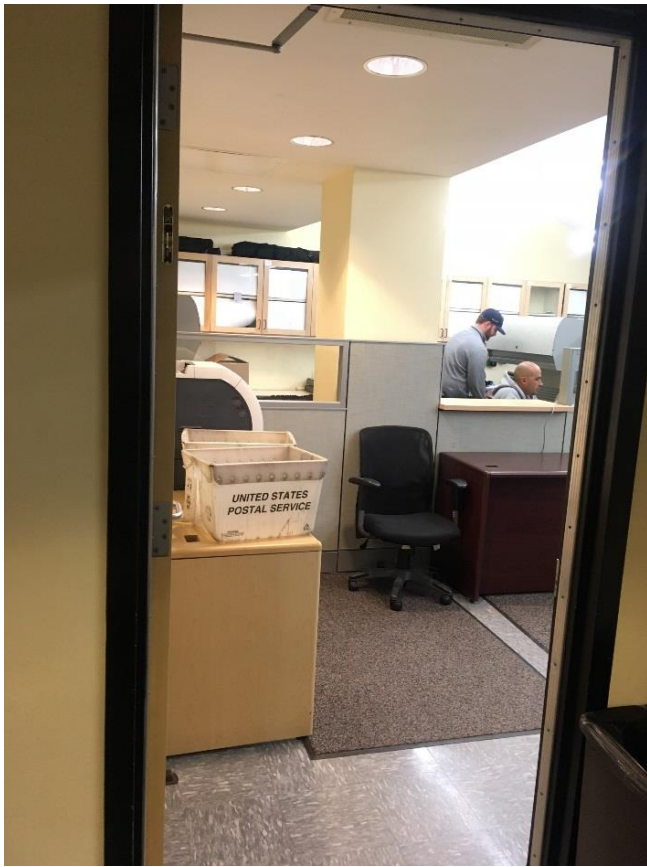
An information and student support center also located on the fourth floor of the Business Building posed a possible fire hazard. This room had an access window with a shutter (it is undetermined if this shutter would automatically close in the case of a fire) and a propped open fire door, as seen in Figures 67 and 68.

Figure 68. Information and Support Services Center – Propped Fire Door.

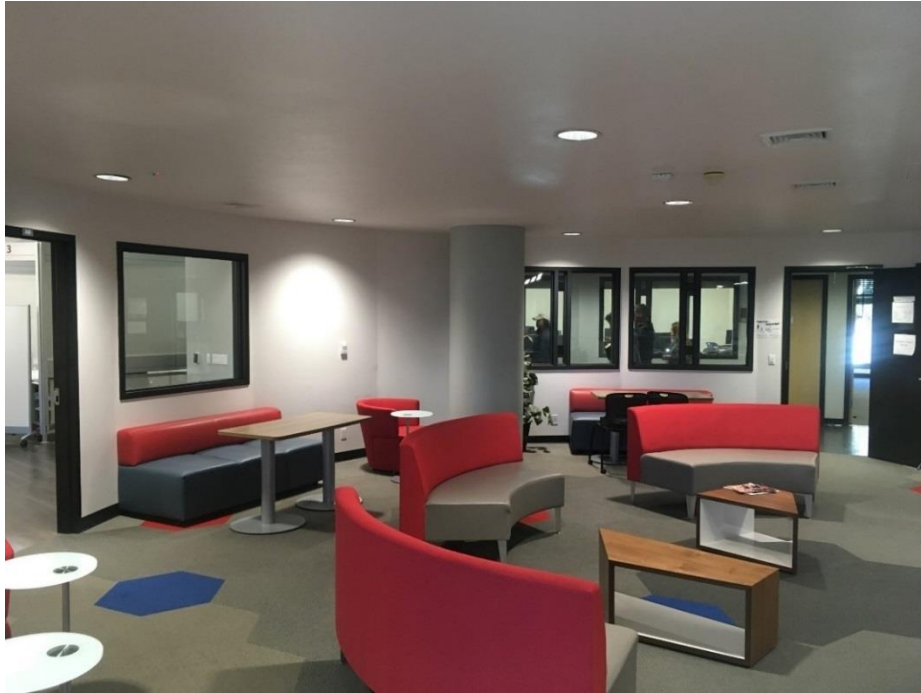
Figure 69. Student Lounge.

On the third floor exists a student lounge directly adjacent to the rated corridor. This student lounge has two self-closing doors propped open, one leading to an adjacent room, and the other leading to the rated corridor. Directly across from the propped-open door leading into the corridor is another propped open door leading into a computer lab. Figures 69, 70, and 71 show the lounge and location of the propped open doors.

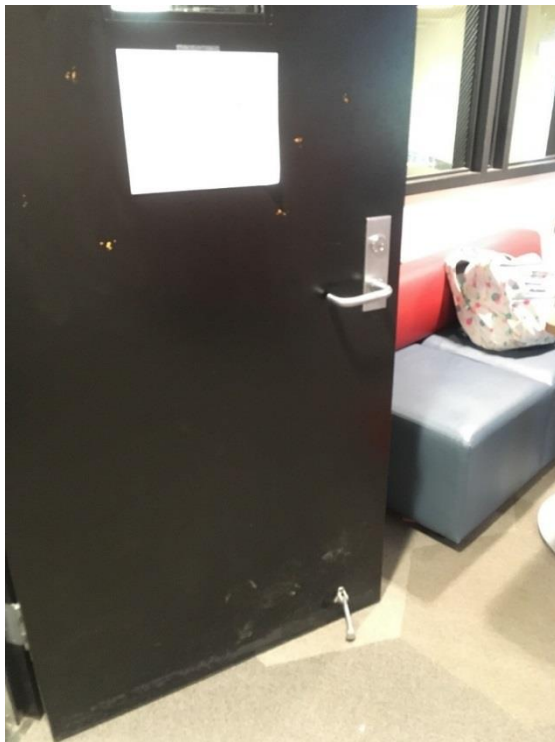
Figure 71. Student Lounge – Propped Fire Door.

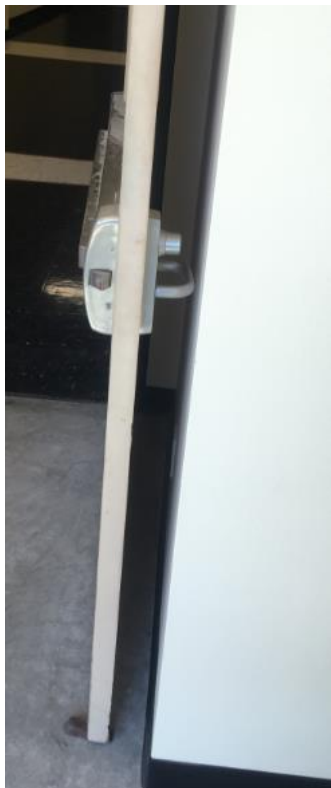
Figure 73. Enclosed Stair – Propped Fire Door Leading into Corridor

Along with those propped-open doors, the fire door leading into the enclosed stairway is also propped open, effectively compromising the enclosure rating. The propped open stair door and location can be seen in Figures 72, 73, and 74.

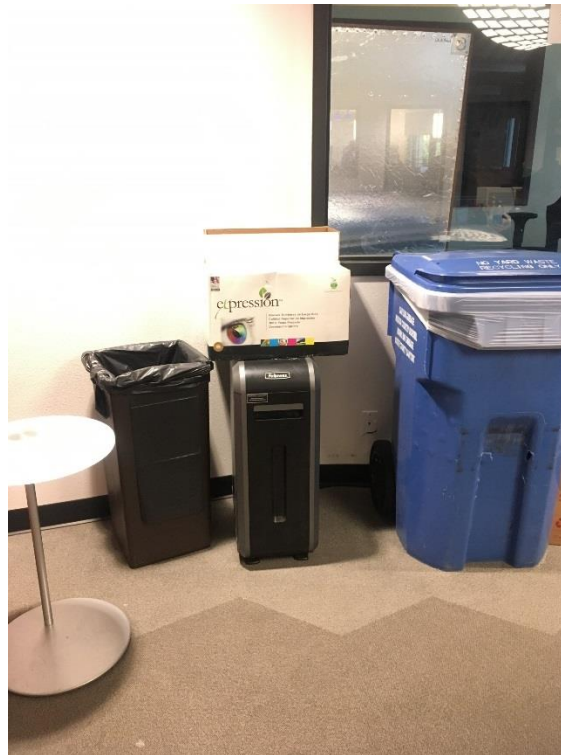
Figure 75. Fire Origin.

A likely fire could start by the ignition of the shredder hooked up to an electrical outlet (assumed to be faulty, which causes the ignition), as seen in Figure 75. After the shredder ignites, the fire is assumed to spread to the cardboard box, and subsequently to the adjacent wastebasket and recycling bin.
