# Prediction of Tribological Behavior of Candidate Materials for Rotor Seals

A Senior Project

California Polytechnic State University, San Luis Obispo

June, 2014

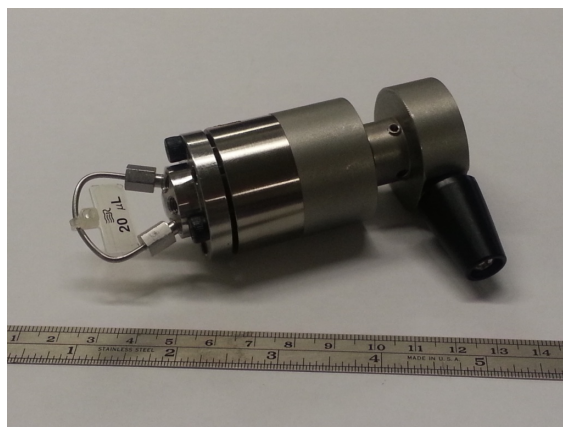
**Figure 2: A multi-position valve assembly produced by IDEX. The input ports can be seen on the right end of the assembly with a volumetric holding loop attached.**

The rotary shear valve developed by IDEX Health and Sciences is a polymer seal for a multi-position selector valve assembly (Figure 2). It is designed to seal the valve ports and control which ports are open at specific points in the chromatography process. Through a process of pressurization and passing a sample through a sorbent material packed in a column, the components of the sample can be identified and quantified based on the time each component takes to pass through the sorbent.<sup>1</sup>

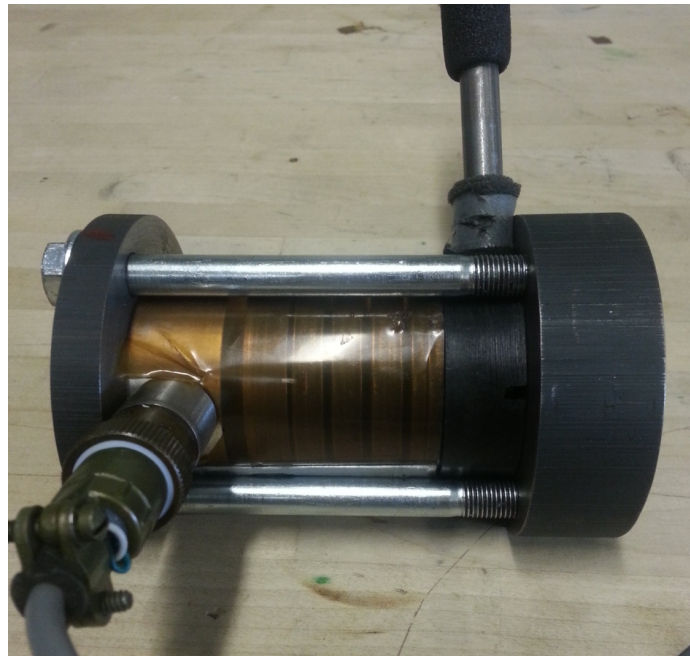
Figure 15. The manual wear rig used in the combination test method. The handle on the right side is connected to the test chamber that holds the stator surface and test sample. Compression bolts can be seen running the length of the device. The load cell is on the right side, with a connection running to a digital readout.

In order to incorporate the shearing stress, while still being able to fatigue a sample under compressive load, a manual wear rig developed by IDEX was employed (Figure 15). The rig consists of three main components: the sample holder, the load cell, and the manual arm. The sample holder ensures that the pucks stay in contact with the DLC counter surface throughout the test. The load cell is used to measure the load seen by the rotor seal surface, allowing the tightening of the bolts to the correct load. The manual arm is what allows the user to induce the shearing stress, resulting in the cyclic fatiguing of the rotor seal.
