Axial Testing of Makeshift Buckling Restrained Braces

Spring 2019

California Polytechnic State University

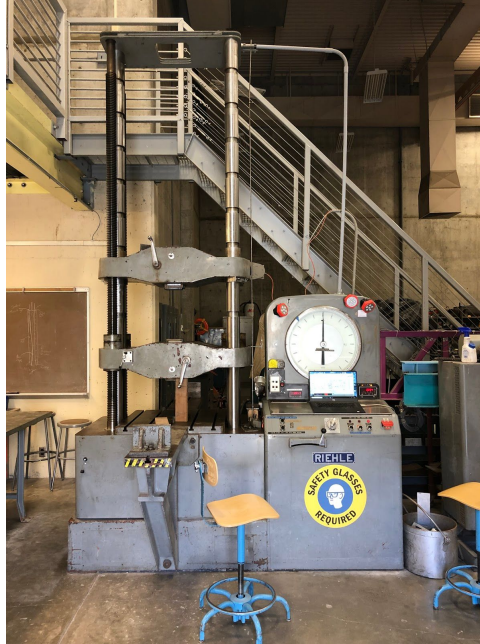
The Riehle Machine

We used the Riehle Machine in the High-Bay Lab at California Polytechnic State University, San Luis Obispo because it was all that was available to provide us a force with a correlating displacement to the nearest thousandth of an inch. The machine is capable of reading forces on a dial to a precision of 5 pounds. The machine is incapable of providing tension and compression loading in a cyclic fashion, so we decided to take the liberty of cycling the members through a series of compressive loading, followed by a tension test. That being said, our test specimen underwent a series of slow, static loading. Dynamic testing was not a means of experiment we could undergo due to time constraints and a lack of sufficient resources.

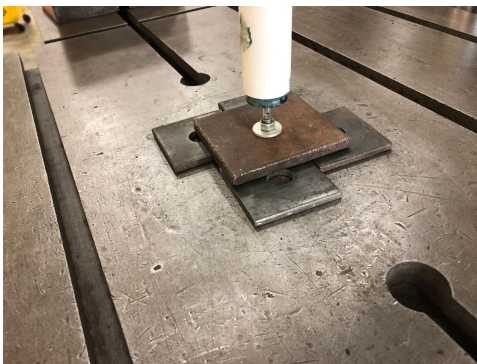
Base Restraint

For the compression tests, we crafted two significantly thick steel plates to pin the ends of the rods into place. They were crafted to friction-fit the machine we had and allow no rotational freedom to the ends of the system. This allowed for the member to be forced into solely axial stresses and provide as little initial P-Delta effects to the ends as possible.

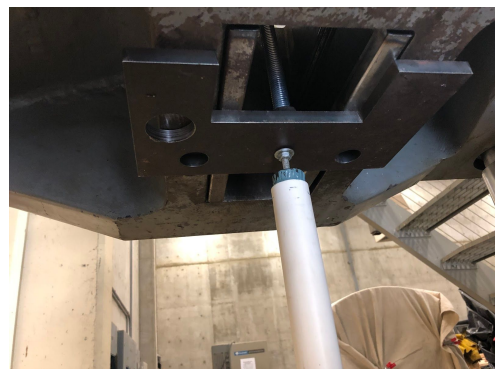
Top Restraint

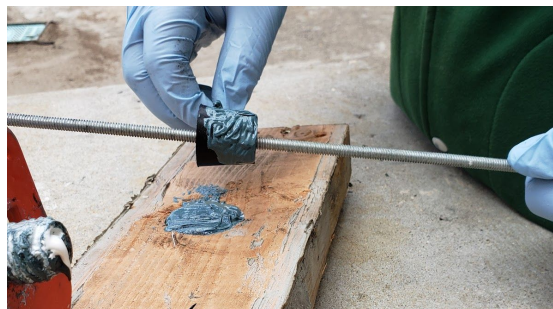
The Thorough Application of Epoxy

Construction of the test specimen consists of cutting the rods and PVC pipes to their designated, equal lengths. The ends of the zinc rods are grinded down in order to be able to screw the respective nuts into place. $\frac{1}{4}$ " holes are drilled into the centers of the rubber stoppers and slid into place on the zinc rod. Heavy amounts of grease is applied to the zinc rods prior to being put into the encasement PVC. This is to ensure that there is no bonding between the rod and the filler materials. The initial stopper is coated with epoxy prior to being jammed into the end of the PVC. Once the stoppers are sealed into place, the designated material is poured into the tubes. Constant vibration and motion is applied to the materials in order to minimize any air pockets from existing. Once full, the second rubber stopper is applied to the open end of the PVC and epoxied into place. The epoxy is left to cure for a minimum of 24 hours to ensure its full strength. The samples with grout material is given a minimum of 7 days to cure in order to ensure significant compressive capacities.

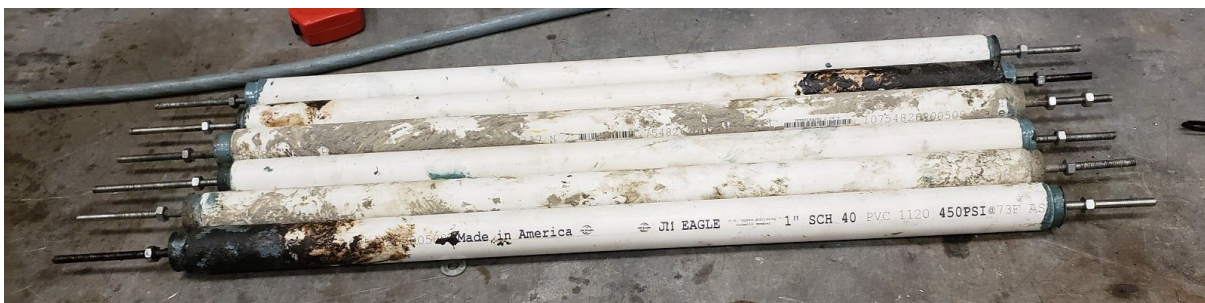
The Test Specimens

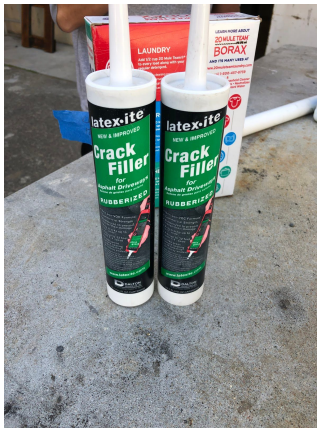
Tar Filler Material

The grout is constructed with a ratio of 3 parts sand to 1 part cement, as well as gradual addition of water until a mashed-potato-like consistency is achieved. The solution is a process learned in the constructing of grout to provide an approximate f'c capacity of 2500 psi (ARCE 305, ARCE Dept. Cal Poly SLO). The tar material used is a Latex-ite Brand substance that has a general purpose of road-crack repairs found at a local department store. The flubber material was constructed with a recipe ratio of 3 teaspoons Borax that has been mixed with 2 cups Elmer's Brand glue and 5 cups water.

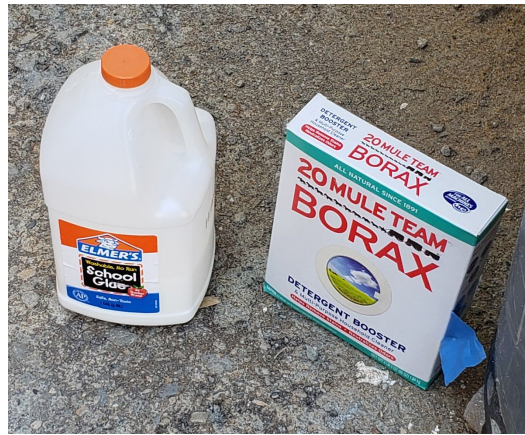
Flubber Filler Material

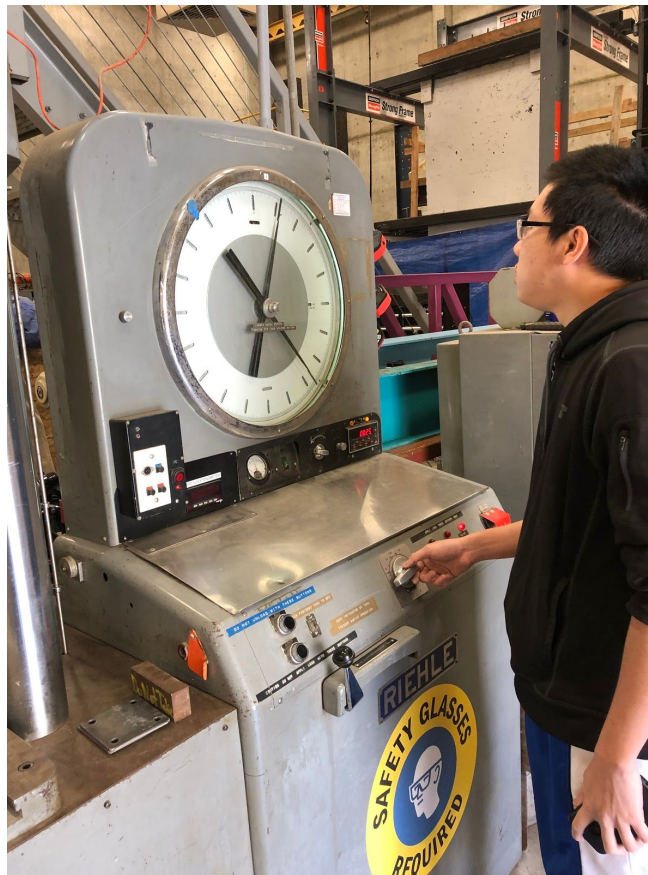
Reading the Force-Displacements off the Machine

The tar and flubber reacted in a fashion that can be categorized as a non-newtonian liquid. This is defined as a material that reacts similar to a solid upon impact forces and a liquid when applied with slow, gradual loading. The materials generally have poor shear capacity when given prolonged loading. Due to this, the experiment proved to be unsuccessful in acquiring data for axial compression since the materials provided no resistance against the buckling of the slender rods. The Rayleigh machine began to apply loading, but the significant slenderness of the 2 foot long rods was too small to be traced by the large machine. The rods gave way to significant displacements without providing any resistance to the forces.

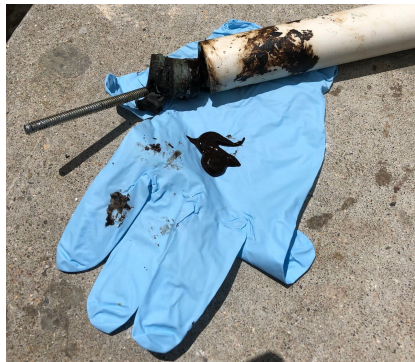
Tar Substance

The failures of the test specimen revealed a significant learning experience for the two of us. Going on into the structural engineering world, there is an understanding that some of the greatest feats learned in the community is what comes out of the failures of the past. Going into the experiment, we had an understanding that a viscous liquid held properties of resisting motion energy and providing damping. With this knowledge, we had hoped that a viscous liquid could also resist the motion of what it encases, similar to the qualities experienced when walking through a dense liquid and experiencing a significant strain to the human legs. What we failed to predetermine was that this stress from the liquid was not significant enough to provide a bi-axial compressive strength large enough to hold the zinc rods in place.

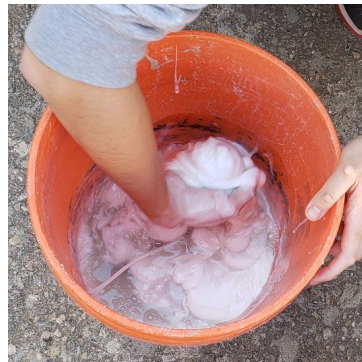
Flubber Substance

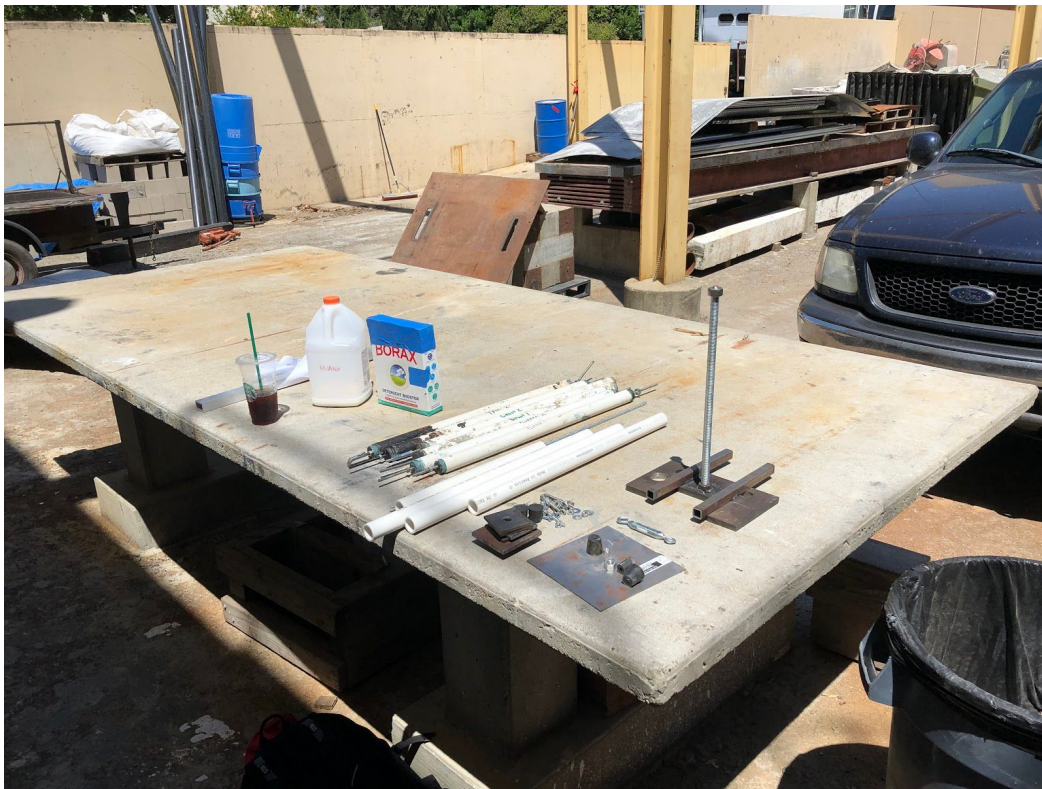
Materials Utilized in the Experiment

The use of solely compressed aggregate to encase the steel rod may provide significant axial compressive capacities to the BRB system. The densities of the aggregate are the key to the overall compressive strength and comparing the specimens is the goal of the experiment. Even if the qualities are not as great as the grout substance, it will allow for these BRB members to be constructed under different prefaces to meet different project qualities.

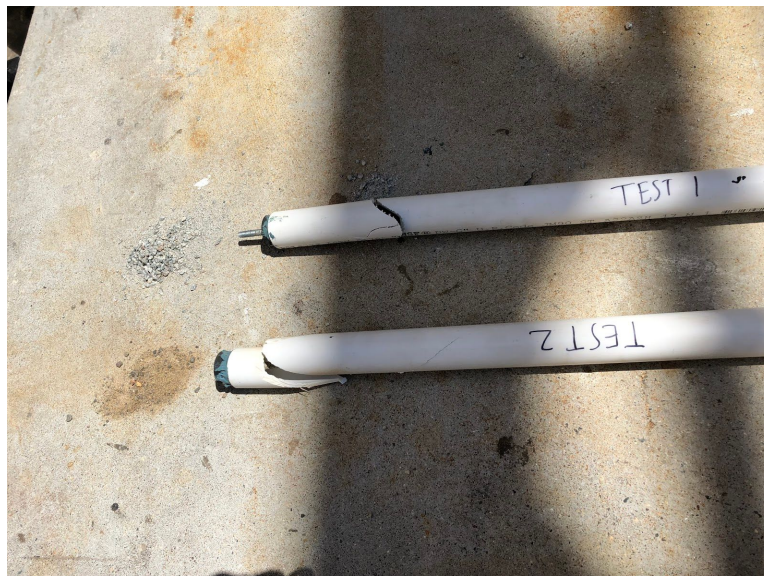
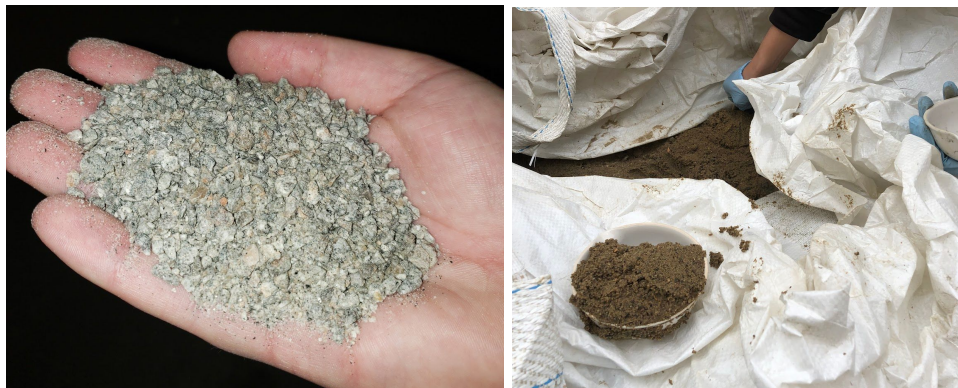
Coarse and Fine Aggregate

The same materials and setup were used with a change in the encasement materials. For the grout, the 3 parts sand to 1 part cement ratio with water still holds. For the aggregate, we tested two different sizes in the PVC. One aggregate we used was sand that we categorized as fine. The other consisted of small pebbles that we categorized as coarse. The method of constructing these specimen remained the same as the previously constructed test specimens.

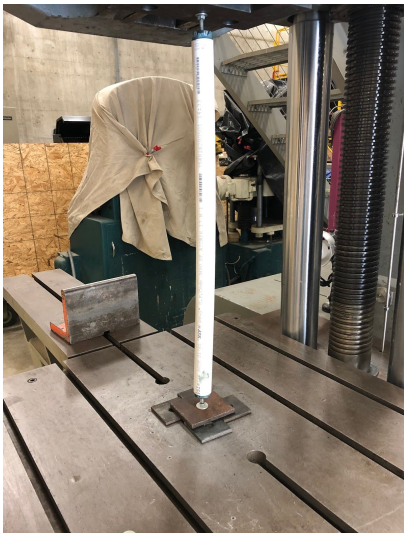
Compression Testing of Makeshift BRB

Compression testing of the test specimens varied between 100lb increments for grout specimen and 50lb increments for aggregate specimens. The increased increment scale for the grout specimen was with the understanding that the grout substance was able to withstand a higher compressive load than the aggregates alone. Unlike the flubber and tar substances, the aggregates were able to take on significant loading and provide reasonable force-displacement data.

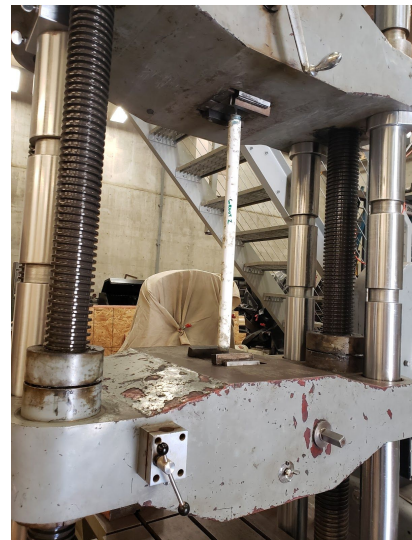
Tension Testing of Makeshift BRB

Once compression tests were cycled on each of the test specimens we had the machine switched from compression mechanics to tension. Once set up, we utilized the two clamping mechanisms on the Riehle machine that hold the ends of the member being stretched. In order for the rods to stay in place, we tightened nuts onto each end to give the clamps something to grasp to. Once the tests were completed, we observed the nuts and noticed they did not have any give to them. This ensured that they worked very well for our experiment. We took the members to their ultimate force and gathered their force displacements.

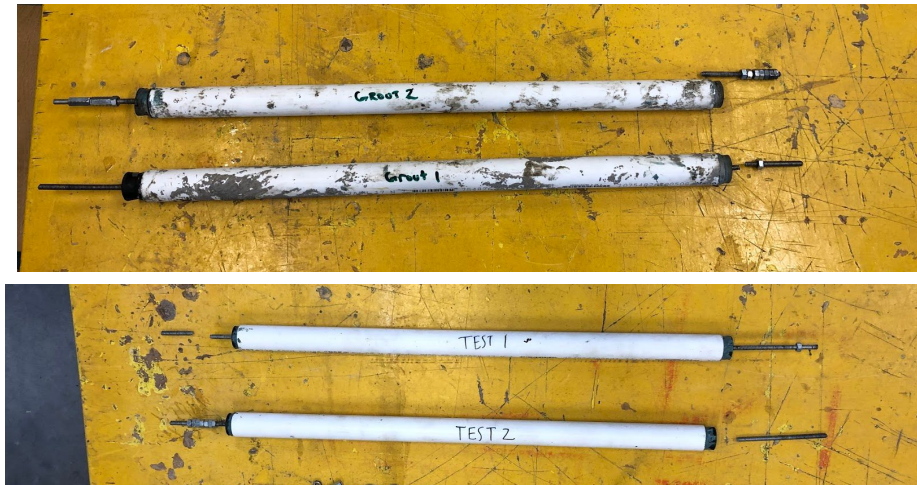
After testing for compression, we analyzed the tensile capacities of the systems. What we noticed was that there is no significant difference between the tensile capacity of the different BRB specimens. However, a common failure mechanism between each specimen was that the rod broke near the “joints” of the BRB.

Tension Rupture Locations for the Test specimens

Unlike an ideal BRB, the encased portion of the rods were not reduced compared to the exterior, therefore the location of failure were not controlled to be in the middle of the BRB. Although this had little effect on the results of the compressive capacities, it was reason for our tensile capacities to be relatively flawed. Another important thing to note is the tensile capacity of the grout 1 specimen. Due to the significant higher ultimate tensile strength of the rod, it became known that the grout 1 specimen used a steel rod instead of a zinc rod. Therefore, data from the grout 1 specimen was excluded in the overall analysis and comparisons.
