Feasibility of a Fiber Reinforced Polymer Retrofit for Non-Ductile Concrete Walls

Abstract

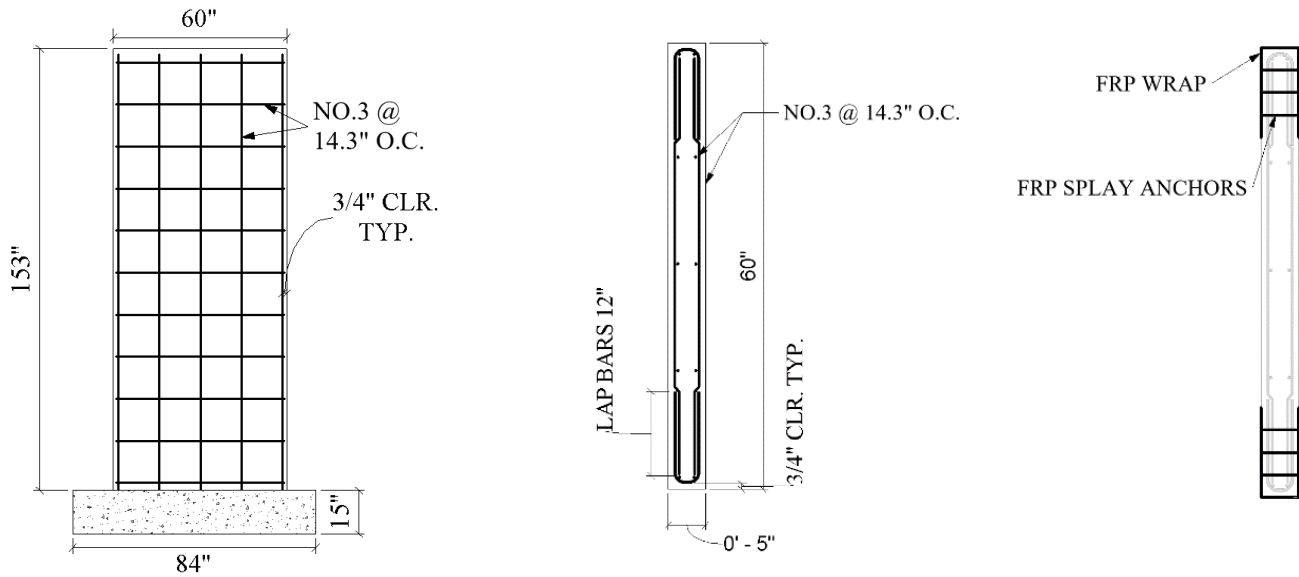
Figure 1. Wall specimen dimensions and rebar layout: (left) wall elevation, (center) original wall cross-section, (right) proposed retrofit wall cross-section

This paper focuses on the experimental testing of a baseline lightly reinforced slender planar RC wall with no boundary elements that was conducted at California Polytechnic State University, San Luis Obispo (Cal Poly). Figure 1 shows the wall design intended to be representative of wall designs from pre-1980s concrete buildings found in Los Angeles and is based specifically on design details from a sample 1958 RC shear wall building. After identifying the failure mechanism of the baseline wall, the authors planned to construct an identical wall to implement a retrofit scheme intended to improve the confinement of the wall end zones by wrapping these regions on three sides with FRP and closing the fourth side with a splay anchors, also shown in Figure 1.

The wall is 5-in. thick, 60-in. long, and 153-in. tall and was designed to be relatively thin with a cross-sectional aspect ratio of 12 and have as large a shear span ratio ≥ 2.0 as permitted by laboratory constraints to achieve a flexurally-dominated response. Longitudinal and horizontal reinforcement consisted of #3 deformed rebar at 14.3-in. spacing to achieve ratios of $\rho_l = \rho_h = 0.37\%$; slightly above the ACI 318 minimum requirement. The longitudinal rebar is embedded in the 15-in. deep foundation and horizontal bars are lap-spliced approximately 12-in. in the wall end zones with open u-bars, which is not considered to provide confinement of these regions. The average concrete compressive strength at the time of testing was 3.8 ksi and the average steel yield and ultimate strengths were 54 and 82 ksi, respectively. The concrete mix and steel reinforcement were intentionally selected to represent the material properties of vintage concrete walls.

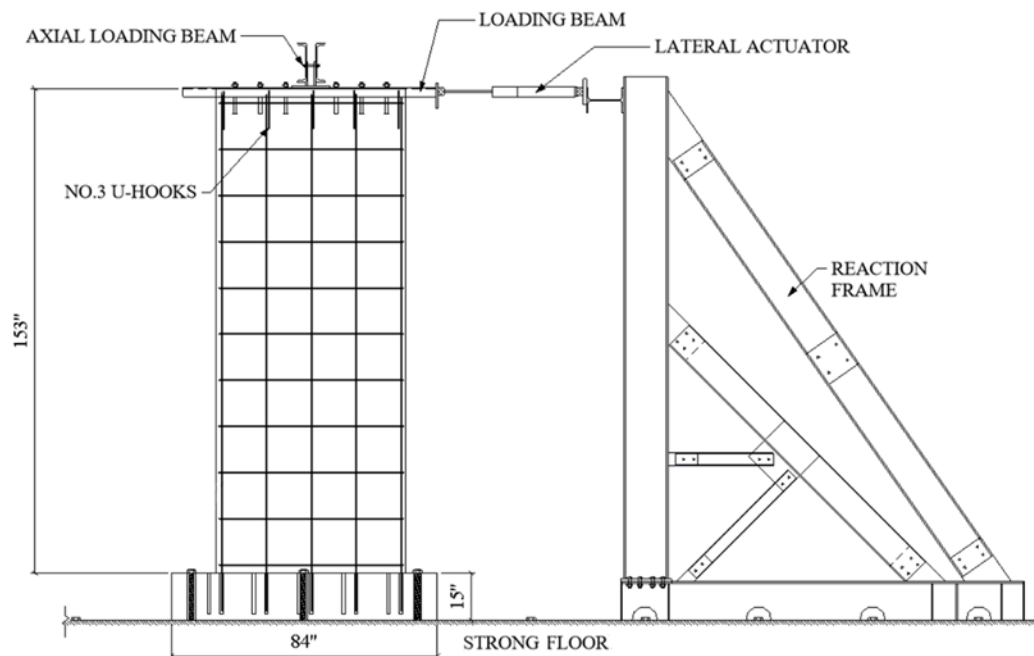
Figure 2. Experimental test setup

The experimental test was conducted in the Cal Poly College of Architecture & Environmental Design (CAED) High Bay Laboratory. This wall test program represented a considerable upgrade to the laboratory with respect to strengthening the existing steel reaction frame as well as design and fabrication of an out-of-plane stability frame and axial load application system. A detailed drawing of the laboratory test setup is shown in Figure 2; the out-of-plane stability frame is excluded for clarity.

The wall foundation was secured to the strong floor to achieve a fixed-base condition. A horizontal hand-pump actuator mounted to the steel reaction frame applied lateral forces to the centroid of a loading beam (steel channel section) that was connected to the wall via anchor bolts and grouted shear keys. There were additional #3 open hoops at this location to provide confinement for lateral and axial loading at the top of the wall. The axial load was applied using a “teeter” beam placed atop the loading beam. The “teeter” beam was loaded on each end by pre-stressed rods and a vertical actuator to transfer an axially applied reaction force to the wall that totaled approximately $0.035A_g f_c'$. To maintain out-of-plane stability of the test specimen, a two-story Simpson Strong-Tie Ordinary Moment Frame was assembled with two steel HSS tubes placed parallel to the wall on each side. Teflon pads were placed between the steel HSS tubes and the wall to reduce friction in the system during loading.

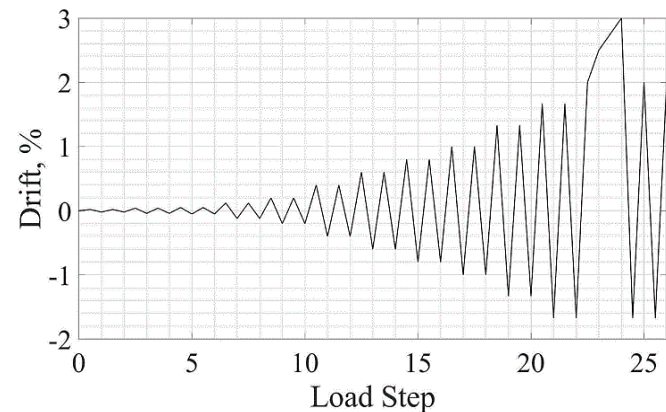
Figure 3. Loading protocol

Lateral loading at the top of the wall followed a two-cycle set pattern. Before global yielding of the wall specimen, the loading was force controlled and after yielding it was modified to displacement controlled. Figure 3 shows the protocol followed during the test where a load step designates a full cycle of loading at a given displacement level. Based on the physical test setup in the laboratory, the maximum actuator stroke in the pull direction was about -1.67% drift, while there was more stroke capacity in the push direction. Prior to load step 20, there was very little strength degradation despite having already subjected the wall to +/- 1.67% drift; therefore

during load steps 22-23, a pushover was attempted. Having still not achieved significant loss of load carrying capacity, additional cycles were attempted to examine the collapse prevention limit state. The test was terminated when the wall when strength decreased by about 30% and the wall proceeded to exhibit significant base rotation at the wall-foundation interface (rocking) with no additional changes in behavior.

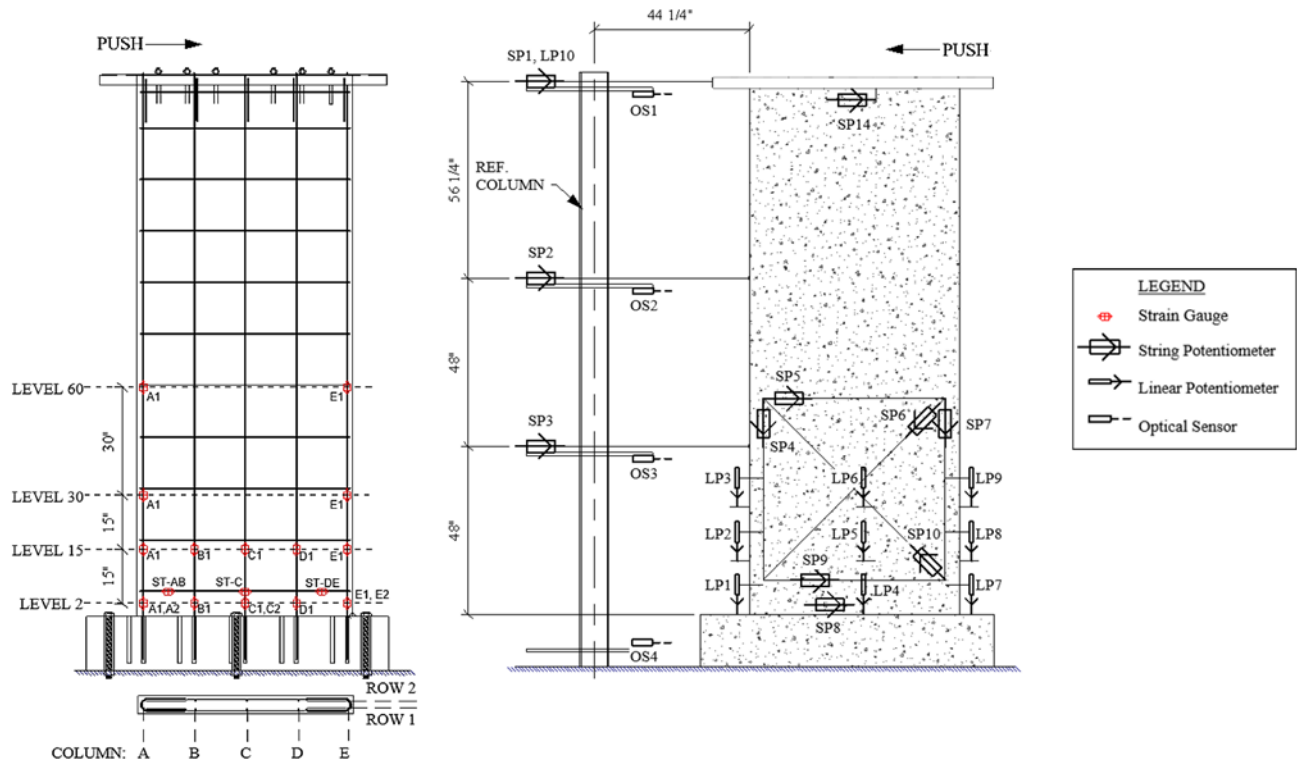
Figure 4. Instrumentation layout: (left) strain gauge layout, (right) displacement transducer layout.
 Note: Front and back of wall as indicated by push direction.

steel strain gauge configuration is shown in Figure 4 and consists of eighteen strain gauges attached to longitudinal rebar and two attached to horizontal rebar. The primary objective was to measure steel reinforcement strain in the expected plastic hinge region of the wall, and specifically in the wall end zones, which could serve as a point of comparison in future tests that had been retrofitted with FRP. The various displacement transducers, also shown in Figure 4, were used to measure wall behavior: lateral displacement, flexural and shear deformations, and base slip/rotation with some intentional redundancy. Instruments were also used to measure test set-up behavior, such as: slip between the strong floor and wall footing, strong floor and reaction frame, as well as loading beam and top of wall. Note that sensors shown on the reference column are physically isolated from the test specimen.

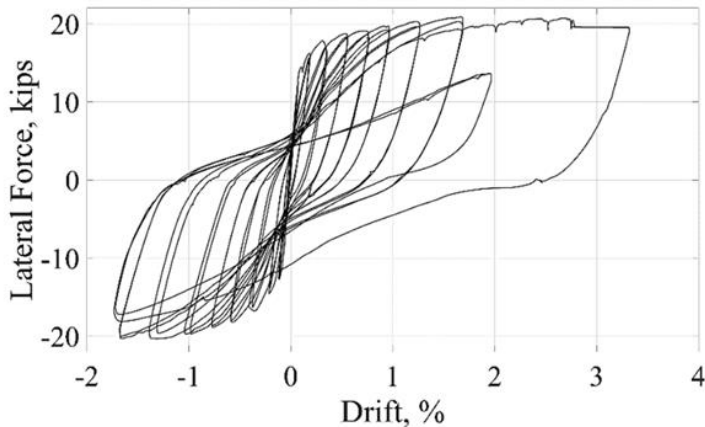
Figure 5. Wall load-deformation response

The hysteretic load-deformation curve for the wall test is shown in Figure 5. The wall response is symmetric and exhibits relatively consistent peak strength during drift cycles up to +/-1.67% as well as in the +3.3% monotonic push. The significant reduction in load carrying capacity after the push when returning to cyclic loading at +2% / -1.67% drift. This strength loss is observed primarily in the same loading direction as the monotonic push. The authors anticipate that if the wall test had continued with two-cycle sets, not including the monotonic push, the drift capacity of the wall would likely be between 2 to 3% drift rather than the 3.3% drift level

during a monotonic push. The wall sustained a maximum moment of $1.20M_n$ and shear of $0.24V_n$, where nominal strengths were calculated in accordance with ACI 318-14.

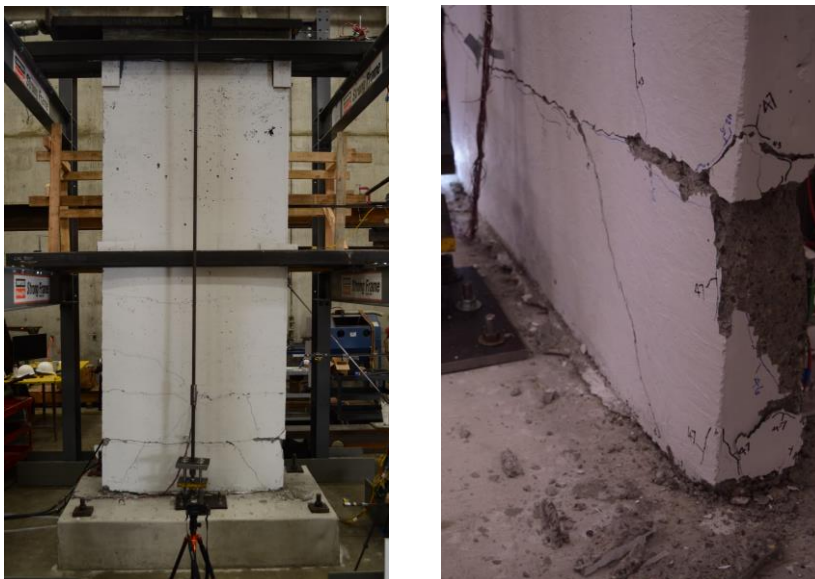
Figure 6. Final damage state of wall: (left) overall, (right) north wall end zone

After a monotonic push to about +3% drift and two subsequent cycles at +2% / -1.67% drift, the lateral load dropped by 30% from the peak strength. The wall failure was determined to be primarily due to multiple rebar fractures. There was minor concrete crushing on the north side at the wall base; additionally, only two longitudinal rebar showed slight, if any, signs of buckling at the wall base. During the final cycles, the wall exhibited significant base rotation (rocking on the footing) in way best described as rigid-body rotation; there was no significant base sliding. Figure 6 shows the final damage state of the wall. The compression related damage mechanisms were deemed secondary contributors to the wall failure. Both the final damage mechanism and the relatively high drift capacities were consistent with observations from other lightly reinforced concrete wall tests (Cardenas & Magura, 1973; Ireland et. al., 2007; Lu et. al., 2017).

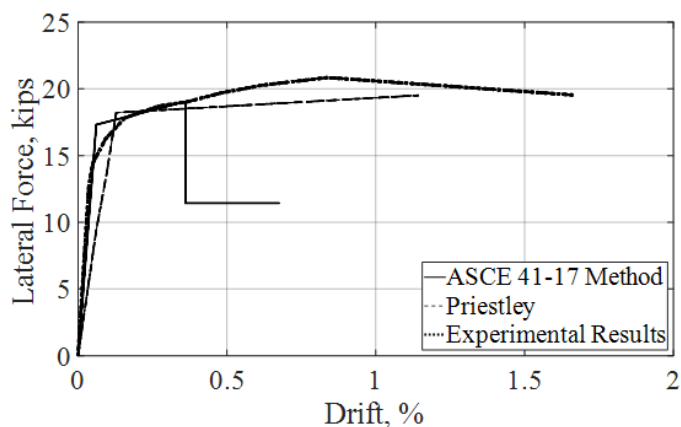
Figure 7. Pushover comparison of predictions vs. test results

Two methods, Priestly (2017) and ASCE 41-17, were used to obtain a pushover curve to approximate strength and drift capacity of the wall at various limit states. In Figure 7, these results are compared to the experimental backbone curve for only the portion of the test prior to the monotonic pushover. As indicated previously, the true ultimate drift is likely somewhere between 2 to 3% drift. For the Priestly method a moment-curvature analysis was performed in XTRACT (Chadwell & Imbsen, 2004) sectional analysis software using expected material properties and appropriately calibrated material backbone models. The stress-strain relationship for unconfined concrete was based on Mander (1984) while that for steel reinforcement was based on three rebar tensile tests. For the ASCE 41-17 method, Section 10.3.2 and specifically Table 10-19, were utilized to estimate a generalized force-displacement relation for the wall. The ASCE 41-17 approach appears to capture the initial stiffness more accurately but suggests that the wall would have very limited deformation ductility with a failure slightly above 0.3% drift. The Priestly approach has a slightly lower initial stiffness but predicts a higher drift capacity that is relatively closer to the experimental performance of the wall.

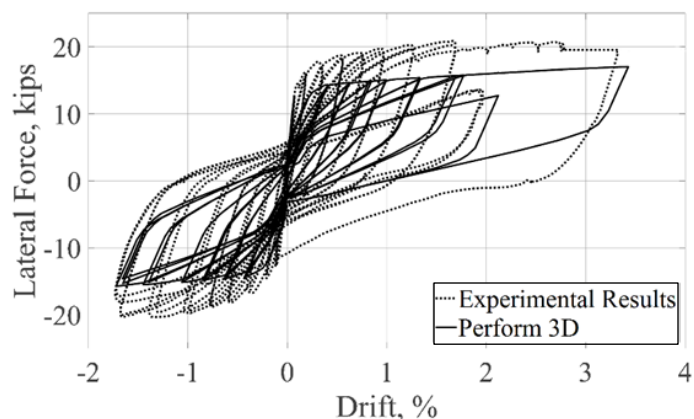
Figure 8. PERFORM-3D predictions vs. test results

symmetric two-cycle sets, the wall was analyzed using Perform-3D (CSI, 2011). Figure 8 presents the predicted hysteretic response of the wall from a preliminary Perform-3D analysis as compared to the experimental results. Currently the model is underpredicting strength and exhibits a more pronounced pinching behavior than the experiment, though the stiffnesses appear to be reasonably consistent for the beginning portion of each drift cycle. The authors plan to undertake additional calibration efforts to better model the response of the baseline lightly reinforced wall specimen.
