My Contributions to the Cryogenic Underground Observatory for Rare Events Experiment And the Utilization of Geant4 in Their Analysis

Bachelor of Science, Physics

Department of Physics, California Polytechnic State University, San Luis Obispo

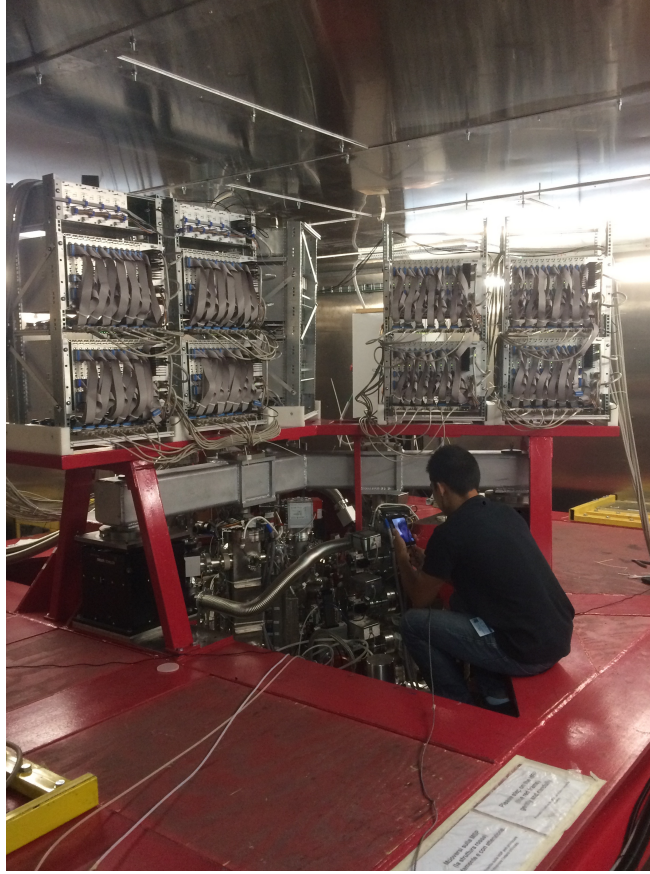
Figure 12: My partner Aaron Skyping with another collaborator, who is telling him how to fix a problem with the cryostat. This is on the third floor of the CUORE hut.

The third floor consists of many computers, the primary component of the large cryostat (Figure blank), and a desk with two computers that allow you to monitor the activities going on inside of the clean room. There is also a telephone that allows communication between people in the clean rooms and people on the third floor. This is where I primarily worked as the onsite shifter for the installation of the TeO_2 towers, which was an extremely important moment in the CUORE timeline¹³.

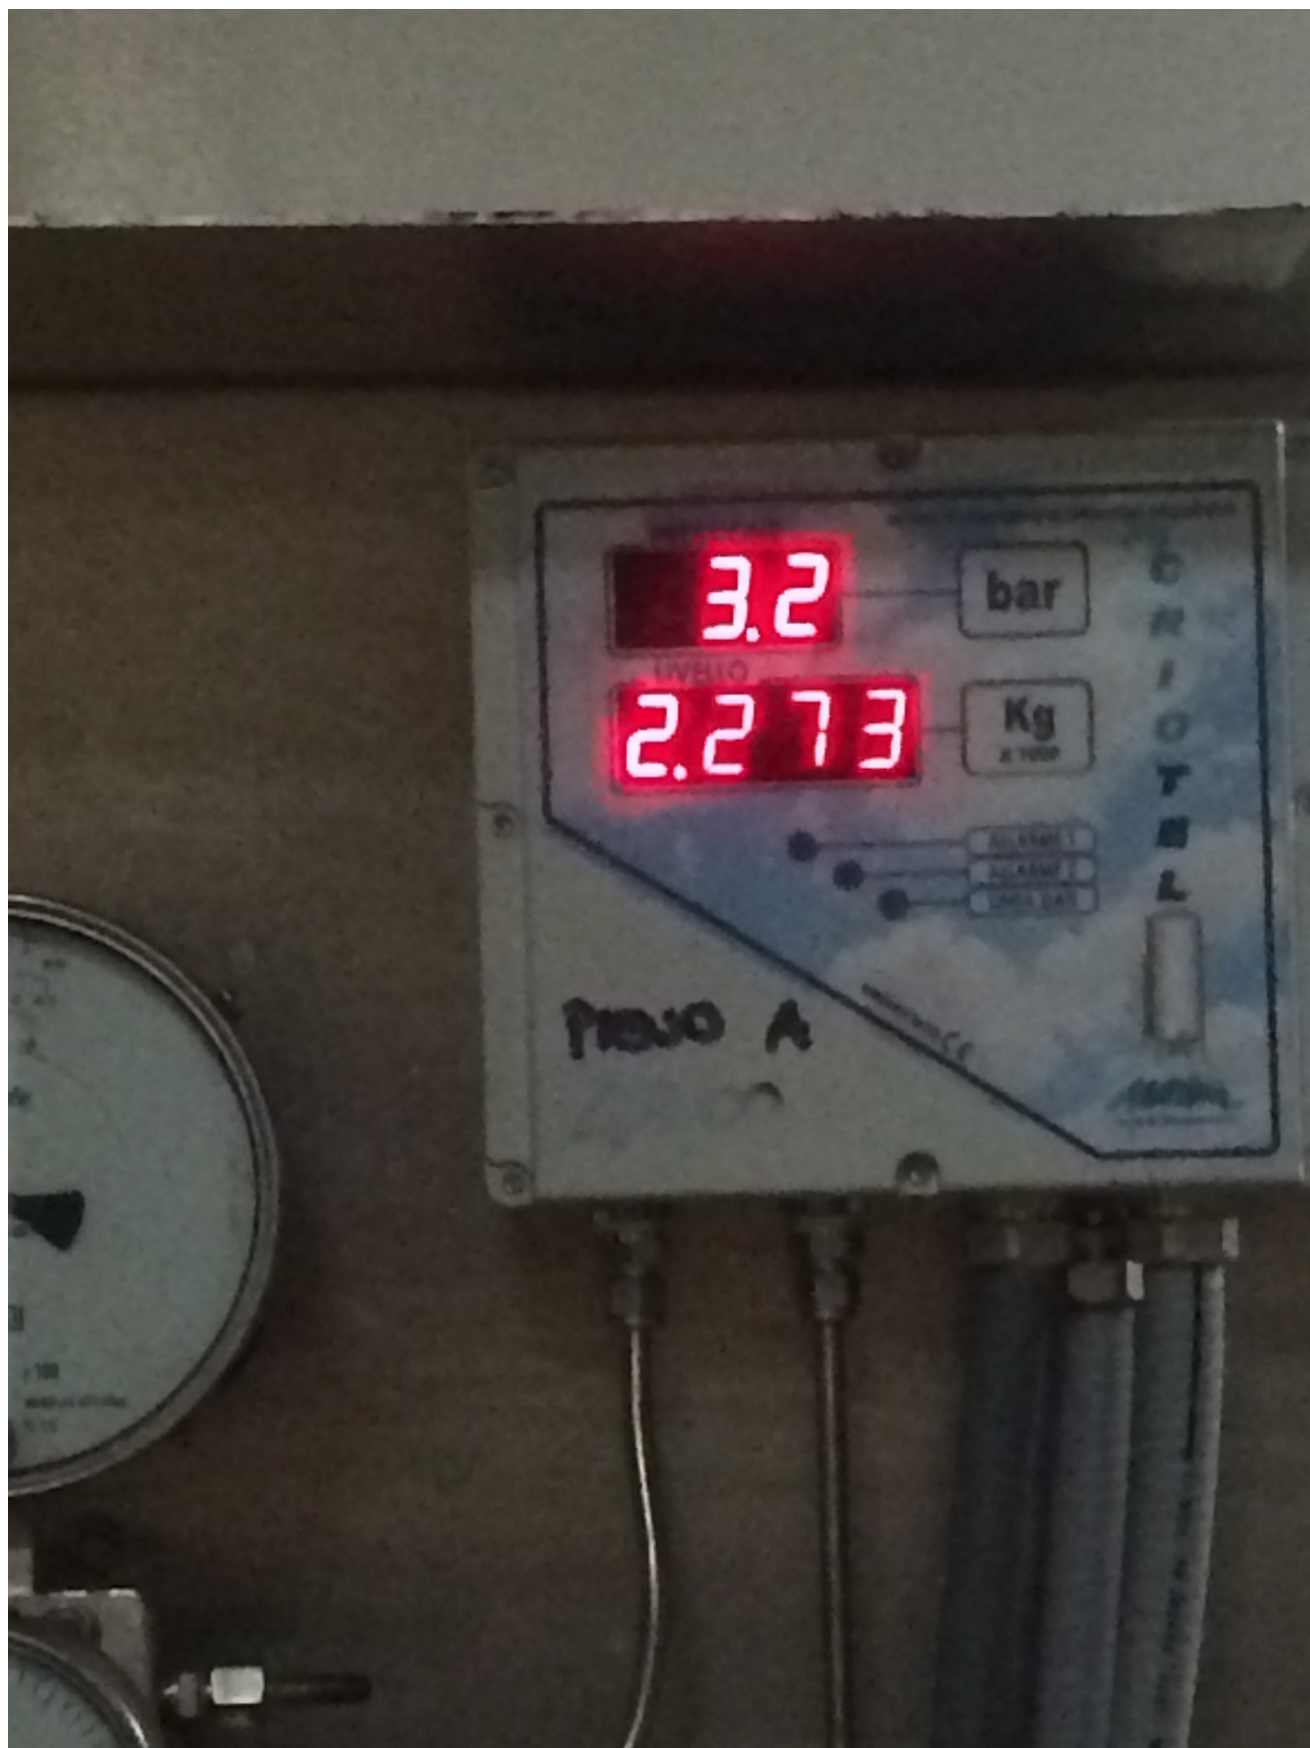
Figure 26: Indicator on the liquid nitrogen tank that conveyed the pressure and mass of the liquid nitrogen.

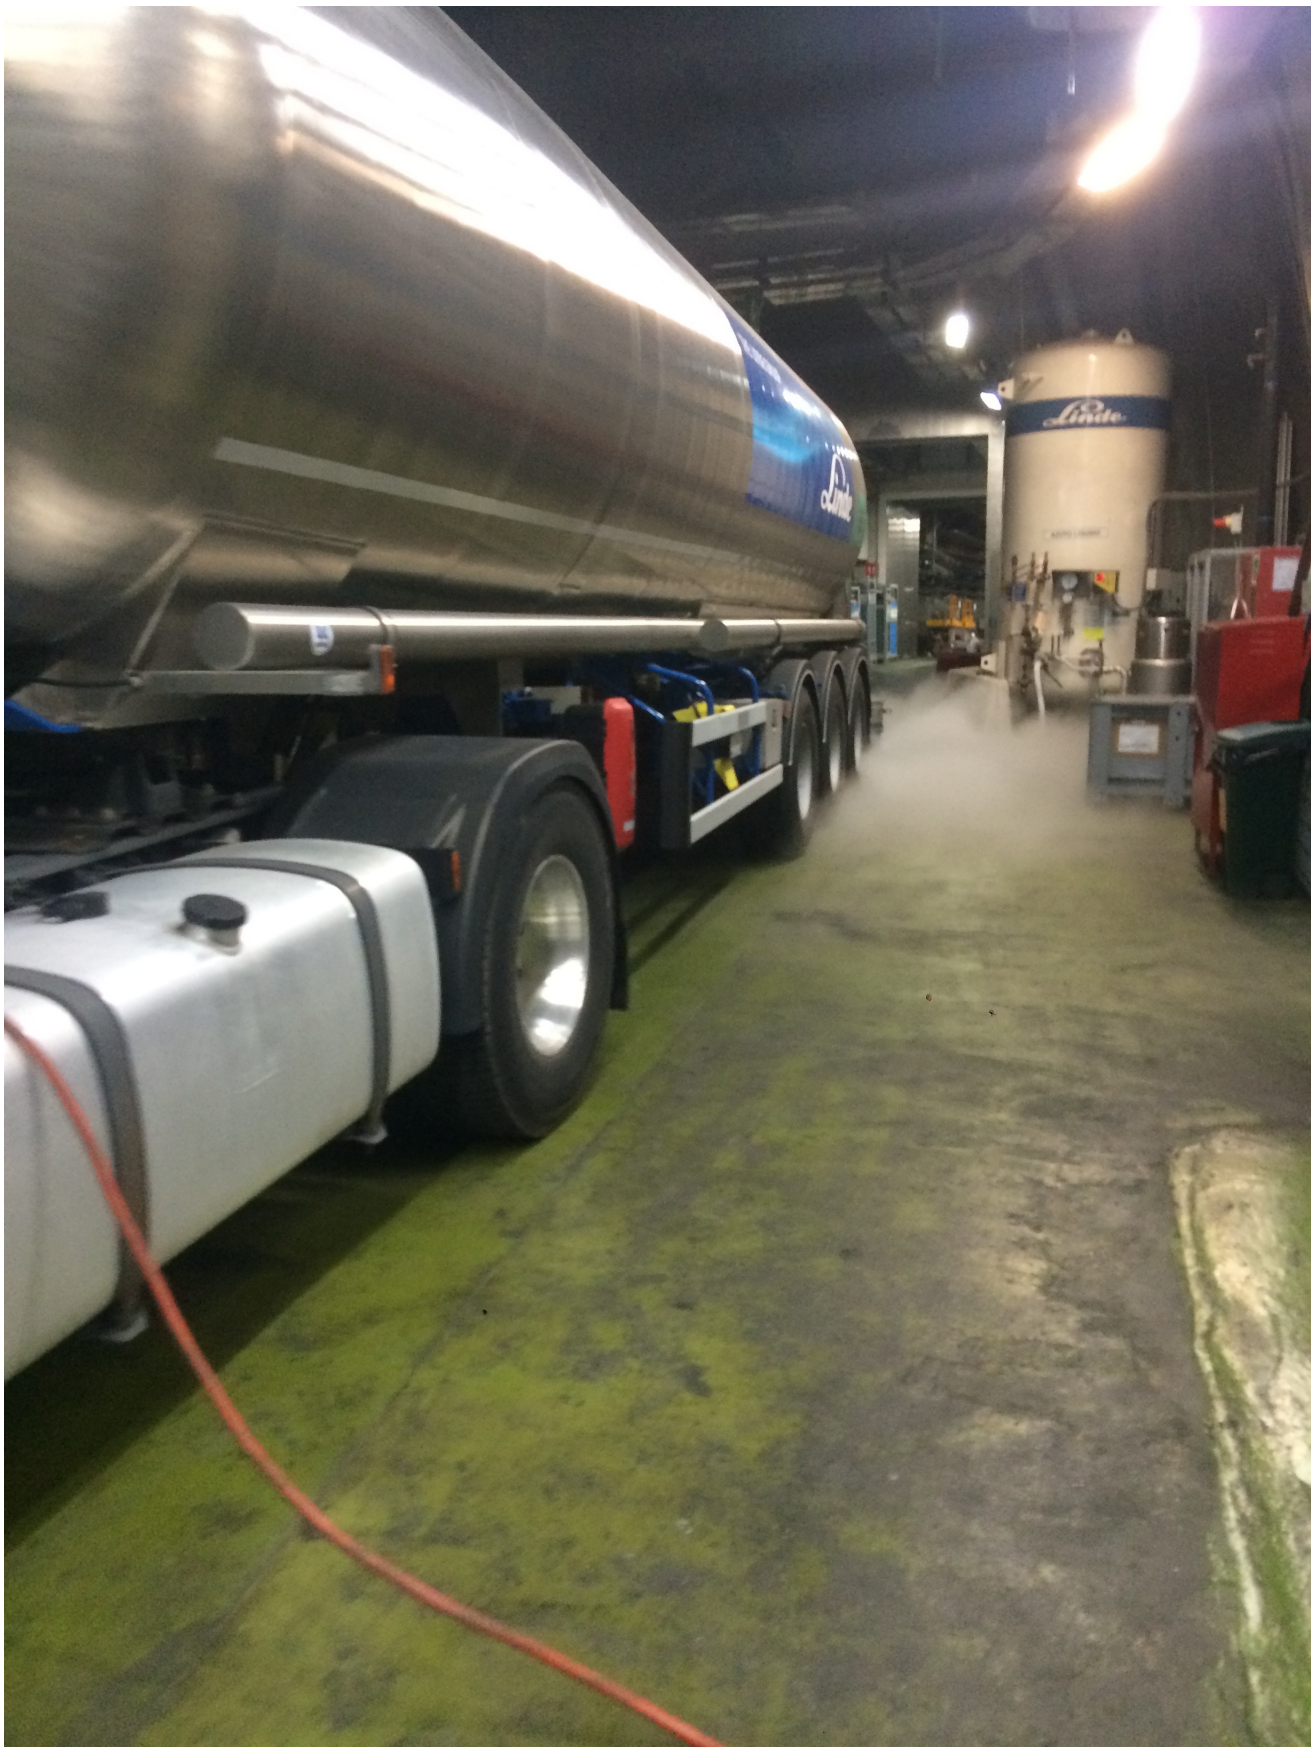
Figure 28: Liquid nitrogen tanks being refilled for all experiments taking place at LNGS.

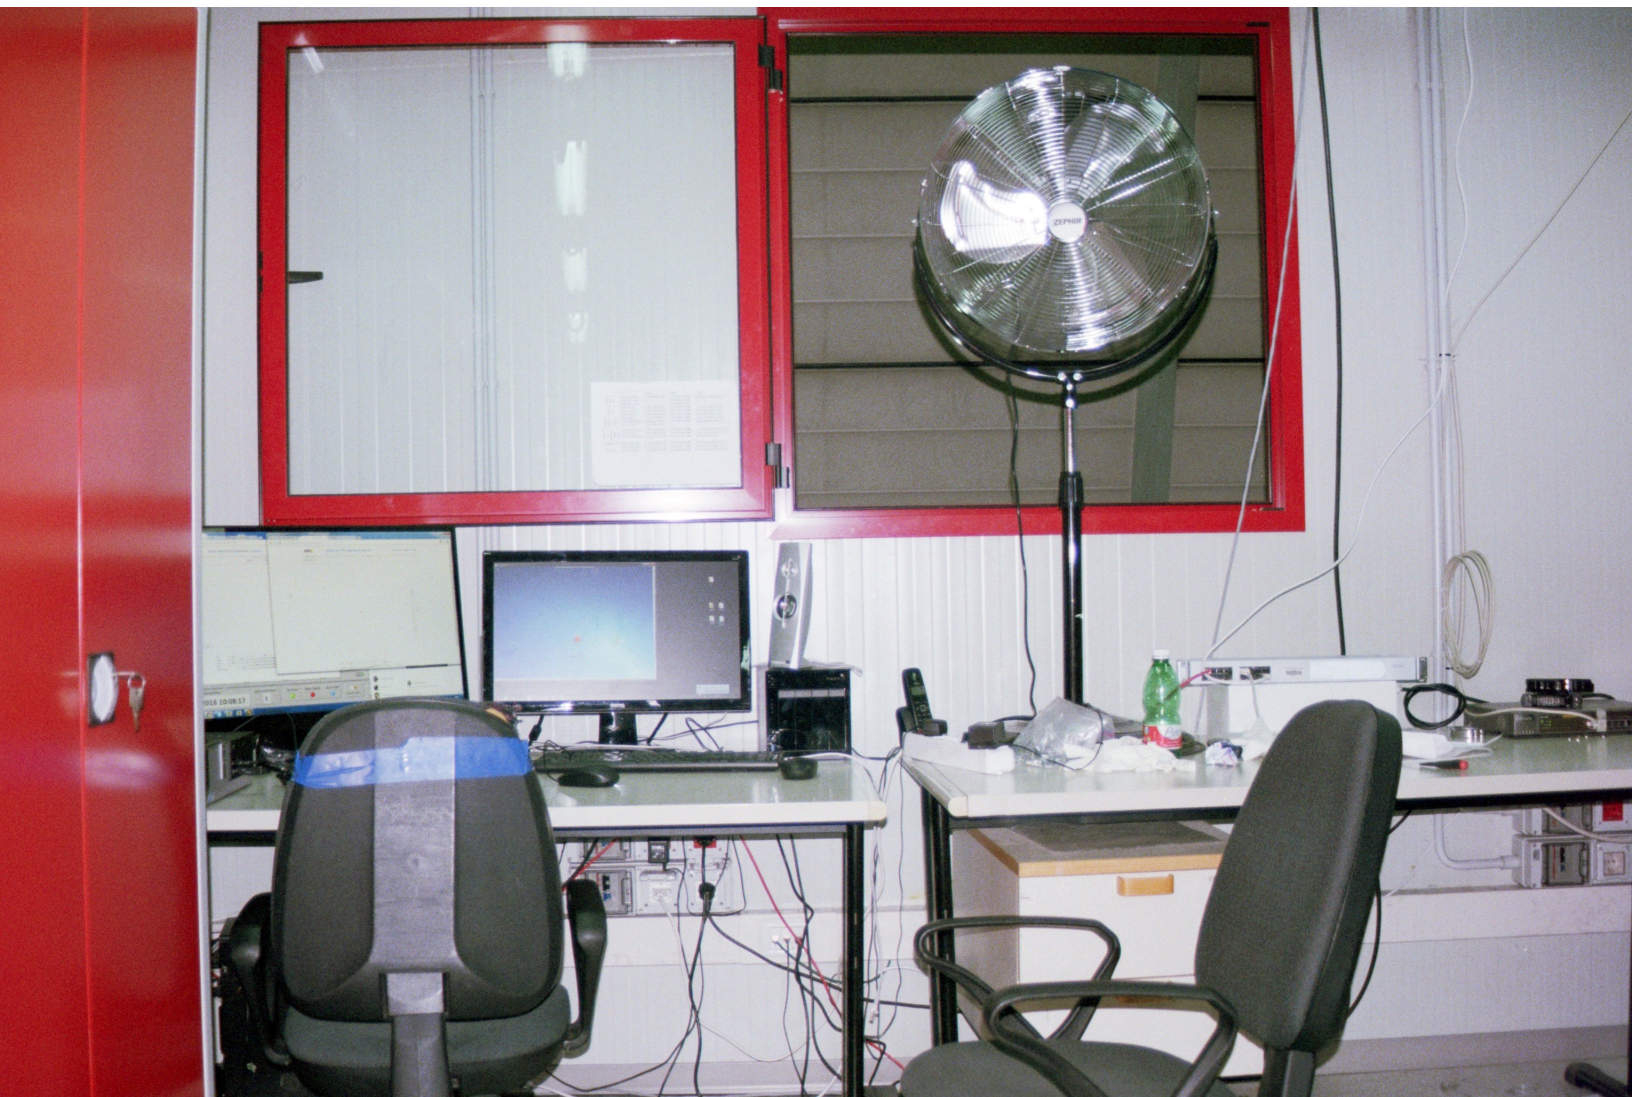
Figure 29: The main station where I worked, on the third floor of the CUORE hut. The fan was extremely helpful as it got really hot in that room from all the computers.

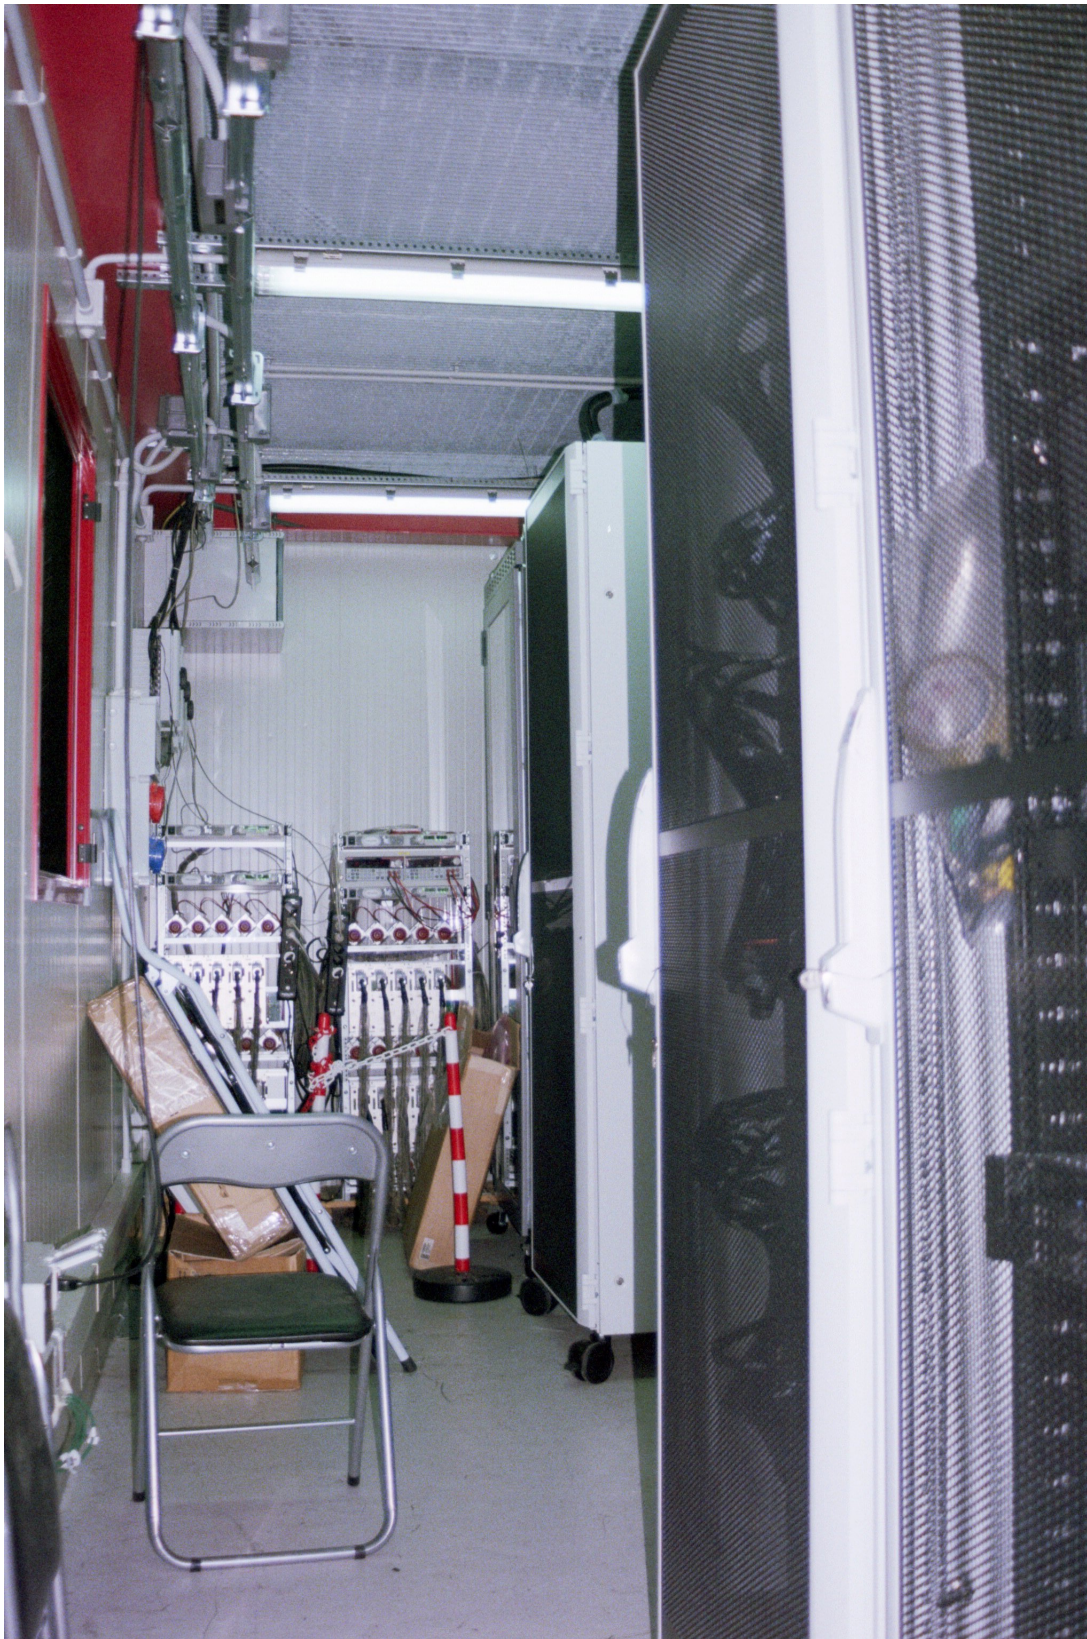
Figure 30: Large computers that do the necessary calculations for the cryostat to operate.

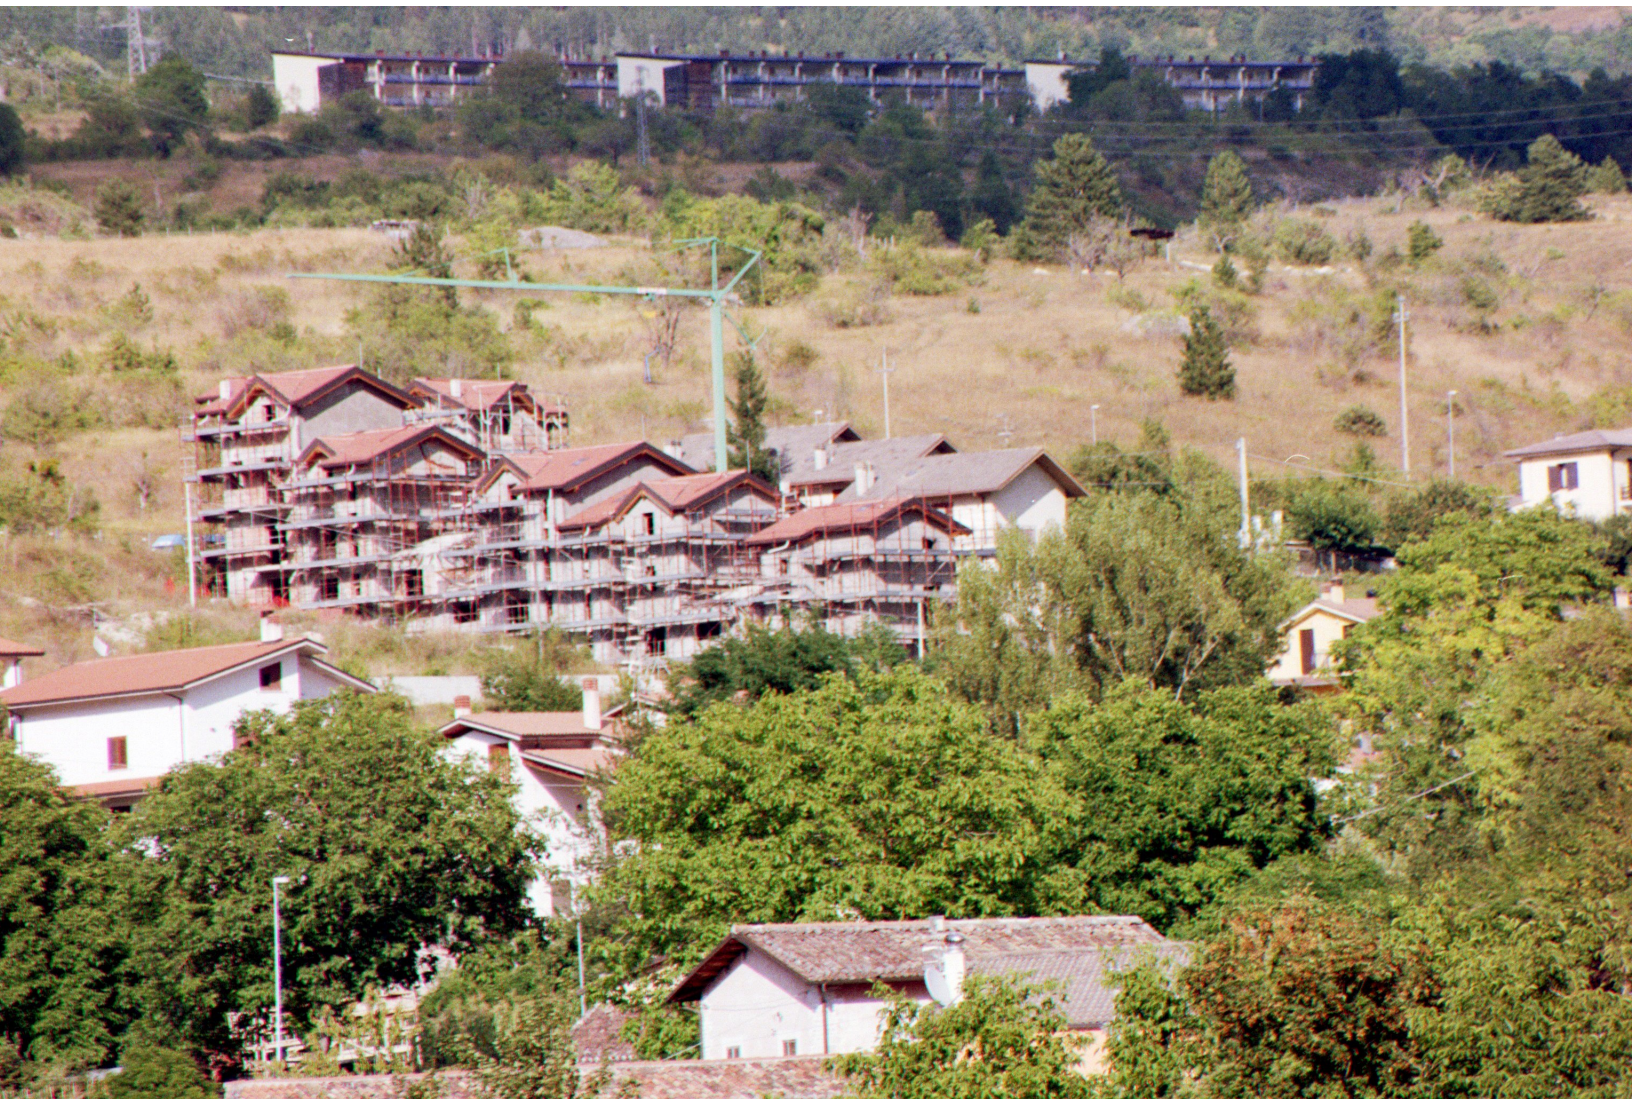
Figure 35: Houses in Assergi were still being rebuilt from an earthquake that struck a nearby town named L'Aquila in 2009. A local resident named Mathew (he was actually from Australia and grew up in Italy) who worked at a place known as Hotel Giampy (hotel and restaurant) told me about some of the government corruption that takes place at the local level, and how many of the foundations of the buildings weren't structured with cement, but with a mixture of cement and sand because it was cheaper. The constant rain eroded many foundations over time, and they fell easily when the 5.8 earthquake hit.
