# **Investigation into Excessive Deflections in a Concrete Flat Slab**

*Senior Project Fall 2021*

California Polytechnic State University, San Luis Obispo  
Architectural Engineering

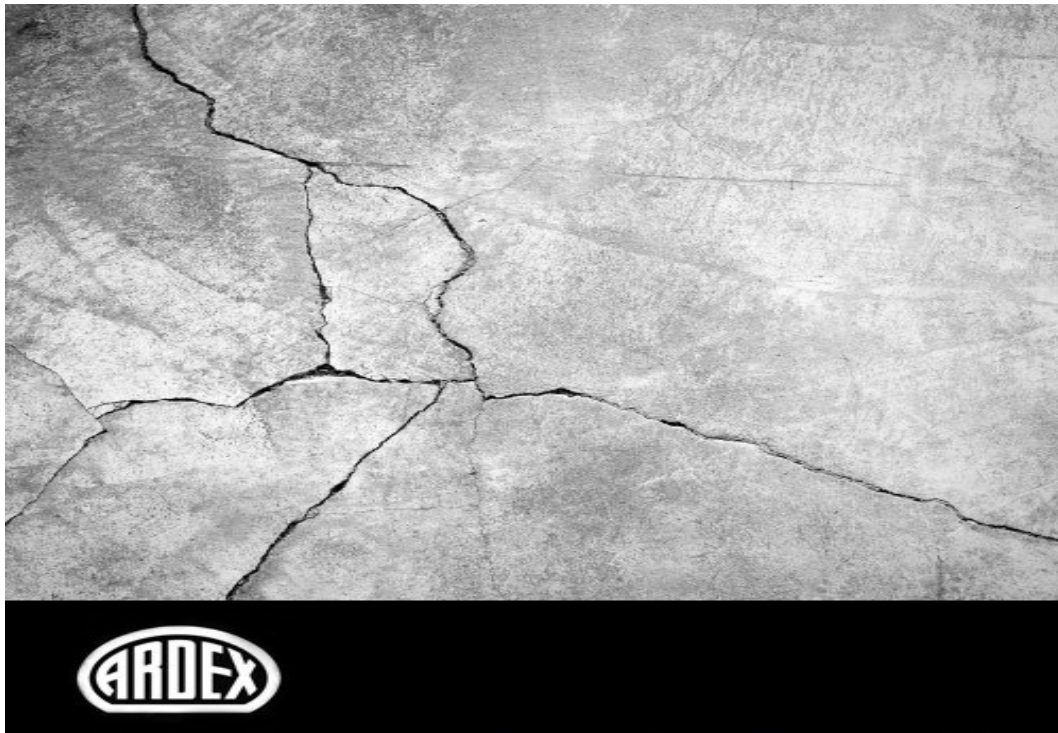
Figure 3 [2]

The next item that was investigated during the site visit was the cracks in the concrete. Cracks were discovered mainly in areas of tension in the top surface of the slab, where the slab is experiencing negative moments. These cracks were clean and sharp, which indicates that they are likely new. Had they been dull and dirty, it would be more difficult to say with confidence that the cracks were due to the flood event. However, given their condition, they are likely associated with the flood. The crack widths reached up to 1/16 in. which is not extreme, but definitely something that needs to be taken seriously. There was concentrated cracking around the columns lined up with the foundational support piers as can be seen in Figure 4.

- Non-destructive visual observation
  - Clean, sharp cracking in areas of top-surface tension
    - Crack widths reached 1/16"

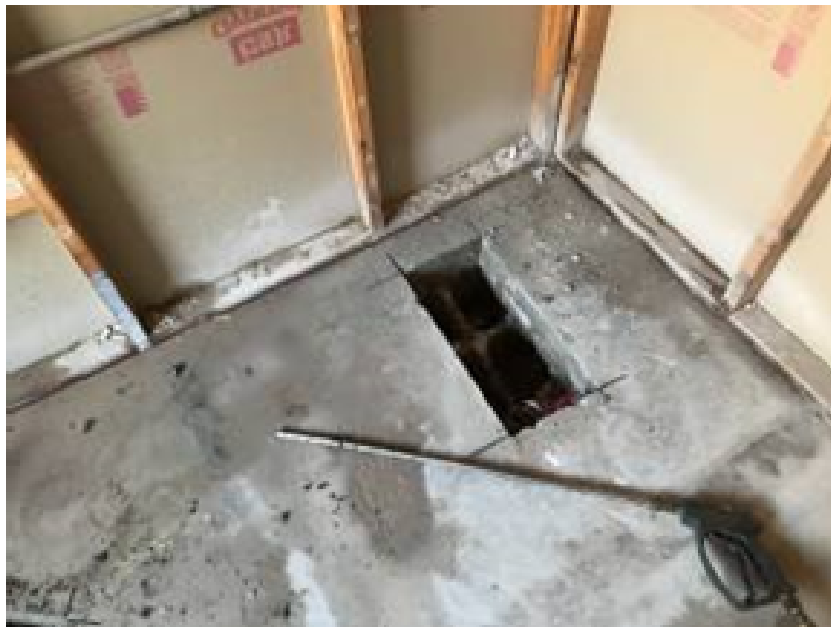
Figure 5 [4]

One of the more concerning things found during the site visit was discovered when looking inside of a cutout in the slab that was made to facilitate plumbing repairs. The thickness was measured inside the cutout. The slab was originally specified to be 13 in. thick by the design engineer. However, inside the slab cutout, the range of thickness was between 10.5 in. and 12.25 in.

- Non-destructive visual observation
  - Slab cutout made to facilitate plumbing repairs
    - Slab thickness ranged from 10.5" – 12.25"
    - Less than the specified 13"

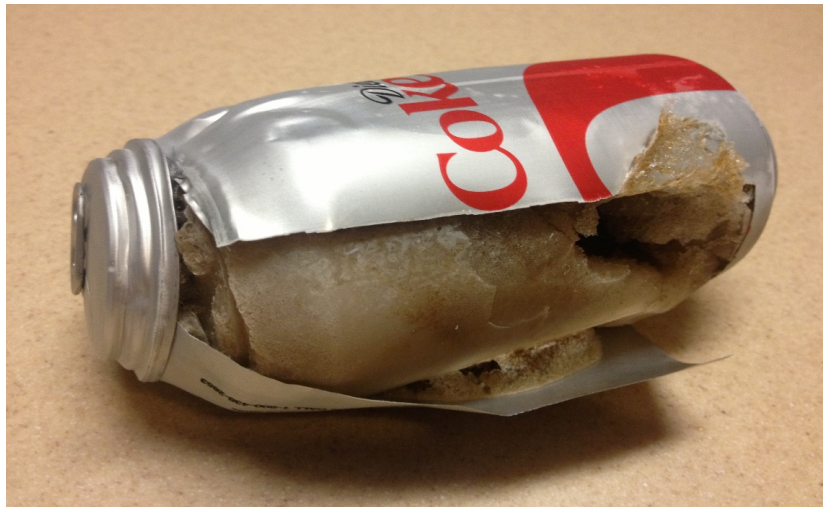
- Water based fire suppression line
  - Froze, expanded, and burst
  - Went unnoticed for hours
  - Water pumped out over a subsequent week

- A dry pipe sprinkler could have avoided the flood event altogether

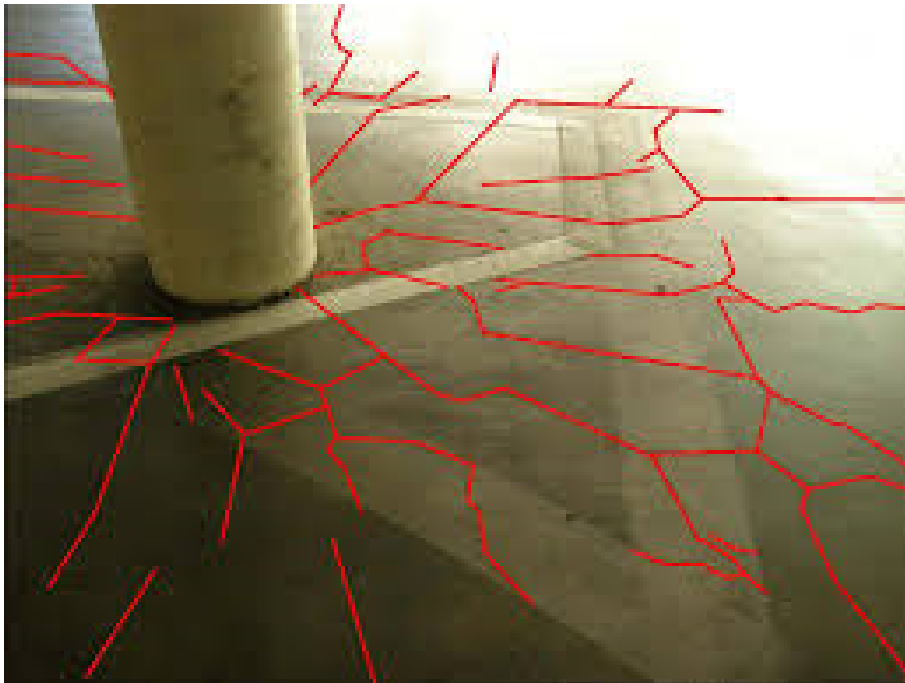
- Non-destructive visual observation
  - Concentrated cracking around interior columns aligned with foundation support piers

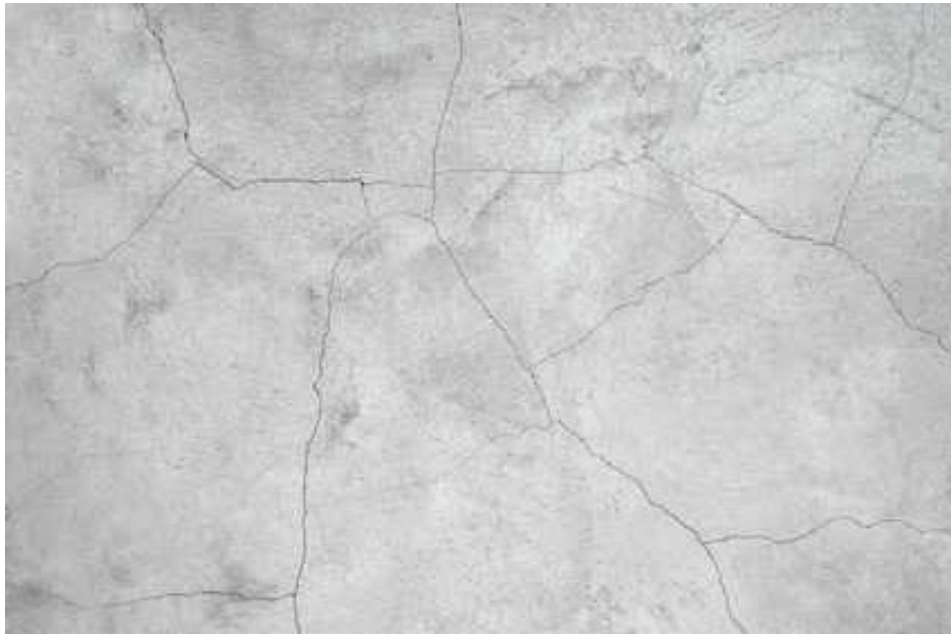
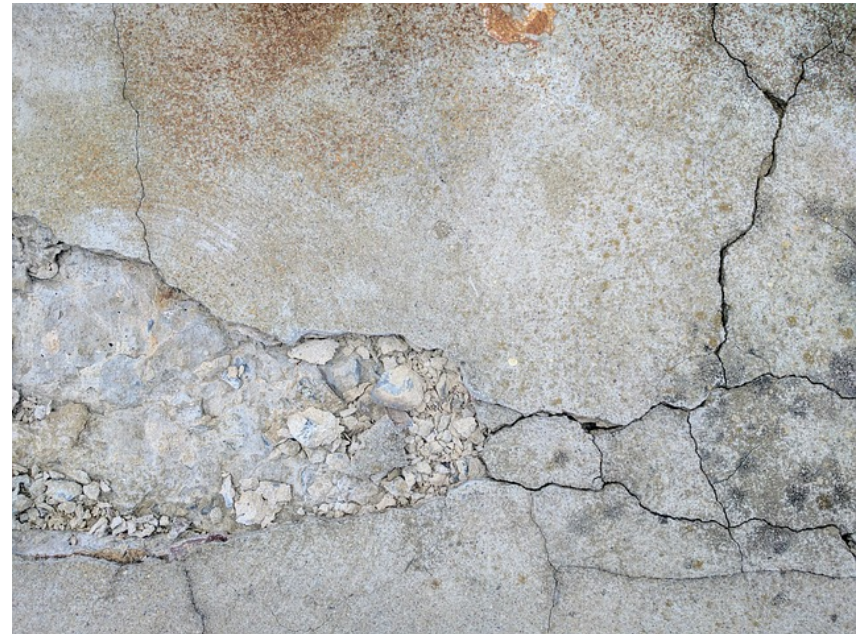
- Volume change due to moisture loss causes shrinkage cracks
- Rebar restraint may increase cracking

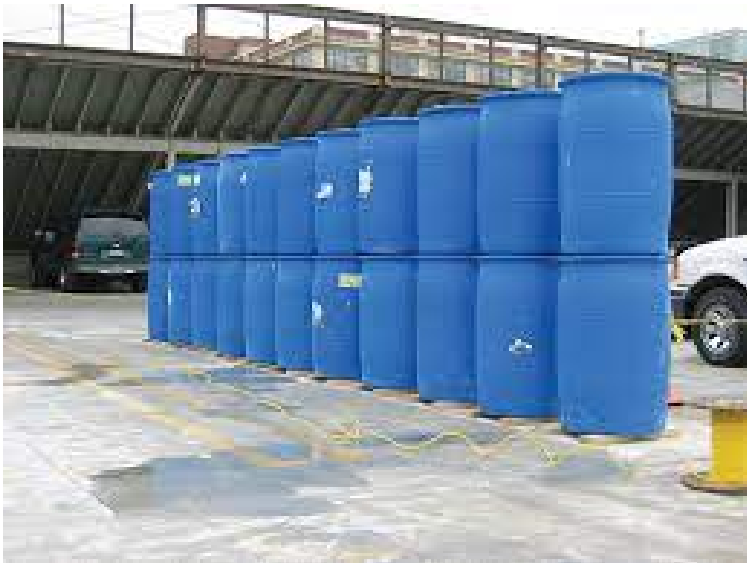
- Load testing philosophy
  - If a structure can handle a large enough load, it can be deemed code compliant despite design flaws or loading history
