REBAR IMPALEMENT SAFETY

A Senior Project submitted to
the Faculty of California Polytechnic State University,
San Luis Obispo

Report by
Steven Hoover
Spencer Nefores
March 2020

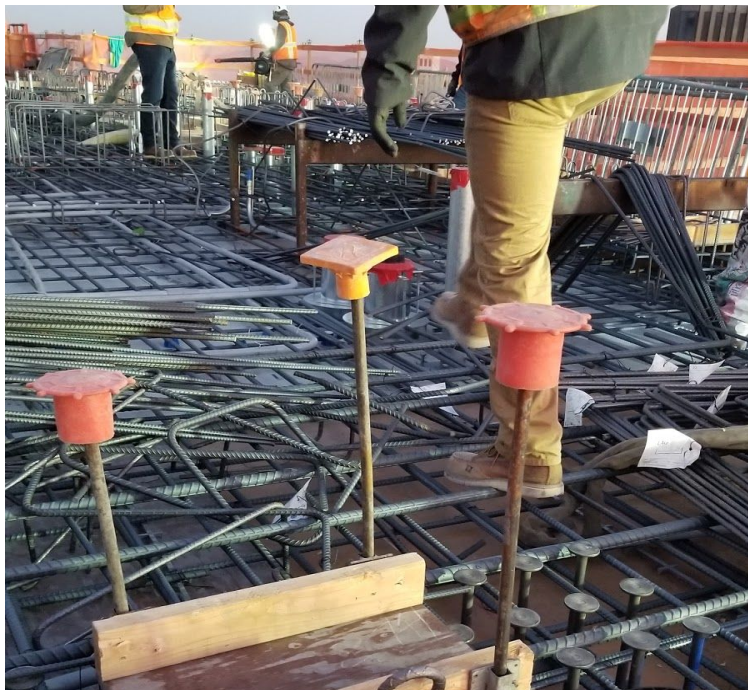
The most important thing learned at this site was that there were extreme tripping hazards everywhere. The floor that was being built was entirely covered in rebar that was raised about 12 inches off the ceiling of the floor below. This means that all of the workers have to balance and walk across half inch diameter bars. While the workers were adapted to this kind of hazard, the risk that any one of them could misstep or lose their balance is very real. Should they fall in the vicinity of an exposed impalement hazard, the results would be severe injury or death by impalement.

Fig 1: The first Webcor site visited by the team

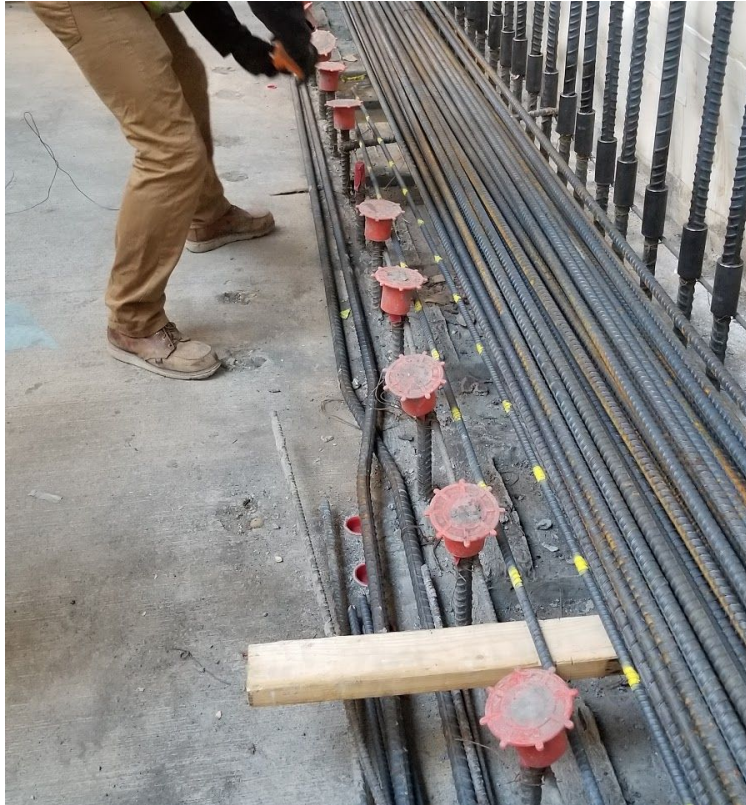
large building requires large amounts of concrete to be poured, and so there was a substantial amount of vertical rebar present. The team observed the first instance of a rebar safety cap that had fallen off while at this site.

Fig 2: The second Webcor site visited by the team

Several potential causes for rebar caps falling off were observed at the second site:

- The rebar sizes for foundations are much larger. Installing caps on larger rebar sizes damages the plastic fins that hold the cap to the bar.
- Damaged caps were frequently still being used and were occasionally taped onto the bar. If the tape wasn't used or failed, the cap was likely to fall off again.
- Long pieces of long rebar were stored horizontally at the base of vertically installed rebar (seen in the image above) that had caps installed. When the stored rebar was retrieved, it could strike the base of the vertical bars or knock the cap itself.

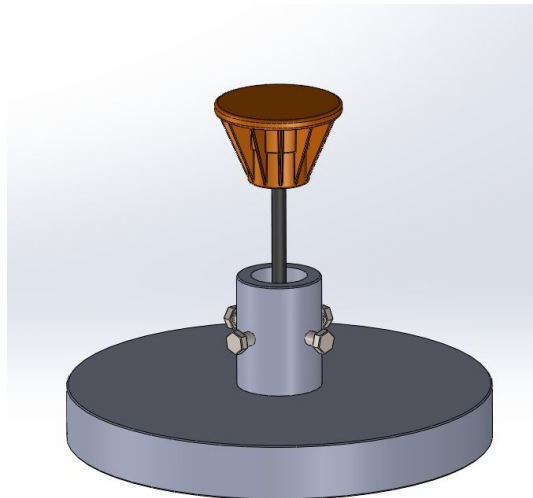
Cal OSHA safety regulations mandate that manufactured safety caps for impalement risk must pass a drop test of a 250 pound dry (less than 10% moisture) sandbag from a height of 10 feet with no penetration of the safety cap. The sandbag should have a round shape with a circumference of 36 to 48 inches. [1]

The rebar used for the test shall be 6 inches long protruding vertically and be of size 4/8 inch diameter. Test stand can be seen below in figure 3.

Figure 3. Rebar test stand design

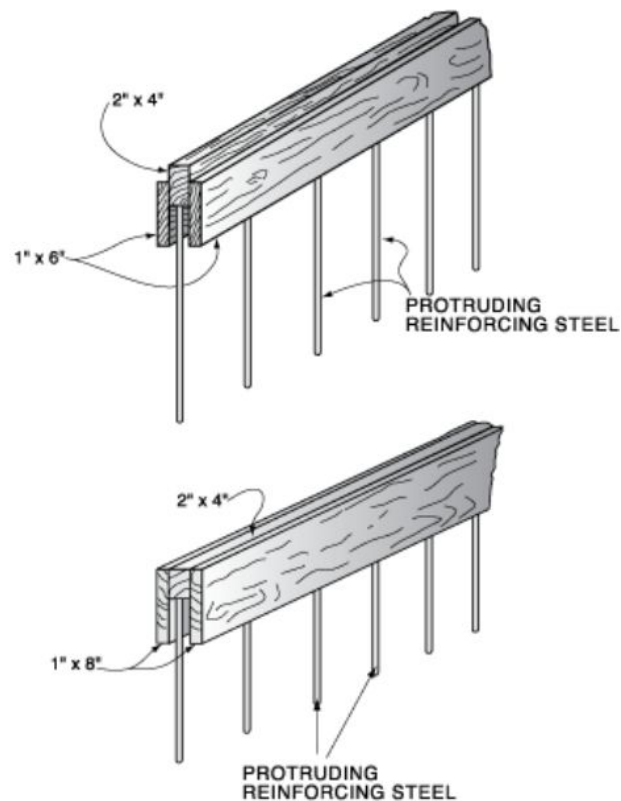
For trough style safety systems, 3 pieces of 4/8 inch rebar are to be used with 12 inches between and on either end of the rebar. [1] A similar test stand may be used that will hold 3 pieces of rebar at the appropriate distances apart.

Figure 4. An example of a trough style rebar protection system [24]

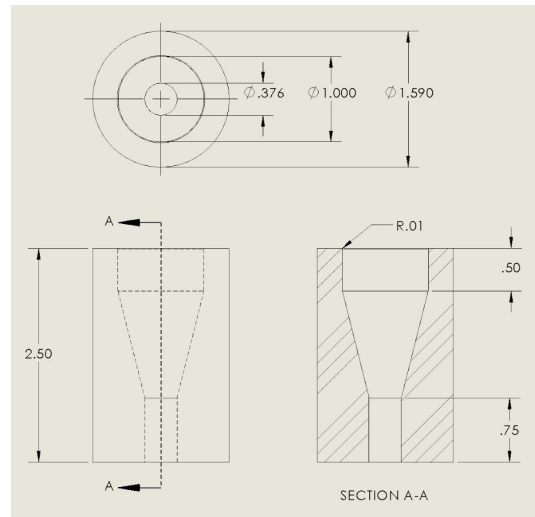
The team believes that the fins located inside the neck of the cap that help it stay installed onto a piece of rebar could be better designed. After brainstorming possible solutions, the team selected a tapered interior cap design that can be seen below.

Figure 7: Tapered design

This tapered design was selected because of its potential durability. The fins in current safety caps seem to be the problem as they easily become damaged and lose their ability to effectively grip the bar. The tapered design has no fins and relies on surface area and surface texture between the cap and the bar to grip the bar. In designing this solution, the team had specific materials in mind to maximize its grip and durability.

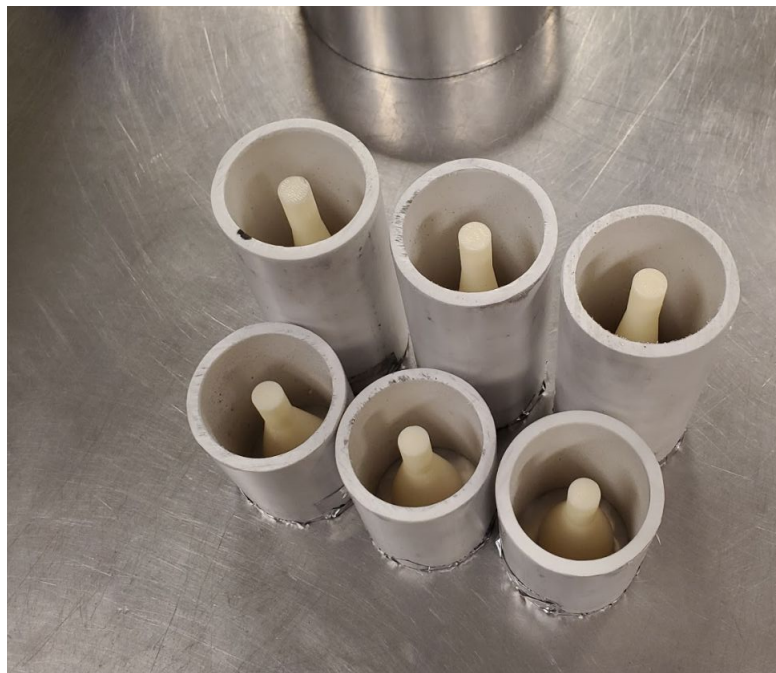
To manufacture the prototypes of the selected design and material combinations, the team first 3D printed inserts of the shape of the interior taper. The inserts were fastened to 1.5in diameter PVC sleeves with metal tape to create the mold. Then the different silicone/urethane compounds were mixed and poured into the molds and allowed to cure. Once cured, the 3D printed inserts had to be removed with a press and were destroyed during the process because they bonded very strongly with the silicone material. These sleeved inserts were created to fit inside the existing 3D printed exterior caps that we prototyped. This was a cheap and efficient way for us to swap out materials and only use one body due to the extremely long build time and high cost of 3D printed material. The cores before silicone casting can be seen below in figure 8.

Figure 8. Core Prototyping

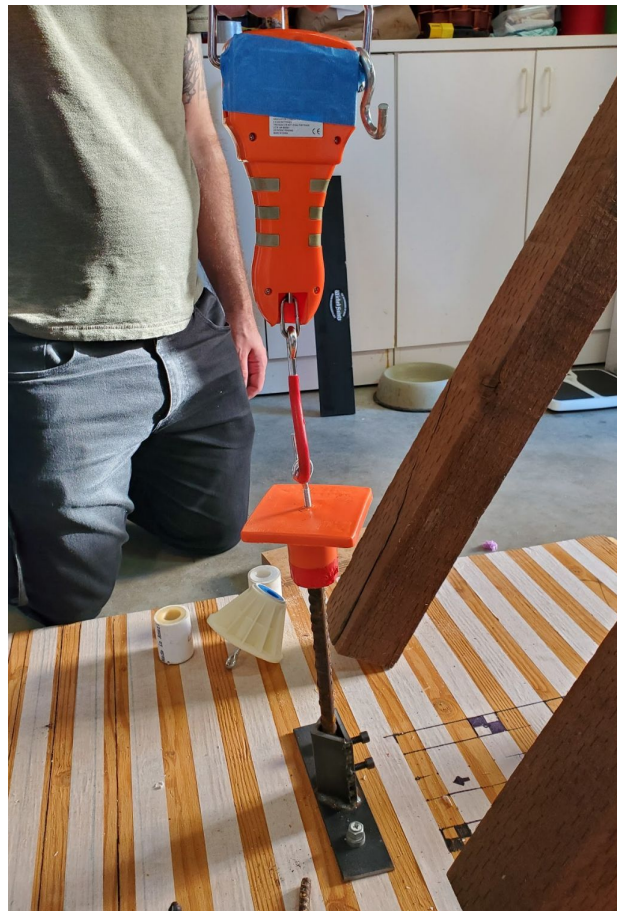
In order to test how the materials compared to the current solution the team developed a test that measured vertical force to remove. This would show which material had the best retention on the bar and thus be less likely to fall or be knocked off.

For this test, a hook was fastened to the center of the top of each cap and a digital hanging scale was attached to the hook. A team member would install the cap being tested and pull straight up very slowly. The digital hanging scale was used to measure the force, in pounds, to remove each cap in the vertical direction. The test can be seen below in figure 9.

Figure 9. Pull Test

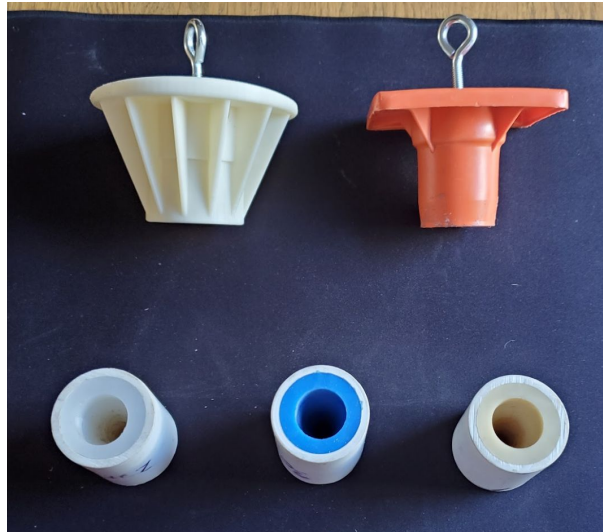
A full factorial design was developed with two factors. The first factor was material which consisted of four levels. The Silicone used in the test was 27T, 30, 60 and the standard cap. The second factor was the size of the bar used during the test. The levels for the bars were $\frac{3}{8}$, $\frac{1}{2}$, $\frac{5}{8}$. The test samples were tested for 3 replications in random order resulting in 36 treatments. The DOE run table can be seen in Appendix D. The test samples can be seen below in figure 10.

Figure 10. *Pull Test Samples*

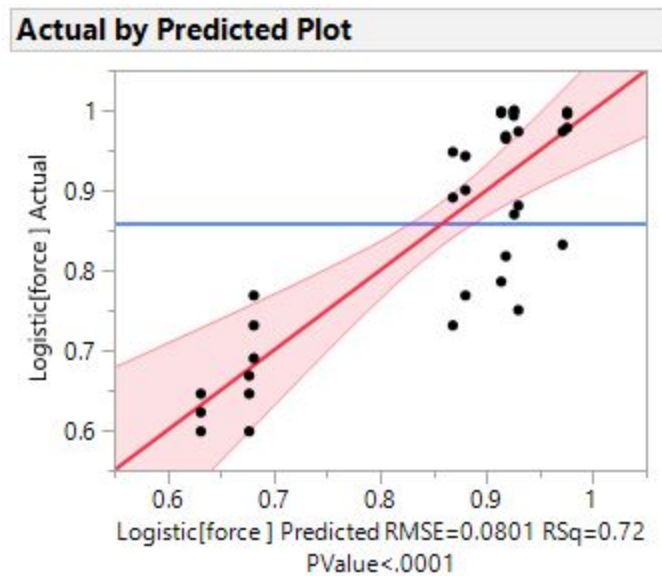
The model can be seen below in figure 13. This shows that our model is statistically significant based on the low p-value. Additionally, the model is a proper fit for the data based on the R Squared value of .72.

Figure 13. Model Fit & Significance

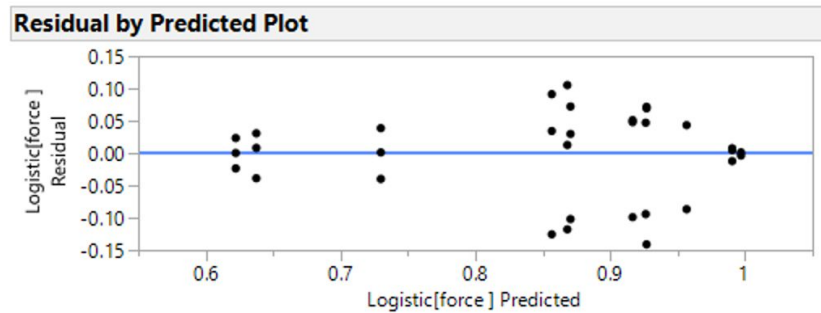
Validation of the three ANOVA assumptions can be seen below in figures 15-17. These three assumptions allow the team to conduct the ANOVA tests seen above and are required in order to have meaningful and accurate data.

Figure 15. Check for Constant Variance

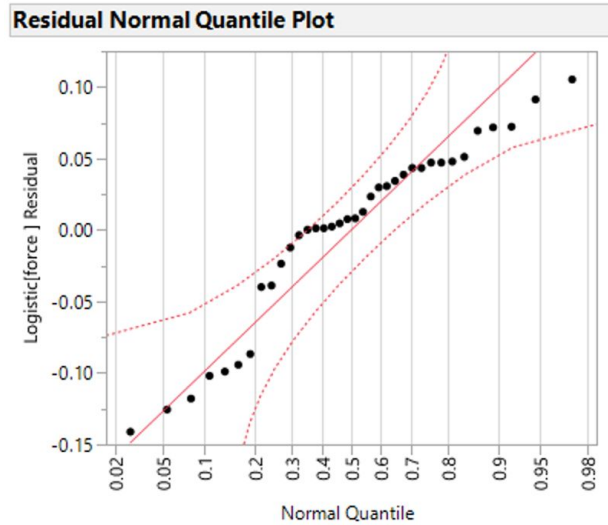
Figure 16. Check for Normality

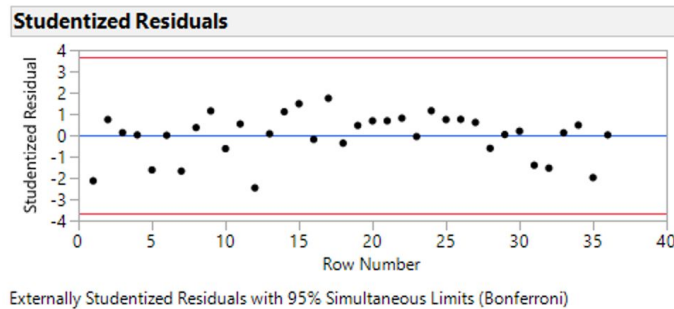
Figure 17. Check for Independence

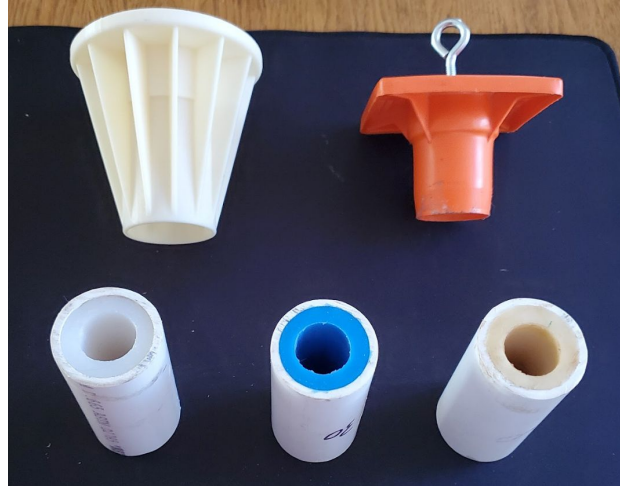
The team wanted to evaluate whether there was a difference between the 2.5inch cap and the 4inch cap. The results of the Fisher LSD seen above in figure 14 showed that the three silicones were statistically similar. Silicone 60 was selected because it was about half the price of the other silicones. The same test as above was run using only cream 2inch and 4inch caps. This was silicone 60 which had the highest average force to remove and we suspected it was the most durable. We tested this suspicion later in the report. The 4inch test samples can be seen below in figure 18 but we only tested silicone 60 to limit the amount of treatments needed.

Figure 18. 4inch test samples

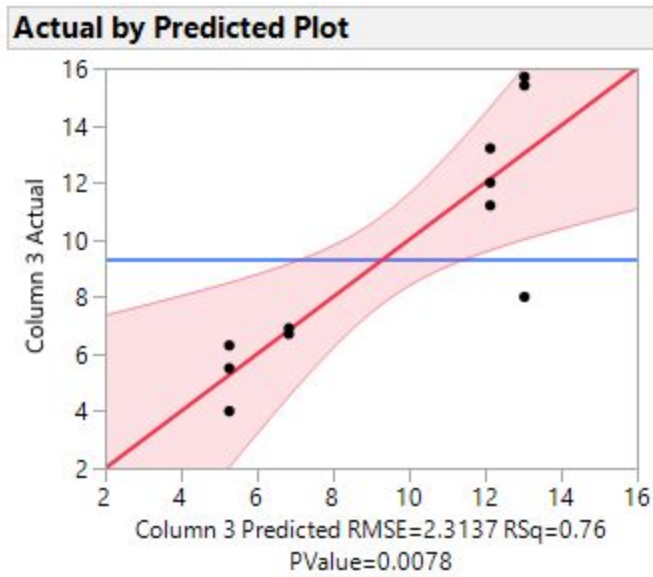
The model was shown to be statistically significant and have a good fit based on the p-value and R squared values below in figure 21.

Figure 21. Model Fit & Significance

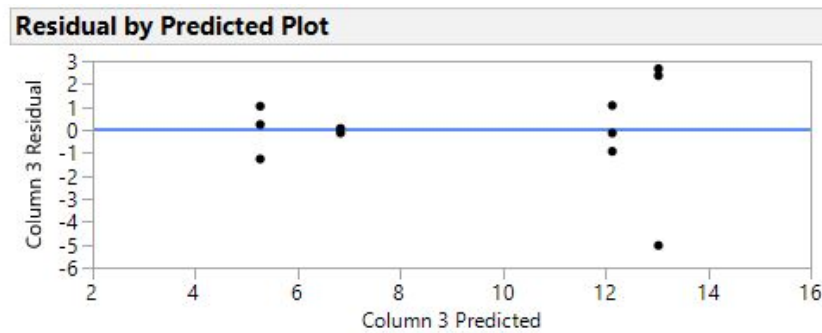
The ANOVA assumptions were validated and can be seen below in figure 22-24.

Figure 22. Check for Constant Variance

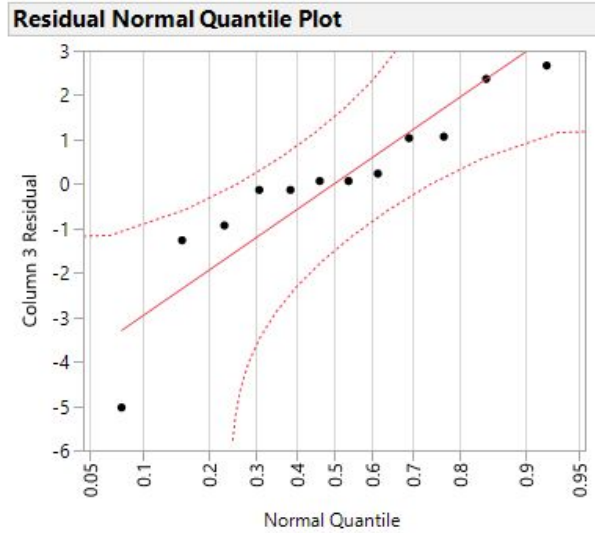
Figure 23. Check for Normality

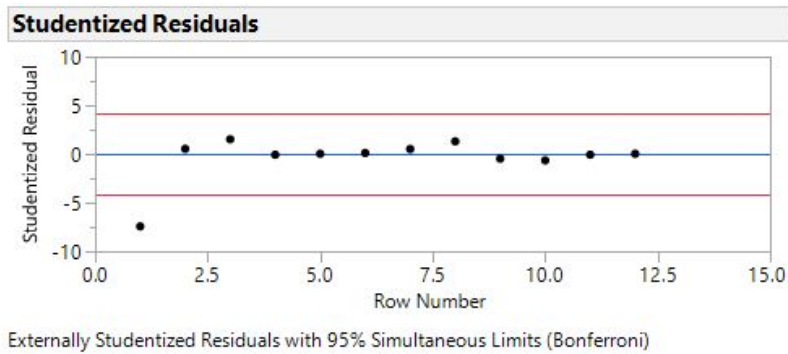
Figure 24. Check for Independence

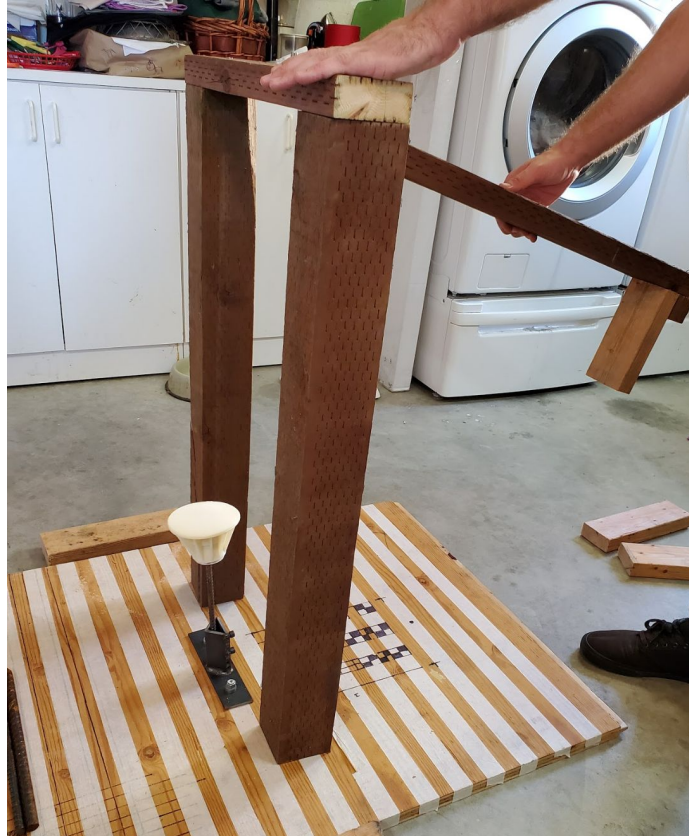
Given what the team observed during their site visit and what Galen Dougherty has observed in his time working for Webcor, there was a desire to test how the caps do in relation to being struck and sustaining impacts. To accomplish this, a kicking apparatus was constructed to strike each bar and cap combination. The test was run with 3 replications for a total of 36 treatments similar to the first pull test. The test consisted of 3 bars with levels $\frac{3}{8}$, $\frac{1}{2}$, $\frac{5}{8}$, and with the 27A silicone, 30A silicone, 60A urethane, and the standard cap. The test setup can be seen below in figure 25. The run order can be seen in appendix d.

Figure 25. Strike Test

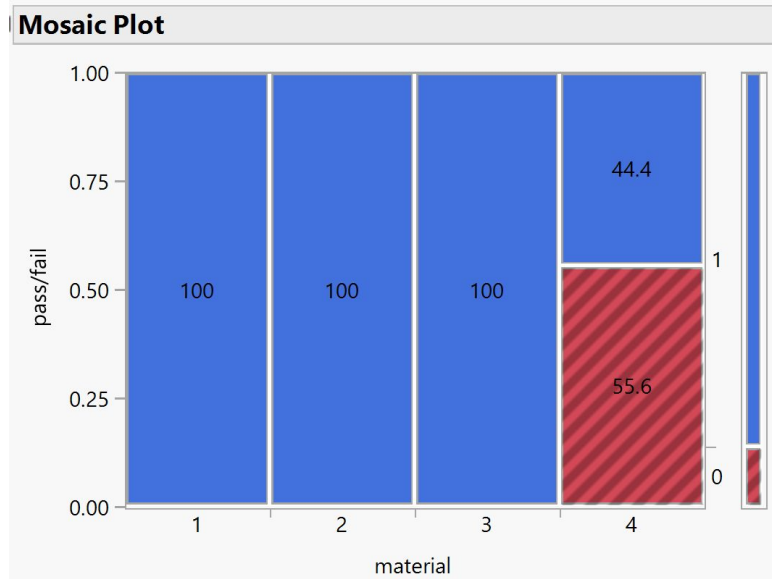
Because the data was binary the team conducted a proportion analysis and compared fall off rates. The current cap fell off 55.6% of the time whereas the silicone caps remained on the bar 100% of the time. The Mosaic plot in figure 26 is a graphical representation of the fall off rates of the caps. The raw data can be seen in appendix d. This test showed that the prototyped designs all held up very well when experiencing a strong impact, while the current cap was prone to falling off.

Figure 26. Mosaic Plot

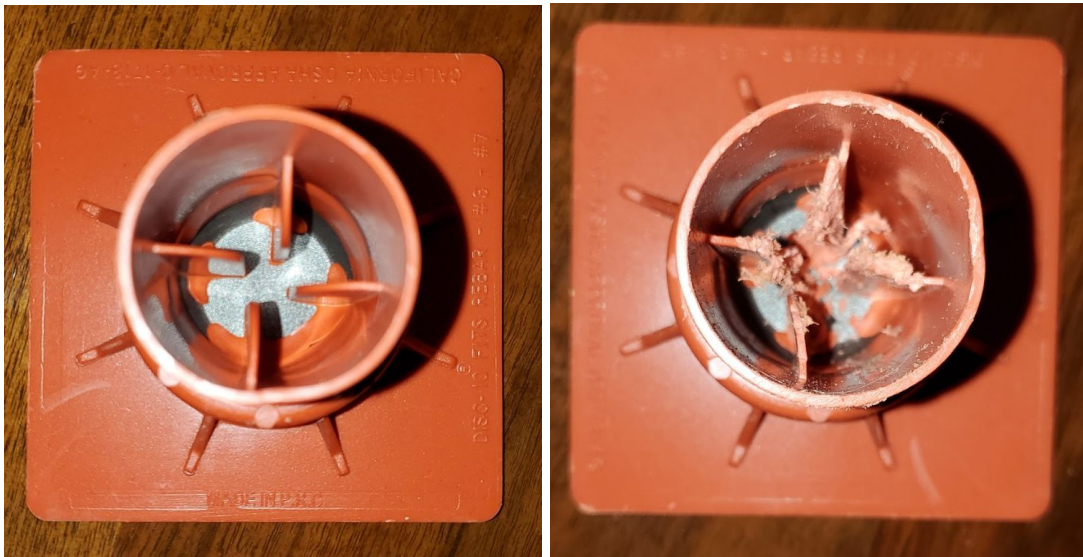
The durability of the current solution was evaluated by placing the current rebar safety cap on a $\frac{5}{8}$ rebar dowel and removing it for 100 cycles. The results can be seen below in figure 27.

Figure 24. Standard cap before and after 100 cycles

An important thing to note when comparing these two results is that both designs are rated for the size of rebar they were tested on. Despite being rated for the bar, the standard cap deteriorated significantly faster than the urethane material. Even after being tested for over three times longer than the standard cap, the urethane material showed little signs of wear and tear. This is a promising result as damage to the fins in standard caps is suspected to be a major cause of their fall off frequency.

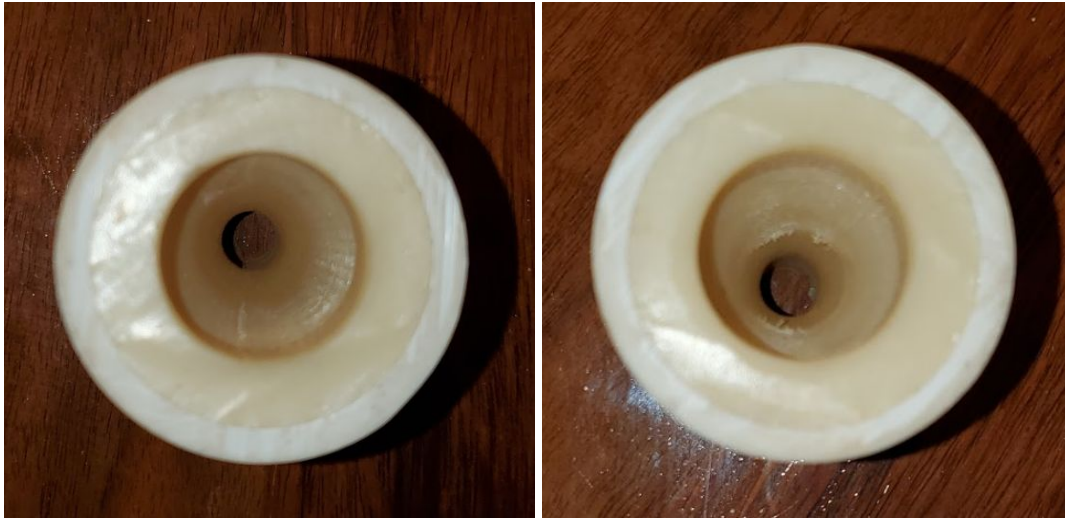
The urethane 60A prototype was then tested for 300 cycles and the results can be seen below in figure 28. We chose to test the urethane much longer because there was almost no indication of wear after 100 cycles.

Figure 28. The urethane prototype before and after 300 cycles

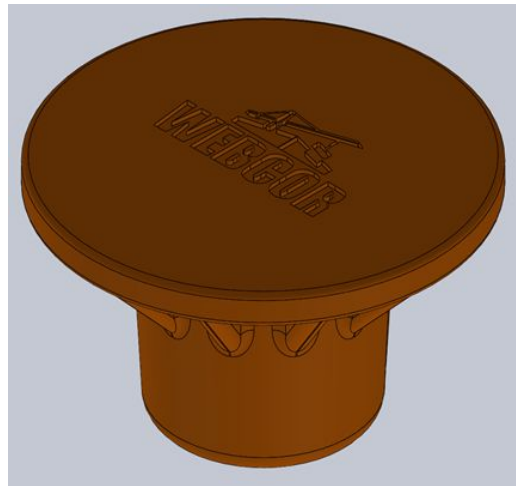
After testing the taper design, the team decided it could be improved by stair-stepping the taper in $\frac{1}{8}$ th increments to maximize the surface area on the bar. This is because after conducting testing they noticed that the $\frac{1}{4}$ rebar fit the best and had the best retention when the tapered design was installed. The $\frac{1}{4}$ is the only bar size that would fit into the straight section of the tapered design and the additional surface area is believed to be the cause of the better retention.

This design was not tested and will need further study. This design can be seen below in figure 29. A cross section of the design can be seen in Figure 30. An engineering drawing of the final cap can be seen in appendix c.

Figure 29. Final Design

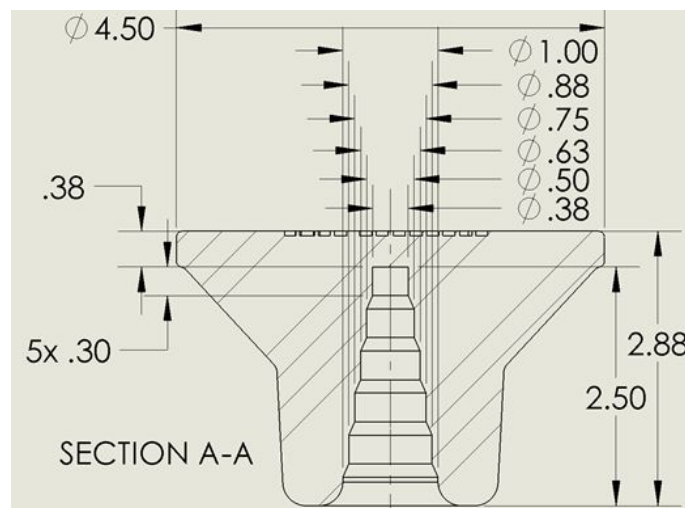
Figure 30. Cross section

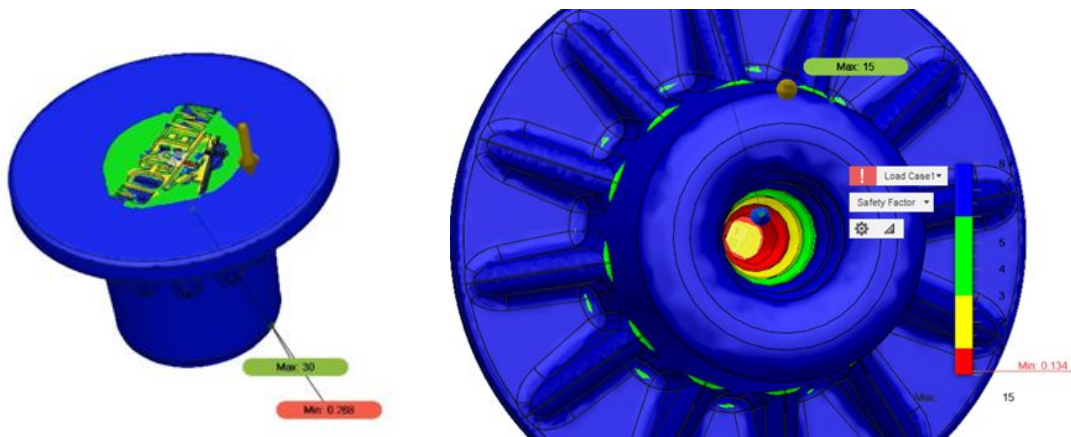
It was suspected that the final cap may not need a steel reinforcing plate. This was never tested and is a topic for further evaluation in the future. A finite element analysis of the solution without a plate was conducted at various weights until the cap started to show failure. Figure 31 below shows a test with 2248lbs load applied to the cap. The test shows that the inner sleeve starts to fail but the rebar does not puncture the cap. The team is unsure if this is sufficient to pass a drop test and would need to be tested. If the test failed, the design would need to be altered to compensate or a steel plate would need to be added. The material properties can be seen in figure 32.

Figure 31. FEA Analysis

Material: Rubber, Silicone	
Density	1.25E-06 kg / mm ³
Young's Modulus	3 MPa
Poisson's Ratio	0.49
Yield Strength	10.34 MPa
Ultimate Tensile Strength	6.5 MPa
Thermal Conductivity	2.275E-04 W / (mm C)
Thermal Expansion Coefficient	8.1E-06 / C
Specific Heat	1880 J / (kg C)

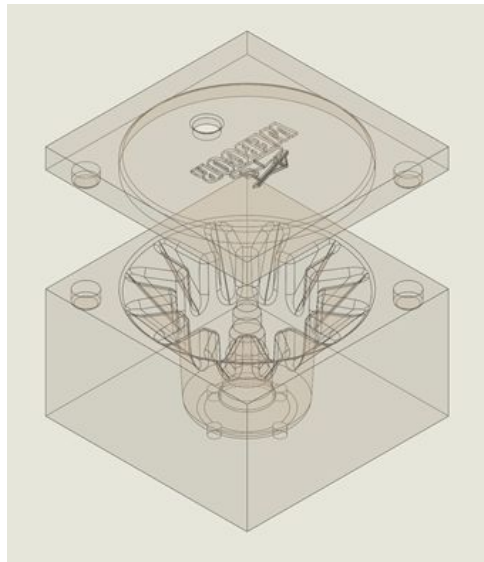
The exterior of the cap was modified so that standard tools could be used in the machining of the mold cavity. The mold can be seen below in figure 33. Appropriate draft of 3 degrees was applied to vertical edges for ease of ejection from the mold seen in figure 34. Additionally, the parting line can be seen at the intersection of the red and green sections. Lastly, 4 ejector pins would eject the part from the mold.

Figure 33. Injection Mold

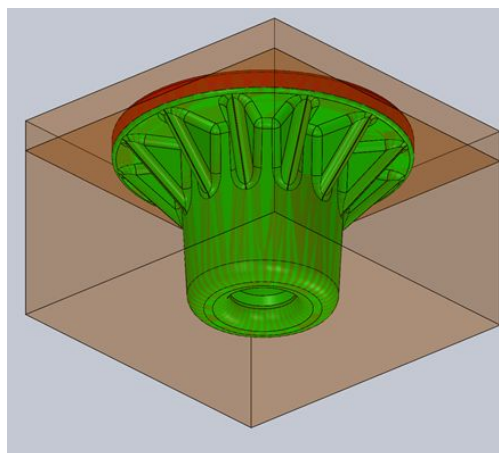
Figure 34. Draft Analysis

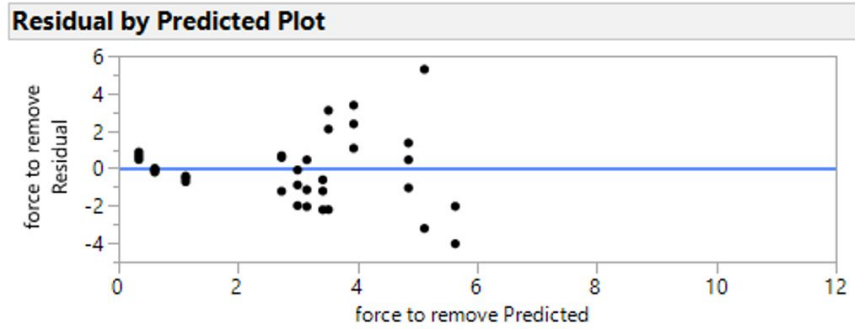
The initial data showed that the constant variance assumption was violated and thus needed to be transformed. Figure X shows the original data before transformation.

Check for Constant Variance
