# **Kentucky St. Fence Rebuild: Planning, 3-D Modeling, & Philanthropic Construction**

**Michael Cerone**  
Cal Poly Construction Management  
San Luis Obispo, CA

**Key Words:** Fence, Rebuild, Design, Construction, Residential

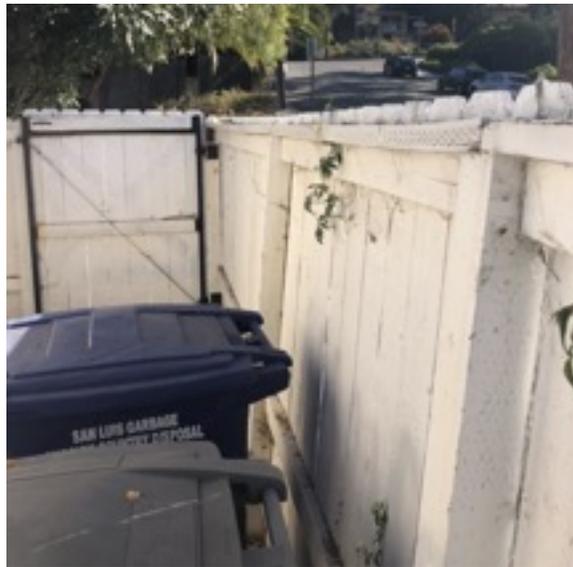
However, one day Cerone was walking home and noticed an elderly member of the San Luis Obispo (SLO) community who lives on his street outside of her home adjacent to an extremely worn and damaged looking fence as seen in Figure 1 below. Cerone had seen this woman gardening in her front yard frequently when walking home from his Cal Poly CM classes.

Figure 1. Existing fence nearly falling over

To begin the construction of the fence, the builders' first step was to take down the existing fence. Out of the beneficiary's and the builders' desire to keep the fence as cheap as possible to stay within Labdesign's donation limit, it was decided that reusing posts from the existing fence that remained in good condition would be a great way to implement value engineering. So, it was decided that the posts connecting to the gate would be reused, but all other posts except one would be removed and replaced with new ones for a total of two new posts. The old fence was then cautiously demoed using framing hammers and crowbars for the top rails, a drill to remove screws for the pickets, and a monkey wrench to remove the gate hardware to prevent any damage to the surrounding garden.

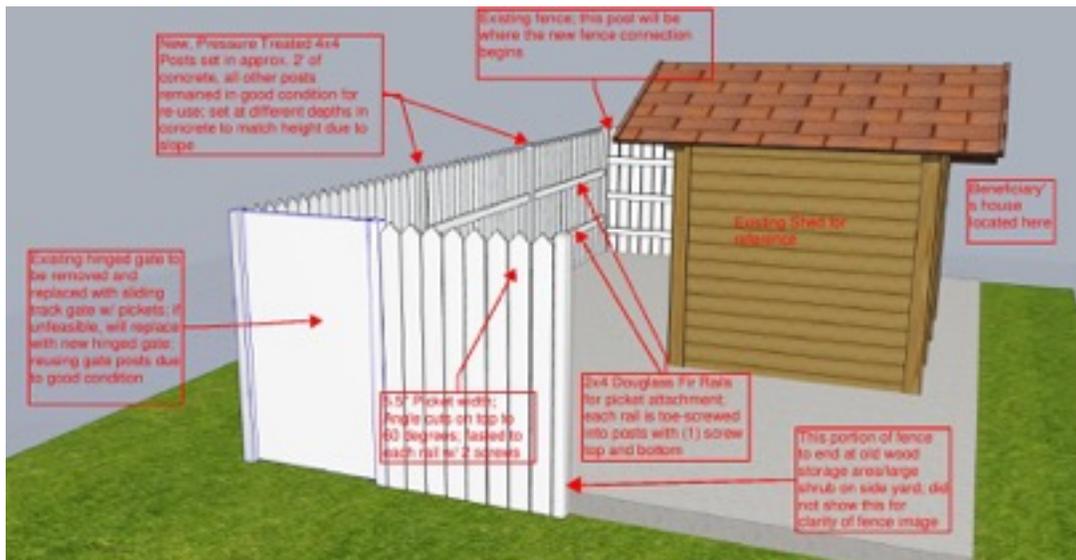
Through online research, Cerone found different picket fence styles to consider and took measurements of lengths/heights of fence sections (6 foot height with approximately 30 feet of length), distances between posts, rail sizes, picket widths, etc. on the existing fence footprint in order to create a new, "low cost" model for a possible new fence design. This model includes callouts of each material and how they will be connected. The model consisted of 4x4 pressure treated lumber posts with (2) 2x4 Douglas Fir rails for 5.5", pointed-top pickets to be attached to. This model differed from the original fence design, which included notched picket tops and (4) 2x4 Douglass Fir rails, with one of the rails being placed horizontally at the top.

Figure 2. Cerone's "Low Cost" Conceptual 3D Model for possible new fence design

Since her deceased husband was a contractor, the beneficiary has immense knowledge and interest in residential construction and she wanted to be very involved in the process. So, Shafer and Cerone reviewed the designs with her to get her input. The beneficiary was very impressed by the level of detail that went into the models and liked the designs the builders had come up with. However, since Cerone's design did not match the existing fence they were connecting to, the beneficiary ultimately requested that they use the design Shafer created as it closer resembled the existing fence in order to maintain the aesthetic appeal and keep the cost as low as possible to leave room for potential cost overruns. Also, Shafer's design included more rails which would make the fence sturdier as this was another goal of the beneficiary's for her new fence. Details of Cerone's model can be seen in Figure 2 on the following page.

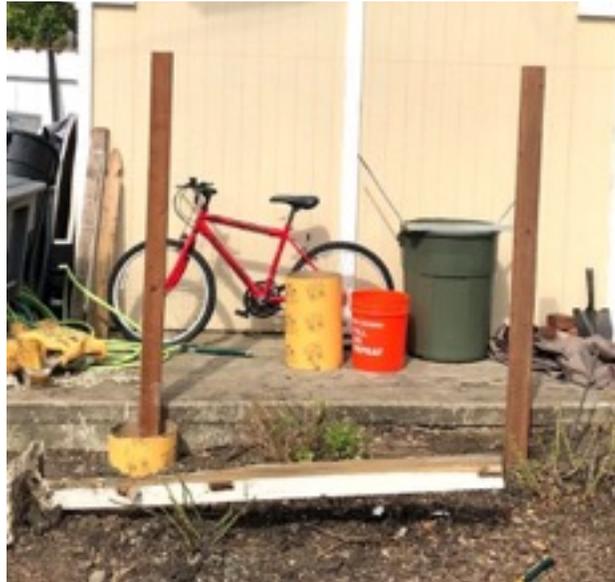
The first step to building the fence was to mix, pour, and set concrete into approximately 24" deep by 24" wide circular holes for the new 4x4, 8' tall pressure treated posts to be set in. The holes were dug using shovels, and shaping the holes was difficult as the constructor of the existing fence made his piers significantly different sizes. Backfilling methods were utilized in order to make the two holes even for the posts to sit in properly. For the hole that required backfilling, the builders opted to use a Sonotube to ensure the posts would be properly poured to the right shape. Before adding concrete into the holes, 3" of gravel was poured to allow for drainage. Once the concrete was mixed, it was poured into the holes and troweled using pieces of rebar that were purchased at home depot. Once the concrete was poured, the 8' posts were set into the concrete.

To ensure the new posts lined up with the existing posts, that the fence would be level across the top, and run in a perfectly straight line, the builders used leveling string to keep the posts in line. A level was then used at the top of the posts to ensure each post was level. Since there is a slope to the grade that the fence is being built on, the post higher up the slope of the hill was set a few inches deeper in order to match heights with the other post that had been set at a lower elevation of the slope. The posts after being set and leveled can be seen below in Figure 3. After the posts were set, the concrete hardened and the holes were then backfilled with native soil to hide the piers below grade as well as filling in the holes for the posts.

Figure 3. New posts set in concrete and completing leveling process

To adjust for the slope, the builders had to be very careful to use leveling lines and a leveling tool to make sure that they did not accidentally slope the fence up or down along this section; the goal was a straight line that is perfectly level from post to post. The level line extended from the existing fence post to the existing gate post, and the tops of the posts were lined up with this string. To make the new posts line up in height, one of the posts was set slightly deeper in concrete. Once the posts were lined up, it was much easier for the rails to be placed level and in a straight line since the builders had ensured the posts were at the same heights.

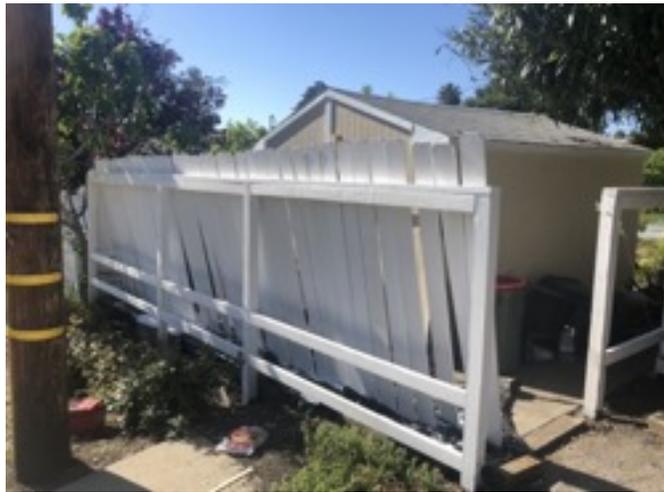
Figure 4. Pickets preparing for attachment to rails, both fully painted

Completion of construction and painting of the rails and posts was followed by the installation of the pickets. Notched-top, 6' tall, 5.5" wide pickets were used for this project. Each picket was secured to the top, middle, and bottom rails using 2 screws going into each rail through the pickets; they were also to be fully primed and painted (two coats of each) as seen in Figure 4 above before attachment to the rails. This would ensure they were fully covered in paint as the edges would not be able to be reached with a paintbrush once they were attached to the fence frame.

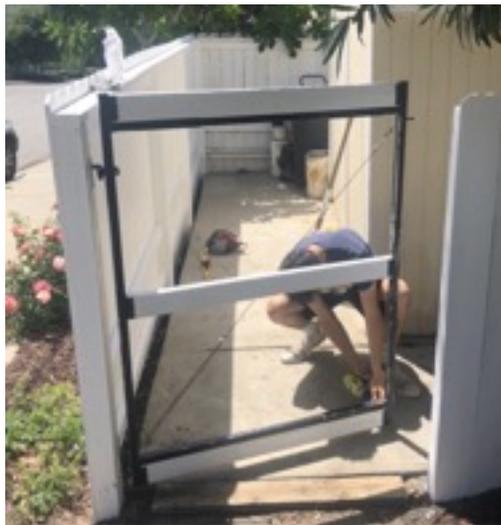
The last remaining structural task of the fence after complete installation and painting of the pickets was to install the gate. The builders originally opted to provide the beneficiary with a new, sliding gate that rested on a track. However, due to some low quality construction she had received in the past, a sliding gate was not able to be put in because of existing site conditions (that will be discussed later) and the beneficiary opted to keep the existing hinged frame style instead. Since the existing gate frame was old and worn, the builders purchased a new hinged gate frame identical to the beneficiary's old one. With this frame, three 2x4s were installed into mounts within the gate to provide a surface for the gate pickets to be attached to in the same fashion as the rails on the fence. These 2x4s were first fully primed and painted with 2 coats of each, and then securely fastened into the gate frame mounts with screws as seen in Figure 5 below.

Figure 5. Gate frame with rails installed, no picket attachment yet

After the gate frame 2x4s were placed and new screws were provided for the existing gate hardware, the pickets were then ready to be attached. Before putting them on the gate frame, the pickets needed to be cut to match the height of the fence sections that were built adjacent to the gate. After these cuts were made with Shafer's circular saw, the pickets were then fully primed and painted before being attached to the frame in order to minimize the amount of paint that would get on the existing black metal gate frame. Once painted, they were then screwed into each of the 2x4s on the gate frame with two screws on each 2x4, identically to the way the pickets were attached to the normal fence.

As was the case with two of the pickets on the actual fence itself, one of the gate pickets needed to be trimmed to fit between the posts. The same method of using a table saw to make a rip cut was employed, and the angles of the notches were constructed to match. This allowed the pickets to fit perfectly on the frame, with very minimal reduction in aesthetic appeal. Once all of the pickets were properly secured to the gate frame and it was ensured that the gate would properly close, a new lock was installed on the post to match the gate frame color and replace the old broken one.

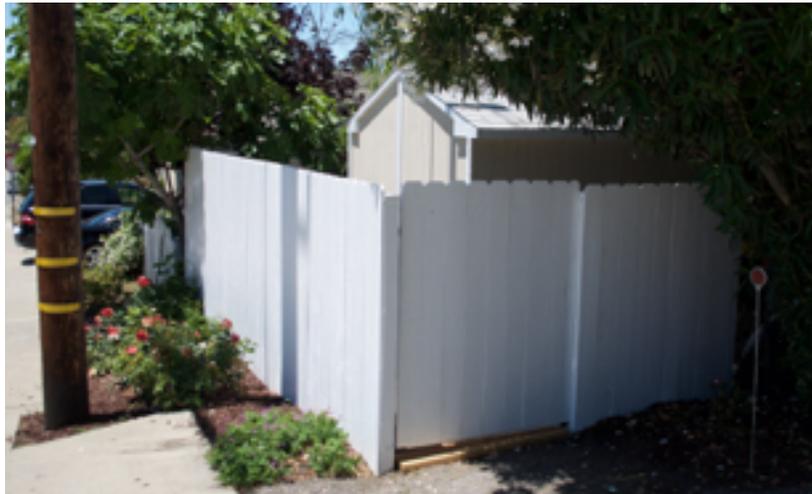
After completion of the gate construction the fence was then entirely finished including painting, leaving only a final cleaning of the job site remaining. There was an extensive amount of paint required for the fence, and the builders had made a decent sized mess on the surrounding concrete with paint splatter even after putting tarps down. To remedy this, a power washer was used to rid the concrete of any spilled paint, as well as cleaning the new and existing fences. For the concrete, the power washer was used at a very high setting to make sure all the paint came off the ground to keep the beneficiary's side yard looking nice. For the fences, a lighter setting was used to clear off any dirt, dust, etc. from the fences as an added bonus. The completed fence can be seen in Figure 6 below.

Figure 6: Finished fence including painting and gate

Paint had also gotten onto the black metal hardware for the gate frame, making it look very unprofessional. To remove this paint, the builders used paint thinner and brushes to scrub off all of the white paint from this hardware. The final step to clean-up was removing debris from the beneficiary's garden and providing new mulch for her garden as an added bonus. The beneficiary was extremely pleased with the quality of the finished project and unexpected bonuses of power washing and landscaping, and stated that she could not be more grateful and appreciative for Shafer and Cerone providing her with a new fence free of charge.
