Residential Bathroom and Tile Shower Addition During COVID-19 Quarantine

Joseph Q. Szillinsky

California Polytechnic University San Luis Obispo
San Luis Obispo, California

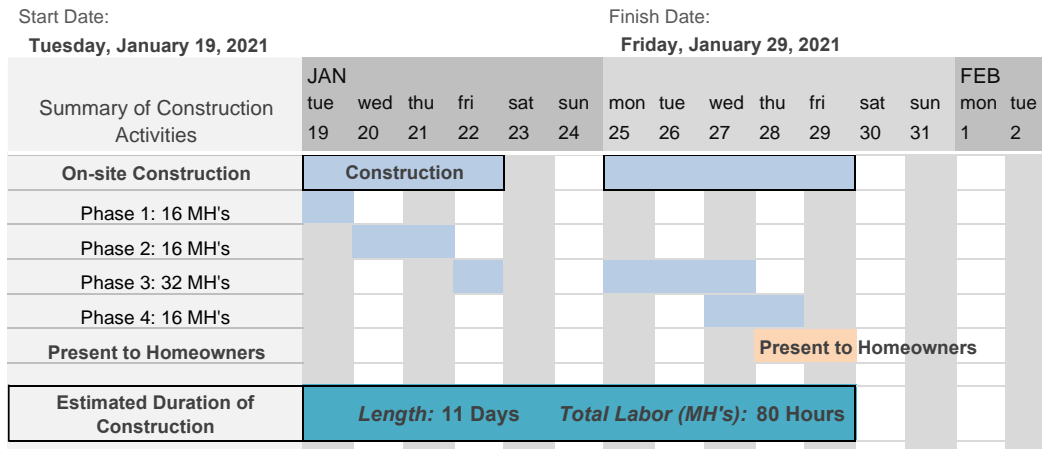
Figure 1. Summary of construction stages

During the next preconstruction meeting the material list was finalized, the material quantities were confirmed, and material procurement deadlines were identified. Another developing topic that was addressed during this meeting was the breakdown of work activities. Next, a detailed work sequence was created to support on-site labor efficiency. For a project this small, this scheduling technique could seem like a waste of time, however for the purpose of communicating the work plan with the financial sponsor, this method was used to establish a cost for labor prior to construction. With consideration to the nature of the project the tradesman agreed that a work breakdown structure could be built into the schedule. After a collaborative effort to refine the activity sequence and confirm schedule availability, the assisting tradesman and author finalized the construction schedule, shown in Figure 1 below.

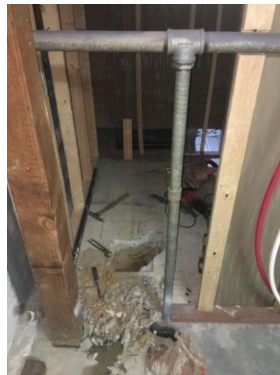
Figure 2a. Demo to access existing plumbing

When work on-site began the first objective was to update the plumbing in and around the project footprint. This phase of the work required coordination with the contractor and with his apprentice who were scheduled to work. A jackhammer was used to access cast iron sections which were replaced with 4" ABS DWV Pipe, and to create space for a new ABS P-trap for the shower. Another task that was addressed during this time was structural framing, which was only achievable after removing the old drywall. Once the studs were exposed, a few had to be replaced in order to ensure a proper surface for the tiles to be installed. At this point 2x4 studs were also used to frame a wall section which would serve as the front wall of the shower enclosure. During the first day of construction the schedule budgeted for 16 hours of labor between the local tradesman and his apprentice. The daily goals were met and there were no unexpected findings or delays. Photos of the existing piping is shown in Figure 2.

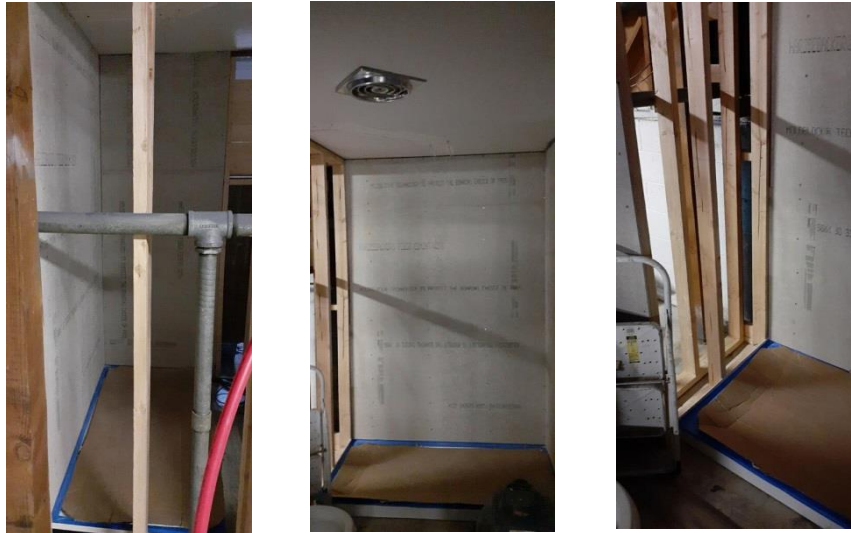
Figure 2b. Progress photos for shower pan and wall preparation

Once the plumbing rough-in was complete, installing the shower pan was the next task completed. Next, the drain was installed in the shower pan and it was caulked, the edge of the shower pan was secured to wall studs. After securing the shower pan the team installed the shower valve and piping into the 1' wall section. Then the electrical rough-in and wall blocking were addressed, and the walls were prepared for cement backer board installation the following day.

The 3' x 5' cement backer boards were approximately 50 pounds each, and needed to be attached tight and level to one another. An important consideration for this stage is to procure the proper screws for attaching cement board, which are corrosion resistant and have a unique threading depth that can grip backer board. Cement backer board is a moisture resistant alternative to normal drywall. Aside from its moisture resistance, cement backer board is an ideal surface for tile installation because it is rigid, workable, and durable. After the walls were covered with backer board the first cover of fiberglass joint tape and adhesive was applied at the board seams, depressions, and gaps which is shown in Figure 2b.

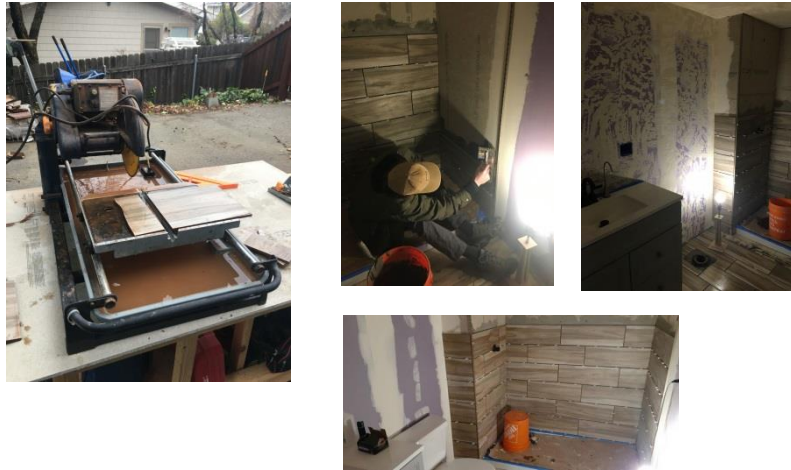
Figure 2c. Wet tile saw, tile installation, wall texture

On the fourth day of construction, the first task was sanding the fiberglass tape at the shower walls. Next, a second coat of tape/adhesive were installed, followed by installation of the metal trim pieces which run vertical to conceal the tile edge. After the shower was waterproofed and ready for tile, preparation and layout for the floor tiles was done using a chalk line, level, measuring tape, and straight edge. Once measurements and layout was complete the floor tiles were installed and left to cure over the weekend.

Following the 48hour curing period, the team arrived to fill grout at the floor tiles. Next, it was time to prepare the layout for installation of the wall tiles. When that was done the final activity of the day was to install the lower half of the wall tiles. The decision to schedule the lower and upper wall tiling on separate days was included in the work breakdown structure in order to accommodate the compounding weight of stacked rows.

The following day the tradesman's apprentice was scheduled to assist. The team began with installing the porcelain corner shelves, the remaining wall tiles, and applying texture to the drywall remaining walls. After that, the work crew filled grout on the lower half of the wall tiles and trimmed out and hung the bathroom door. Finally, our team painted the non-tile walls and ceiling which concluded the on-site work for the day.

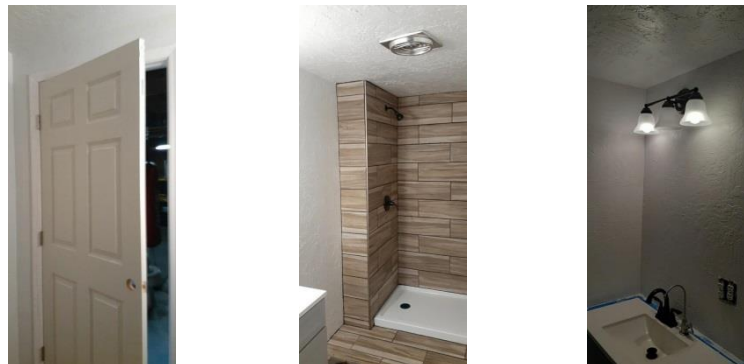
Figure 2d. Bathroom door, finished tile, finished light fixture

On the final day of construction, the team began by installing fixtures and finishes to complete the final plumbing and electrical requirements. This included shower hardware, lighting fixtures, and electrical covers and switches. The next task was to install the hanging 5' x 6' ANSI Certified 3/8 in. clear tempered Deco-Glass shower door which had been selected by the homeowners during the design stage. The shower door assembly included: a guide rail, door stoppers, glass brackets, 2x high forged rollers, threshold and cover, stainless steel door handles, and splash proof seals. The shower door installation began with measurements and preparation to confirm the attachment points were level, solid, and able to support the entire weight of the door. Then the crew proceeded to install the door beginning with the guide rail and finishing with splash proof seals. Once the shower door was properly assembled all that was left to complete the project was cleaning, minor touch-ups, and approval by the homeowners. On the following day the final project was revealed to the homeowners who were delighted with their brand new shower and bathroom.

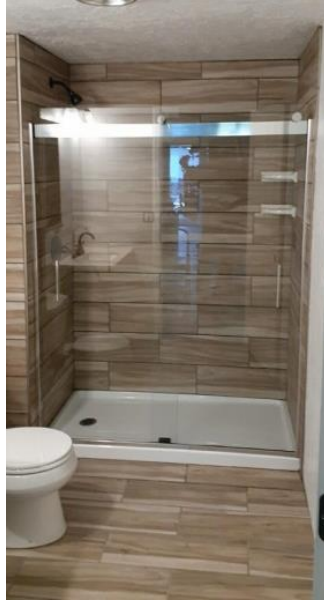
Figure 3. Finished six-foot by ten-foot bathroom including shower

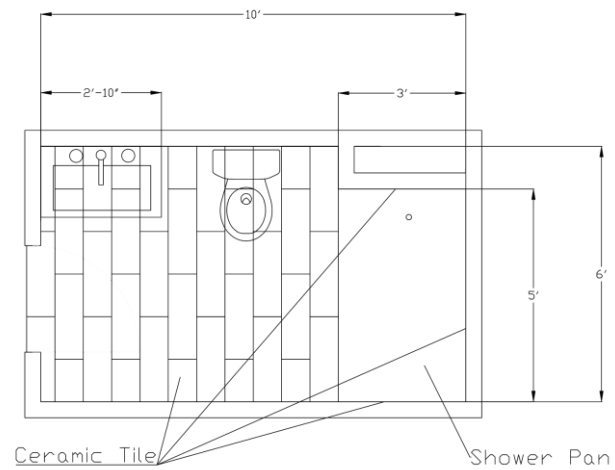
Figure 4. AutoCAD layout

With the team selected, which was the author and the tradesman with his apprentice available to assist, we quickly scheduled a visit to the project site in order to evaluate possible solutions to the homeowner's needs. With the tradesman now involved, access to equipment and home improvement experience were no longer issues that dictated the design. As the team considered alternatives to the initial proposition to remodel the freestanding tub, they identified a space on the lower level of the house that had an existing drain. The area to one side of the existing drain contained old 2x4 walls which enclosed the laundry room adjacent to the design area. The design proposition was to construct the new shower at the existing drain using an acrylic shower pan and ceramic tiles for the enclosure. Prior to installing the shower, the plumbing would be updated and two new walls would be framed to create the new bathroom. Measurements of the space were recorded and the concept was communicated to the homeowners for approval. Following the site visit, an AutoCAD drawing was drafted using the recorded measurements. The drawing included a six-foot by ten-foot three-quarter-style bathroom with the shower placed against the back wall. The steps to complete the model using AutoCAD included: drafting a plan, discussing with clients and tradesman, revising, editing, and

completing the final details. Creating an AutoCAD drawing early in the process was helpful in order to communicate design ideas and possibilities.
