Field Welding Repair of Heavy Equipment

Phil Akahori

California Polytechnic State University
San Luis Obispo, California

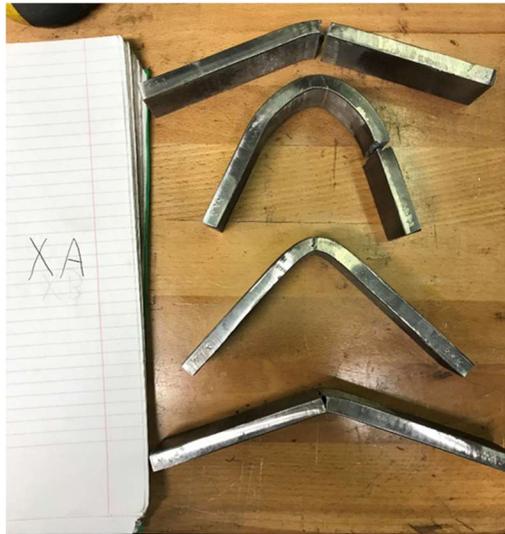
Figure 1. Profile view of procedure "XA" guided bend tests

on the 4140 side in 3 of the samples. These three samples also show very little deformation in the base metals. All ductility seems to have taken place within the weld area and the sample simply hinged in the weld prior to fracture. One root bend shows some deformation in the base metal but then fractured ~2" away from the weld in the 4140 before making fully through the bender as can be seen in Figure 1. The weld area of these samples would have passed as discontinues are $<.375"$.

Guided bend tests were done with a roller-equipped bend test jig using 2.5” rollers to match the >90 ksi steels and filler metal per AWS D1.1. XA failed with brittle fracture directly adjacent to the weld

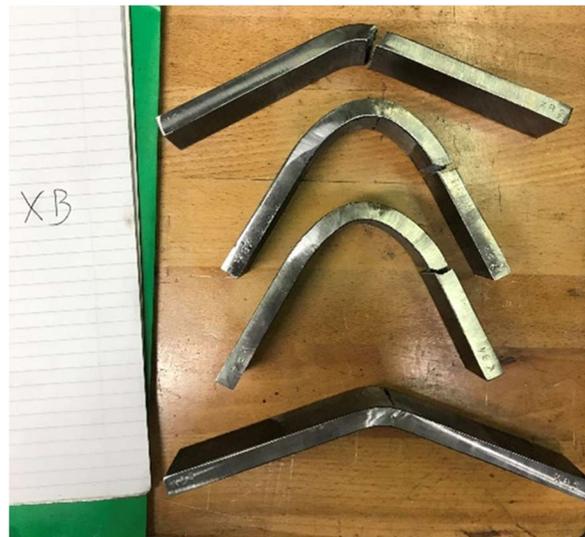
Figure 2. Profile view of procedure “XB” guided bend tests

"XB" showed similar failures to that seen in "XA." The two face bend specimens have a fracture adjacent to the weld in the 4140 side with little to no deformation in the base metals. The root bends show more deformation in the base metals but still fractured in the 4140 side ~2" from the weld before making it fully through the bender as can be seen in Figure 2. The weld areas in these two root bends would have passed as discontinues are $<.375"$.

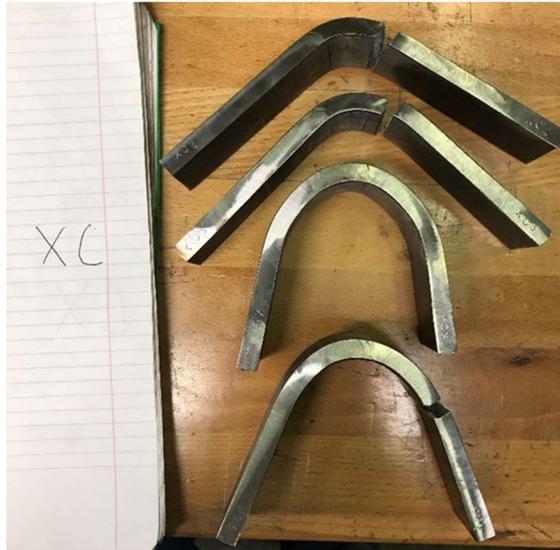
Figure 3. Profile view of procedure “XC” guided bend tests

“XC” seems to have performed the best. One root bend sample passed, third sample down in Figure 3. There was no fracture and discontinuities are $<3/8$ ". Both face bends had a fracture adjacent the weld in the 4140 side. The other root bend fractured ~ 2 " away from the weld in the 4140 side.

The guided bend test is perhaps not the best way to verify this type of welding with dissimilar metals. Ultimately, we want a hard tooth welded to a bucket with a ductile weld able to take an impact. A hard material in a guided bend test that requires deformation of the metal might not be ideal in evaluating this special application's weld even if the structural welding code calls out such testing. However, there are some observations that can be made. The first being the 4140 side seems to be the side of concern with all the fractures taking place adjacent to the weld or farther along in the sample. Secondly, the samples that did the worse were all face bends in all the procedures. The root bends performed far better. This is counter intuitive of typical guided bend test results. The root bends typically display concern. In this instance, this could be due to the amount of heat the root area of the plates experience. In all the procedures more heat was concentrated at the bottom and then moved up. This could suggest that a "tempering bead" on the surface near the cover passes is all that would be needed to introduce ductility into the base metal. The "butter" of XC and XD might have not had enough effect around the face of the base metals. Thirdly, many of the root bend samples fracture 2" away from the weld. This could possibly be explained simply due to geometry as the sample goes through the bender. Or some grain growth is happening in all the procedures in that region. The temperature gradient through the sample test plates is producing temperatures in that region that are just right to make detrimental metallurgical changes in the base metal such as the Widmanstatten structure mentioned above. The performance in XC and XD might also be explained due to the large size of the weld metal in these samples. The ductile filler metal was able to deform over a larger area compared to that of the small welds of XA and XB.

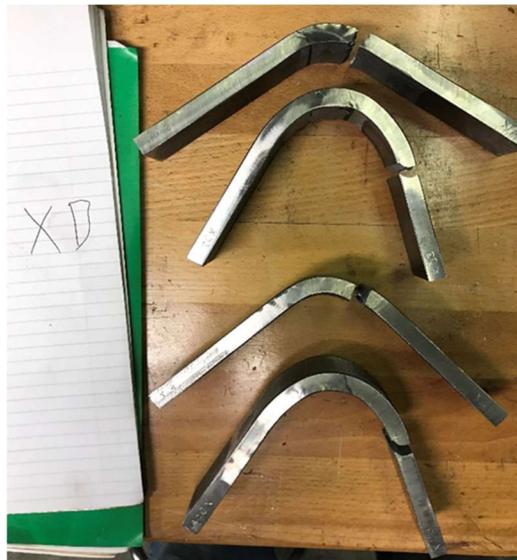
Figure 4. Profile view of procedure “XD” guided bend tests

In the “XD” samples, both face bends fractured adjacent to the weld on the 4140 side as noted in Figure 4. The root bends fractured ~ 2 " away from the weld in the 4140 base metal and the weld area of these samples showed total discontinuities $<.375$ ".
