Effects of Habitat Restoration on Soil Retention on Santa Rosa Island

Sato Academy of Math and Science¹, U.S. Geological Survey², Mountains Restoration Trust³

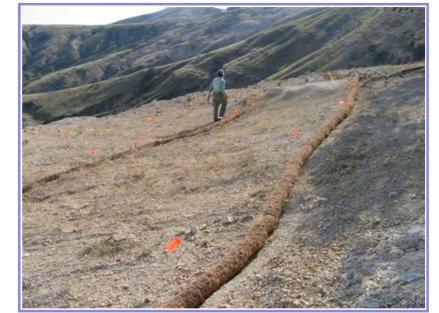
An example of wattles, soil erosion control structures
