French Drain Project at Woods Humane Society

Tommy Collins

California Polytechnic State University
San Luis Obispo, CA

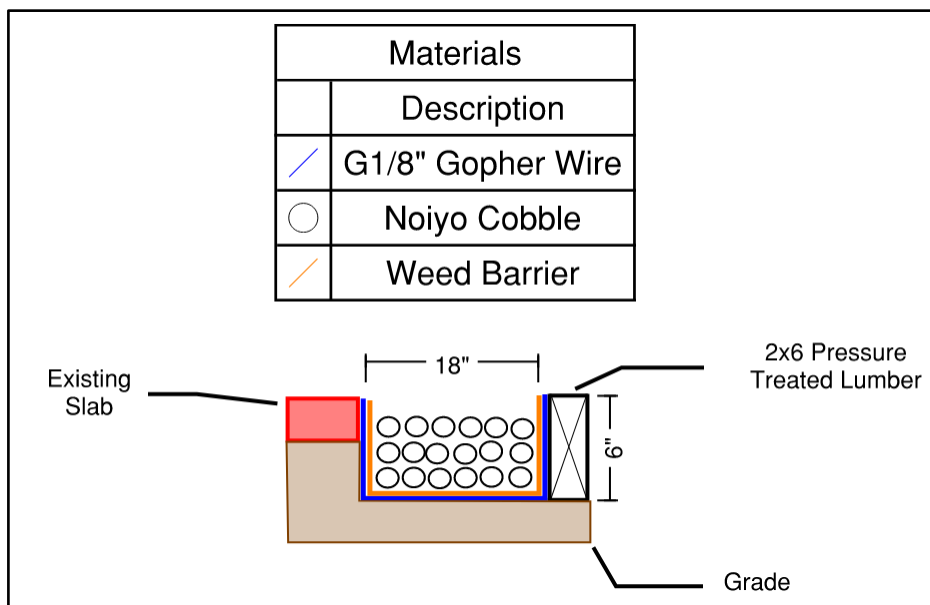
Figure 2 - Section View

The original plan for the french drain project was to install 2x6s 18 inches away from the play yard slab along the entire 173-foot span. Full breakdown of the section view is shown in figure 2. To do this, the team had to calculate a multitude of factors before making this happen. First, they would have to determine the length of each 2x6 and furthermore how many 2x6s would be needed to cover the entire span on one side. After this they had to understand the thickness of both the weed barrier and gopher wire that would be needed to cover the bottom and sides of the inside of the trench. The gopher wire was determined, after much research, to be best suited at 1/8in thick by 2 feet wide and 100 feet long. The vapor barrier had less variety in options so a 3ft by 100ft sheet was chosen. 2 of

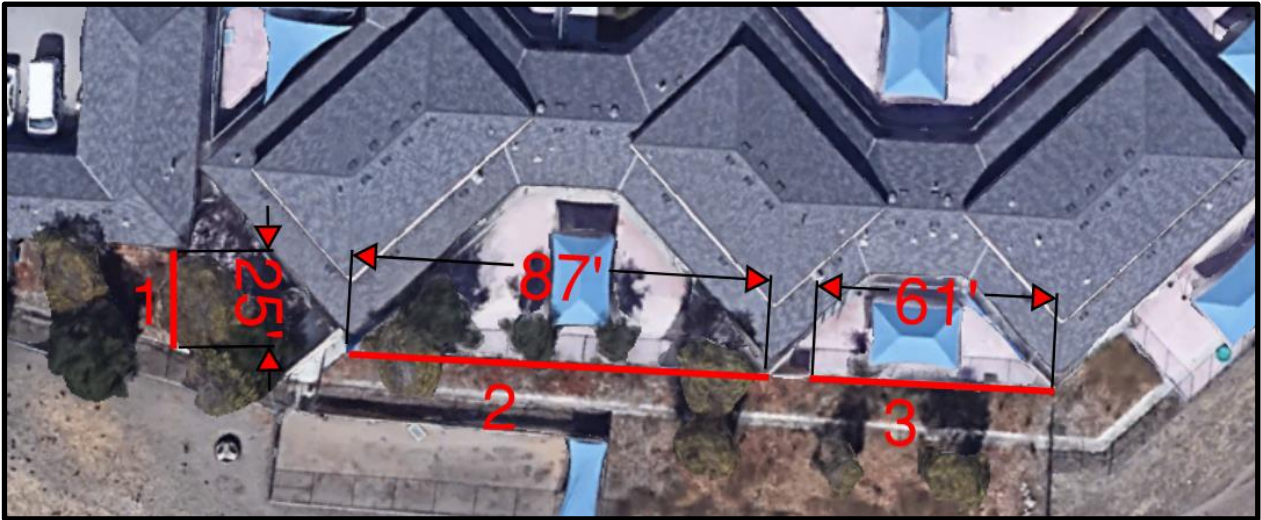
Figure 3 - French Drain 3 Section Breakdown By Length

Construction began with the shortest of the three sections of the 173 feet French drain (Figure 3, showing all section length breakdown). Both students excavated that section in full, 18 inches down and six inches deep, and timed themselves to analyze how long it would take 2 people to perform 25 feet of excavation. Their research resulted in the conclusion that 2 people could perform the 25-foot excavation in about an hour but when they considered fatigue they rounded up to an hour and 30 minutes for each 25 foot section. Soon the team would go out again and start working on further excavation on the longest section of the drain (Figure 4), this would further cause many issues to tree roots, (Figure 5), and existing fence footings. The issues faced by the team would slow down much of their project but did not stop them in any way that affected the schedule of the budget. As mentioned

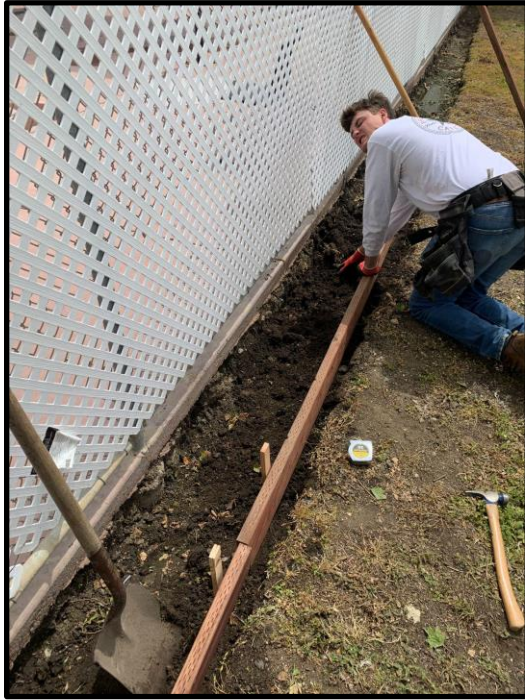
Figure 4 - Excavation

earlier, the excavation of the project alone took around 40 hours or more and was the most physically draining aspect of the project. Once excavation was complete the team then installed 2x6s in all sections of the French drain, making sure to carefully measure distance from slab and level at each end of the lumber. Each 2x6 was required, by the owner, to be level to the existing slab of the play area. Some exceptions were made to keep the 2x6 in line with an existing path that split the two longer sections of the French drain to prevent a tripping hazard. Each 2x6 was then nailed together using nail plates, (Figure 6), and were then backfilled for any sections behind the 2x6 so the lumber would be to grade with the existing grass yard. This is the point when the team decided to tamp, (Figure 7), the entire trench down and begin the installation of the gopher wire and weed barrier. The main issue encountered during this process was getting the flimsy weed barrier to stay flush with the concrete slab side of the trench as it could not be drilled into this side like it could on the lumber side of the trench. Using landscaping staples we were able to attach both the gopher wire and weed barrier to the bottom of the trench and to the fullest extent of the side we could.

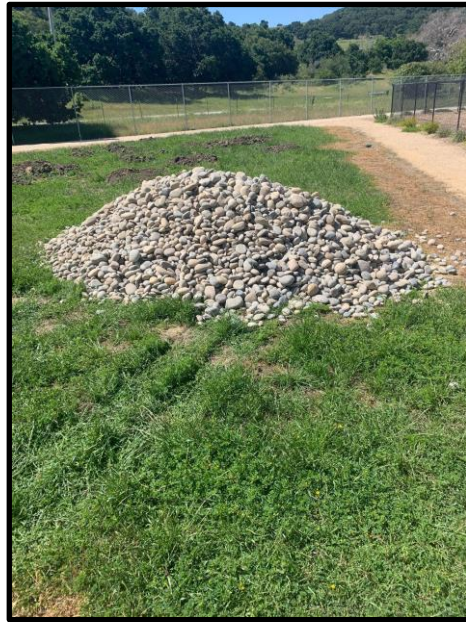
Figure 8 - Cobblestone Laydown Area

Cobblestone installation did not go as expected in any way as the team discovered shortly that they could not shovel the cobble into a wheelbarrow due to the large size of the rocks. Many methods were tried to find the most productive way to fill up wheel barrels or our tractor trailer but the method that ended up being the most efficient was filling up buckets with rocks and using the buckets to fill up each load. When the students brought the cobble loads to the drain site from the cobblestone laydown area, (Figure 8), they then loaded up the buckets once more to gently place the cobblestone in the existing french drain until the cobble completely covered the exposed gopher wire and weed barrier. The overall construction of the project required constant measuring, releveling, and backfilling. In no way was the project performed perfectly at every point but the way the team remedied any issues throughout allowed the project to result in a fantastic product (Figure 9).
