Final Design Review

Improved Combustor Liner Seal

Final Design Review Report

Prepared for: Matt Ostiguy of Solar Turbines, Mercury 50 Engine Lead
and Andrew Rutland of Solar Turbines, Taurus 65 Engine Lead

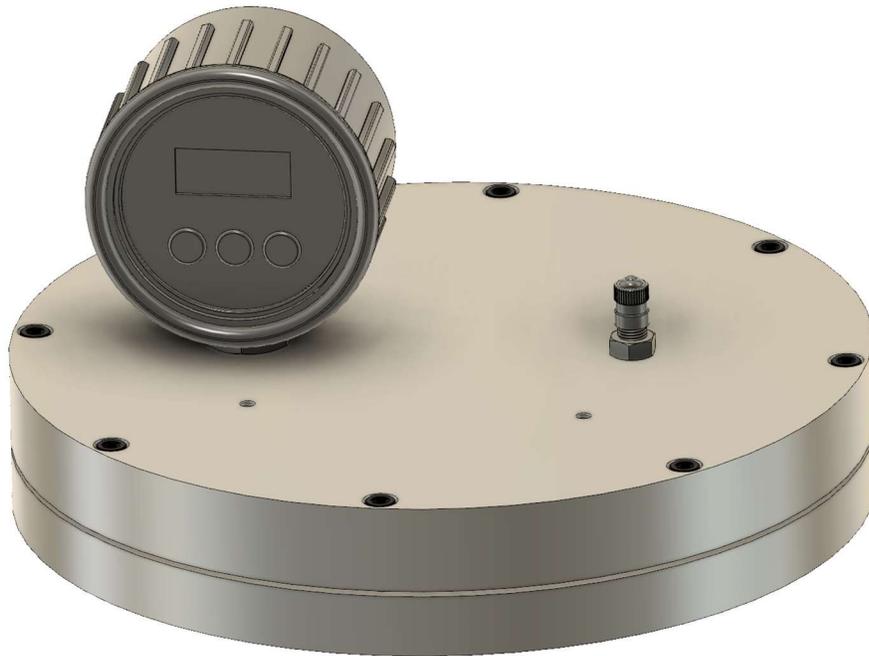
Figure 2.2. Functional prototype test rig.

The design that was manufactured and tested as a functional prototype for this design, and is the focus of this report, is the prototype test rig as seen in Figure 2.2. This design uses an around 7.8” diameter Inconel 718 E-seal that was donated by JETSEAL to simulate various environments that the full-scale design would experience. Features such as a pressure gauge, fill-valve, and additional load frame fixtures are included to facilitate leak and deflection testing. A cross-section of this design is seen in Figure 2.3 and shows the pressurized cavity and E-seal grooves that were CNC machined.

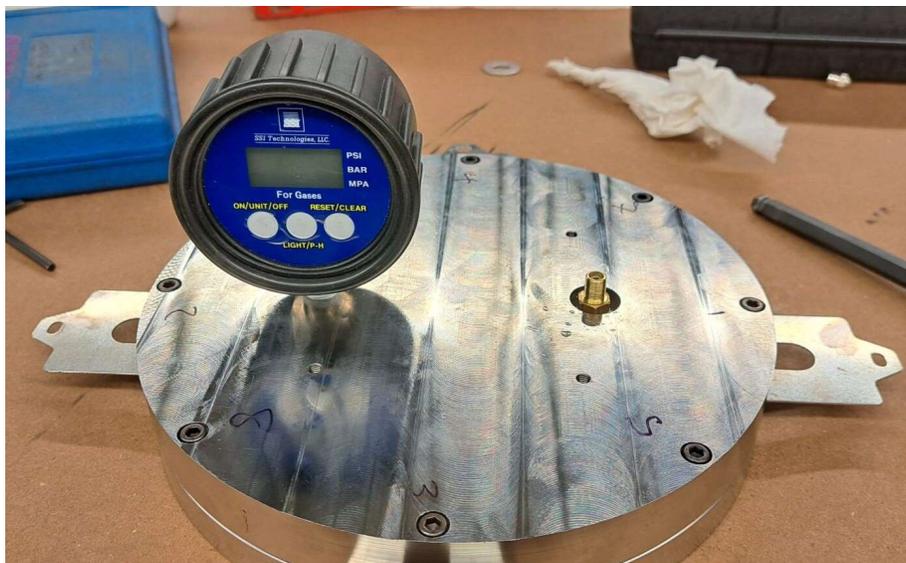
Figure 3.1. Prototype test rig completed assembly.

To test the overall functionality of the Axial E-Seal design, two main systems were designed for manufacturing – the prototype test rig and the baseline test rig as seen in Figures 3.1 and 3.2. These designs included the various external components listed in the procurement section including load frame fixtures, NPT fittings that required threading, and CNC fixtures.

Several smaller components were manufactured before and during the use of the CNC mill either for testing or assisting in the assembly or manufacturing of the prototype test rig. The first component manufactured was a small pressure chamber intended to test the leak rate of the air-fill valve and the pressure gauge NPT fittings. Using a manual lathe in Mustang '60, a small section of 4-inch long by 1.5-inch diameter round steel stock was hollowed out to create a thick-walled tube with one entrance of the tube was widened to accommodate the larger thread diameter of the pressure gauge. Each end of the tube was tapped using an NPT tap, the smaller side using a 1/8th-inch and the larger side using a 1/4th-inch NPT tap. The full assembly can be seen in Figure 3.1.

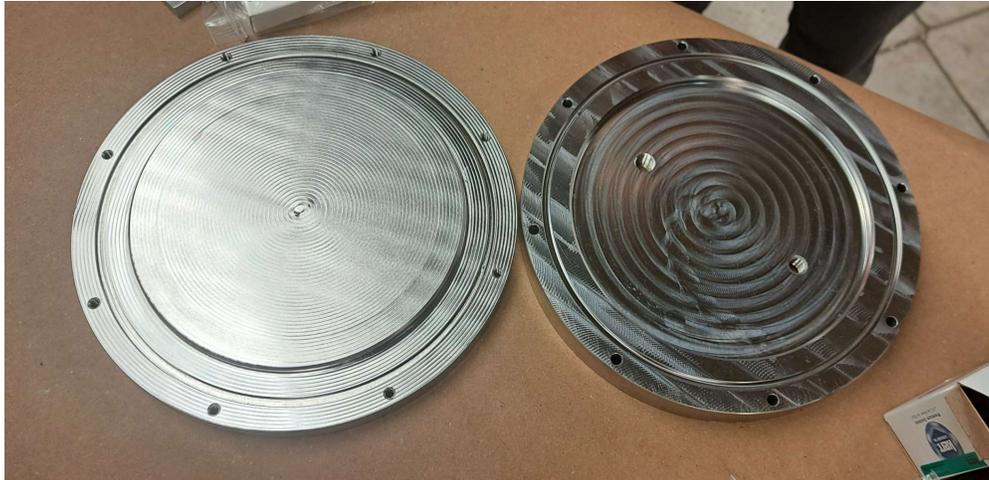
Figure 3.3. Post CNC milled test rig plates.

Manufacturing of the prototype test rig for the Axial E-Seal design was primarily done using a HAAS VF-4 CNC mill. CNC milling was chosen for the two stainless steel 1-inch thick by 9-inch diameter plates containing the seal groove to ensure that the strict tolerances and surface finish specified by the seal manufacturer were met. Unfortunately, the mill surface finish does not meet the circular lay requirement of the seal manufacturer, but due to the limits of the Cal Poly CNC lathes, a mill was used regardless. During CNC milling, several operations were performed on each side of each plate. As seen in Figure 3.3, the features for the design required facing the plates, drilling and tapping the bolt holes on the perimeter of both plates, creating the seal groove in both plates, and drilling holes for fittings on the top plate. The NPT holes were tapped later using a Bridgeport manual mill and a hand tap as shown in Figure 3.4.

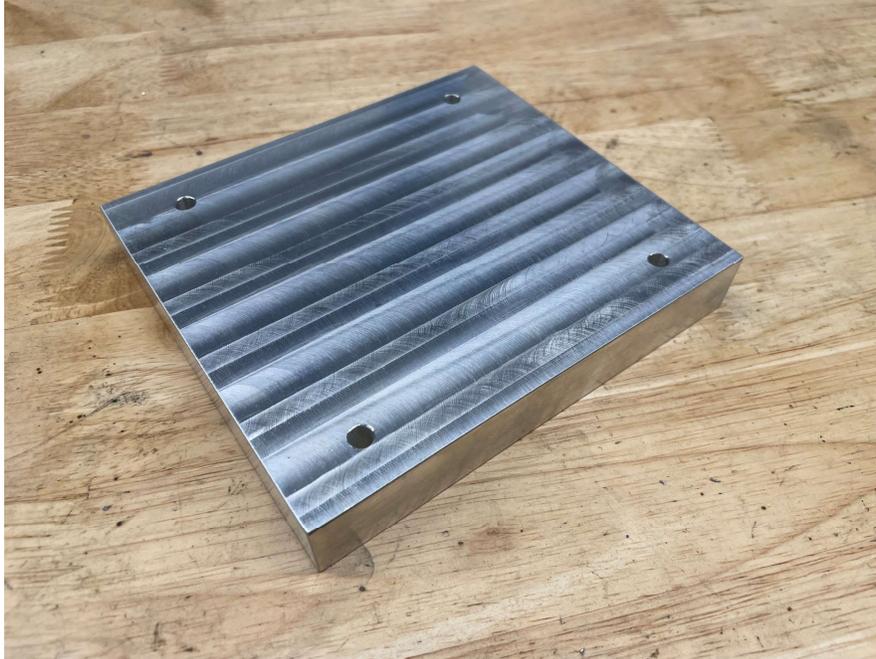
Figure 3.6. The fixture plate used to hold stock during CNC machining.

The second component manufactured was a disposable rectangular plate, seen in Figure 3.6, used to provide a safe clamping area for the vice during CNC machining of the actual rig components. This component was not used in the actual test rig and was only used to assist in the manufacturing of other test rig components. The part was manufactured out of a 4x4-inch by 3/4 inch-thick piece of aluminum on the Bridgeport manual mill in Mustang '60. An endmill was used to face and square all six sides of the block. After using an edge finder to accurately find the center of the block, 4 loose fit holes for size 10 bolts were drilled in a square pattern 3.5-inches from one another using a center drill and drill bit.

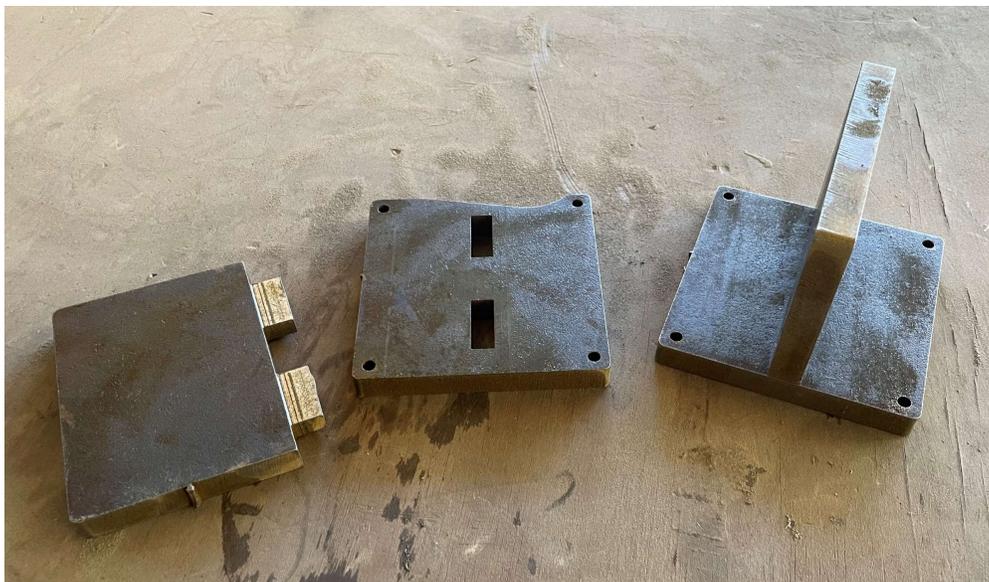
Figure 3.7. Post machining pre-welding of load frame attachment points.

The next manufactured components, shown in Figure 3.7, were two identical fixture pieces to hold the seal test rig in the load frame machine. They were initially cut by the water jet out of a steel plate. The water jet cuts also included rectangular slots in two of the plates and teeth to fit into the slots on the side of the other two plates. The plate with the slots also included four holes, drilled in a square pattern 3.5-inches from one another, to attach to the test rig. These holes were pierced on the waterjet and widened out to size with a hand drill. The toothed piece was fitted into the slotted piece and MIG welded together as shown in Figure 3.8.

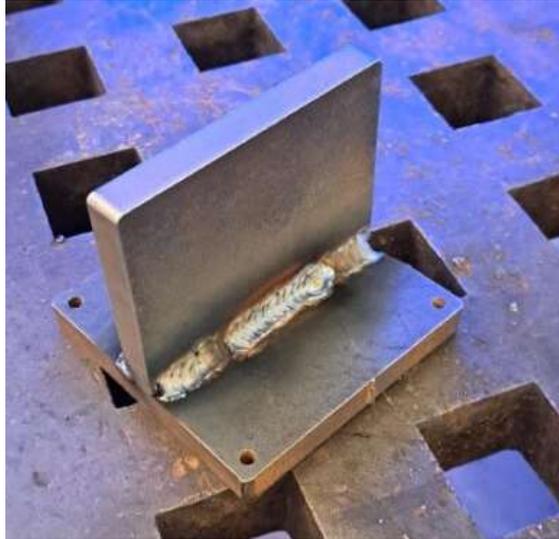
Figure 3.8. Welded fixture for load frame machine.

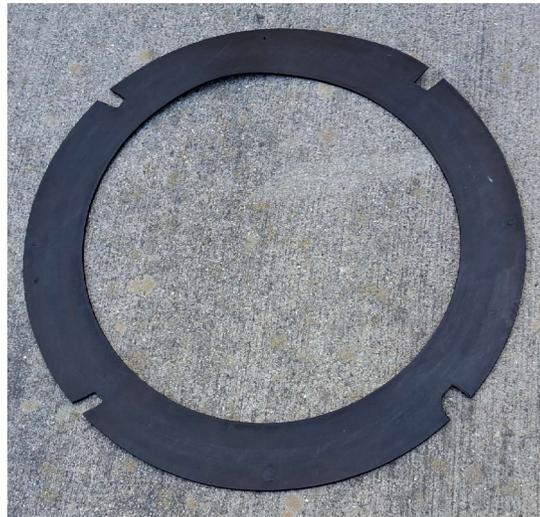
Figure 3.9. Additional baseline rubber gasket.

To facilitate an additional baseline test, a rubber gasket, shown in Figure 3.9, was made to test the baseline leak rate from both the air fill valve and pressure gauge fittings. The gasket was used in the prototype test rig between the two test rig plates instead of the E-seal. The gasket was cut from a butyl rubber sheet using the laser cutter in Mustang '60. An X-acto knife was used to cut holes in the gasket for the screws to pass through.

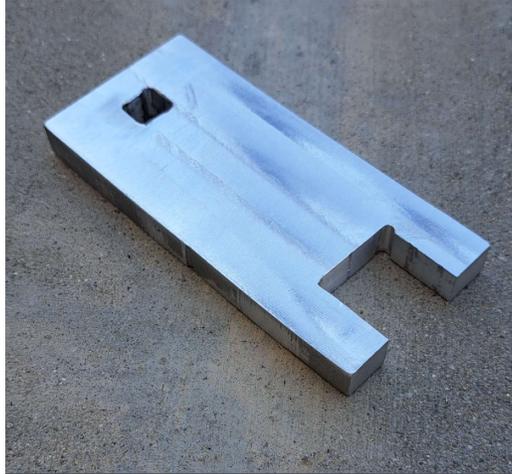
Figure 3.10. Custom crowfoot attachment.

The final manufactured component was a custom crowfoot, shown in Figure 3.10, to be used to tighten the pressure gauge to the prototype test rig to the manufacturer specified torque. This crowfoot was required due to a low clearance between the head of the gauge and the top of the test rig. The crowfoot was initially cut from a 3/4-inch piece of aluminum using a waterjet. The team then used a Bridgeport manual mill to correct some dimensions of the crowfoot and to face off a significant amount of the material allowing the crowfoot to fit under the pressure gauge.

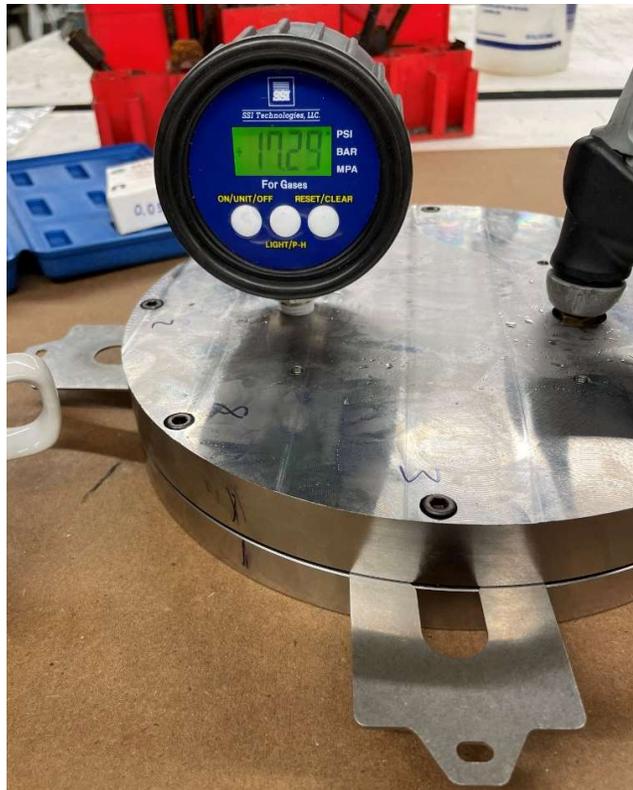
Figure 4.1. Leak testing setup. The bike pump pressurizes, and the digital gauge reads cavity pressure.

Overall, four pairs of tests, with full and no-load tests comprising each pair, were conducted for leak rates during various scenarios. Two pairs prior to the test rig undergoing cyclic loading and two after. The first pair evaluated the leak rates of an unsanded groove surface finish and was used to evaluate the effects of an out-of-specification surface finish. The next pair evaluated the leak rates of the groove after sanding to compare the first set to. This test acted to simulate the leak rate that the seal would have at the beginning of its life in the turbine. An image of this test can be seen in Figure 4.1.

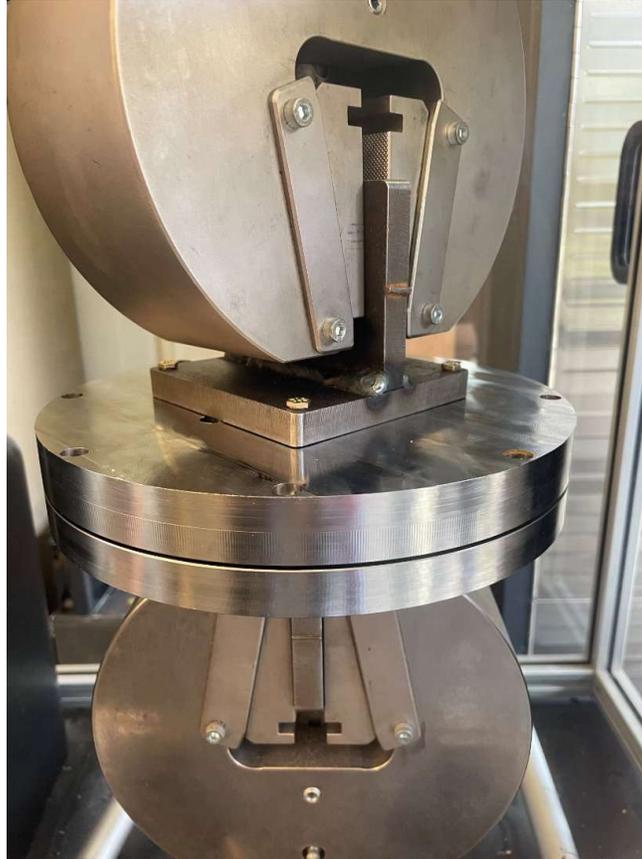
Figure 4.2. Load frame test setup.

The load frame deflection cycling test served the purpose of determining if the seal will fail due to thermal cycling and allowing later leak testing for a simulated end-of-life seal, verifying Specifications 3 and 5 for cycling and sealing, respectively. Testing was done on a load frame material tester, shown in Figure 4.2, that compressed the seal in the test rig by 0.030 (no-load to full-load) for 5000 cycles. The force required to achieve this deflection was measured for each cycle to characterize seal characteristics over time. Full details of this cyclic loading test can be found in Appendix E.

After completion of cycling testing, further leak tests were performed to determine the impact of cycling on the test rig's sealing ability. First, the test rig was removed from the load frame without any disassembly. This was to ensure that the seal's position remained constant relative to any surface imperfections created by cycling. The team, however, had to rotate one half around 5 degrees to get the bolt holes to line up. Once leak tests were completed, the test rig was disassembled and inspected for damage caused by cycling. After inspection, another set of leak tests were performed to determine the impact of changing the seal's position.

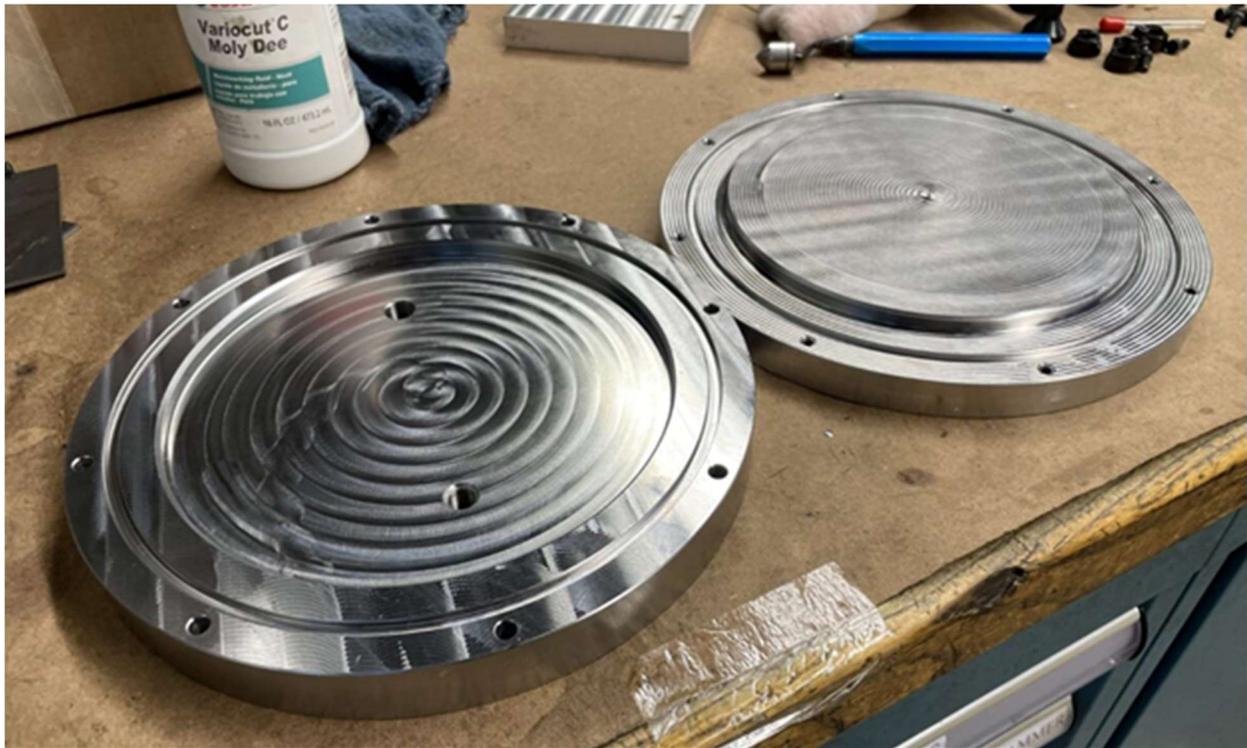
Figure 1. Scaled-Down Assembled Prototype Test Rig

To evaluate the functionality of the E-seal sealing mechanism that would be implemented in the Solar Turbines T250 SoLoNOx engine, a scaled-down test rig was designed, manufactured, and tested for leak rates and cycling endurance. As seen in Figure 1, the prototype test rig was manufactured to be sealed using the specifications for the E-seal donated by JETSEAL.

Using this test rig, a leak rate test was conducted to determine how much internal fluid escapes through the E-seal, and a cyclic loading test was done to determine if the E-seal used in the uncommon application would continue operation after 5000 thermal cycles. The leak rate test consisted of observing pressure decay, where the test rig was pressurized to around a gauge pressure of double the operating internal pressure of the T250 engine and then allowed to leak. The cyclic loading test utilized a load frame machine to observe load variations and simulate the thermal cycling for a full life, where the E-seal underwent 5000 cycles of a deflection of 0.030” from the anticipated “full-load” to “no-load” of the prototype. The leak rate test was conducted for both 0.025” compression and 0.050” compression before and after the cyclic loading test.

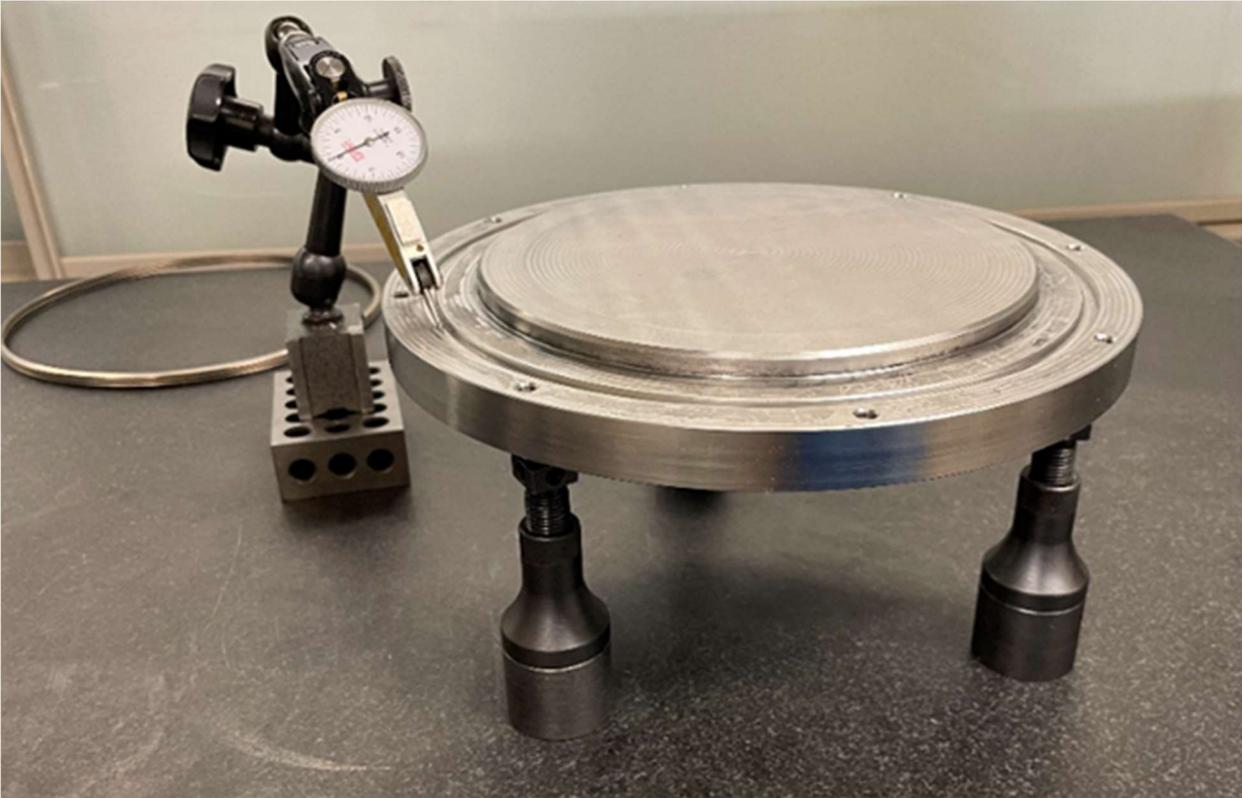
Figure 2. E-Seal Groove Flatness Inspection

One of the largest issues found during the manufacturing of the E-Seal test prototype was a low-quality surface finish of the sealing surface. The team chose to use a HAAS V4 CNC mill to machine all critical features of the prototype. This machine produced an acceptable surface finish per comparison with a surface measured with a profilometer, and the flatness of the sealing surface was within 0.0005” as measured in Figure 2. But while the finish meets the standards set by the E-seal manufacturer, JETSEAL, it did not have an appropriate circular lay pattern as shown in Figure 3a. After initial testing and consultation with the seal manufacturer, it was determined that the circular lay pattern is a critical aspect of creating a sealing surface between the groove and the E-seal. After carefully applying sandpaper to remove the CNC milled surface

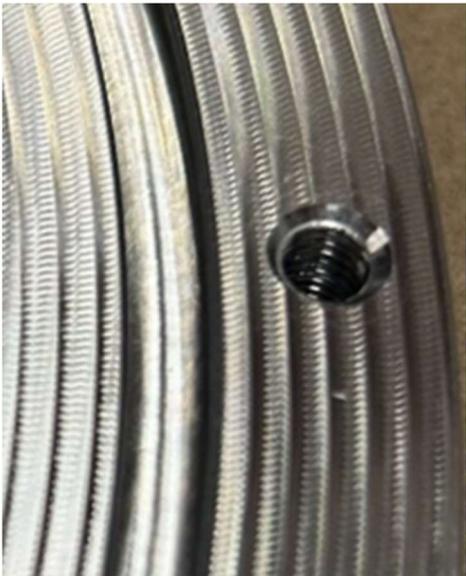
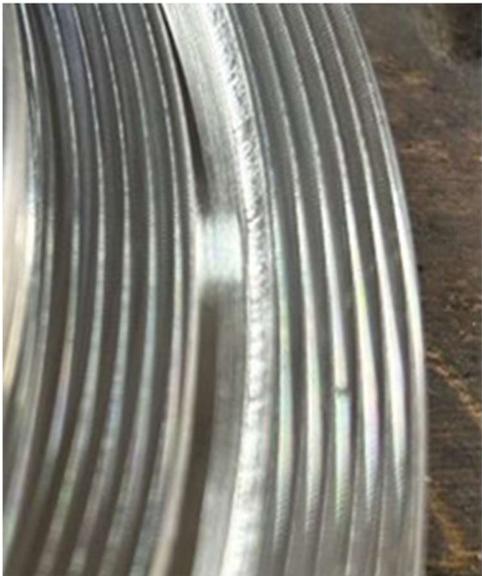
- a) Pre-Sanding Groove Surface Finish b) Post Sanding Groove Surface Finish
Figure 3. E-Seal Groove Surface Finish a) Before Sanding and b) After Sanding

finish and creating a circular lay following the groove, testing showed significant improvements in ability to seal. The team believes manufacturing the groove with a lathe or grinding the sealing surface may further improve the seal, and if possible, a more accurate way to test the surface finish may be necessary.

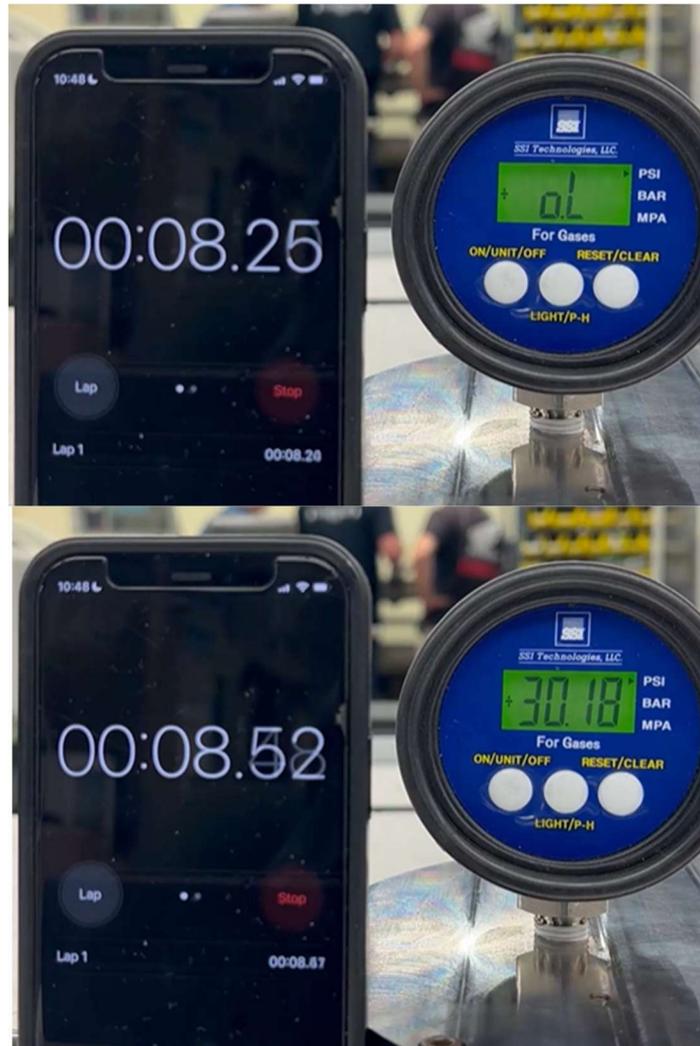
Figure 4: The Pressure Gauge Overloaded at about 30psi While Testing.

The team decided to mirror pressures observed during the turbine's operation as closely as possible in their testing. To do this, the test prototype was pressurized to about 28psig – double the actual operating pressure – to see the full range of pressures. The team also only purchased a pressure gauge that could read up to 30psig. A better course of action to find the leak rate would be to pressurize the test prototype to a much higher pressure with a gauge accurate to a higher pressure. This option would yield a more accurate leak rate from testing. In the case of Solar Turbines' testing, a different route to determine leak rate is suggested. A more intensive test setup that ensures a constant pressure both inside and outside of the sealing surface and capability to evaluate leaks would allow for more consistent data around the actual operating points. Testing equipment is commercially available that will measure a leak rate for a setup while keeping its pressure differential constant.

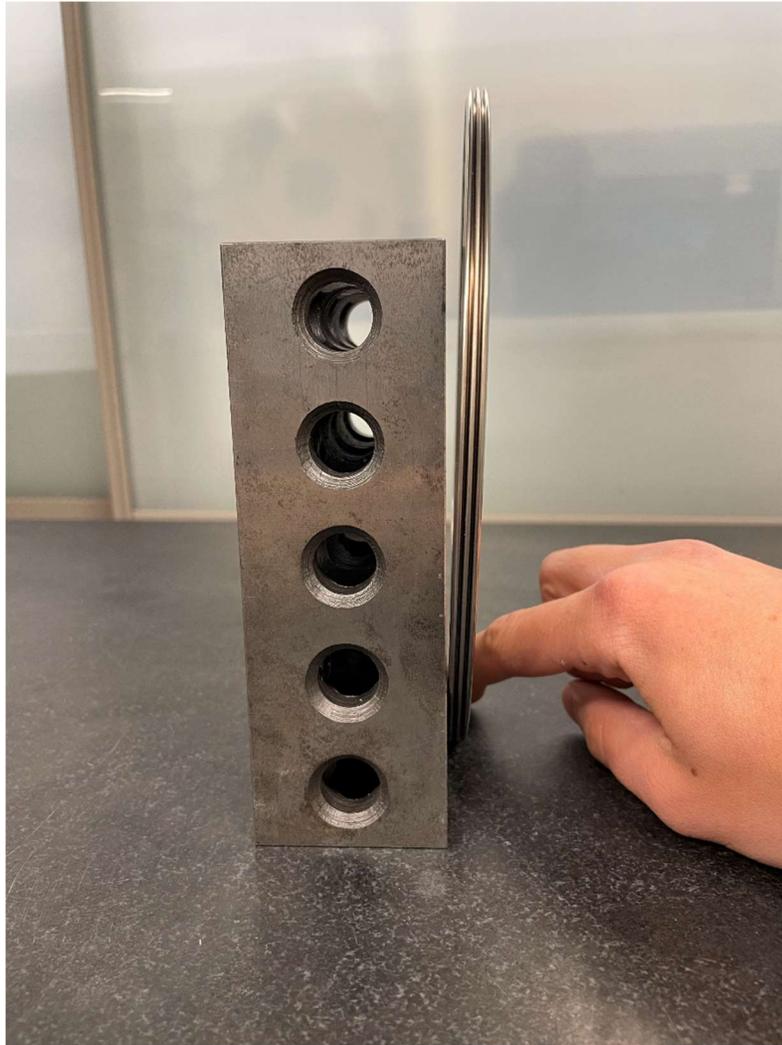
Figure 6. The Seal Held Flat on a Surface Plate Next to a One-Two-Three Block Showcasing the Seal's Asymmetry.

The team was donated a seal by JETSEAL. They measured the seal using calipers to find the exact radius, height, and thickness. Some of the initial problems found in testing could have come from the fact that the seal was not perfectly symmetric. The seal appeared to be somewhat conical in shape. This is shown better in the image below where one side's diameter appears to be smaller than the other. This failure to measure the seal properly resulted in problems during assembly because only the smaller side fit into the groove of the test prototype properly.
