IN-PLANE SHEAR WALL PERFORMANCE AS AFFECTED BY  
COMPRESSED EARTH BLOCK SHAPE

A Thesis

Master of Science in Civil and Environmental Engineering

March 2017

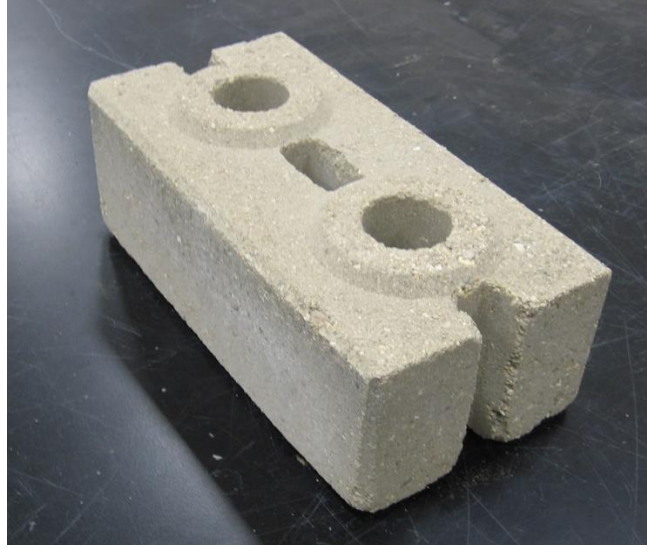
**Figure 2.1: Rhino Block**

Bales, Donahue, Fischer, Mellbom, and Pearson (2009) evaluated characteristics of interlocking compressed earth blocks, specifically the Rhino block design depicted in Figure 2.1 used by the Center for Vocational Building Technology (CVBT). The cement-stabilized blocks gained compressive strength in a trend similar to concrete over the first 28 days after pressing. Compressive tests were performed both on individual blocks and three-block-high prisms; the latter was performed both with and without grout in the blocks' grout key channels. The ratio of prism strength to block strength was 0.43 for grouted prisms and 0.37 for one ungrouted prism, less than typical values for interlocking dry-stack masonry.

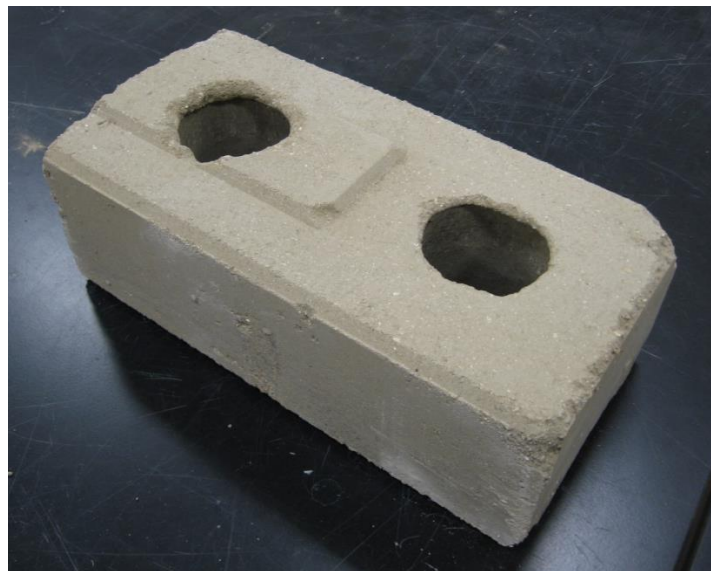
**Figure 2.2: V-Lock Block**

Banker-Hix (2014) tested the effects of factors like clay content, cement content, and added fibers on block strength and durability. The test samples consisted of Vermeer V-Lock blocks, shown in Figure 2.2. The tested soil came from three separate sites, although most samples used the same Las Tablas soil as this thesis. (See Chapter 3 for further details.) Adding polypropylene fibers did not significantly improve block compressive strength or modulus of rupture, although they did result in a more ductile failure. Lower clay content resulted in stronger blocks, while increasing cement content resulted in a linear increase of compressive strength and modulus of rupture. Durability also increased with cement content, but the precise amount depended on the clay properties.

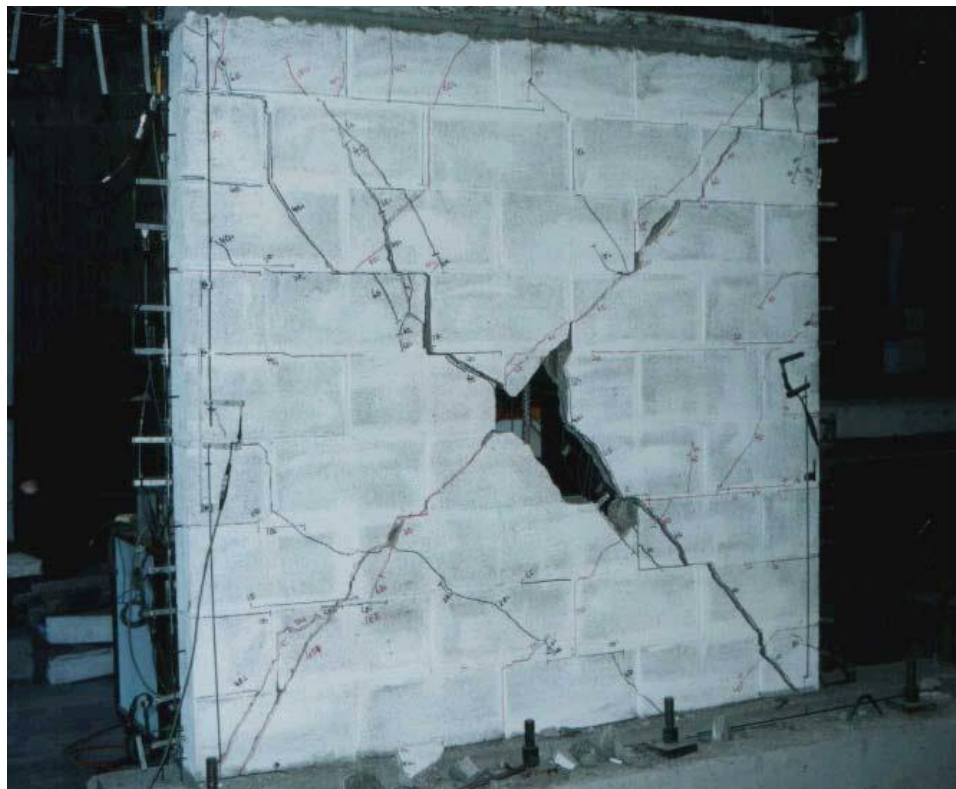
**Figure 2.3: Lightly Reinforced Masonry Shear Failure (from Voon, 2007)**

of horizontal reinforcement, the level of axial compression, the grouting pattern, and the height-to-length ratio. Increasing the horizontal shear reinforcement directly increased the maximum shear strength; lightly reinforced walls experienced an abrupt drop in load after cracking, while higher amounts of reinforcement were able to continue carrying load across the initial cracks. Walls with little reinforcement tended to fail with major X-shaped cracking as the original cracks continued to grow, as shown in Figure 2.3, while more significantly reinforced walls instead developed additional smaller cracks as loading increased. Similarly, using smaller, more tightly distributed bars also improved performance, resulting in a better stress distribution with many small cracks.

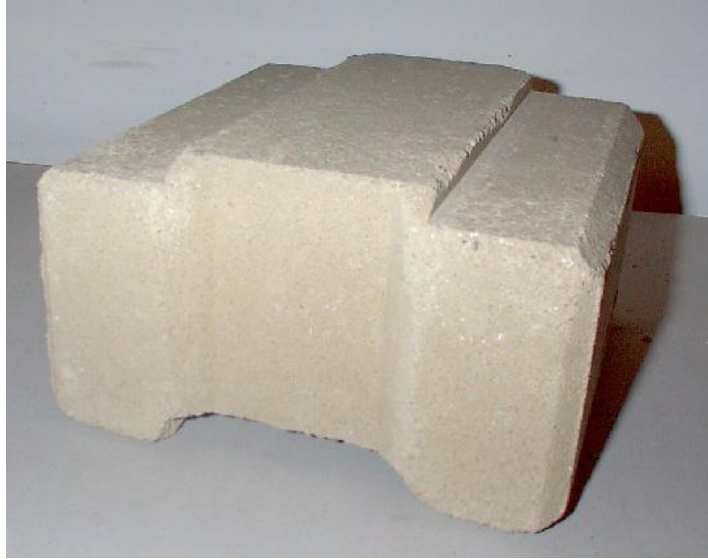
**Figure 2.4: Hydraform Block (from Ngowi, 2006)**

Research does not always distinguish between the structural behavior of dry-stack masonry (any masonry designed for use without mortared joints) and compressed earth blocks (specifically made from compressed soil). Ngowi (2006) explicitly tests performance of dry-stack masonry but implicitly deals with compressed earth blocks, in this case the Hydraform system which consists of solid blocks made from compressed soil, depicted in Figure 2.4. Compressive tests of full-scale walls resulted in brittle failure characterized by vertical splitting at the midpoint of the wall. The dry-stack

compressive strength was about 60% of the strength of conventional masonry, attributed to the interlock system reducing the blocks' contact area.

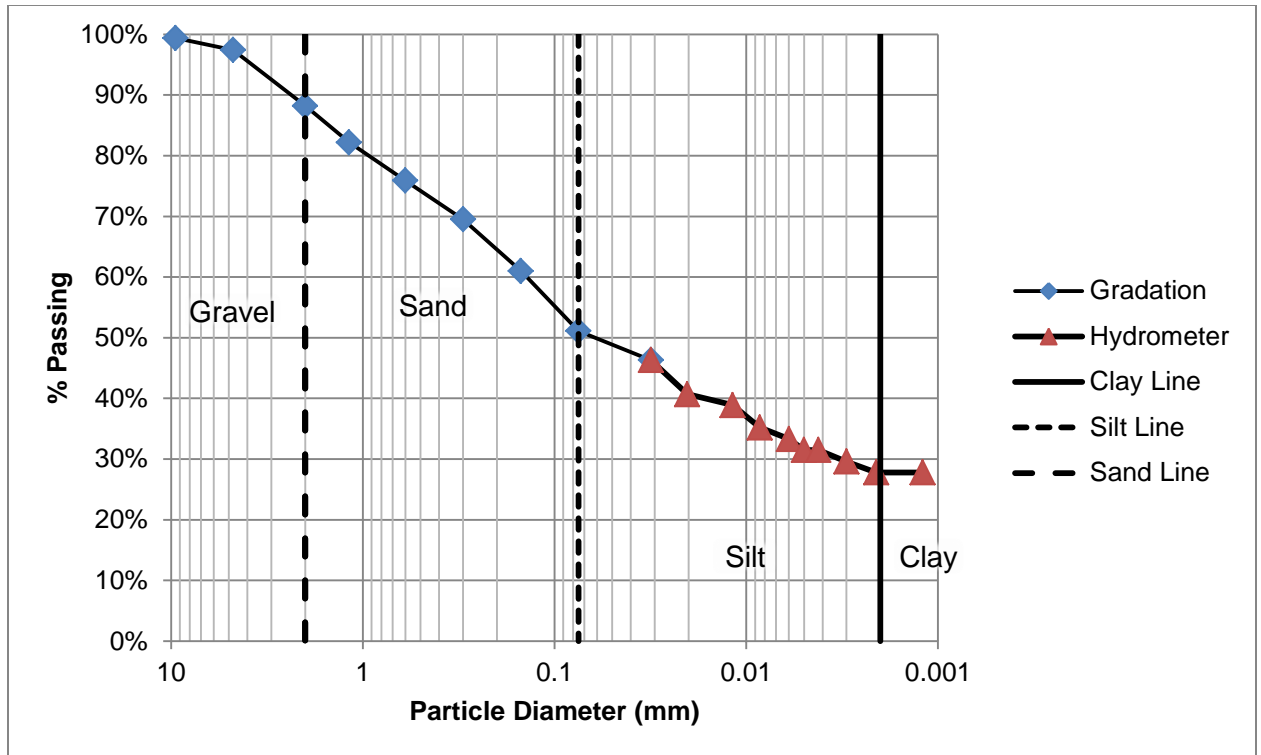
**Figure 3.2: Las Tablas Gradation (from Banker-Hix, 2014)**

Clay (%)	Silt (%)	Sand (%)	Gravel (%)
24.7	23.3	37.1	11.8

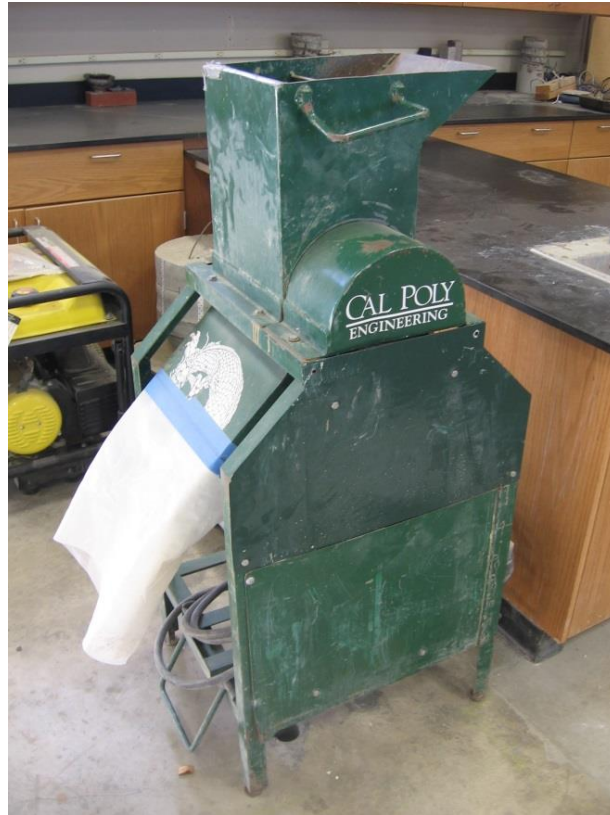
**Figure 3.3: Soeng Thai SP3 Soil Pulverizer**

Raw Las Tablas soil contained significant particles larger than one centimeter which were unsuitable in compressed earth blocks. All used soil was therefore pulverized using a Soeng Thai SP3 Soil Pulverizer made by the Center for Vocational Building Technology (CVBT). The pulverizer, shown in Figure 3.3, uses a set of rotating steel blades to break down the soil to pass a #4 sieve. The soil must be relatively dry so that the finer particles do not clog the sieve; in some cases, soil was air dried outdoors in plastic tubs for a few days before being pulverized, depicted in Figure 3.4.

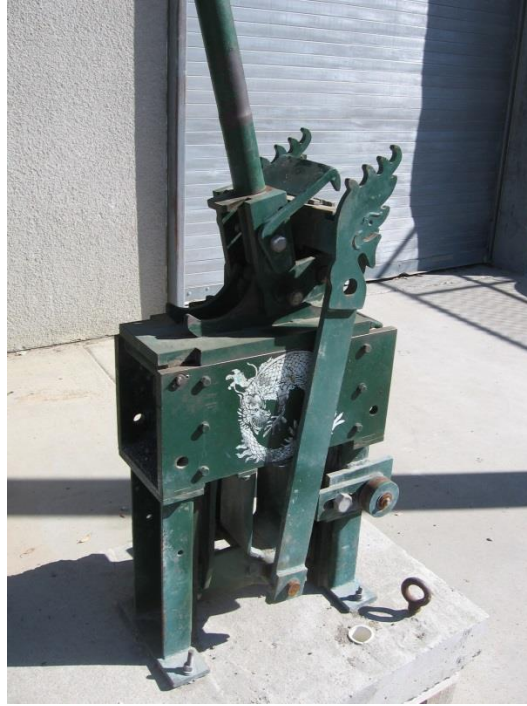
**Figure 3.6: Soeng Thai BP6 Block Press**

The Rhino block was developed in Thailand by the Asian Institute of Technology in collaboration with the Soil Block Development Company, continuing in the vein of a smaller interlocking block previously developed by the Thailand Institute of Scientific and Technological Research in 1983 (Wheeler, 2005). The Rhino block design is currently in widespread use in Thailand. The Center for Vocational Building Technology (CVBT), which manufactures and promotes both blocks and presses, designed and made the Soeng Thai BP6 manual press shown in Figure 3.6 that was used to make the Rhino blocks for this research.

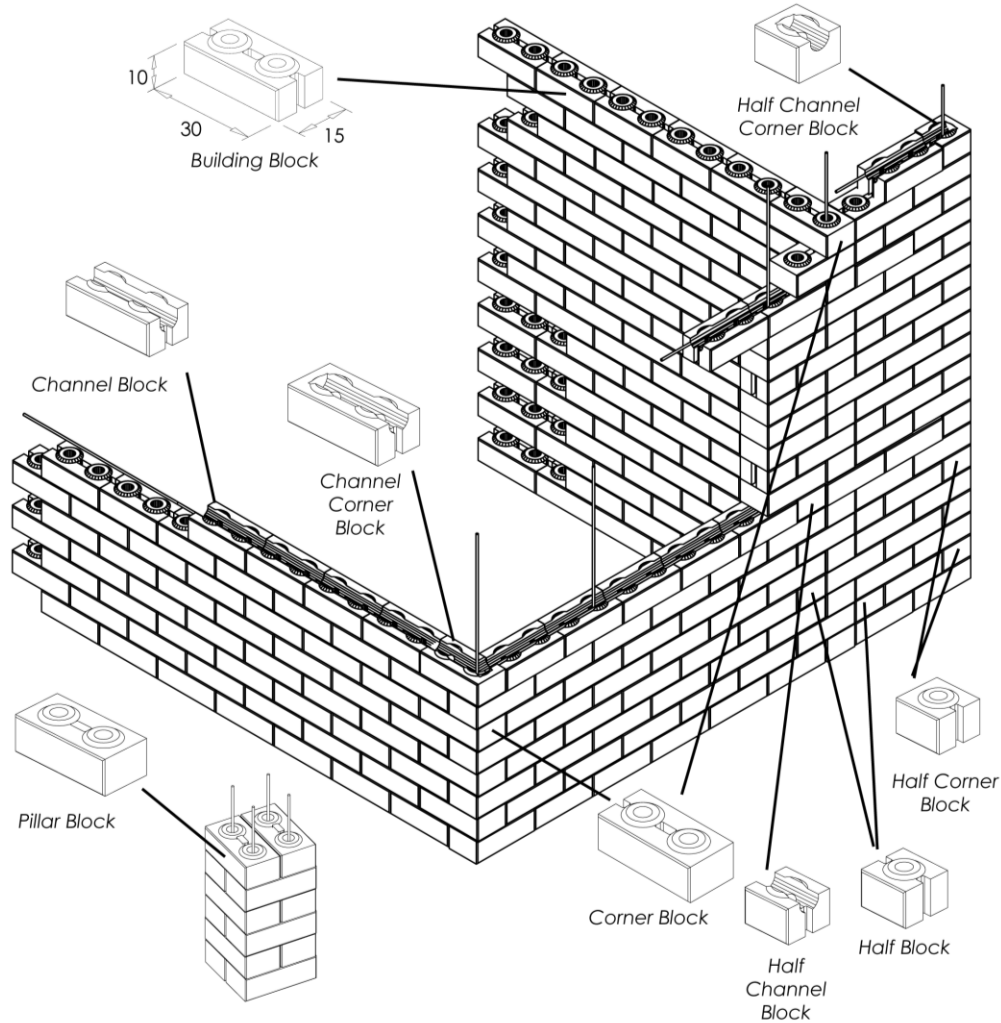
**Figure 3.7: Rhino Block Variations and Typical Uses (from Wheeler, 2005)**

test the effects of removing the head joint shear keys for Wall 3, pillar blocks and half corner blocks directly replaced the standard full and half blocks.

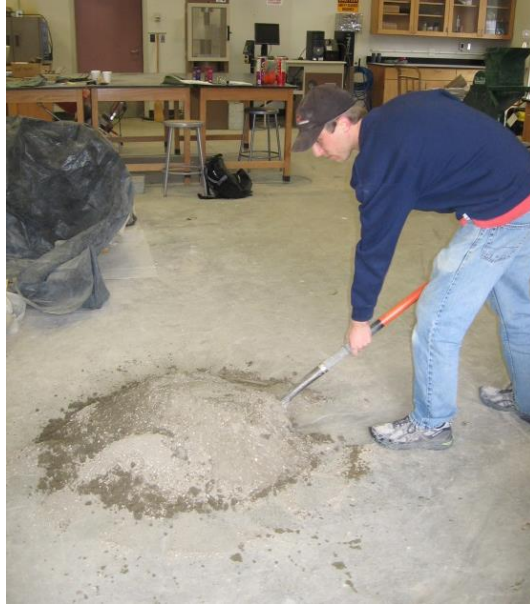
**Figure 3.8: Mixing Block Ingredients**

The dry ingredients were mixed with a shovel as shown in Figure 3.8. Once the dry ingredients were uniformly mixed, the blade of the shovel was dragged in a spiral pattern out from the center to make a flattened pile with a broad depression. This allowed the water to soak into the pile without running off onto the ground, as can be seen in Figure 3.9.

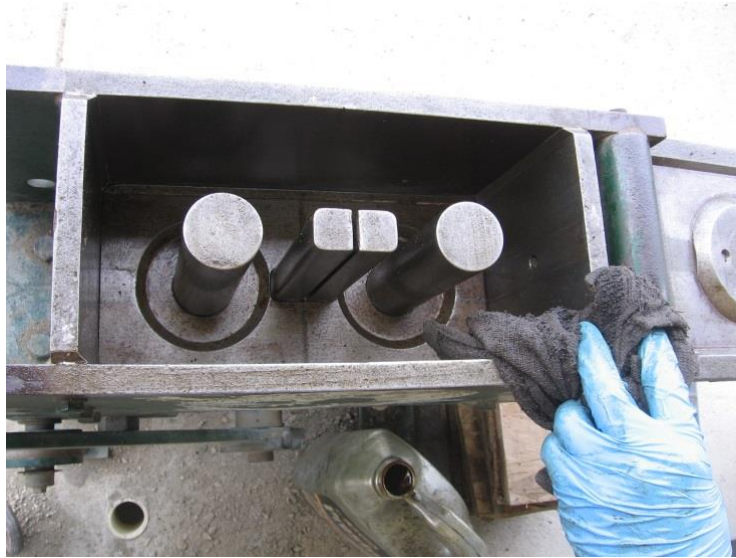
**Figure 3.10: Oiling Block Press**

The inside of the press was oiled before pressing each block to enable smooth ejection of blocks, necessary in this case because of the press's state of wear. Enough oil was used to thinly coat the inside surfaces without making the final blocks feel significant oily. Similarly, the slides on the underside of the press were oiled before each batch to ensure easy ejection. Used motor oil was utilized because of its relatively high viscosity.

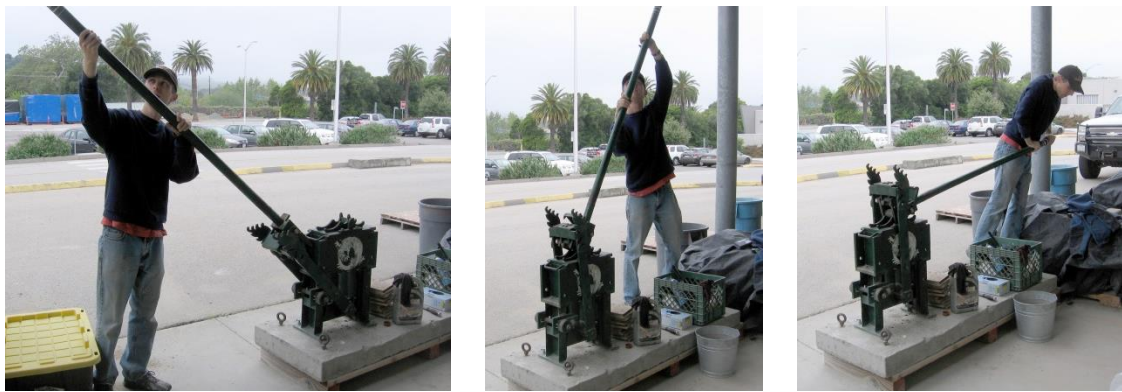
**Figure 3.11: BP6 Pressing Action**

Once the material was placed in the press, the press operator swung the press's lever over to the far side in a smooth motion until it was fully pressed down. The lever should provide some resistance while pressing but not an excessive amount (e.g. the operator should not need to hang from the lever to force it downwards). The operator held the lever down for a few seconds before returning it back to its original position. Once the lid of the press was opened, pressing down on the lever would then eject the block. Figure 3.11 illustrates the pressing action.

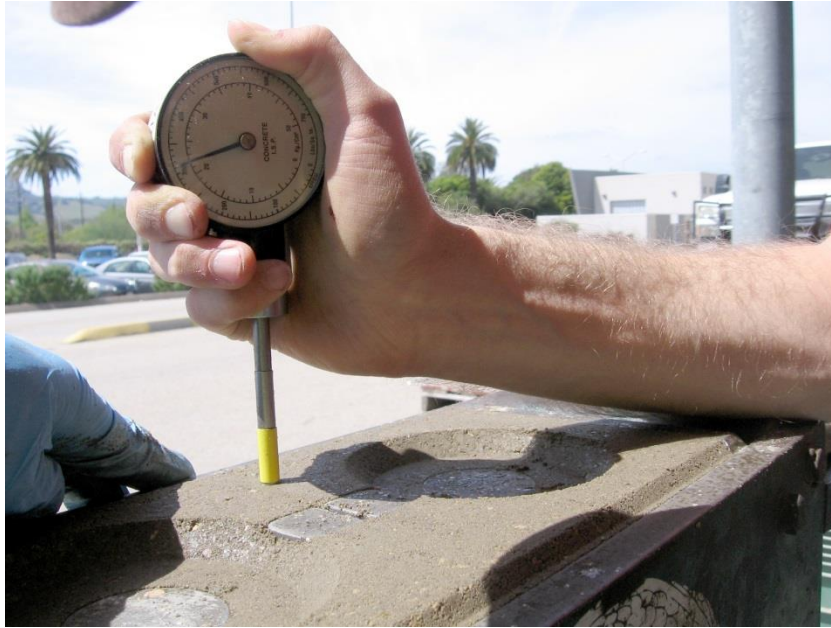
**Figure 3.12: Penetrometer Test**

Acceptable readings were 300 psi (2100 kPa) at the center of the block and 250 psi (1700 kPa) at the corner. Readings below these points indicated that more material per block was necessary; thoroughly crumbling the block back into the material pile allowed it to be reused. High readings above 500 psi (3400 kPa) indicated less material should be used, especially if the press required an unusually high amount of force to operate.

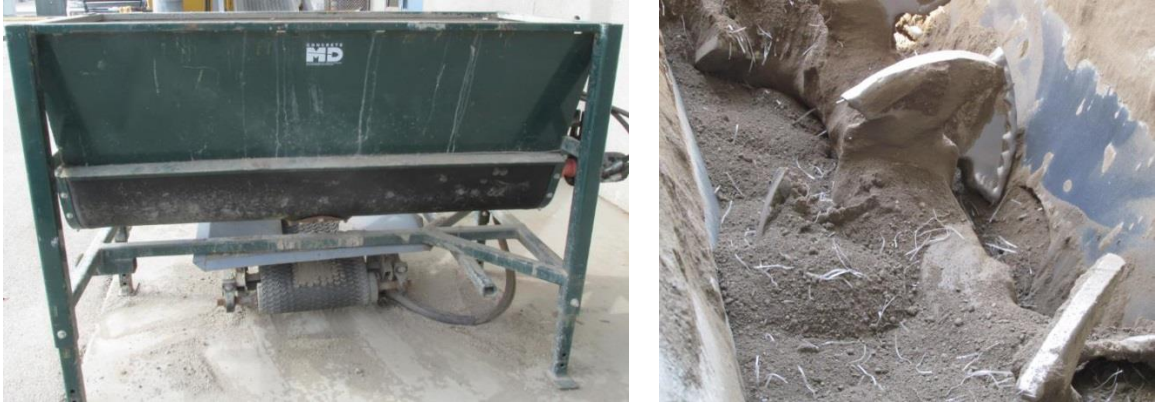
**Figure 3.15: Concrete MD Mixer (from Banker-Hix, 2014)**

The materials were mixed in a Concrete MD mixer using a “sheep’s foot” hydraulic auger, shown in Figure 3.15. Pulverized soil was mixed with the sand and some of the water for approximately five minutes before the cement and additional water were added. Whenever the mixer was stopped, the material was further mixed with a shovel to break up any unmixed material, particularly near the ends of the mixer and the bottom of the auger.

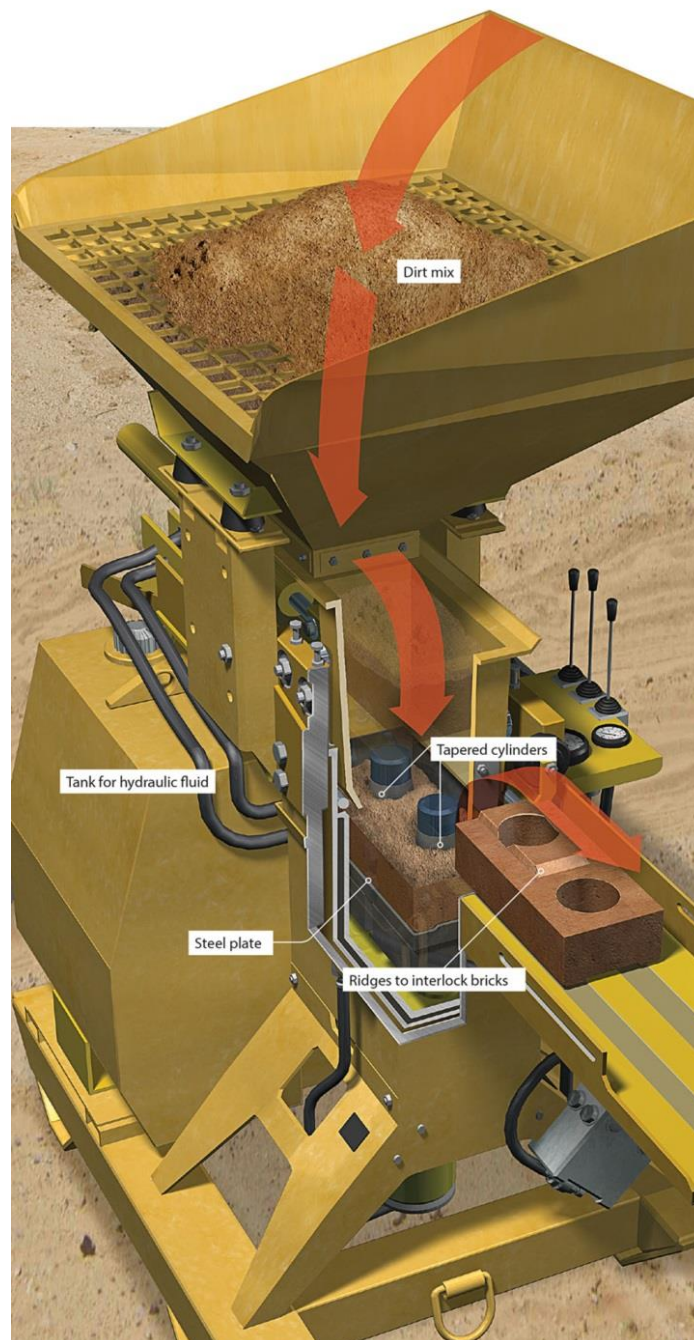
**Figure 3.16: V-Lock Pressing Process (Hand, 2013)**

compress the block. Two tapered plates then rise from the bottom plate within the block's grout chambers to further compact the block. The measuring bucket retracts to fill with more material from the hopper, and the block is raised up where it could be transferred from the press to the curing rack.

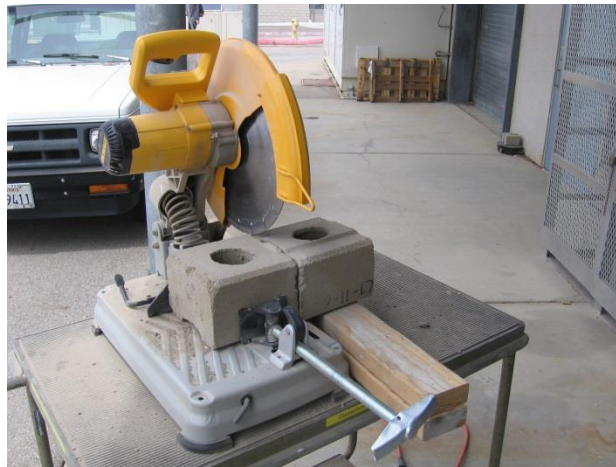
**Figure 3.17: Cutting V-Lock Half Blocks**

Because only full V-Lock blocks were available, half blocks were made by cutting existing full blocks in half with a miter saw fitted with a masonry blade, as shown in Figure 3.17.

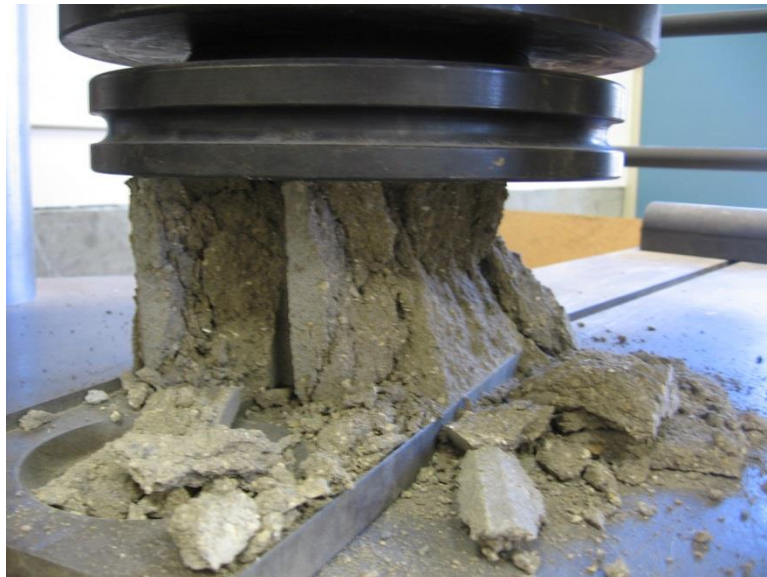
**Figure 3.19: Single-Block Conical Failure**

Single compressed earth blocks tested in compression suffer from a testing artifact where the contact plates act to confine the compressed soil cement at the block/plate interface. This artificially increases the block's strength compared to the completely unconfined failure that would take place in a full-scale stack of blocks. It also causes a characteristic conical failure visible in Figure 3.19 that has been widely observed by past research, including Bland (2011) and Pringle (2016). These testing artifacts can be overcome with prism tests.

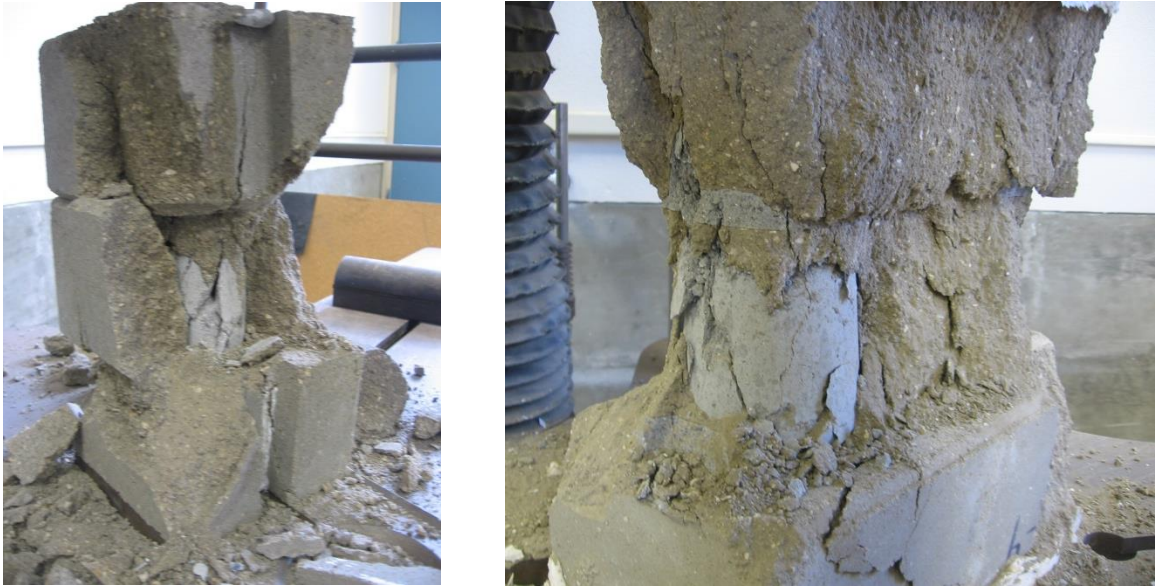
**Figure 3.21: Rhino (left) and V-Lock (right) Prism Failures**

As can be seen in Table 3.3 above, the ratio of average prism strength to average block strength was approximately 0.4 for both block types, with the V-Lock blocks having a slightly higher ratio. This is lower than the range reported by Bland (2011) of 0.43 to 0.55 but within the range reported by Bales (2009) of 0.37 to 0.43. Most prism samples failed with extensive vertical cracking that propagated through the grout cores, with the outer block material tending to split away from the cores. This behavior was particularly noticeable in the V-Lock prisms, which tended to have less cracking in the grout with large, relatively intact portions of blocks which fell away from the cores.

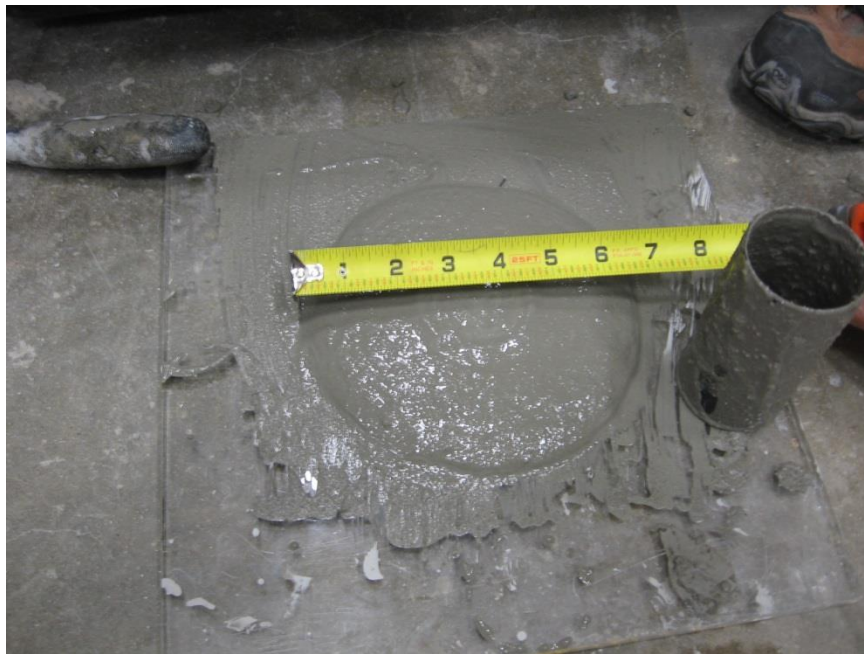
**Figure 3.22: Grout Slump Flow Test, Units in Inches**

Because a mechanical mixer would cause the sand to settle out, grout was mixed by hand with a metal scoop in a large plastic tub. All dry ingredients were mixed together before incrementally adding water, remixing with each additional increment. When the batch became noticeably fluid (gauged from experience), workability was tested by filling a 100-mm length of 50-mm-diameter cylinder with grout. The cylinder was held in place against a smooth plate; rapidly lifting the cylinder allowed the grout to

flow out on the plate, similar to the slump flow test. The resulting diameter provided a quantitative measure of workability. If the diameter was too low, the grout was returned to the mixing tub along with additional water, and the process was repeated until reaching a target diameter of 19 cm (illustrated in inches in Figure 3.22).

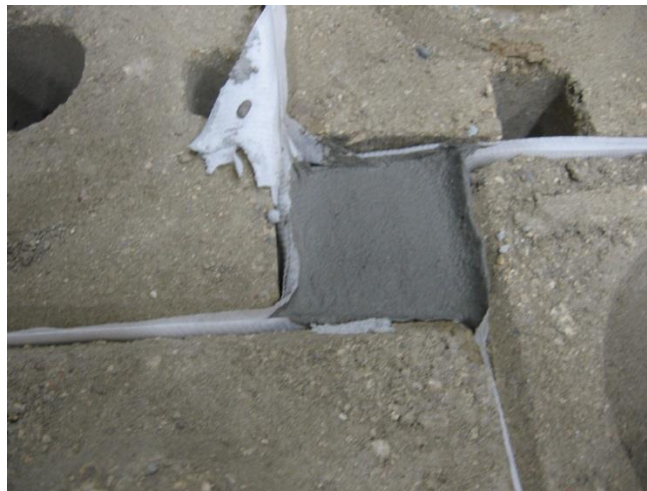
**Figure 3.25: Casting a Porous Cube Sample**

To capture the effect of water absorption on grout strength, samples were cast between spare Rhino blocks as shown in Figure 3.25 below, with paper towels placed to allow water absorption while preventing the grout from bonding to the blocks. (The grout did, however, firmly bond to the paper towels, which could not be entirely removed before testing, as can be seen on the outside of the sample in Figure 3.24. This was assumed to have a negligible effect on measured compressive strength.) This follows the

general principle of ASTM C1019 – Standard Test Method for Sampling and Testing Grout. The samples themselves deviated from the standard in several ways, however, particularly in size: The samples were approximately 50 mm by 50 mm like the non-porous cubes with a height of 90 mm, while ASTM C1019 specifies a minimum side length of 76 mm and a height twice the width. Technically the samples are rectangular prisms rather than cubes, but here they shall be referred to as “cubes” to succinctly distinguish them from the porous cylinders.

As with the non-porous cubes, the porous cubes were capped with neoprene pads for testing. Owing to the course nature of casting samples between blocks, the samples frequently had geometric imperfections that did not fit within the bounds of the neoprene pad and instead would contact the metal portion of the cap. For the samples for Wall 1, these imperfections were coarsely chiseled away, which no doubt explains the unusually high standard deviation for those samples. For subsequent walls, the imperfections were more carefully ground from the sample. Compressive testing followed the same loading protocol as the non-porous samples.

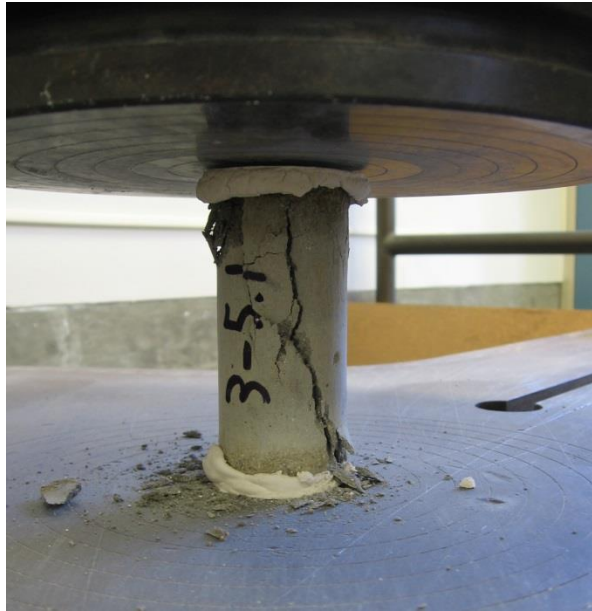
**Figure 3.26: Porous Cylinder Sample**

For comparison purposes, grout samples were also cast within the grout chambers of spare Rhino blocks, similar to the method used by Bland (2011). Carefully splitting and shaving the compressed soil away from the grout chamber resulted in 43-mm-diameter cylinders. The cylinders were capped with gypsum cement before testing. The samples from Walls 1 and 2 had somewhat irregular caps; this was corrected for the Wall 3 samples. Samples from Walls 1 and 2 were loaded at a rate of 240 kPa/s; the weak nature of the grout resulted in extremely short test durations of approximately 30 seconds. The loading rate for Wall 3 was therefore reduced to 30 kPa/s. The results of the porous cylinder and cube samples are compared in depth in Section 6.4.

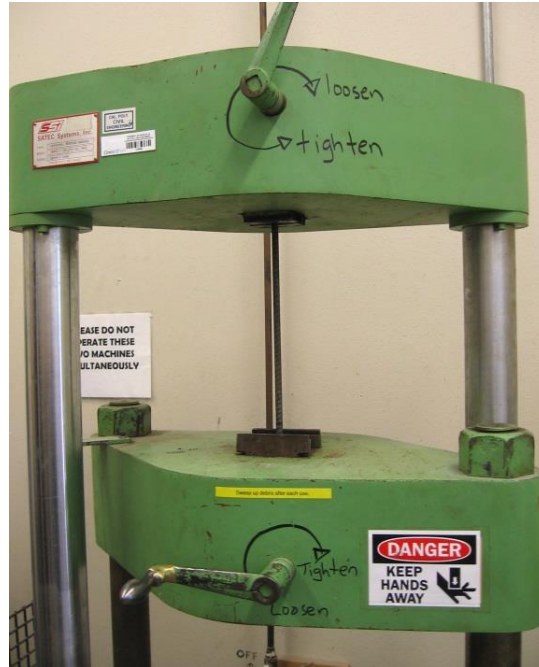
**Figure 3.28: Steel Tensile Test Setup**

All tested walls incorporated three distinct types of reinforcing steel in their construction: #3 deformed reinforcing bar, 6-mm-diameter “pencil rod,” and 4 mm-diameter “ladder reinforcement.” Samples of each steel type were subjected to tensile testing; Figure 3.28 shows the test setup, while Table 3.8 summarizes the results and Appendix D contains individual sample results. Each variety of steel is briefly described in the following sections along with its application.

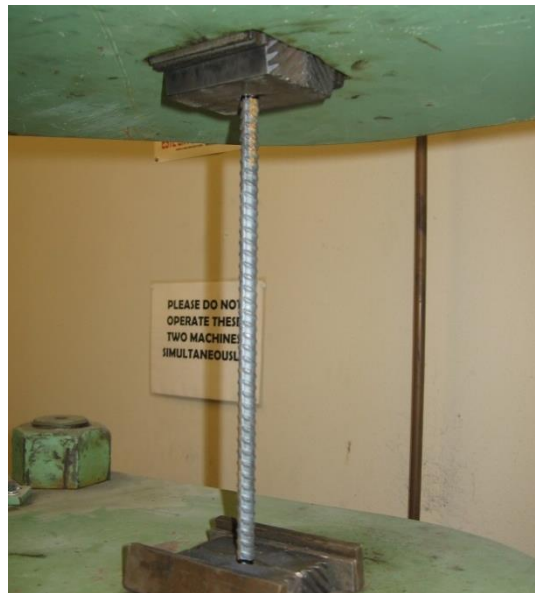
**Figure 3.29: #3 Deformed Bar**

All longitudinal reinforcement for the tested walls consisted of deformed #3 reinforcing bar. The reinforcement consisted of ASTM 615 Grade 40 steel and was purchased from a local masonry construction supplier.

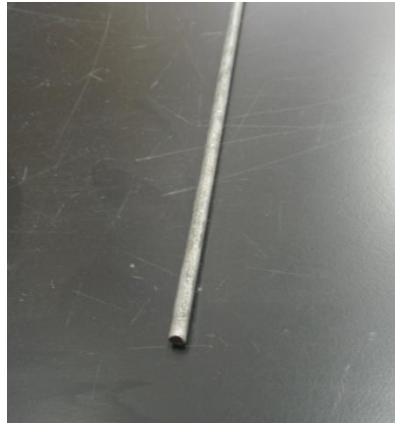
**Figure 3.30: Pencil Rod**

Smooth 6-mm-diameter steel rod, referred to as “pencil rod,” reinforced the concrete beam at the top of each wall. It consisted of ungraded mild steel purchased from a local steel supplier. Testing revealed two distinct types of steel: One which was weaker and highly ductile, and one which was stronger but more brittle. Since the steel strength only mattered inasmuch as it held the bond beam together, this was not deemed important, although it did affect the pencil rod’s workability during construction.

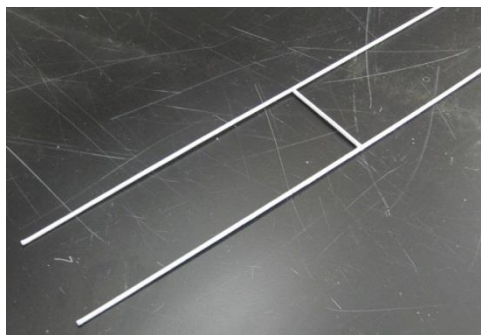
**Figure 3.31: Ladder Reinforcement**

“Ladder reinforcement” consisted of two 4-mm-diameter steel rods laterally connected at regular intervals for ease of placement. Ladder reinforcement supplemented the pencil rod reinforcement in the concrete beams at the top of each wall.

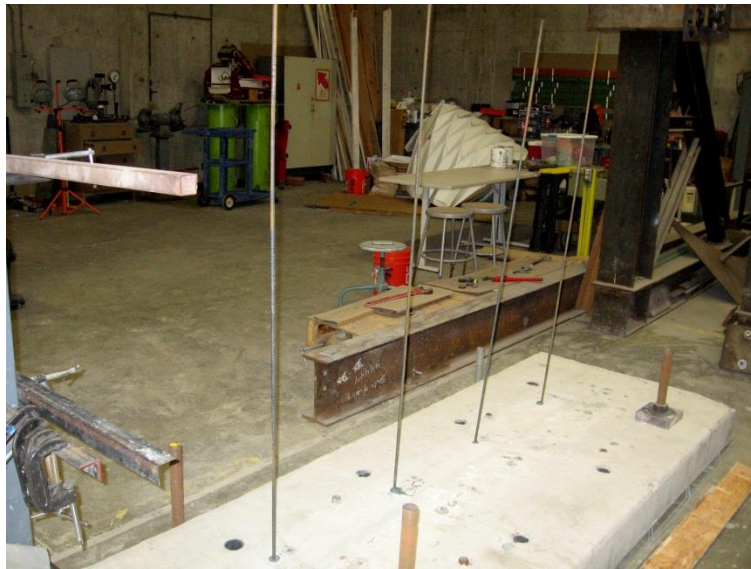
**Figure 4.1: Vertical Reinforcement**

Each wall was built on a portable, 20-mm-thick reinforced concrete slab bolted to the laboratory strong floor. Vertical reinforcement for all three walls consisted of four #3 bars epoxied 190 millimeters (7.5 inches) into the slab with Simpson Strong-Tie Set-XP epoxy, installed in accordance with manufacturer's instructions. Reinforcement was not disturbed for at least 24 hours after placement to allow the epoxy time to cure. After this period, each bar was bent at its base to make it plumb. To facilitate the placement of lower block courses, the reinforcement incorporated a 91-cm lap splice, beginning and ending at the elevations listed in the table below. This length is not sufficient to fully

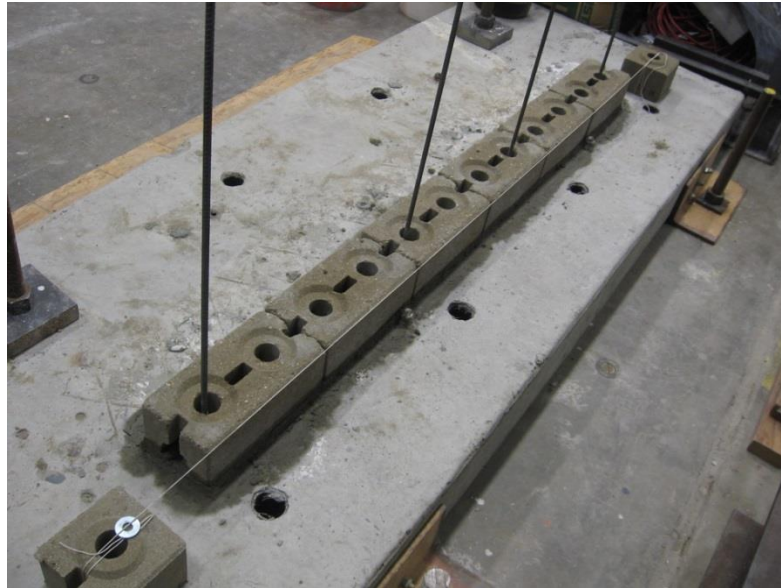
**Figure 4.2: Base Course**

The base course of each wall consisted of a layer of blocks mortared to the base slab with a Type S mortar, described above in Section 3.4. Before mortaring, the slab was cleaned of residual mortar, epoxy, and debris from prior testing. The foundation had embedded, protruding anchors for transporting the slab which infringed on the edge of the base course; small portions were gouged from the adjacent blocks to accommodate the anchors and properly fit the course, as can be seen in Figure 4.3.

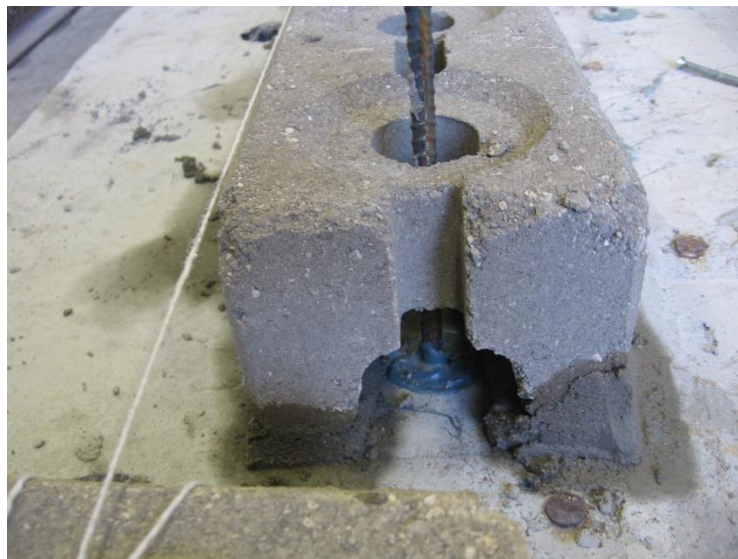
**Figure 4.4: Inverted Channel Blocks as Base Course**

The base course of Wall 2 used the same Vermeer blocks as the rest of the wall, while Walls 1 and 3 used Rhino channel blocks flipped upside-down as in Figure 4.4 with the small raised portions chiseled off. In both cases, this created two narrow contact surfaces on either side of the block, which eased the process of levelling the blocks on the mortar. Using a bubble level in combination with the level string visible in Figures 4.2 and 4.4 ensured the base course was level both in and out of the plane of the wall. The mortar was allowed to harden for at least 24 hours before adding subsequent courses.

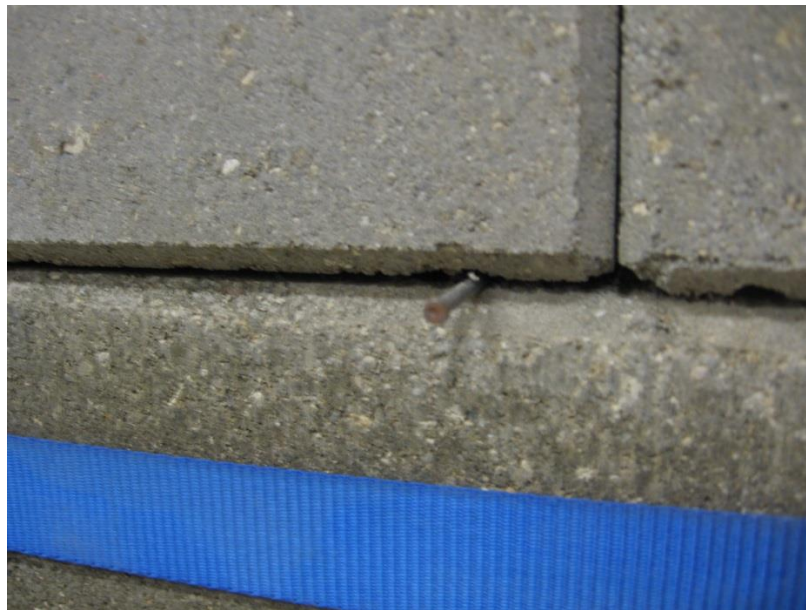
**Figure 4.5: Nail Used as a Block Shim**

- rotating blocks 180 degrees (useful in cases where one end of a block was taller than the other)
- exchanging the locations of specific blocks
- purposely selecting over- or undersized blocks to fit a specific situation
- selectively wearing down the tops or bottoms of blocks, either the entire surface (when the block as a whole was too high) or a select region (to accommodate a crown immediately under the block and prevent rocking)
- shimming blocks with nails to raise one end or the other (Figure 4.5)

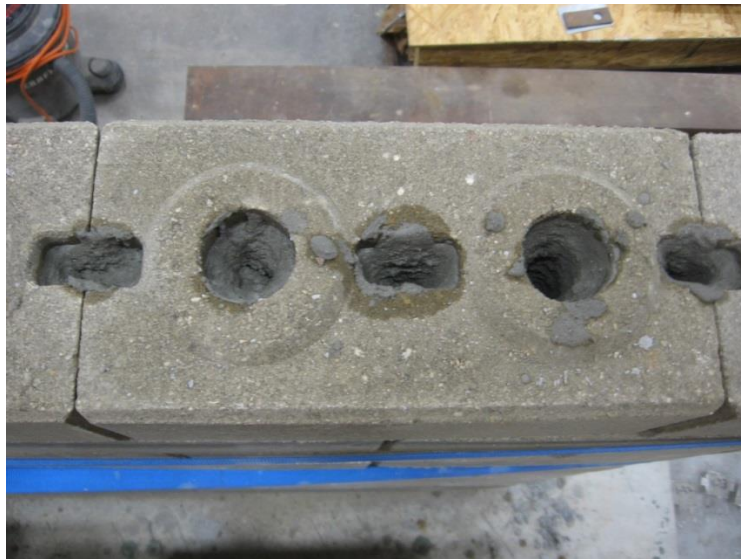
**Figure 4.7: Grout Cores and Short-Term Shrinkage**

Each grout lift ended slightly below the top of the topmost course to provide a shear key and avoid a cold joint exactly at the boundary between courses. This can be seen in Figure 4.7, which also illustrates the amount of shrinkage in the grout due to water absorption after less than 20 minutes; the grout clinging to the insides of the cores corresponds to the original height of the grout pour. Because the grout stiffened so rapidly, care was taken to minimize disturbing the rebar and creating adjacent voids in the stiffened grout. Similarly, rodding to aid consolidation would have counterproductively left voids in the stiffening grout. Consolidation instead relied solely on the grout's fluidity. Any stray grout on the top surfaces of the blocks was removed before placing the next course

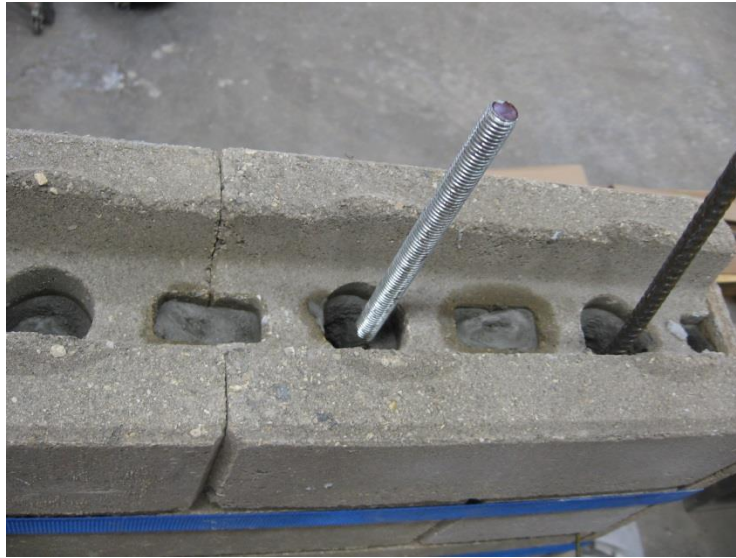
**Figure 4.8: Loading Beam Anchor, Post-Grouting**

Thirteen-mm-diameter steel threaded rod to anchor the loading beam was installed into the final grout lift of each wall. Five anchors per wall were spaced as evenly and symmetrically along the wall as possible in grout cores not already occupied by vertical reinforcement. Each anchor was embedded into a full grout lift and through the top concrete beam, approximately 330 mm total. For installation, the anchor was rested on the top of the previous grout lift (usually in a convenient indentation left by shrinkage) and was held in place by hand while the grout lift was poured. The anchor was then released as soon as the grout stiffened enough to hold it upright, typically in less than one minute after pouring.

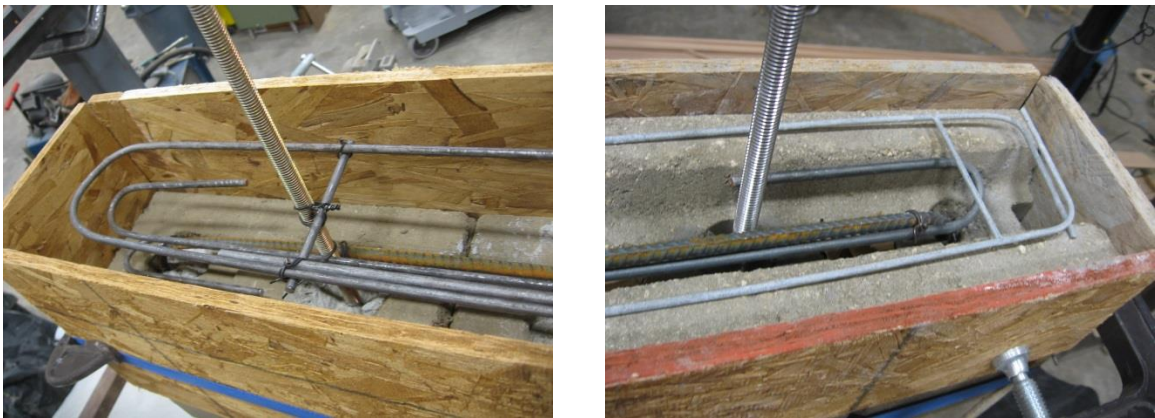
**Figure 4.10: Concrete Reinforcement for Walls 2 (left) and 3 (right)**

Figure 4.10 shows the beam's reinforcement immediately before casting. Ladder reinforcement terminated in horizontal 90° hooks. Pencil rod at the center of the beam used 180° hooks at each end, also possibly tighter than code minimum radii. In Wall 2,

the pencil rod along the edges of the beam ended in two 90° bends. Each rod's ends were tied to the other rod's to create a loop around the perimeter of the beam.

Hooks at the top of the vertical reinforcement were not bent until at least one day after pouring the final grout lift. The ends of the reinforcement were bent towards the center of the wall either to fit within the channel as much as possible or to be as close to the top course as possible when channel blocks were not present. No attempt was made to match the bend radius to code-based minimums. The actual lengths of the hooks were not measured during construction, but each reinforcing bar was sized to account for a hook approximately 61 cm long for Wall 1 and 41 cm long for Walls 2 and 3. A few centimeters of one of the hooks in Wall 1 were removed via hacksaw because they interfered with another hook pointing towards them. It was not physically possible to bend the hooks far enough such that they remained horizontal when released, so the hooks were tied in place to the threaded anchors.

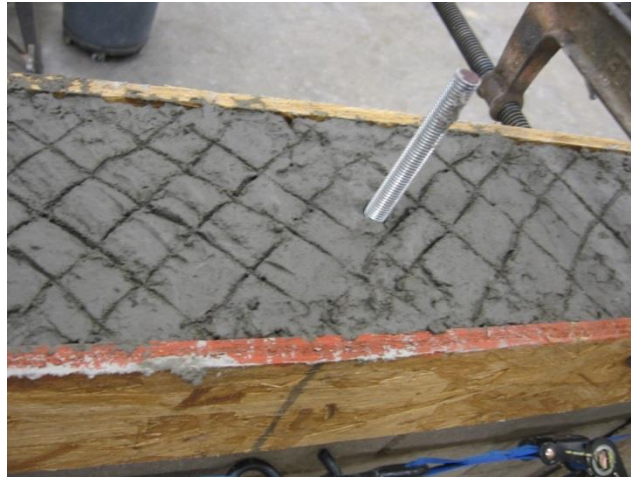
**Figure 4.11: Freshly Poured Concrete Beam with Crosshatch Texture**

The concrete was placed and consolidated by hand. After the concrete was placed and troweled level, the sharp edge of the trowel was used to inscribe the crosshatch texture shown in Figure 4.11, roughening the surface to help bond the steel loading beam to the top of the wall.

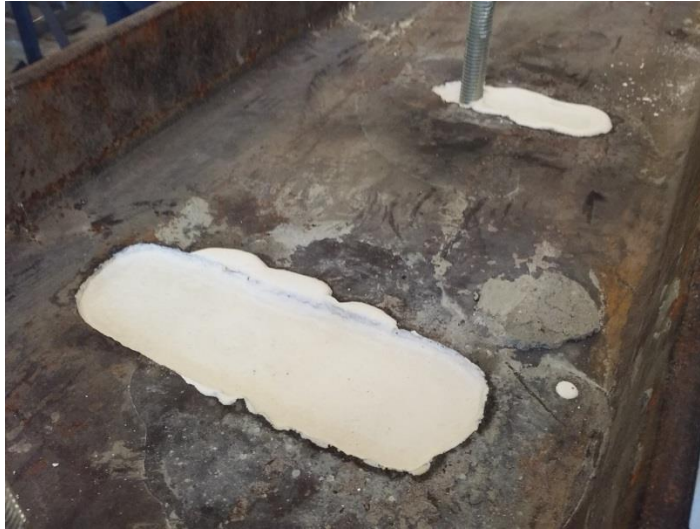
**Figure 4.12: Gypsum Cement Shear Keys**

minimize leakage. Gypsum cement was mixed with water to reach a very thin, almost watery consistency, and the mixture was poured through preexisting holes in the top of the beam. Ideally, the cement flowed to fill the gap between the loading beam and the top of the wall. Adding enough cement to fill the holes also created shear keys to improve load transfer, shown in Figure 4.12.

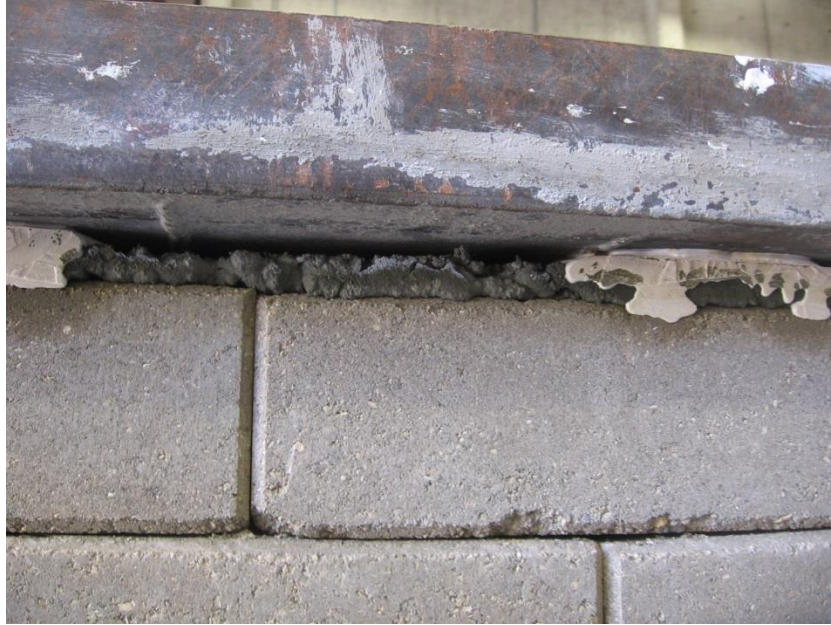
**Figure 4.13: Gypsum Cement Gaps, Wall 1**

In practice, the effectiveness of this technique highly depended on the viscosity of the gypsum cement mixture. Particularly for the first few batches for Wall 1, the mix was too thick and only flowed within a few inches of each hole as can be seen in Figure 4.13, leaving large regions with no gypsum cement and therefore no contact between the wall and the loading beam. Adding more water to thin the mix helped alleviate the issue, but little could be done for areas where previously poured cement blocked access. Using a much thinner mixture for Wall 2 resulted in few such voids, but the cement leaked through the tiniest holes in the caulk and ran down the face of the wall. An intermediate cement mixture for Wall 3 filled the space reasonably well but still left significant gaps that required remediation.

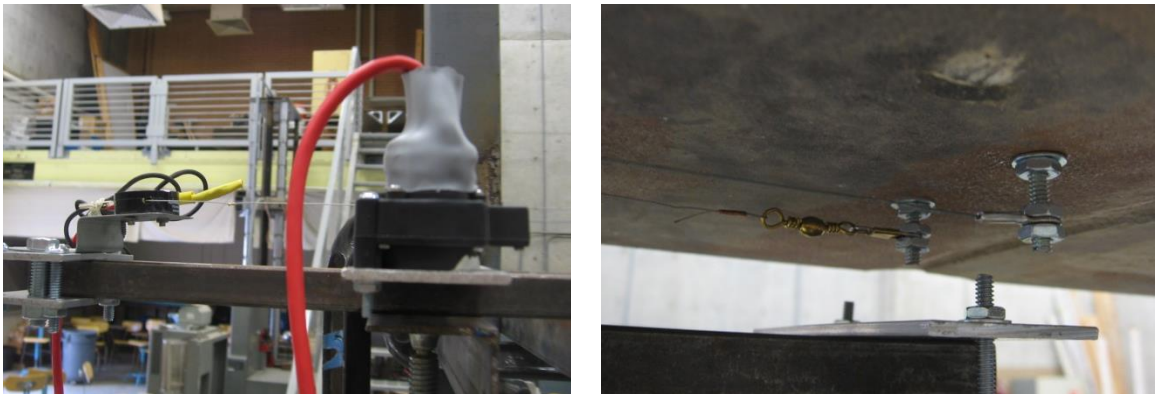
**Figure 5.4: Displacement Instruments and Attachments to Loading Beam**

threaded rod running through the loading beam. The two instruments provided redundant readings: One potentiometer had a 75-mm stroke for more sensitive readings early in testing, and the other had a 635-mm stroke for high displacements when the small-stroke potentiometer was removed to avoid damage.
