IN-PLANE SHEAR WALL PERFORMANCE AS AFFECTED BY  
COMPRESSED EARTH BLOCK SHAPE

A Thesis

Master of Science in Civil and Environmental Engineering

March 2017

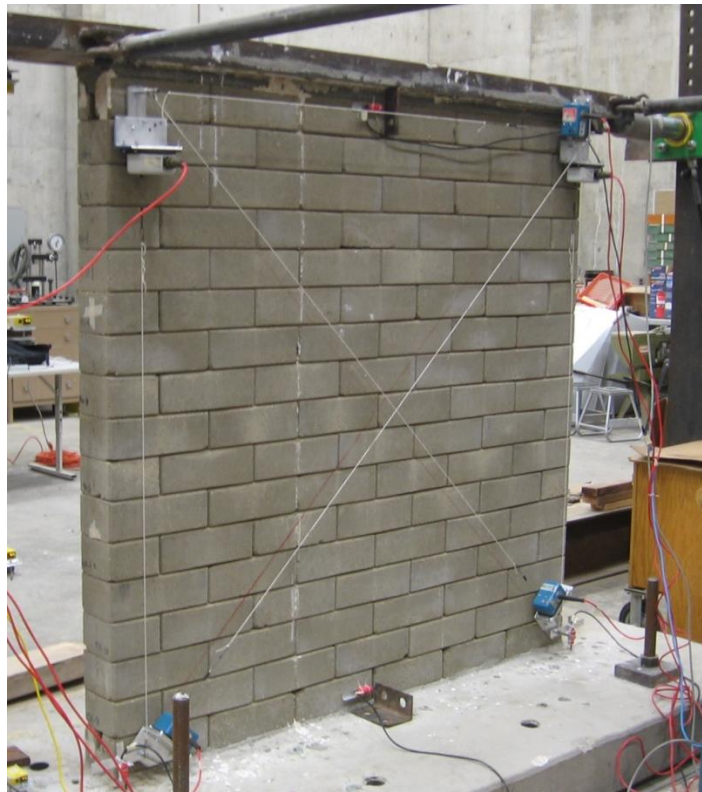
**Figure 5.5: Panel Deformation Instruments on Wall 3**

Five string potentiometers on the face of the wall were intended to measure panel deformation: Two on the diagonals, two on the vertical edges, and one along the top horizontal edge. Figure 5.5 shows the instruments applied to Wall 3; they are also labeled as instruments 4 through 8 on Figure 5.3. The base course was assumed to be inextensible and not instrumented. Equations 5-1 and 5-2 convert these readings into the shear and bending displacement components; Appendix C of Voon (2007) contains the full derivation. Figure 5.6 defines the dimensions and relevant instrument measurements.

Walls 1 and 2 used the same instruments to measure panel deformation; the only difference was that Wall 1 used a 635-mm-stroke string potentiometer for the top horizontal, while Wall 2 used no instrument at all. The instrument in question sustained damage between testing Walls 1 and 2; because no extension was expected on the rigid reinforced concrete beam, the instrument was deemed unnecessary and was not immediately replaced. Both walls used string potentiometers with 510-mm strokes on the diagonals and 250-mm strokes on the verticals. Wall 3 used new 130-mm potentiometers on the verticals, moved one of the 510-mm potentiometers to the top horizontal, and moved both 250-mm potentiometers to the diagonals.

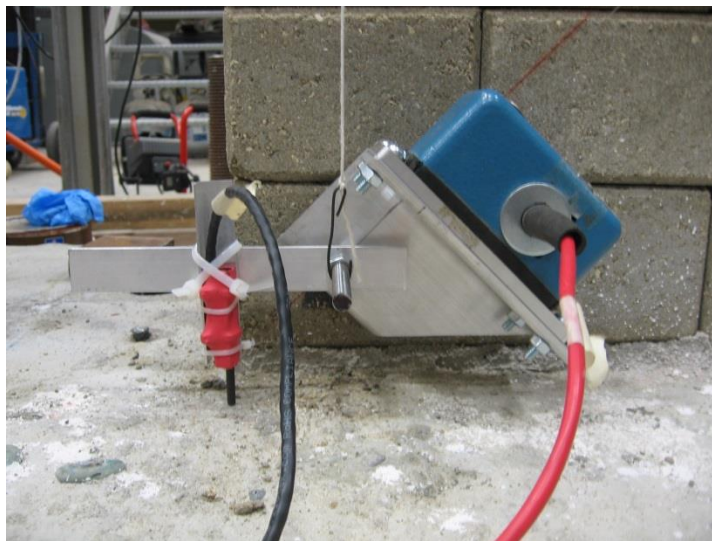
**Figure 5.7: Deformation String Potentiometer with Rocking Linear Potentiometer**

Two linear potentiometers at either edge of the wall measured rocking, labeled as 9 and 10 on Figure 5.3. Both shared anchors with the lower two string potentiometers on the face of the wall, as shown in Figure 5.7. Equation 5-3 was used to calculate the rocking displacement component of the top of the wall from these measurements. Section 3.5.2 of Voon (2007) contains the derivation for the equation, and Figure 5.8 defines the dimensions and instrument measurements.

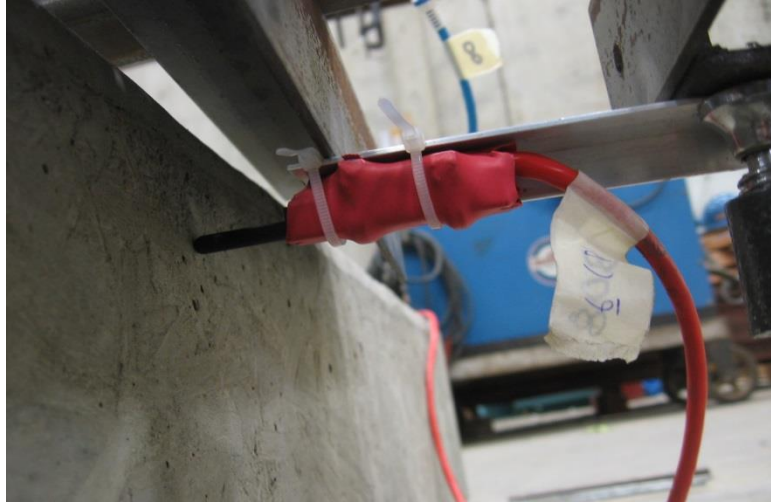
**Figure 5.9: Foundation/Floor Slip Instrument**

Three linear potentiometers measured slip between the loading beam and the wall, the wall and the foundation, and the foundation and the laboratory floor. This allowed the raw displacement measurements recording the displacement of the loading beam relative to the floor (by proxy of the reference frame) to be corrected to reflect the actual wall deformation. The foundation/floor instrument was suspended from the reference frame and pushed against the edge of the concrete foundation.

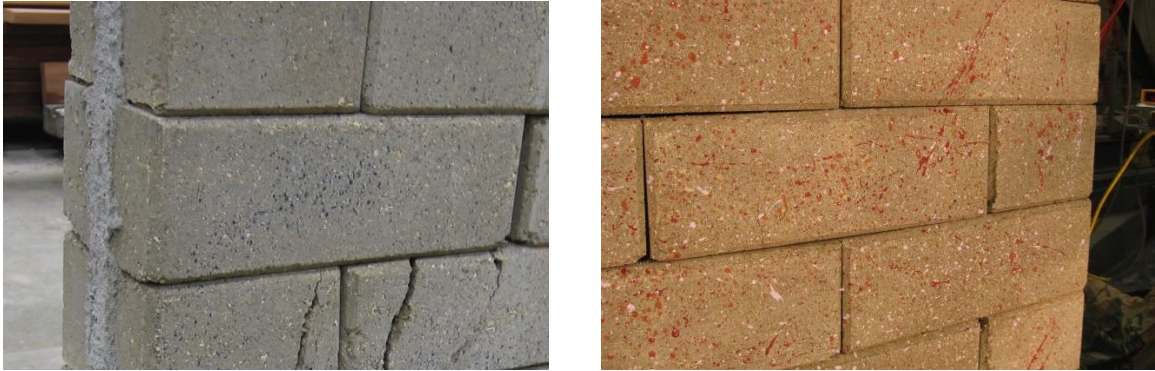
**Figure 5.12: Paint Speckles on Walls 1 (left) and 3 (right)**

was coated in paint speckles. For Walls 1 and 2, these speckles were applied with a dark texture spray paint, while Wall 3 used larger splatters of latex paint and decking stain. 0 describes the image processing technique in more depth.

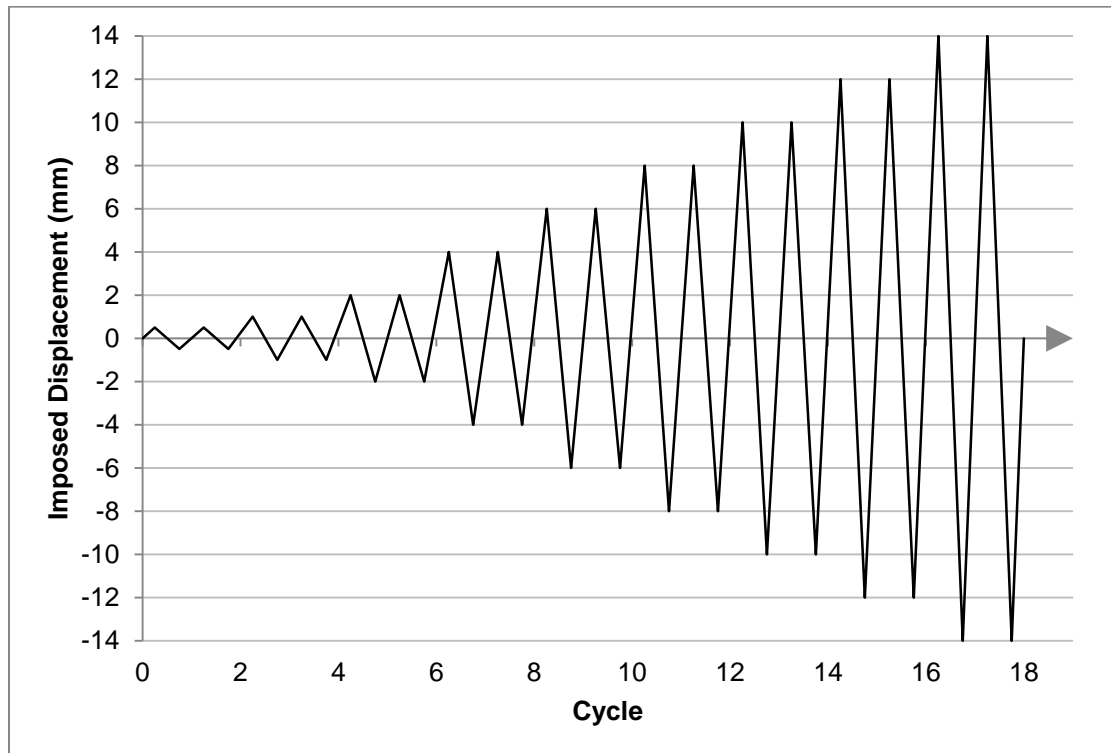
**Figure 5.14: Partial Imposed Displacement History (adapted from Voon, 2007)**

Cycles	Displacement (mm)	Displacement (in)	Drift (%)
1-2	0.5	0.020	0.028%
3-4	1	0.039	0.056%
5-6	2	0.079	0.11%
7-8	4	0.16	0.22%
9-10	6	0.24	0.34%
11-12	8	0.31	0.45%
13-14	10	0.39	0.56%
15-16	12	0.47	0.67%
17-18	14	0.55	0.78%
19-20	16	0.63	0.89%
21-22	20	0.79	1.1%
23-24	24	0.94	1.3%
25-26	28	1.1	1.6%
27-28	32	1.3	1.8%
29-30	36	1.4	2.0%
31-32	40	1.6	2.2%

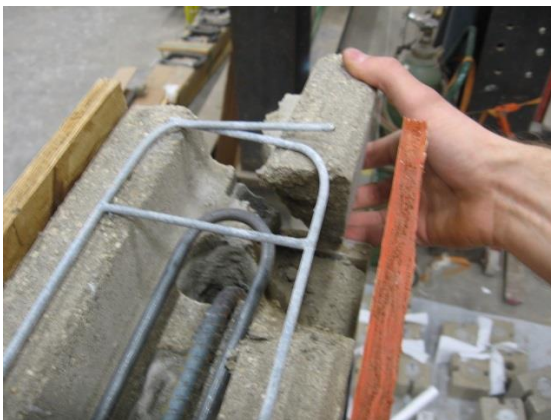
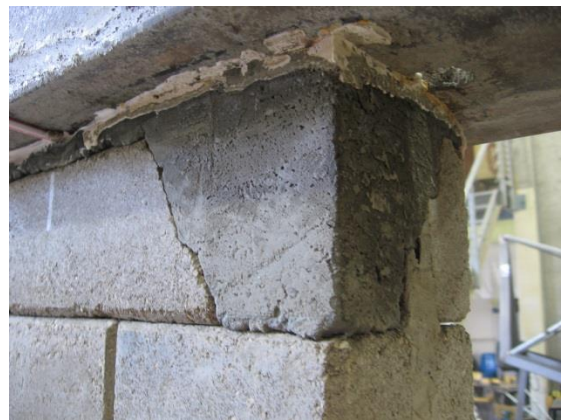
**Figure 5.16: Channel Block Damage and Concrete Fill**

- The vertical reinforcing of Wall 1 was spaced slightly too far apart, causing the extreme rebar at either end to be in contact with the edges of the grout cores.
- While clamping the formwork for the concrete bond beam, the C-clamp on the end closest to the loading frame was overtightened, breaking one side of the channel block. Since the block could not be replaced without damaging the intersecting grout cores, the damaged section was removed and allowed to fill with concrete, shown in Figure 5.16.

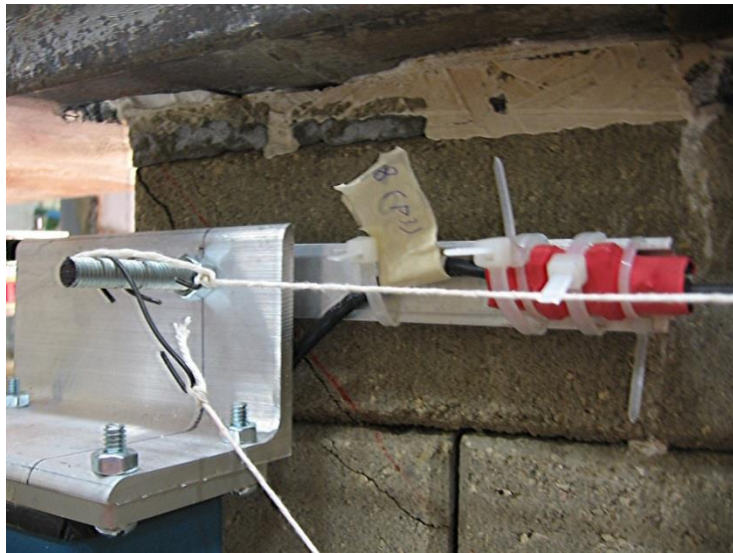
**Figure 5.18: Diagonal Cracking Through Instrument Anchor**

the wall revealed that the cracking pattern propagated through the grout cores as well as the blocks. After the first cycle, the wall required an applied load to pull it into a zero displacement condition, suggesting that some inelastic deformation occurred as early as this first cycle.

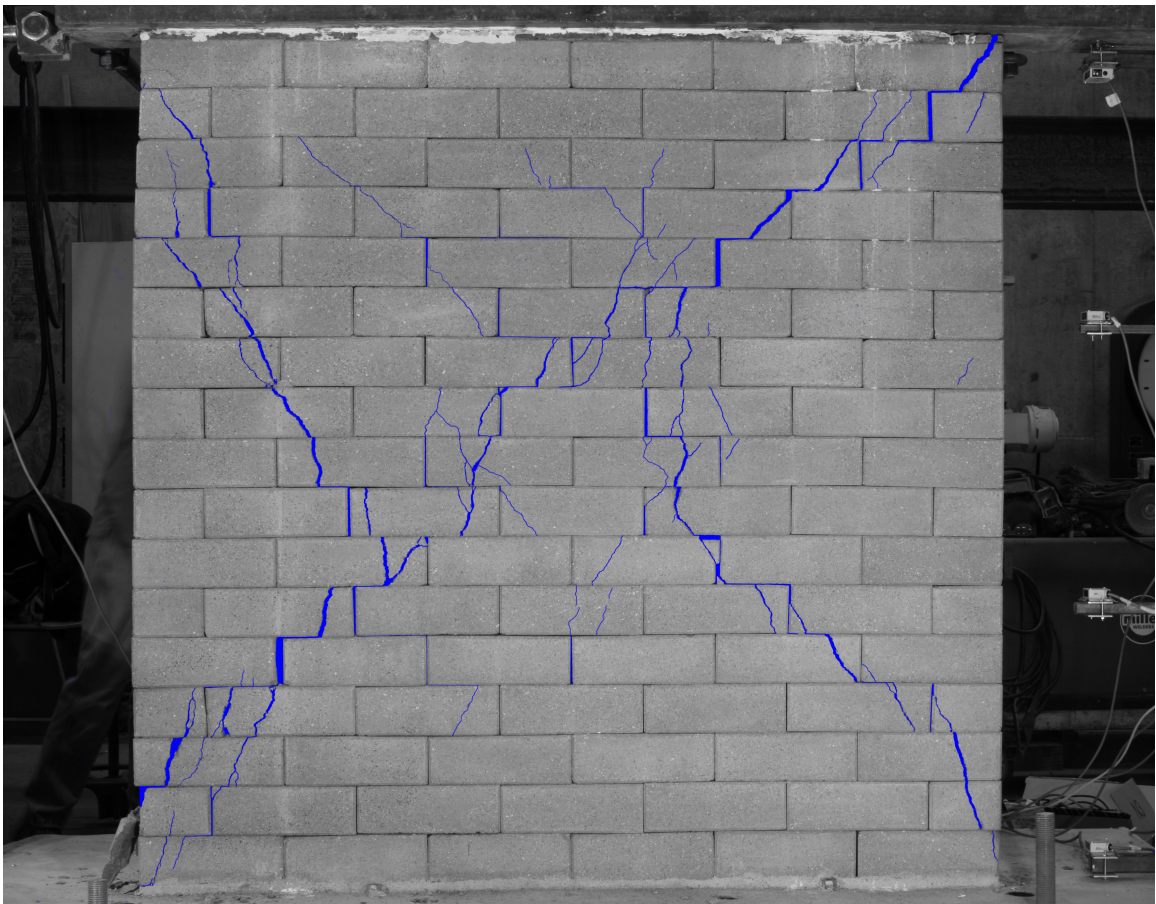
**Figure 5.19: Wall 1 Final Cracking**

foundation to the floor were tightened, which significantly reduced the intra-cycle slip for cycles 11 and 12 (8-mm nominal amplitudes). The bolts were tightened again after cycle 12, which further reduced the slip. For cycle 11 onwards, the slip effectively created a permanent offset of approximately 1.3 mm in the push direction which acted to increase the actual wall deformation on the pull cycles and decrease the deformation on the push cycles. In addition, operator error resulted in the pull stroke of cycle 12 (the second 8-mm cycle) reaching a maximum nominal displacement of 10 mm.

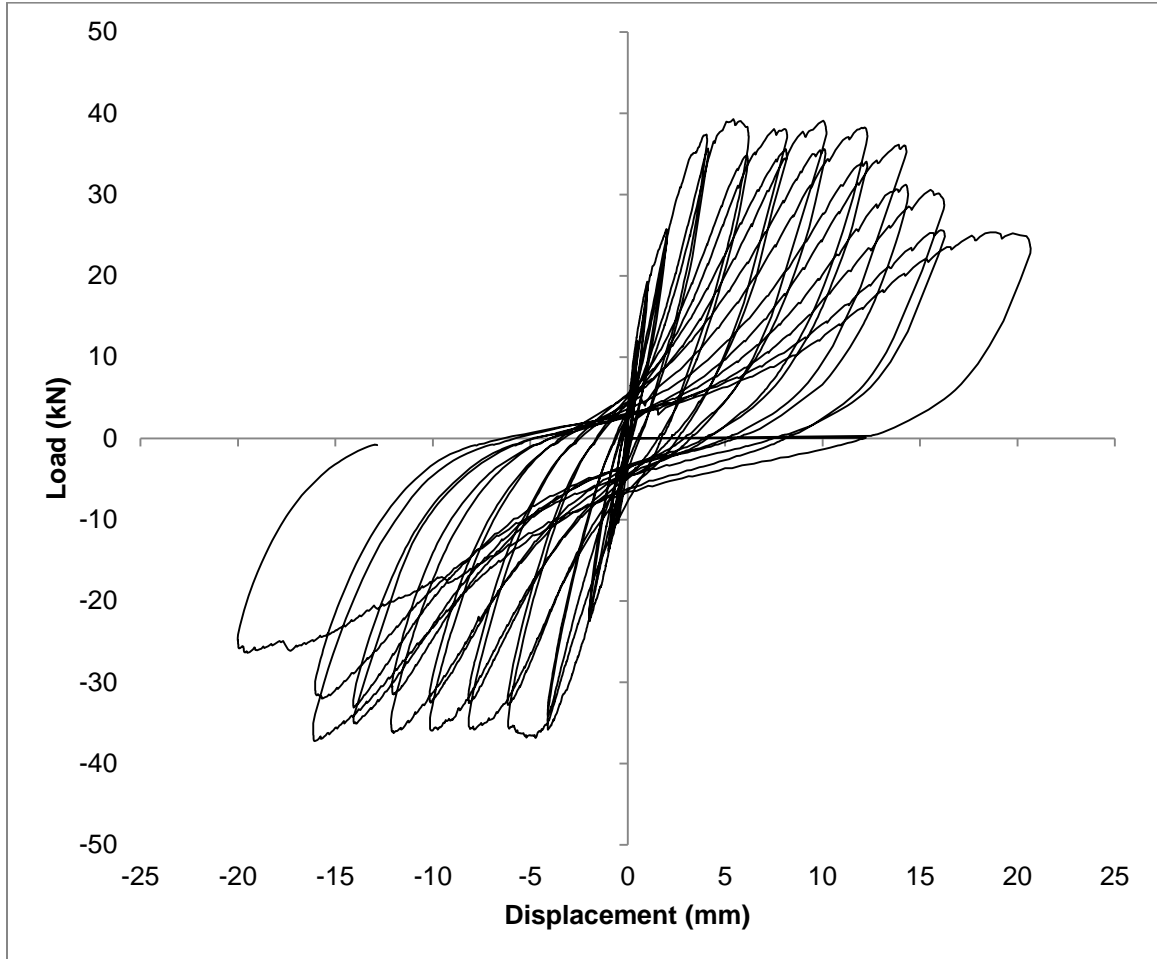
**Figure 5.21: Wall 2 Force-Displacement Plot**

Wall 2 was tested on May 27, 2016. Testing proceeded through cycle 21 to a maximum amplitude of 20 mm. The load initially peaked at 39.3 kN in the pull direction and 36.9 kN in the push direction of cycle 9 (the first 6 mm cycle), which corresponds with the first visible signs of cracking. The load then plateaued for the next several cycles, with the push direction reaching a second peak of 37.2 kN during cycle 19 (the first 16 mm cycle). Testing terminated at cycle 21 because of stability concerns, visible crushing at the toe, and sufficient load degradation. The wall was not returned to zero displacement, but testing instead ended after returning the wall to a position of zero load.

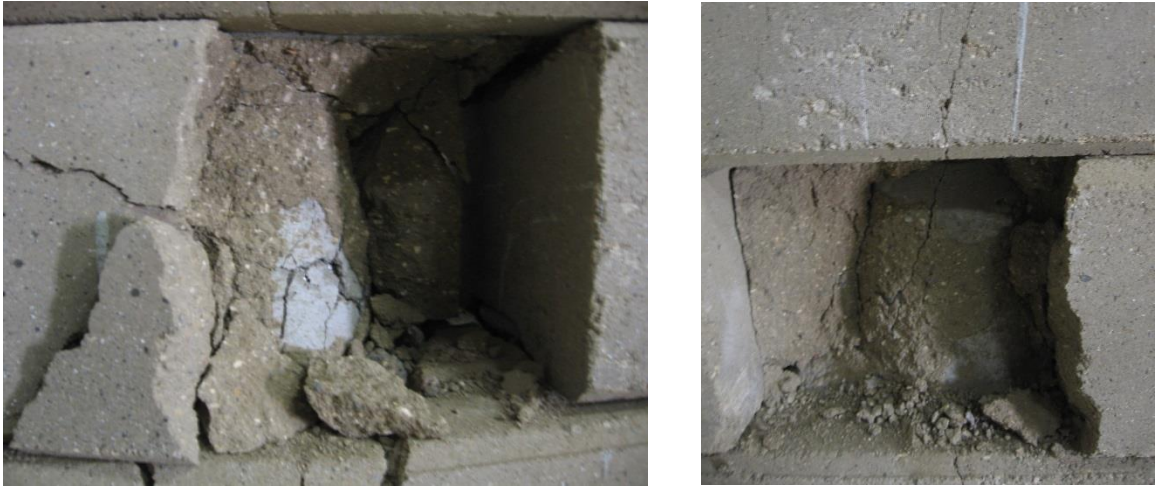
**Figure 5.22: Wall 2 Cracking Through Grout Cores**

Wall 2 exhibited the X-shaped cracking indicative of a shear failure, although the cracking was not as cleanly diagonal as the cracks on Wall 1. These cracks were first observed during the 6 mm displacement cycles, corresponding to the initial load peak. Forensic investigation showed that cracking propagated through the grout cores as well as the blocks. It also revealed significant deformation of the rebar at the top corners of the wall so that the upper, untied region of the lap splice separated, as shown in Figure 5.23. This may have contributed to the damage at the top of the wall by acting to split the blocks and grout cores. There were, however, no signs of slip in the regions of the lap splices still embedded in grout, so they still fulfilled their role in flexure.

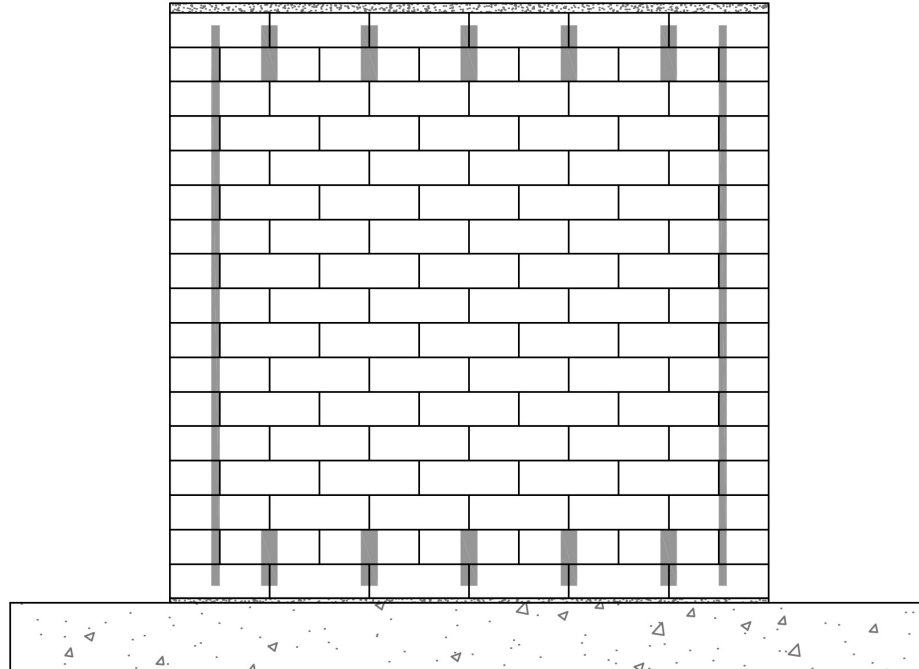
**Figure 5.26: Wall 3 Continuous Voids Between Courses**

- It was not possible to press channel blocks without the edge shear keys. This resulted in a vertical void between courses at every interface between a course of channel blocks and a course of regular blocks, as depicted in Figure 5.26. Scraps of the cement bag were used to obstruct the ends of the voids, to prevent grout or concrete from flowing up or down and inadvertently creating shear keys.

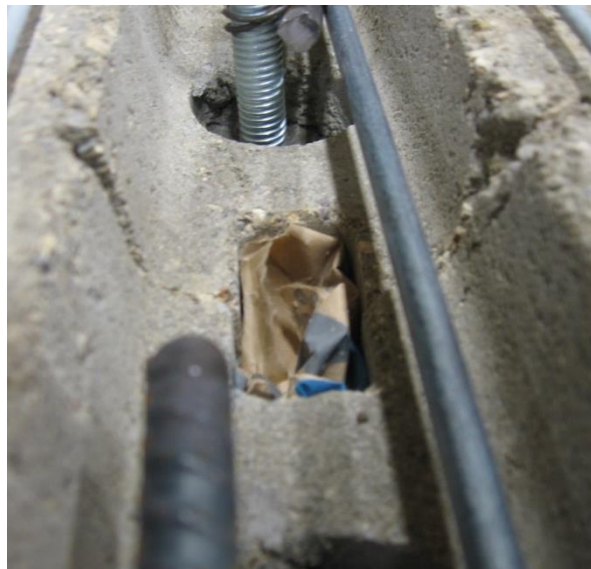
**Figure 5.27: Cement Bag Scraps Used as Filler**

was visible from the outside even though this disrupted the pattern of voids in the course. This also created a continuous void running the height of the wall at the edge of these half blocks, shown above in Figure 5.26. Again, to prevent concrete for the bond beam from running down the void, the top of the hole was filled with scraps of cement bag.

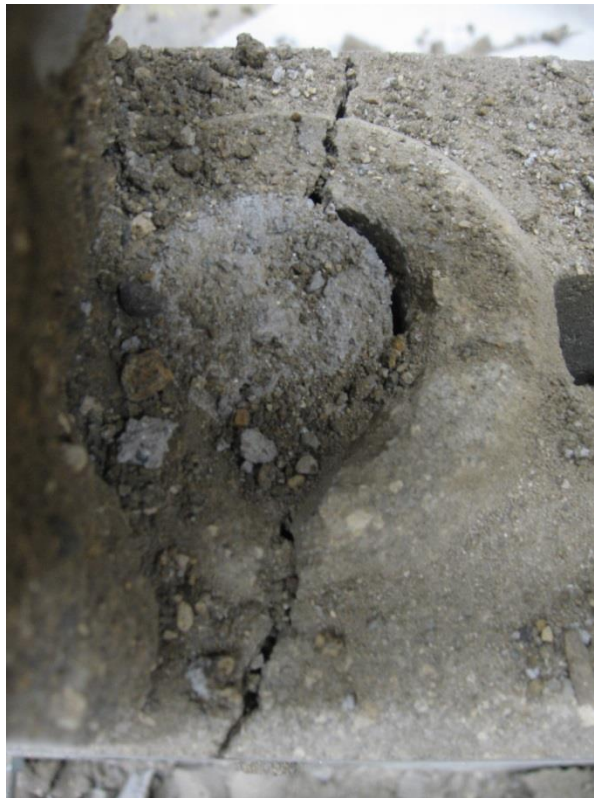
**Figure 5.29: Wall 3 Block Cracking Around Core**

Cracking followed a generally X-shaped pattern that would be expected from cyclic shear failure, but the majority of the cracks were vertical or nearly vertical on the blocks and corresponded to the approximate location of the grout cores. Many of these cracks did not extend through the grout cores; one such case is depicted in Figure 5.29, where the block cracked around the core and cleanly de-bonded from it on one side. Cracking was first observed after the 4 mm displacement cycles, coinciding with the initial peak of the load. As with Wall 2, forensic investigation of the wall showed high

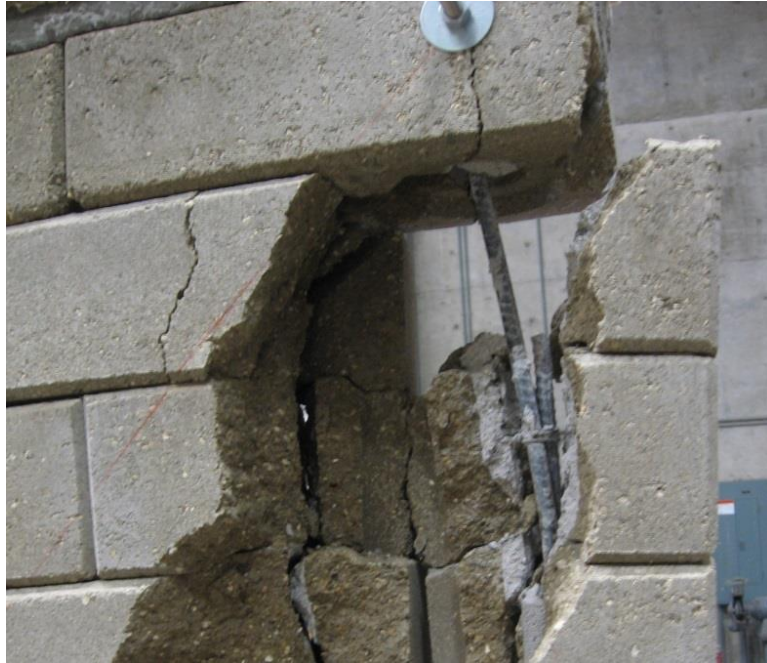
**Figure 5.30: Wall 3 Lap Splice Splitting and Reinforcement Deformation**

deformation in the reinforcement in the upper corners as shown in Figure 5.30, with separation in the top untied portion of the lap splice. This again may have contributed to the extensive damage to the blocks and grout cores in those corners, which in turn allowed the reinforcement above to further deform. As before, though, the lap splice showed no signs of vertical slip.
