# Possible Use for Recycled Disposable Face Masks in Concrete

Lauren Douglas  
California Polytechnic State University  
San Luis Obispo, CA

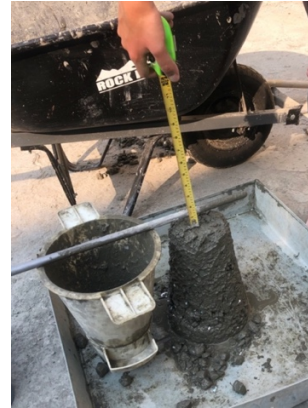
Figure 1: Slump test for Control batch

Concrete workability is tested using a slump test. This measures how many inches fresh concrete slumps down. The test followed ASTM std C143.

The only batch of concrete that had a slump was the Control. The highest average strength was seen in the Control 28-day batch followed by the 10 oz. 28-day batch. Honey combing can be seen in most of the cylinders that were cast.

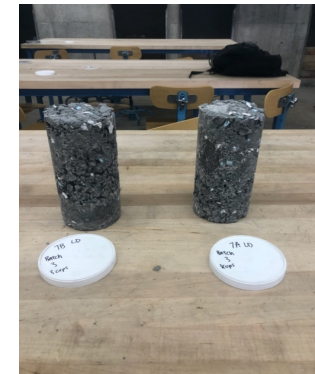
Figure 2: Cylinder 7A and 7B 30 oz. before strength testing

Honey combing in the cylinders could be the result of using aggregate that was too large for a 4x8 form. The cylinders were also poured while a heat advisory was in place in San Luis Obispo, CA. This could result in dry concrete and low workability. This experiment should be redone multiple times using the same methodology.
