## History of the "Powerhouse"

# Feasibility Study: Demolition of Cal Poly's "Powerhouse"

**Evan Tookey:**  
California Polytechnic State University,  
San Luis Obispo

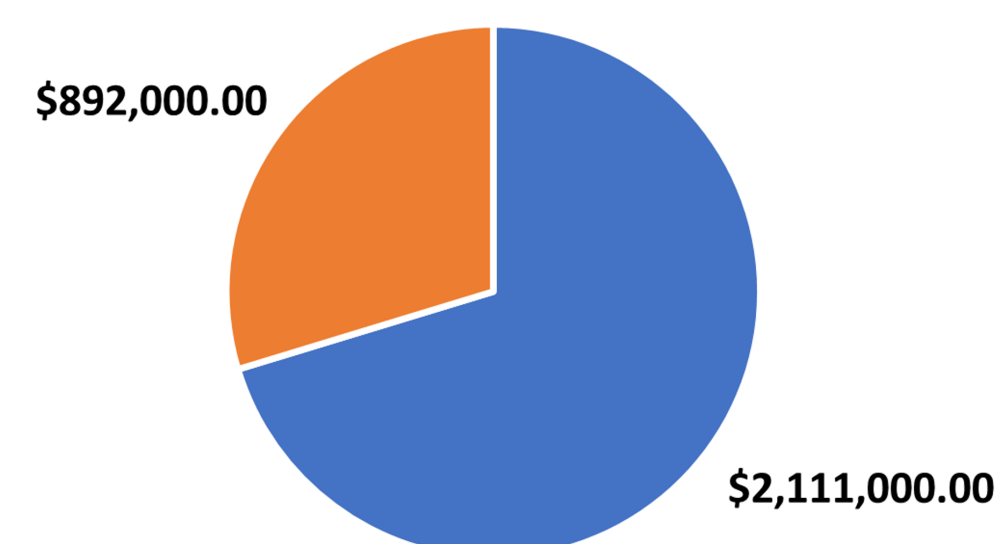
Estimated Cost of Renovation

RRM Estimate: renovation of structural envelope	\$2,111,000
Cal Poly historical costs: interior renovations (\$175 per square foot)	\$ 892,000
Estimated Total Project Cost	\$3,003,000

■ Renovation to Structural Envelope: ■ Renovation to Interiors:

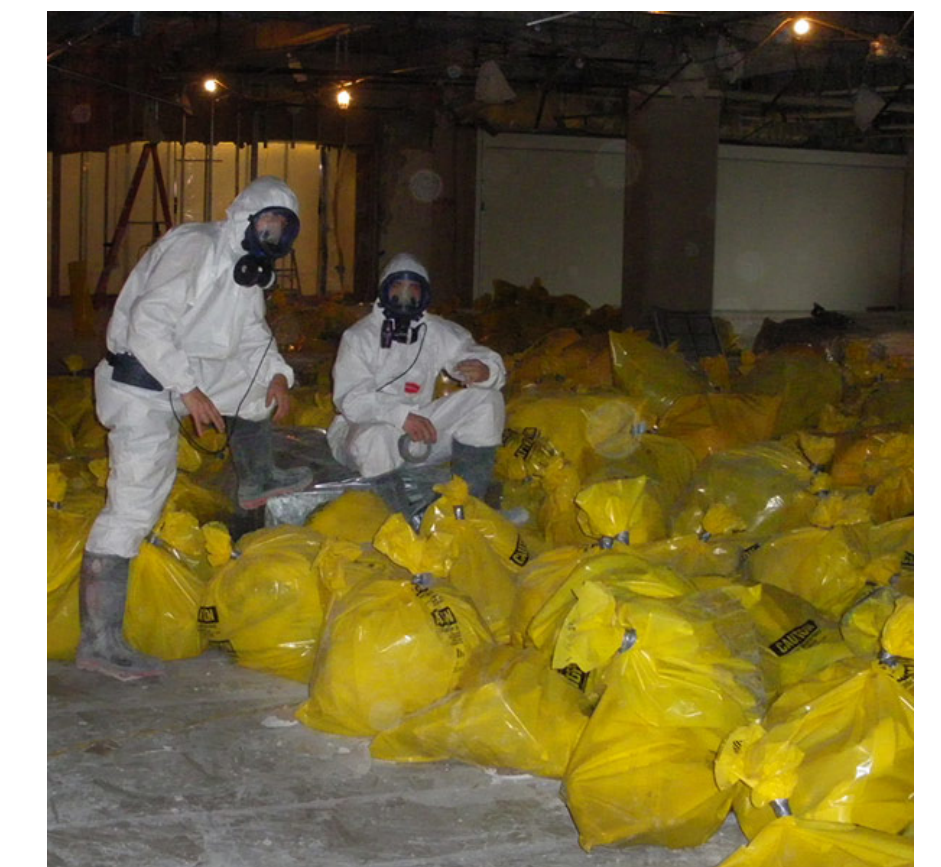
## Demolition Technique

Similar to the demolition of Building 52 on campus, the demolition of the Powerhouse building will most likely need a specialty consultant (Industrial Hygienist). Demolition would require:

- All hand tools for demolition/containment
- Full hazmat suits
- "Piece-by-Piece" demolition for each material to be sent out to different treatment centers.

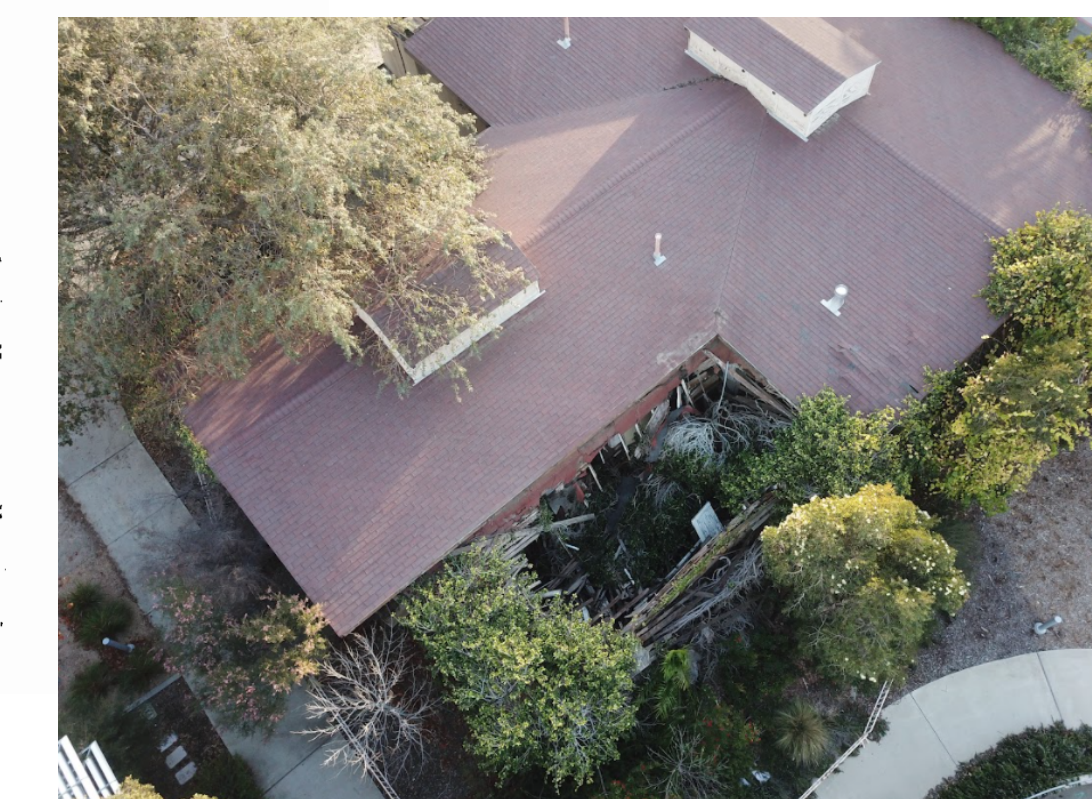
A1

In winter of 2018/2019, The Roof had held so much water-weight from rain that it eventually was damaged/collapsed in 2 different areas.
