Rental Property Energy Efficiency in San Luis Obispo

Department of Physics: California Polytechnic State University, San Luis Obispo

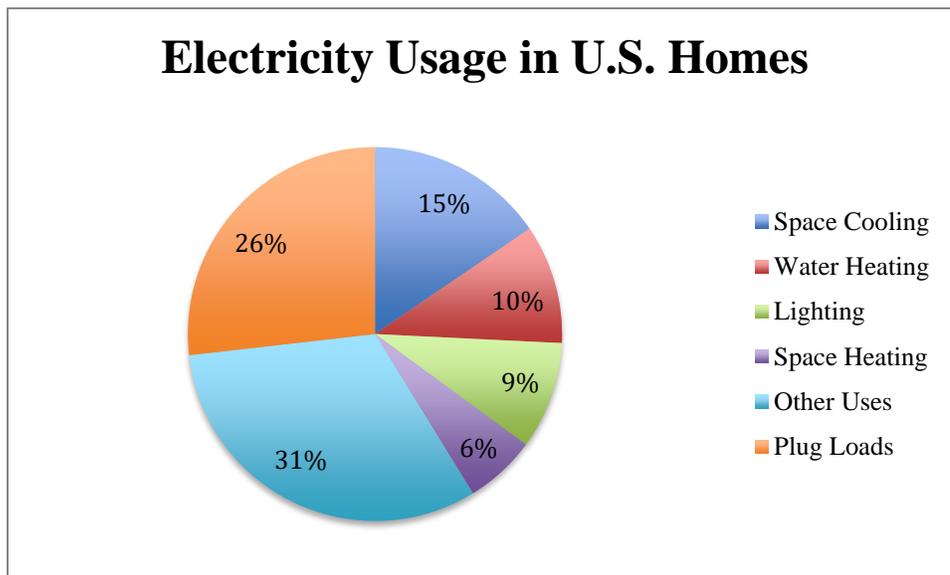
Figure 1. Division of energy usage in United States homes
(U.S. Energy Information Administration, 2017).

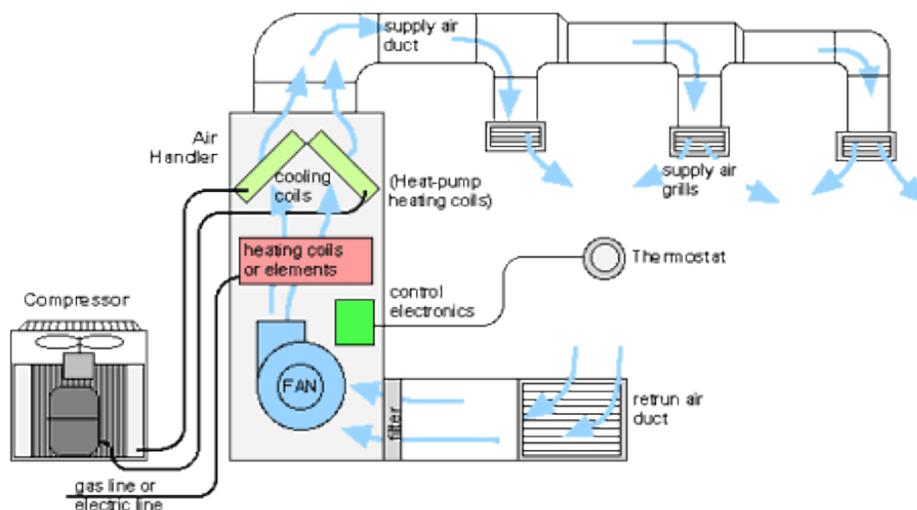
Figure 2. Building HVAC system diagram (Smart Home Ideas, 2011).

Figure 2 shows how a simplified central heating system works. The obvious solution is to replace old, inefficient heating and air conditioning units with newer, high efficiency models. While this can lead to more efficient heat generation, it only addresses one part of the issue. The actual heating unit is only one part of a complex system of interacting parts that heat or cool the living space in a home. Often, maximizing the efficiency of the existing system can be done without replacing the entire HVAC unit. A high performing building envelope is critical to the efficiency of the HVAC system. If the room being heated or cooled is not insulated and sealed properly from the outside environment, then maintaining a comfortable temperature inside the room is difficult and consumes large amounts of energy.

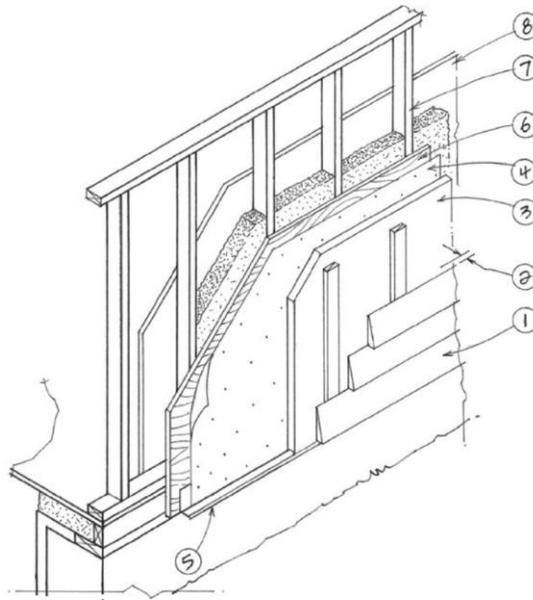
Figure 3. Example high performance wall assembly. (1) exterior siding material, (2) air gap that allows the wall to dry, (3) rigid foam insulation layer, (4) Tyvek or similar house wrap, (5) metal flashing, (6) exterior Oriented Strand Board (OSB) sheathing, (7) wood framing with batt insulation, (8) interior drywall (Racusin, 2016).

A wall assembly such as this has a much higher effective wall value than simple batt insulation in the wall cavities. The rigid foam on the exterior creates a barrier preventing the conductive flow of heat through the wall. In addition, the wall cavity is completely filled thus preventing the movement of air and convective heat loss. These techniques and materials are relatively easy to implement into a new home, but have a higher material and labor cost when compared to traditional framing methods. Wall assemblies such as this can be much harder and more expensive if not impossible to use in a retrofit application. High performance wall assemblies are fairly new in the building industry and therefore are not used in many existing homes.

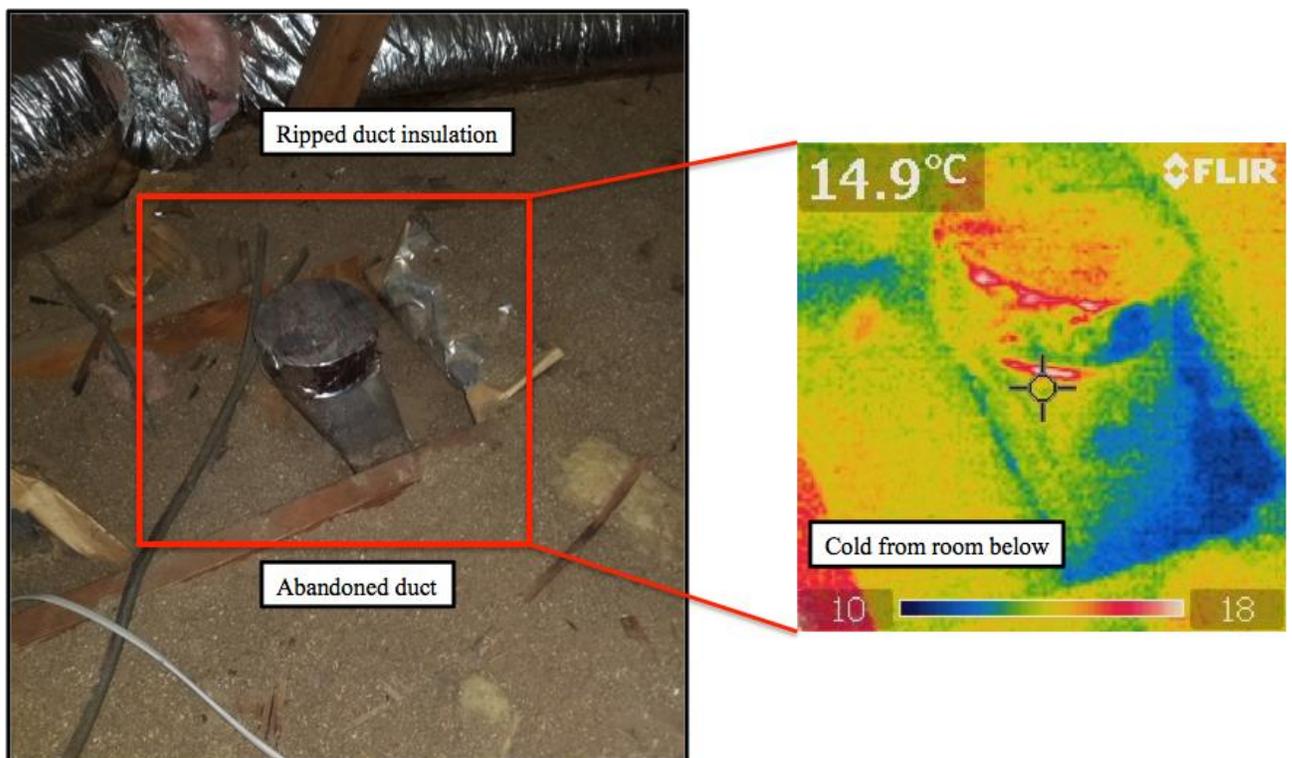
Figure 4: Abandoned duct in rental property ceiling.

The heat vent viewed in figure 4 was abandoned when a new furnace was installed, but left in place and sealed with tape. The image also shows that when this vent was installed, the insulation was peeled back and never replaced. The image on the right of figure 4 shows a thermal camera image of the heat vent. The thermal camera image was taken on a day when the temperature in the attic was higher than the temperature in the building. The dark blue area of this image shows where cold air is seeping up from the non-insulated penetration into the building envelope. Not only is the heating vent not connected to any ducting, but it is also not properly sealed. By having this penetration in the ceiling, the building is losing heat any time the heating or air conditioning is turned on.

Each part of a building when viewed individually is made up of simple components such as drywall, framing, and plumbing/electrical penetrations. These simple components are hidden in the complete building, making it difficult to identify efficiency loss mechanisms. Both attics and crawl spaces are areas of a home where many of these problems can be found. Almost all mechanical, electrical, and plumbing in a house is routed through these unconditioned spaces and then penetrates into the conditioned space. Figure 4 shows the heat vents through the ceiling of a rental property in San Luis Obispo.

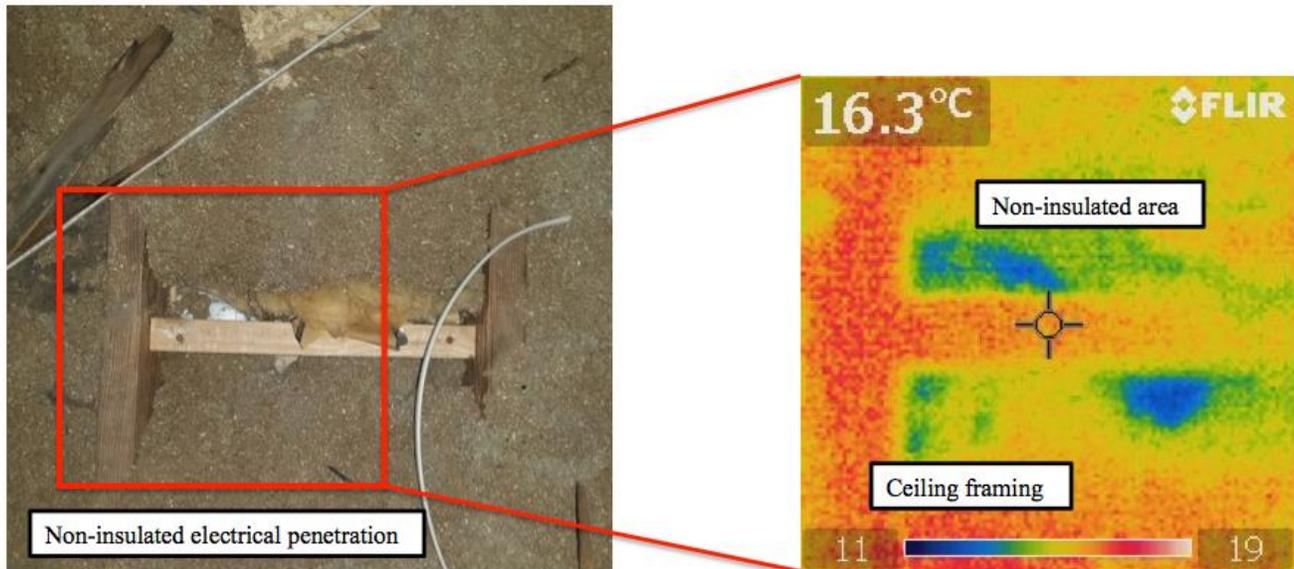
Figure 5. Insulation pulled back from recessed light fixture

In this image, it can be seen that the insulation was pulled back to expose the electrical box so work could be performed. After the work was done, the insulation was not properly put back in place. The image on the right shows the result of not reinstalling the insulation properly. This image shows the temperature difference between the areas with the insulation working properly and where the insulation is not functioning. The temperature difference between these two areas becomes more pronounced with more extreme outside temperatures.

Even though buildings may have insulation in the walls and ceilings, the insulation is only as good as the installation. Improperly installed insulation can be almost as bad as not having insulation in the first place. Figure 5 shows improper installation of insulation around an electrical penetration.

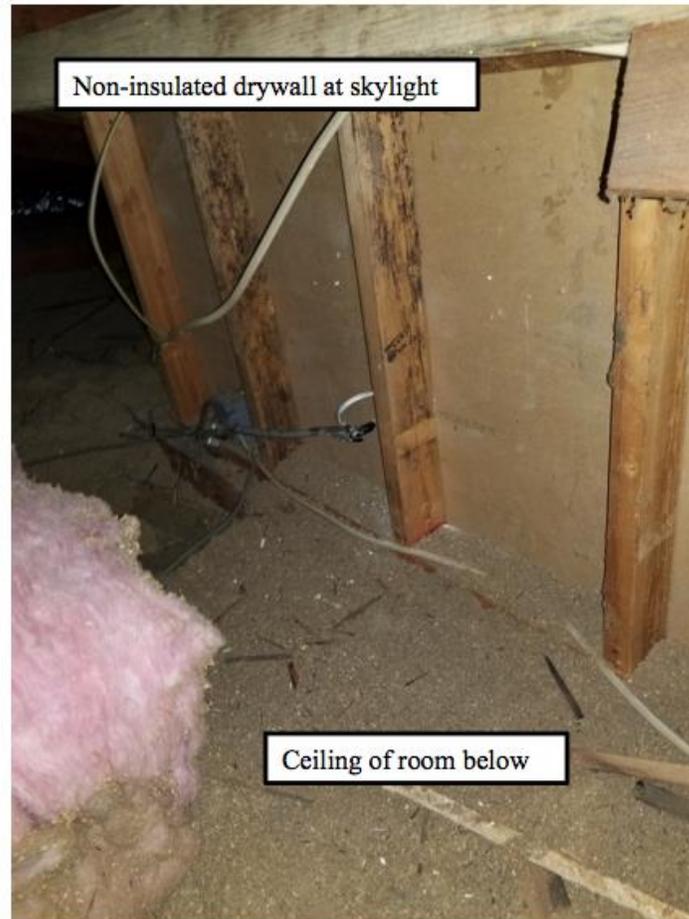
Figure 6. Skylight in home viewed from attic

When this skylight was added to the home, a hole was cut through the existing ceiling and roof in order to add the skylight to the kitchen. While there is no evidence of water damage from the roof penetration, there is also no insulation around the new framing. The implications of this are that the unconditioned space of the attic is almost in direct thermal contact with the conditioned space of the kitchen ceiling. There are also penetrations in the sheet rock for electrical boxes that are not sealed; meaning air is free to flow between the kitchen and attic. These air leaks at the top

of the building envelope are not only active because of the building's pressure differential, but are also causing the dirty air of the attic to be directly circulated through the house.

Improper remodels or additions also lead to building inefficiency. Many of the rental properties in San Luis Obispo have been remodeled or have additions. Additions are common in rental units to convert living rooms to extra bedrooms, or to add bedrooms by sacrificing yard space. “Heat leaks” are introduced when these additions and remodels are not properly done with best building practices in mind. Figure 6 shows an improperly added skylight.

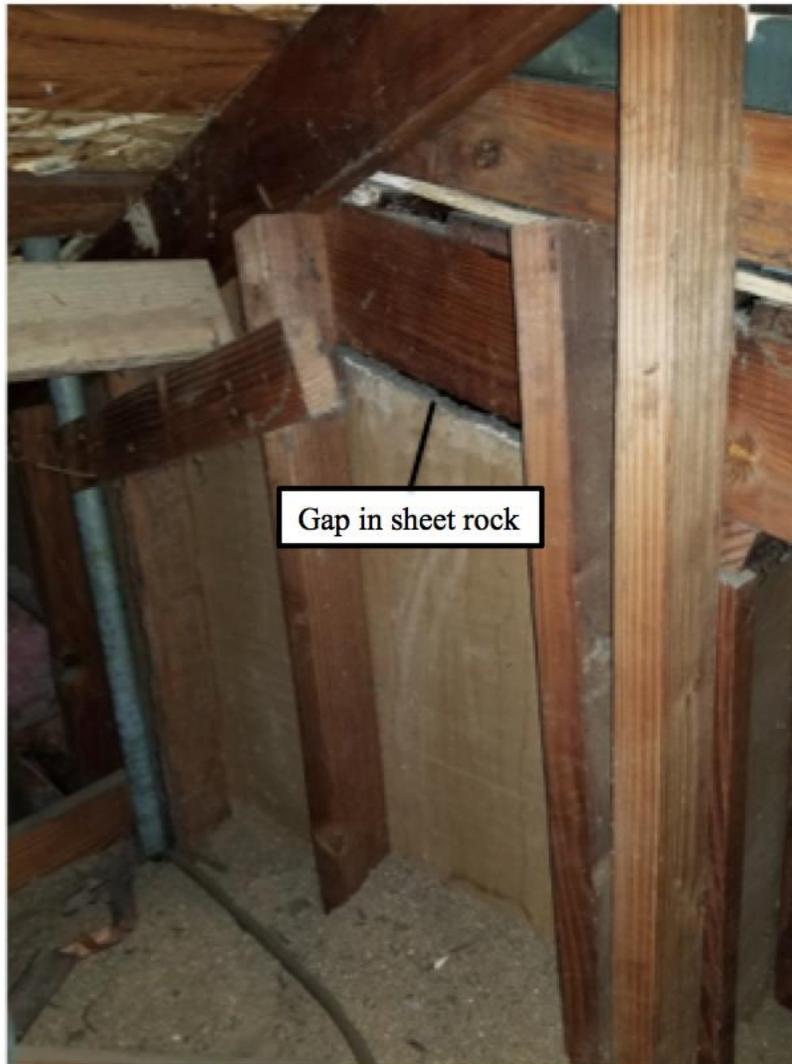
Figure 7. Framing of existing home to garage addition

The framing of this addition is similar to the skylight addition. The new space was framed to the desired shape and then sheet rocked. No insulation was added at the new interface between the

attic and the conditioned space. In this addition, there is also a $\frac{3}{4}$ " gap in the sheet rock, which causes the interior space to be completely open to the attic.

Figure 7 shows an example of a poorly constructed addition. In this home, an existing detached garage was connected to the home and a bedroom was added behind the garage.
