PRELIMINARY REPORT ON DECEMBER 22, 2003 SAN SIMEON EARTHQUAKE

Rakesh K. Goel, M.EERI

Department of Civil & Environmental Engineering,
California Polytechnic State University, San Luis Obispo, CA 93407rgoel@calpoly.edu

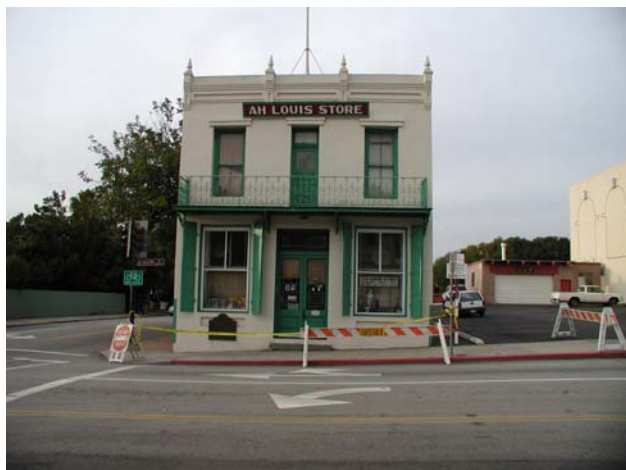
Ah Louis Store (Figure 25), a two-story unreinforced masonry building located on the corner of Palm and Chorro Streets, is designated as a historic landmark in the city. No noticeable change in cracks on the south-west wall, which has been retrofitted, was observed after the earthquake (Figure 26). However, new cracks appeared on the north-east wall of the building

Figure 25. Ah Louis Store in downtown San Luis Obispo (Picture by Rakesh Goel).
