STRUCTURAL RECONNAISSANCE FINDINGS OF
THE 2017 MEXICO CITY EARTHQUAKE

BY
RACHEL G. CHANDLER

SENIOR PROJECT REPORT

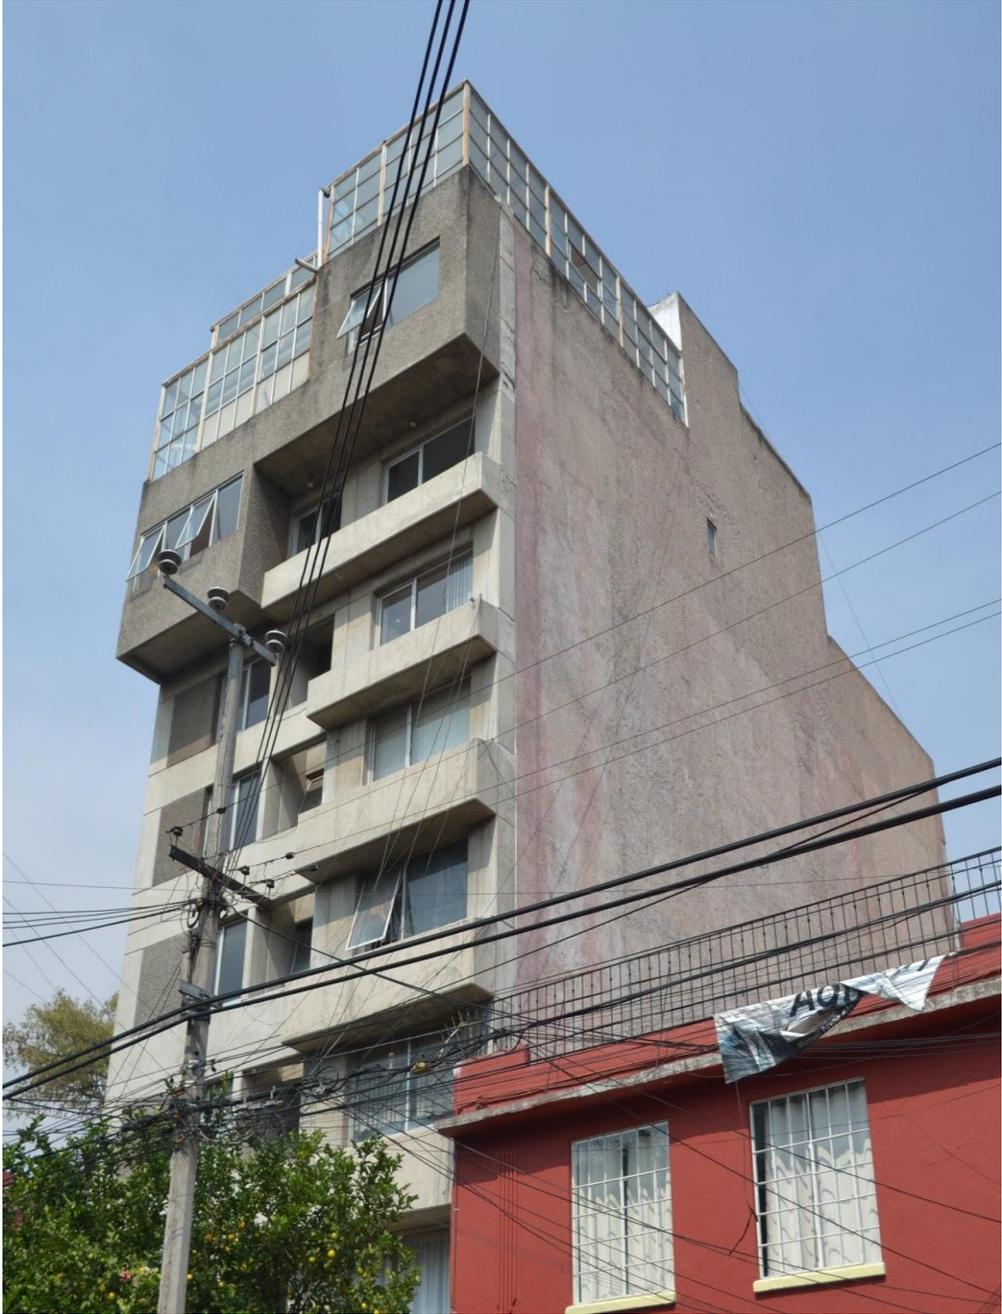
Figure 14: Exterior View

The major vulnerabilities identified in this structure were:

1. Vertical irregularity at first floor parking where walls/columns included on other story levels are discontinued;
2. Torsional irregularity due to the separation gap (reentrant corner) located in between the two apartment units; and
3. Irregular floor plan that resulted in rocking action between the two units.

Pounding between adjacent buildings was common in the 2017 Mexico earthquake; however, visual inspection of this building indicates minimum clearances of at least 2 ft (0.6096 m) on each side, thus avoiding this damage type.

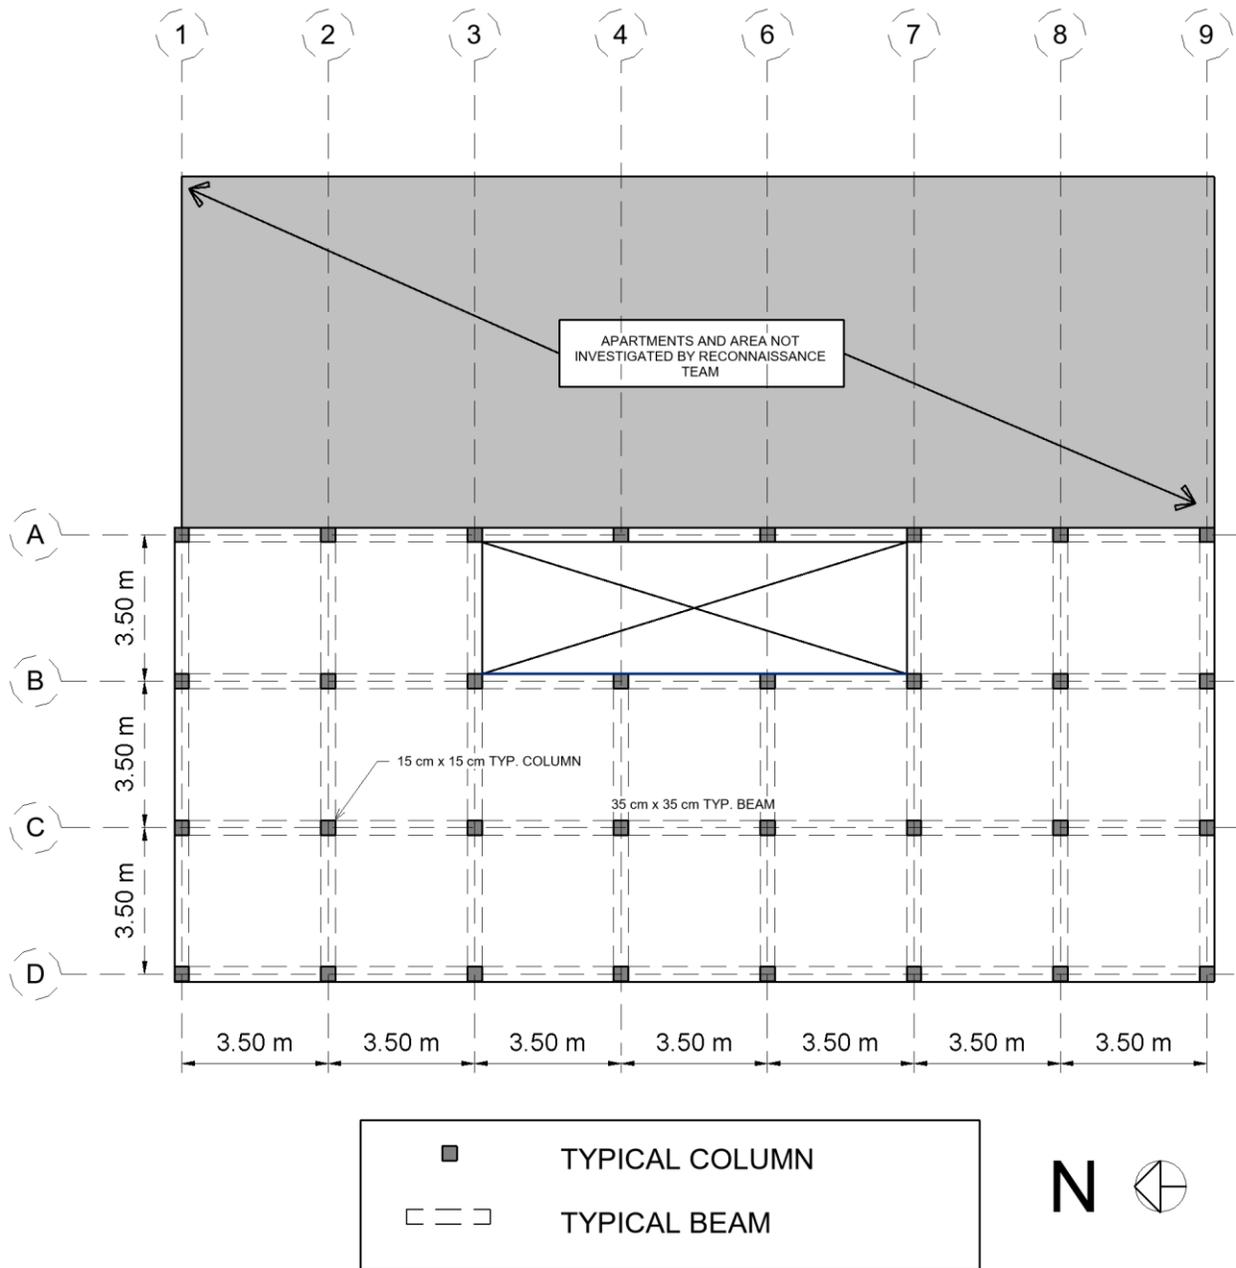
Figure 22: Sketch of Building Plan Level 1

The main lateral force resisting system is comprised of a reinforced concrete frame with unreinforced masonry infill walls. There was a section of the building in which the reconnaissance team did not have access to document or collect data as noted in Figure 22.

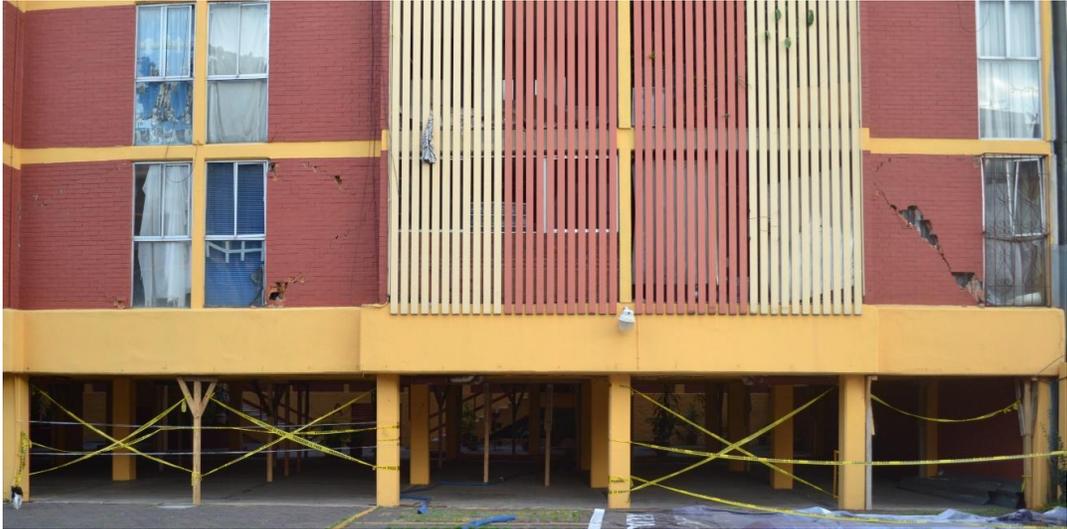
Figure 23: Exterior View of Soft Story Irregularity

The major vulnerabilities identified in this structure were vertical irregularity at the first floor and torsional irregularity located in the center of the floor plan. The vertical irregularity/soft story results from walls and columns that are terminated at the first floor (above the parking level) as shown in Figure 23. The full-height cutout in the center of the building creates a reentrant corner irregularity as shown in Figure 24.

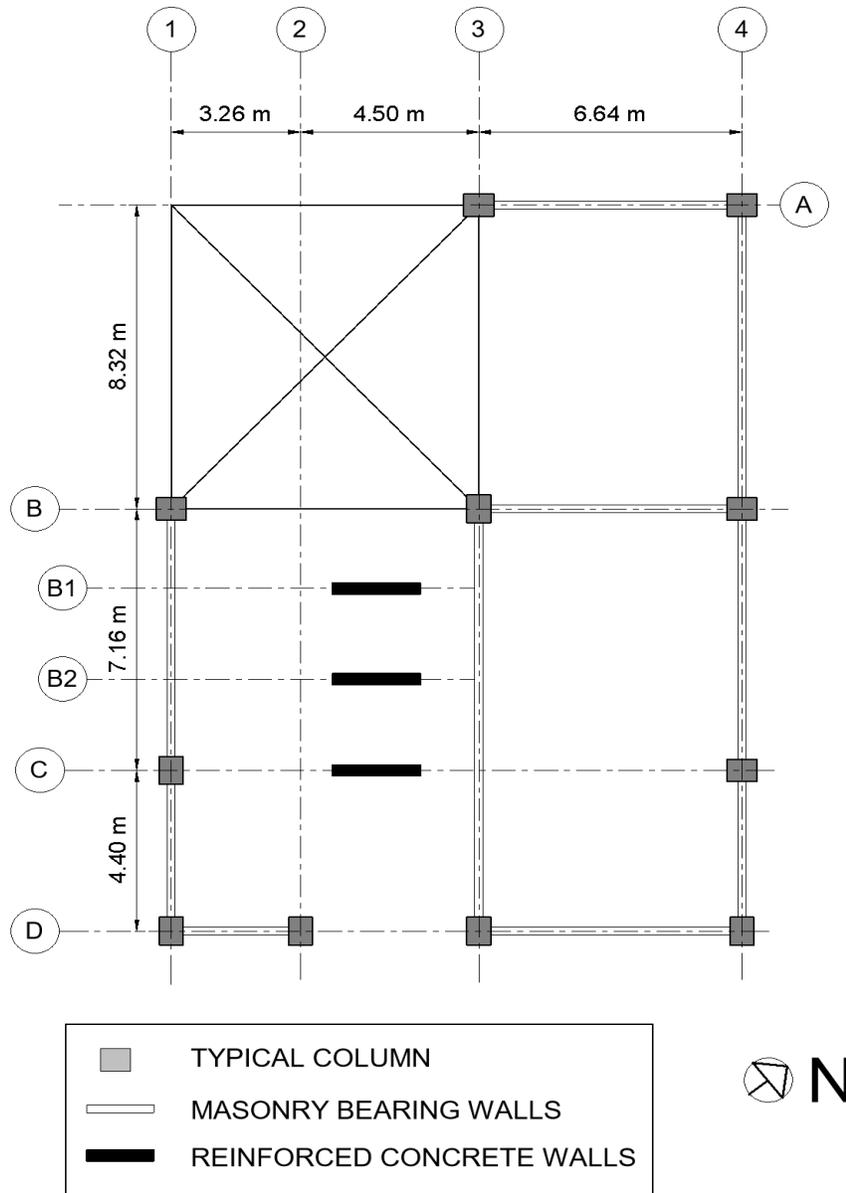
Figure 32: Sketch of Building Plan Level 1

The main lateral force resisting system is comprised of a reinforced concrete frame with unreinforced masonry infill walls. A concrete core around the stairwell and elevator provided additional lateral strength as shown in Figure 32.

The major vulnerabilities identified in this structure were vertical irregularity at the first floor and torsional irregularity continuous along height of the building. The vertical irregularity at the first floor is created by discontinuous walls and columns at the first floor in between lines 3 and 4 in Figure 32 that results in the soft story shown in Figure 33. The reentrant corner in the top left of the building's floor plan seen in Figure 36 creates a torsional irregularity.

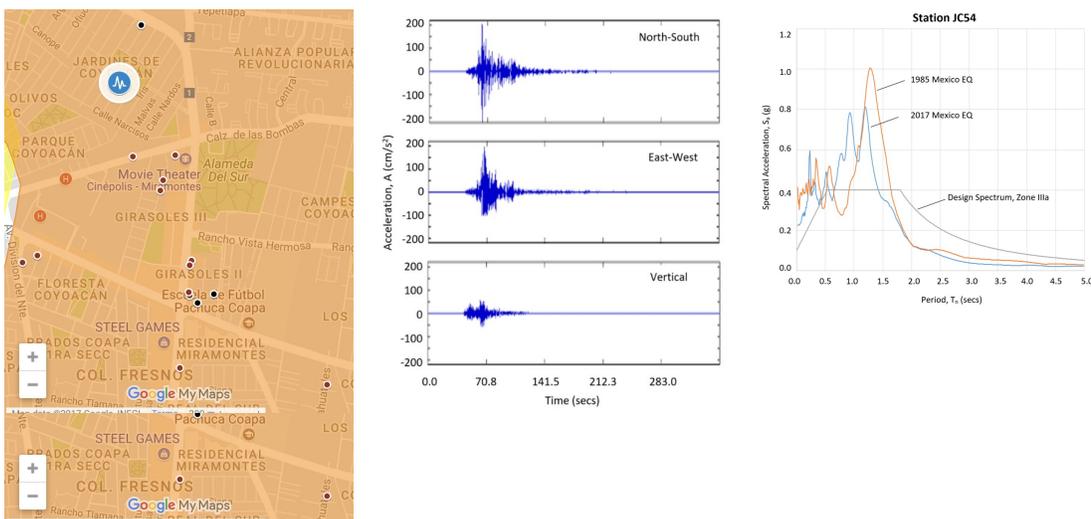
Along Miramontes there are primarily residential buildings with an average height of 5-stories. The map below shows the nearest seismic recording station in Parque Jardines de Coyoacán (Station # JC 54) indicating a peak ground acceleration of 220 gals (1 gal = 1 cm/s^2), equivalent to about 0.22g. To the right of the map is the acceleration record from this station for N-S, E-W, and vertical motion. Note the significant spike in magnitude in the N-S direction nearing a time of 70 seconds. Also located below is a response spectra which plots of building period versus spectral acceleration S_a for the 1985 and 2017 earthquakes, as well as the design spectra for the site (orange, blue, and grey lines; respectively). It is important to note that how both earthquake spectra exceed the design spectrum.

ABOVE: PARQUE JARDINES DE COYOACAN AMAX: 220 GAL (LEFT), ACCELERATION RECORD (CENTER), RESPONSE SPECTRA (RIGHT)

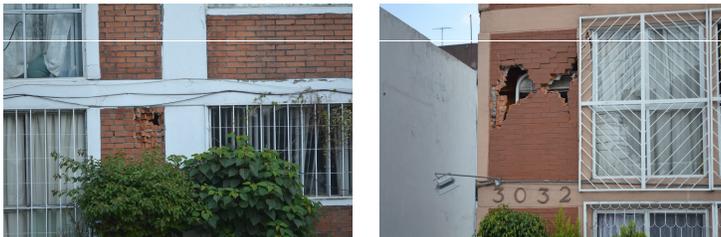
Our investigations of apartment buildings along Miramontes revealed wide shear cracks-to-partial collapse of masonry infill walls and significant structural damage to first-floor columns. The team concluded that the severe damage to masonry infill likely led to loss of stiffness in the building requiring the columns to carry considerably more demand. Dr. Rodriguez pointed out that despite the susceptibility of unreinforced masonry infill walls to severe damage, they are quite prevalent in Mexico due to their low cost, ease of constructability, and construction tradition of over a hundred years.

1. Be careful of first-floor soft stories with low stiffness particularly where shear demands are expected to be high. Use columns with larger cross-sections or more reinforcement so these members (and the story as a whole) can achieve a greater stiffness.
2. Unreinforced masonry infill is brittle and can experience significant non-structural damage. It should be noted that intact infill walls do add stiffness/strength to buildings with reinforced concrete frame systems and when these infills fail, stress will be redistributed to the frame and may lead to column damage.
3. Avoid designing short/captive columns that tend to fail in a brittle manner via shear as shown in the image below. If short/captive columns are unavoidable, they need to be designed to resist high shear demands using larger cross-sections or more closely spaced shear reinforcement.

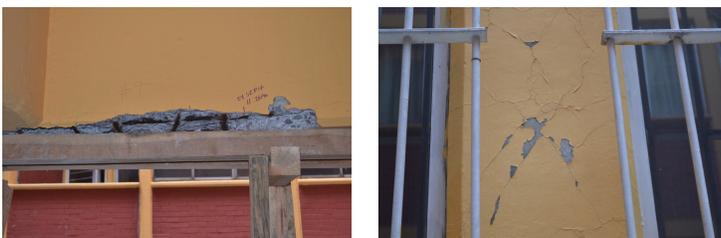
The apartment building, shown above on the left, exhibited shear and flexural cracks on columns and exposed rebar on its deep spandrel beams. The most important thing I learned from this case was that open first-floor garages have a tendency to reduce the building stiffness at this level where the shear force is the greatest.
