**IRRIGATION ENGINEERING IN SEISMIC ZONES – MEXICALI VALLEY, MEXICO**

USCID Sixth International Conference on Irrigation and Drainage

Alan Dennis Gracia, P.E.<sup>1</sup>  
Charles M. Burt, Ph.D., P.E.<sup>2</sup>  
Mario Paredes Vallejo<sup>3</sup>

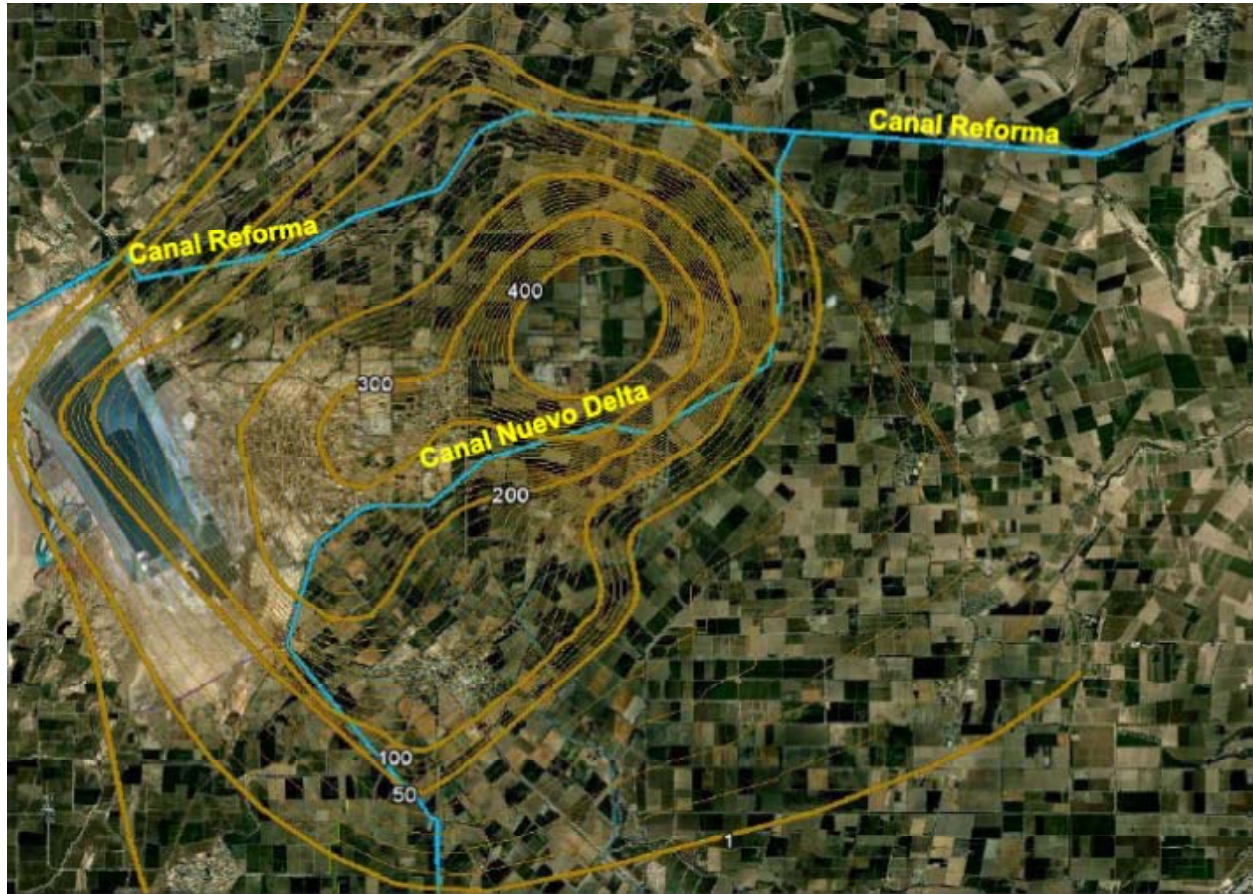
The areas of the Valley that experienced the most earthquake damage had also recently experienced serious subsidence problems, which are attributed by some to the adjacent geothermal energy fields that may have insufficient groundwater recharge. Figure 2 shows anticipated subsidence over the next 30 years, although in some areas the 2010 earthquake caused more than twice the 30-year predicted subsidence.

Figure 2. Lines of equal subsidence predicted by CICESE to occur within 30 years. Units are cm. The geothermal production zone is on the center left-hand side of the figure. The blue lines show the Reforma Canal (top, flowing right to left), and the old, damaged Nuevo Delta Canal (center, flowing from top to down).

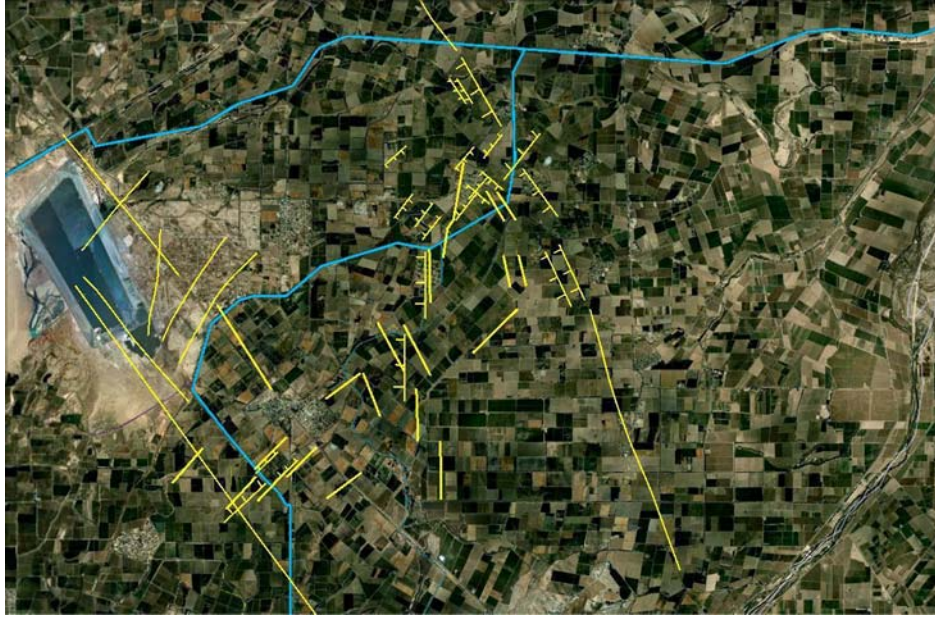
Besides subsidence, the design also had to consider locations of fault lines and zones of liquifaction. Figures 3 and 4 indicate the locations of these potential problem zones.

Figure 3. Fault lines in relation to the Reforma Canal and Nuevo Delta Canal.

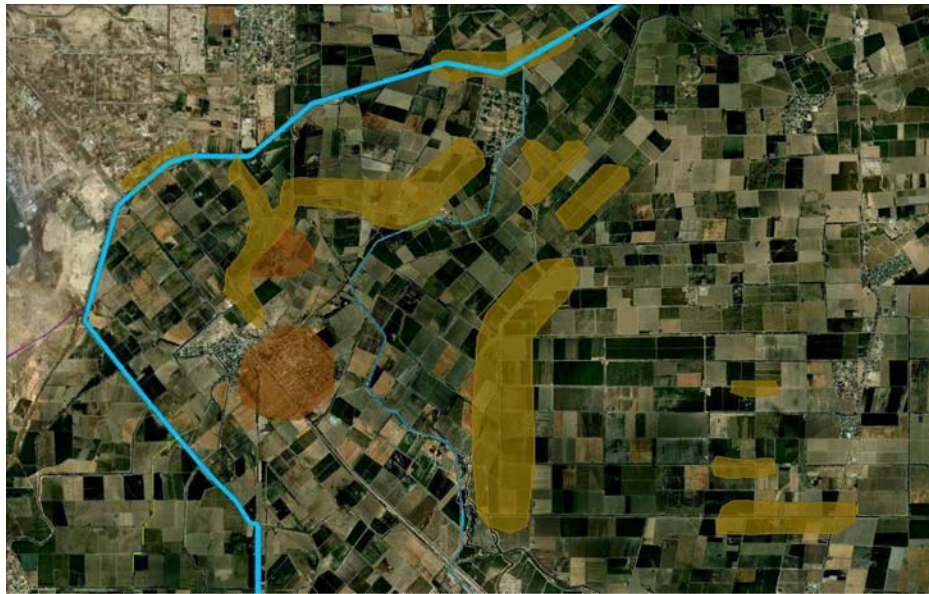
Figure 4. Zones of liquefaction in relation to the Reforma Canal and Nuevo Delta Canal.

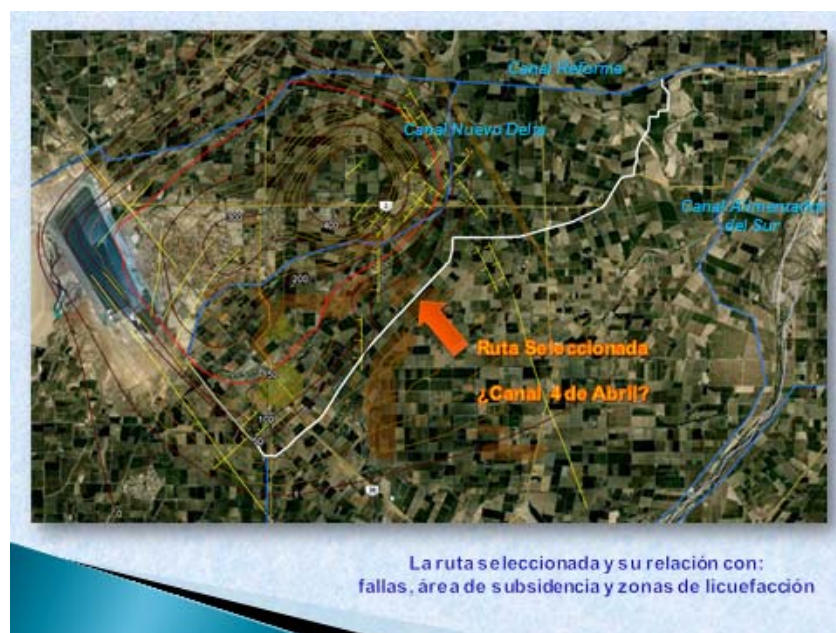
The damaged Nuevo Delta Canal traversed multiple fault lines and liquefaction zones. Plus, it fell within zones of anticipated subsidence.

Figure 10. Proposed route of new canal, showing faults, subsidence, and liquefaction zones.

Over thirty different replacement routes were analyzed and compared in terms of economics, right-of-way acquisitions, residential relocation costs, road crossings, topography, costs, available pressure, command area, and ability to enhance existing water delivery service. These considerations were overlaid on the maps of subsidence, liquefaction, and faults. The final route is shown in Figure 10.
