# INSTRUMENTATION AND EVALUATION OF DISTRICT 10 CALTRANS AUTOMATED WARNING SYSTEM (CAWS)

## Technical and Operational Assessment

Prepared for the California Dept. of Transportation and California Office of Traffic Safety  
by Loragen Corporation, San Luis Obispo, California

Document No. L-D10-FR-03

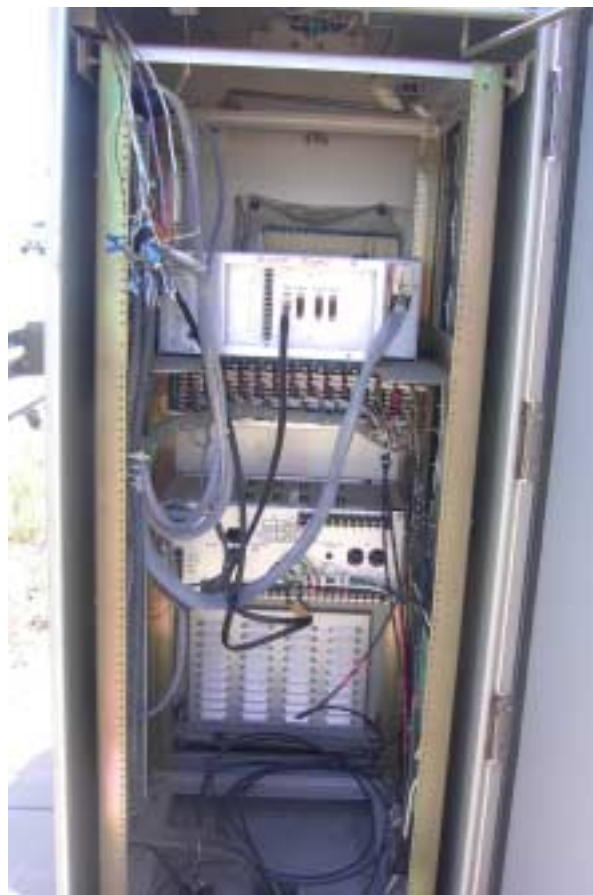
**Figure 3.2.3.1. Inside of Type 334c control cabinet containing CAWS traffic monitoring equipment.**

In our inspection of most of the cabinets of the CAWS, we found the wiring to be neat and well-labeled, and all components in each cabinet installed consistently. The one exception was the phone circuit wiring into some of the cabinets, which can be seen at the top right of Figure 3.2.3.1. This was inconsistent, and in several cases, we noticed that the circuit shields had not been grounded at the cabinet. While the circuits may have been grounded back at the demarcation box, possibly several thousand feet away, the lack of a local ground can cause serious noise problems when terminated at the 170 modem.

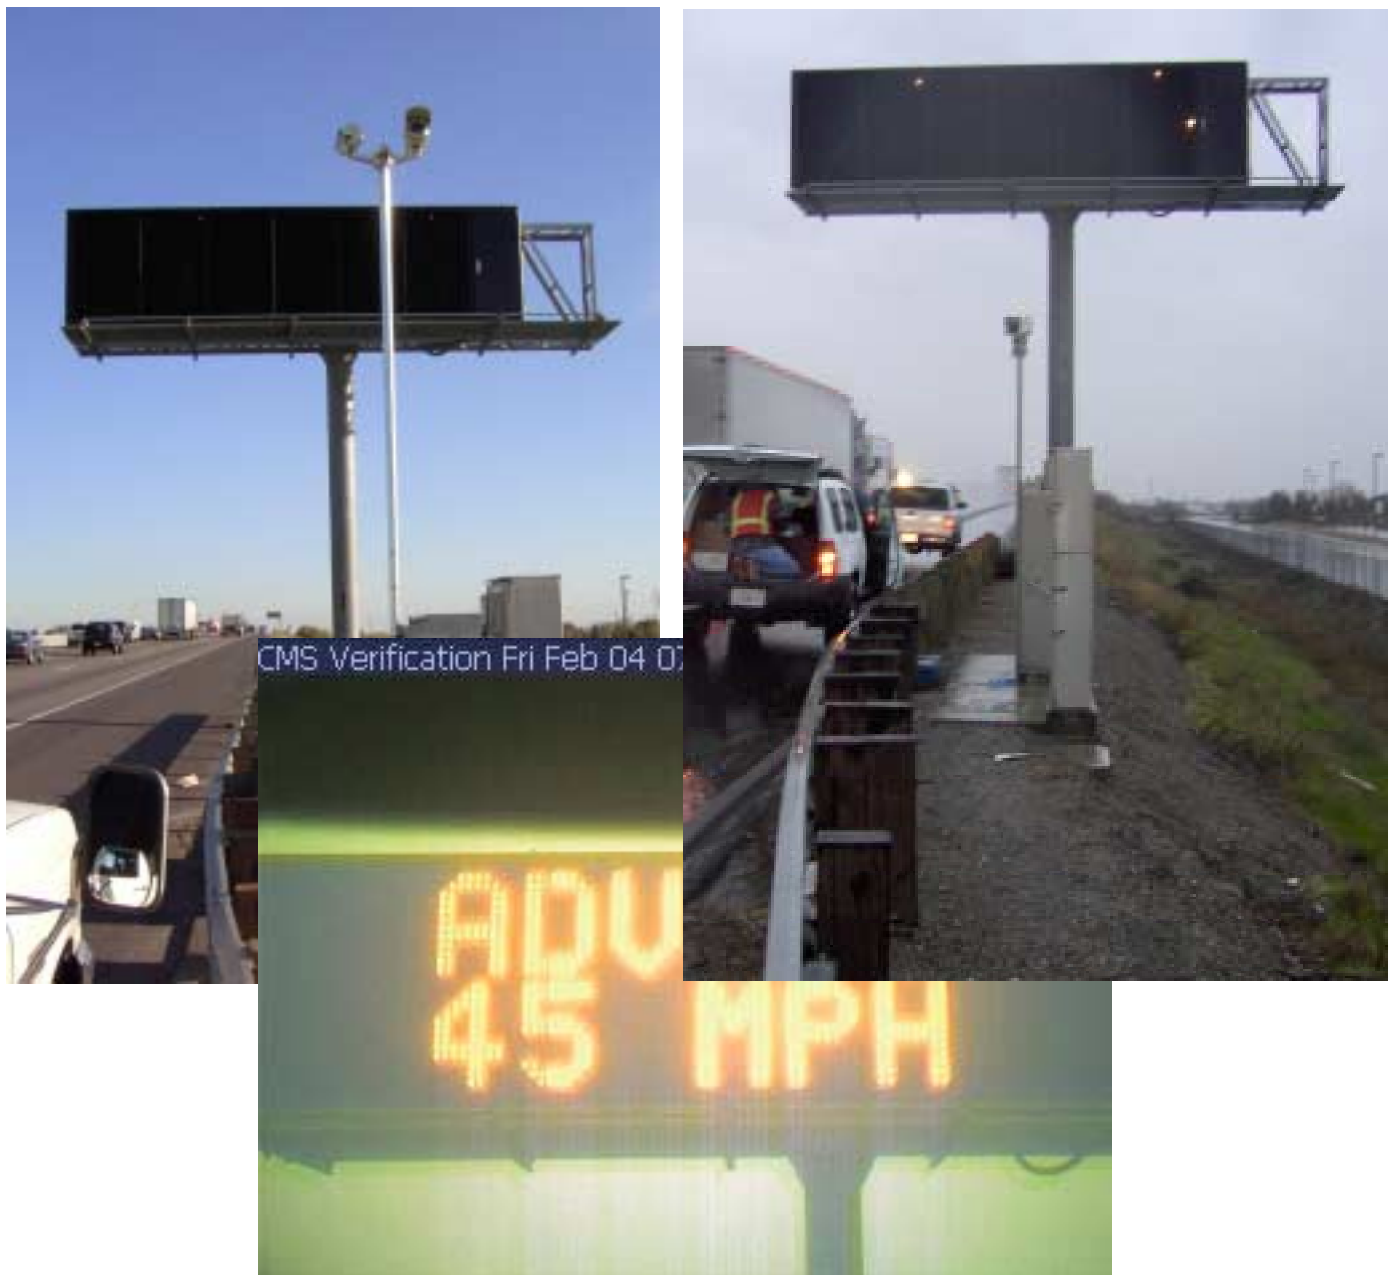
Figure 3.2.4.1. CMS 1, located near County Hospital Road (day on left, ADVISE 45 MPH Message in middle, dusk on right).

Base on our observations and interviews with district maintenance personnel, we were not aware of any significant problems with the CAWS CMSs during our period of evaluation. A persistent problem with occasionally “stuck-on” or burned-out bulbs was observed, which can be seen in the dusk (right) photo of Figure 3.2.4.1. This problem was eliminated following a major panel replacement in November 2003, just prior to the first full fog season considered in the driver behavior study, as captured by our CMS verification camera in Figure 3.2.4.2.

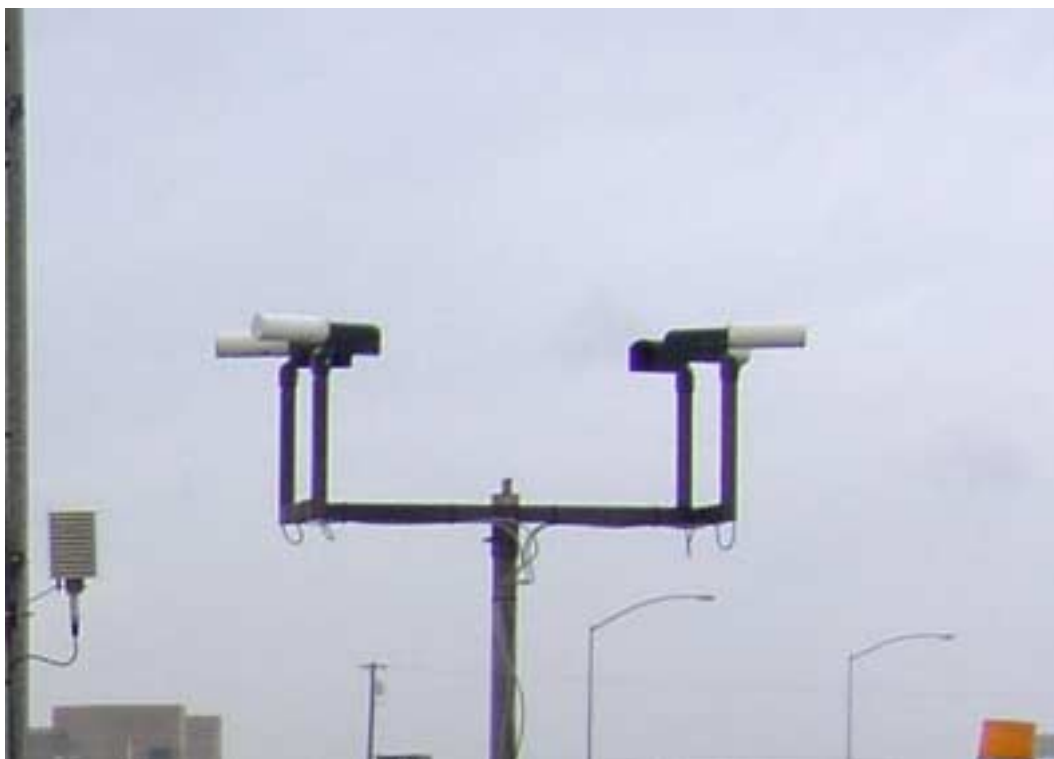
**Figure 3.2.5.3. Qualimetrics Model Z004510 forward scatter visibility sensor (center) and Model 5140 temperature/humidity probe (left), installed at each remote weather station in the CAWS.**

The visibility sensor required the most frequent service (once a month according to the manufacturer's manual), due to the need to periodically clean the windows on the two emitters and two detectors, seen in Figure 3.2.5.3. In addition, frequent recalibration was recommended, since the detector was prone to drift with time. Each of the emitters and detectors contained heaters to prevent condensation forming on the optics. According to the District maintenance staff, the most common failure items in the weather system were the heaters in the visibility sensors.

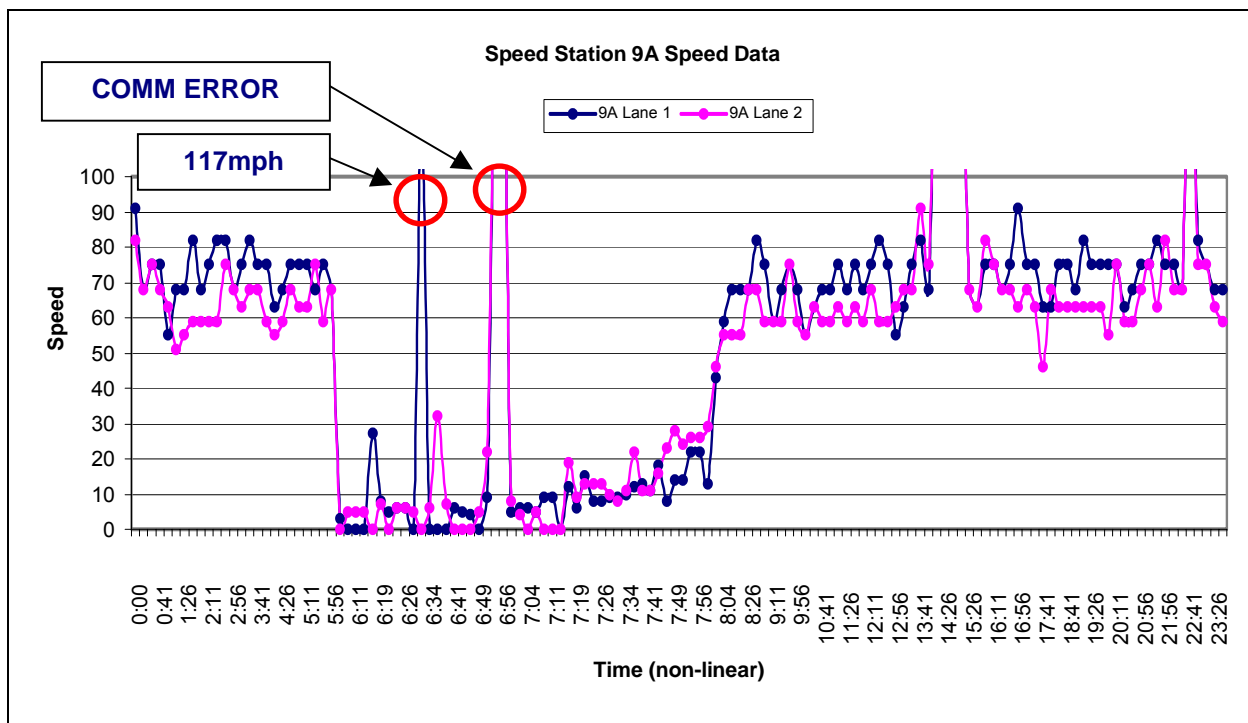
Figure 3.3.2.2. Speed Site 9A.

The exact location of the light pole referred to in the first accident report is unknown although the vehicle may have lost control around the I-5 bend. The traffic data from the TMS (speed monitoring) computer in the D-10 Traffic Management Center (TMC) showed that there were no significant speed disturbances before or after the 'Y' section on I-5 during this time. However, SR-120 traffic slowed down abruptly at speed station 9A. Only a minor decrease in speed was detected at speed site 9B which could be attributed to traffic regaining speed after passing the second accident. The speed data for sites 9A and 9B are shown in Figure 3.3.2.2 and Figure 3.3.2.3, respectively.

We found from examination of the TMS and Signview computer source code that communications failures are reported by the speed monitoring sites as 240 mph (the maximum code-able speed), and detection errors of any type, as well as speeds equal to or above 150mph, are reported as "ERR". In the plots below, for numeric consistency, all "ERR" speed conditions from the TMS log files have been converted to 150mph speeds. Spikes in the speed data plot below actually represent "ERR" conditions.

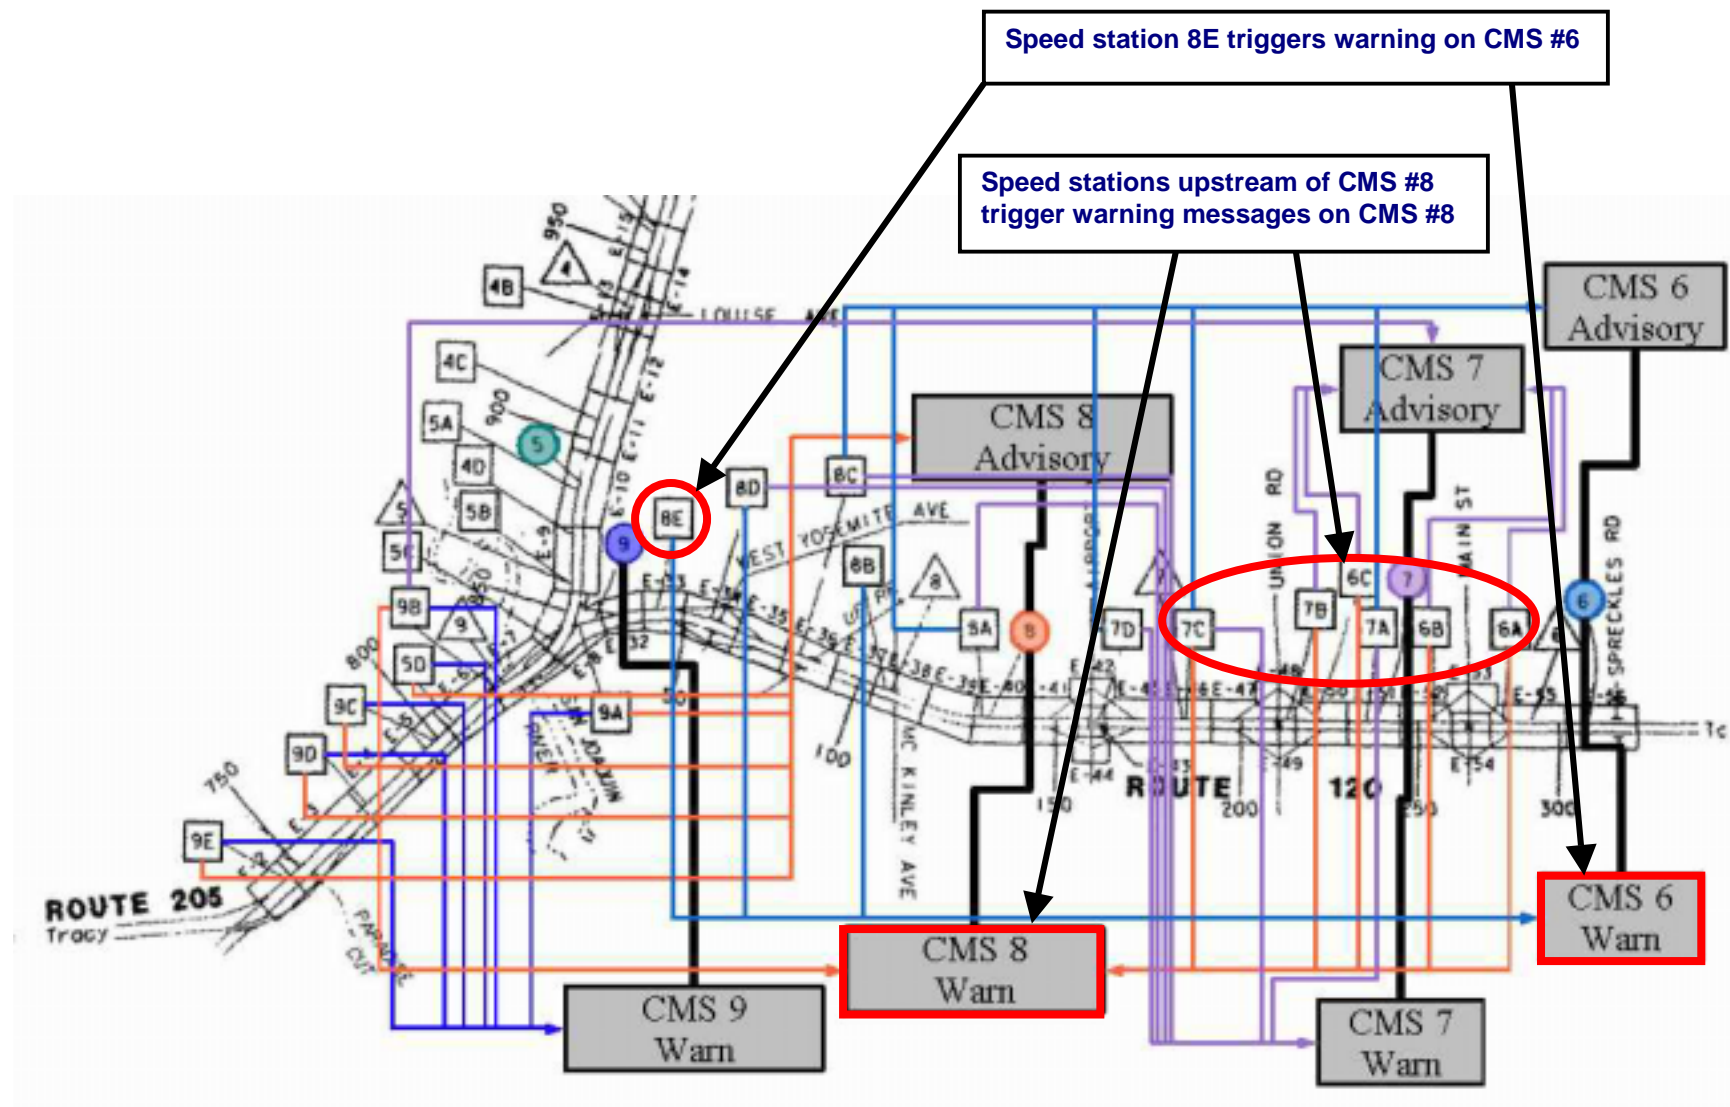
Figure 3.3.2.6. SR-120 Speed Site – CMS Mapping.

incorrectly associated speed monitoring sites with CMS's. This error was eventually found to be due to a change in the site numbering convention incorporated in the final system, but the retention of the old mapping table. The error was corrected during a system software update September 29, 1997, approximately eleven months after the start of CAWS operation. A derived complete diagram of the original version of the CMS-speed station mapping is shown and described later in Figure 3.8.1.2. Figure 3.3.2.6 is a subset of this diagram which provides a close-up of the activation path for CMS 6 and 1:15 pm. The speed log files for this event show that speed station 8E delivered data to Signview at 1:15 pm which triggered the stopped traffic message on CMS 6. The corresponding data from speed site 8E is shown in Figure 3.3.2.7.

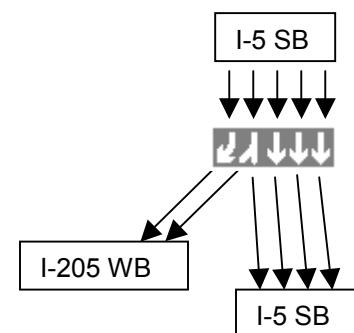
On this same day, speed monitoring site 9E (the closest to the I-205 and I-5 split) showed signs of stopped traffic in lanes 4 and 5 prior to 11:15 am. This data is shown in Figure 3.3.2.8. But the system activated at 11:56 am, 41 minutes later. This delay occurred despite the stopped traffic condition in 4 and 5 at 5-lane Site 9E because lanes 1 and 2 were above 50 mph. Activation did not occur until traffic had backed up all the way to Y junction, and a slow traffic condition was detected by Site 8E.

Speed site 9E is the southern-most of four speed sites monitoring the 5-lane section after the I-5 and SR-120 merge area. Speed site 9E immediately precedes the westbound I-205 exit. If congestion occurs on I-205 and backs up into this transition section, speed site 9E is the first to detect it. Therefore, detection of slow or stopped traffic in the merge lanes at Site 9E is critical to providing advanced warning to drivers entering the I-5 / SR-120 merge zone.

The 5-lane merge zone at the convergence of I-5 and SR-120 (known as the Mossdale Y) is known from the Collision Data Analysis volume of this report to be an area of relatively higher accident rates, and was one of the original motivations for the construction of the CAWS. It appears from the TMS log data that the “inhibit if any lanes greater than 50 mph” strategy that may have been appropriate in the two or three lanes sections of the CAWS area, was inappropriate in this case, since the actual merge lanes (4 and 5) are routinely backed up due to congestion on SR-205, but are beyond the sight distance of traffic approaching from either SR-120 or I-5. Lanes 1-3 are through lanes for I-5 which typically flow at speeds greater than 70 mph. In this case, the 50 mph inhibit strategy resulted in the system’s inability to activate at the ‘Y’ due to congestion occurring only in the merge lanes.

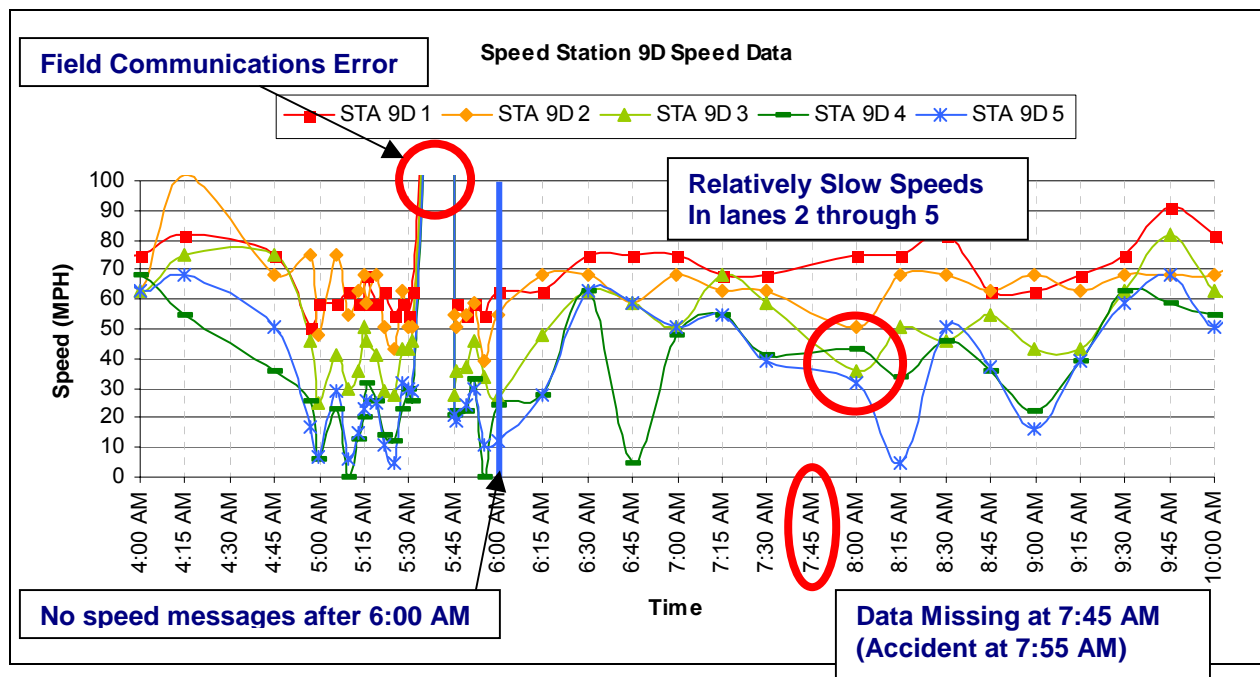
**Figure 3.3.3.2. Speed Site 9D Speed Data.**

Following the accident, the system did not activate for speed despite the slow or stopped traffic in lanes 4 and 5 at speed stations 9D and 9E, since speeds in the I-5 through lanes (1-3) did not all drop below 50 mph. In fact, the speed log file shows that no speed conditions were detected after 6:00am. At this time, the log file resumed the 15-minute logging interval. Unfortunately, the 7:45am reading was absent from the speed log file, potentially due to a full-system communications interruption. That entry would have immediately preceded the 7:55 am accident. Figure 3.3.3.2 and Figure 3.3.3.3 indicate that the system detected slow speeds before the accident occurred.

Constant zeros were reported for the two slow lanes (Lanes 4 and 5) at the southernmost speed site 9E. Because volume information is not logged by the TMS software, there is no way to tell if ‘0’ meant 0 mph or no vehicles had been detected. The system failsafe assumption in the event of no data is zero volume, which inhibits the TMS from generating a speed alarm for these lanes, despite the obviously slow or stopped traffic condition in lanes 4 and 5 due to the accident at this location.

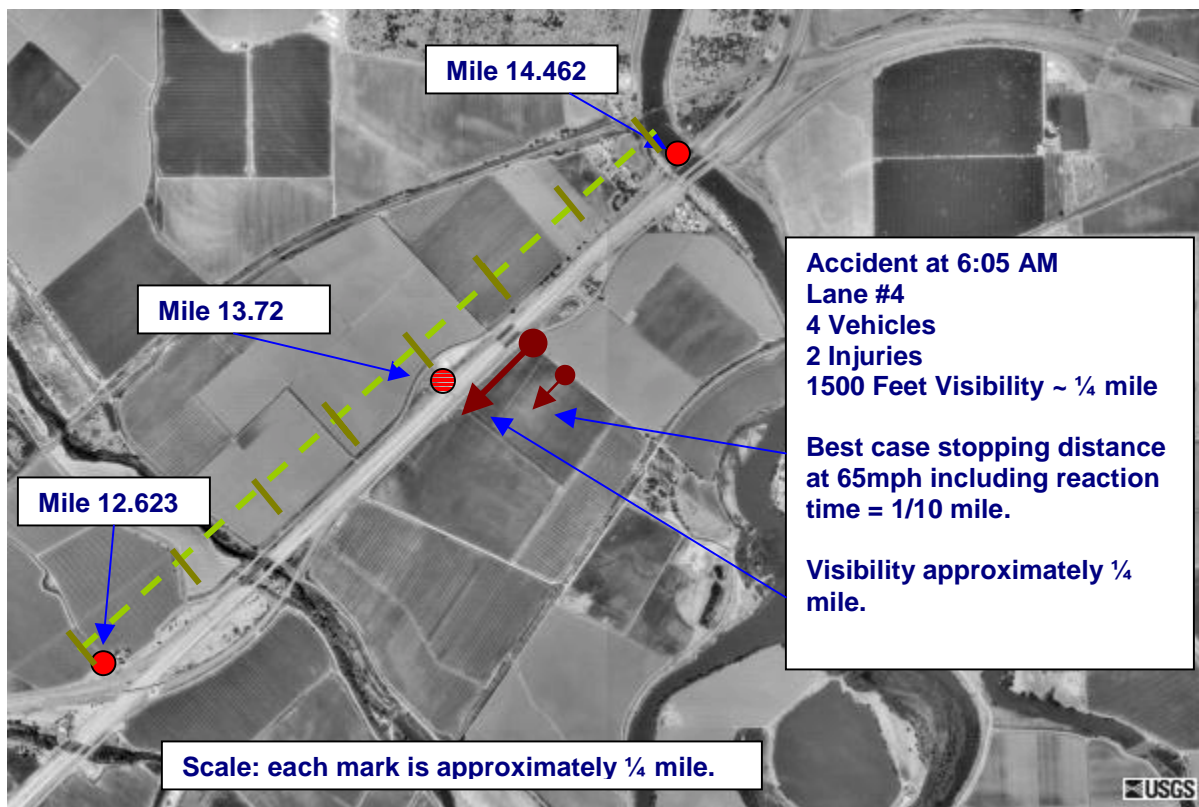
**Figure 3.3.3.5. Accident Location (2004-01-12).**

Weather Station 9, the closest to the accident, reported visibility as 324 meters (1063 feet); the other CMSs showed similar readings. The worst visibility was reported at Weather Station 1 (Mathew's Road) and was 890 feet. The QCMS communications log entries for all Weather Stations at 6:00 am are shown below. The logging interval for the QCMS was 5 minutes. The M M M fields in the entry for Weather Station 9 indicate "Missing Data" at the reporting time.

In this case, the CAWS functioned as designed, and its handling of missing data from WS 9 was confirmed. The other (correctly functioning) weather stations properly did not generate warning messages when visibilities did not warrant it. Although visibility was somewhat poor, the accident could best be attributed to driver error compounded by lane speed differences in the merge zone.

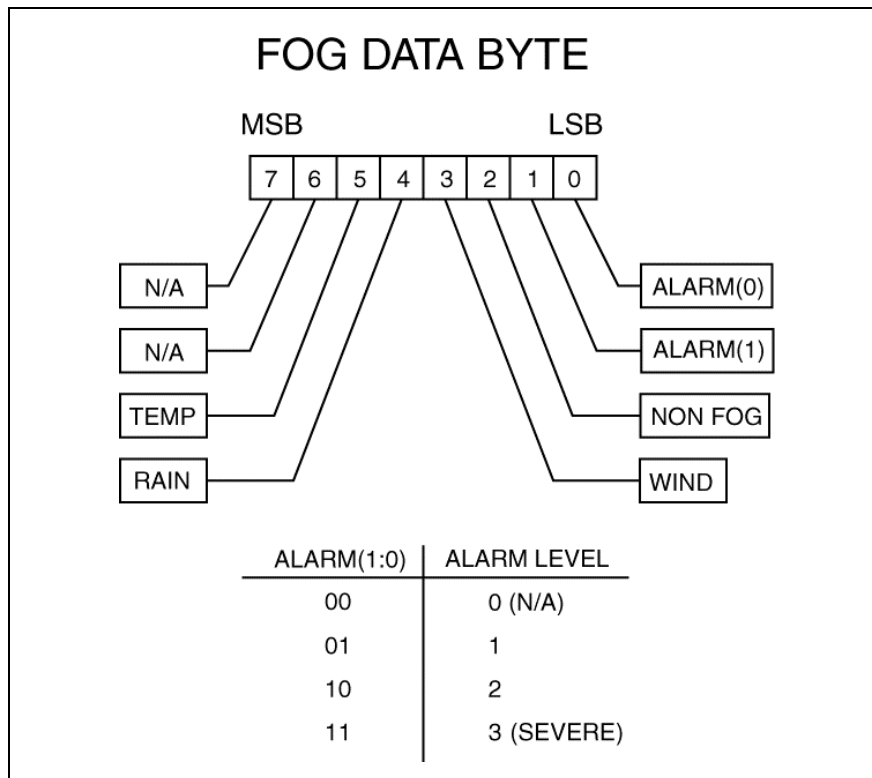
**Figure 3.5.2.2. Fog level alarm byte bit definitions.**

In data transmitted to Signview, the QCMS computer sends two bytes of information per weather station: the first byte contains the weather station number and the second byte contains an alarm flag status. The alarm flag byte is referred to as the “FOG DAT” or “WS FLAGS” byte inside Signview. The mapping of alarm codes to byte values is shown in Figure 3.5.2.1. The format of the alarm flag byte is further explained in shown in Figure 3.5.2.2. Only the two least significant bits are read by Signview for messages activation purposes.

With reference again to Figure 3.5.2.1, Signview recognizes only second byte values hex values 1, 2 or 3 (not 4 through F) as valid fog alarm levels. These codes are generated on when both visibility thresholds are exceeded, and when relative humidity is detected over 75%. Second byte values 5,6,7,D,E, or F correspond to basic visibility thresholds. They are not triggered if RH < 75%. This causes the CAWS to ignore poor visibility caused by sources other than water fog, for example, dust or smoke which are prevalent in the CAWS area. It also cannot respond to poor visibility if the RH temperature/RH sensor has failed, which we observed to occur several times during our two-year driver behavior study. Apparently, the RH sensor is a relatively high failure rate and instrument that is very expensive to replace. Unfortunately, District personnel were unaware of the distinction that Signview was making between fog and visibility because of this decoding strategy. They were therefore not aware that the RH sensor was a vital instrument for the activation of fog warnings by the CAWS, and these instruments were not among the highest service priorities. In most of the fog activation cases cited above, fog messages were not activated because of input, correct or missing, from the RH sensor.
