CHAPTER THREE

Characteristics of Housing Construction in Tecate colonias

HOUSING CHARACTERISTICS IN EL RINCON AND EL DESCANSO, TECATE

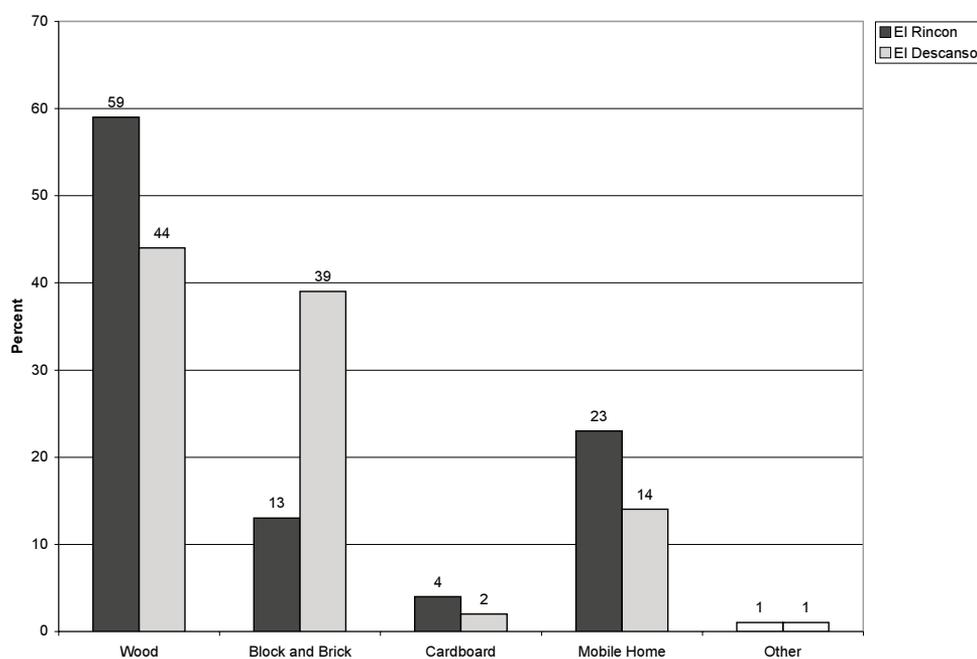
Figure 22: Primary Materials Used in House Construction in El Rincon and El Descanso

This residential area was characterized by substandard living conditions based on a sample of 175 houses. Of the houses in the El Rincon area, 59% were composed primarily of wood, 13% of brick or concrete block, 4% of paper carton, and 23% were pre-manufactured (mobile

homes or recreational vehicles), with the small remaining fraction consisting of amalgamations of found materials (Figure 22). Most dwellings seemed to have been built with local materials. There were some hardware outlets located close to this area and some, smaller scale ones were attached to dwellings within El Rincon.

The El Descanso area exhibited better planning and housing conditions. Some of the streets were paved, and had curbs and gutters to control storm water. A sample of 175 houses was observed in order to obtain a breakdown of the construction materials used in existing housing units in the area (Figure 22).

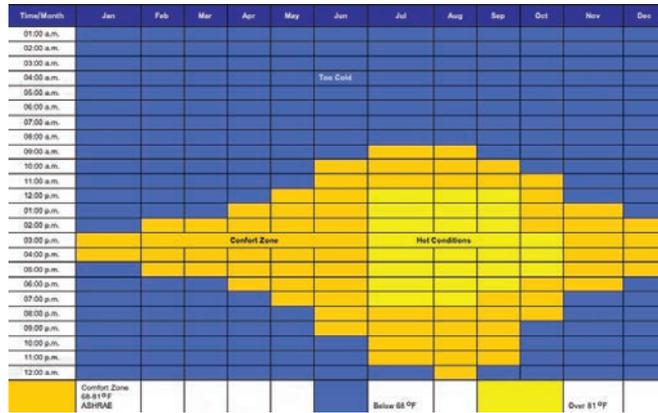
Figure 28: Tecate Comfort Zones
 Source: Ernesto Fonseca

Indoor temperatures in the types of structures observed in El Rincon are not ideal for achieving an acceptable and healthful environment. It is important to understand thermal comfort so that recommendations on construction materials can be developed. Figure 28 delineates the periods during the year when temperatures in Tecate fall above 81° F (dark yellow) or below 68°F (blue) which is the comfort range defined by ASHRAE. The diagram illustrates that both heat and cold must be contended with in Tecate and shows the time of the year when heat or cold is a problem.

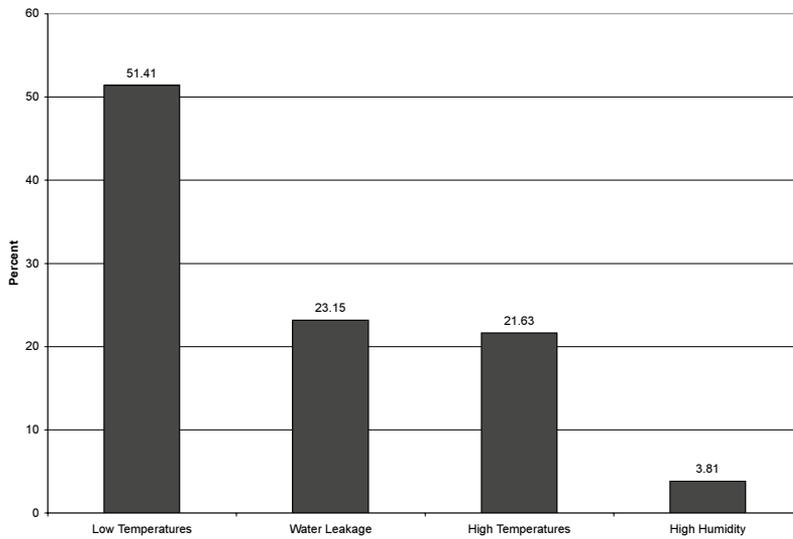
Figure 29: Factors Causing Environmental Discomfort in Homes

Figure 29 illustrates the different environmental factors within a house that affect El Rincon families the most. Most of the thirty

households interviewed reported that it was much easier to adapt and/or to tolerate warm and high temperatures, but that it was not possible to tolerate or protect against extreme low temperatures. Humidity was not reported as an important issue, but some people reported that even though it was not a major problem, it would be useful to design housing taking into consideration humidity rates during the summer.
