# EFFECT OF FOREIGN OBJECT DAMAGE ON THE FATIGUE STRENGTH OF AN XD™ $\gamma$ -TiAl ALLOY

T.S. Harding<sup>1</sup> and J.W. Jones<sup>2</sup>

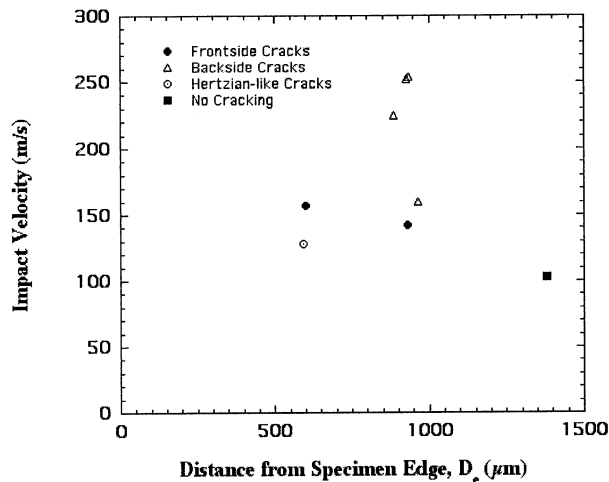
Figure 4. Effect of impact velocity and the location on damage type in the ballistically impacted 47XD alloy.

For the ballistic impacts, the position of the impact site and the impact velocity were chosen to produce a variety of crack sizes and geometries suitable for fracture mechanics analysis. Each specimen was impacted once according to the procedure described above. Specimens were impacted at nominal positions of 500, 1000 and 1500 $\mu\text{m}$  from the specimen edge. For each impact damaged specimen, the critical damage type was identified as that which led to fatigue failure as determined from fractography. As Figure 4 shows, at a distance of 1000 $\mu\text{m}$  from the specimen edge, the dominant damage type was a backside crack at moderate to high impact velocities. Backside crack size was observed to increase with increasing impact velocity. At low velocities, frontside cracks appear to be the dominant damage type. Closer to the specimen edge, impacts at relatively low velocities resulted in the formation of frontside and Hertzian-like cracks, suggesting that the formation of these sorts of cracks may be highly dependent on impact location. Furthermore, far from the specimen edge and at very low impact velocities, the impact resulted in only the formation of a crater with no signs of cracking at the specimen surface. This suggests that for the specimen geometry and impacting procedure examined here there is a critical combination of impact location and velocity below which no cracking will occur.

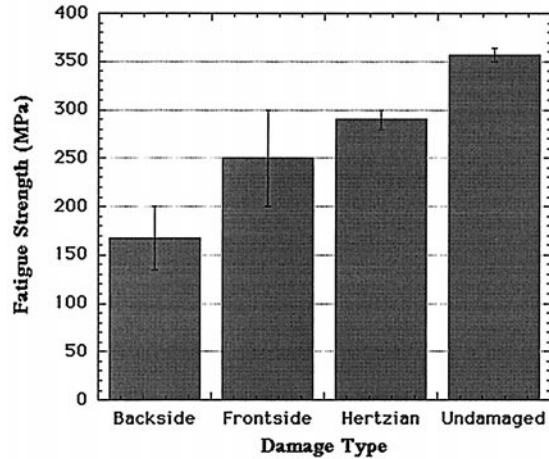
Figure 5. Reduction in fatigue strength for ballistically impacted 47XD as a function of damage type. The fatigue strength of undamaged material is shown for comparison.

The reduction in fatigue strength caused by the impact event was examined both in terms of the type of damage, as well as, the size of the critical crack that grew to failure. The reduction in fatigue strength resulting from each damage type is shown in Figure 5. Relative to the fatigue strength of undamaged specimens, Hertzian-like cracks appear to be the least severe form of damage, though only a single specimen failed by this damage type. Frontside cracks appear to cause the next greatest reduction in fatigue strength on average, though there is considerable scatter in the measured results. Finally, backside cracks cause the most significant reduction in fatigue strength.
