EFFECT OF FOREIGN OBJECT DAMAGE ON THE FATIGUE STRENGTH OF AN XD™ γ -TiAl ALLOY

T.S. Harding¹ and J.W. Jones²

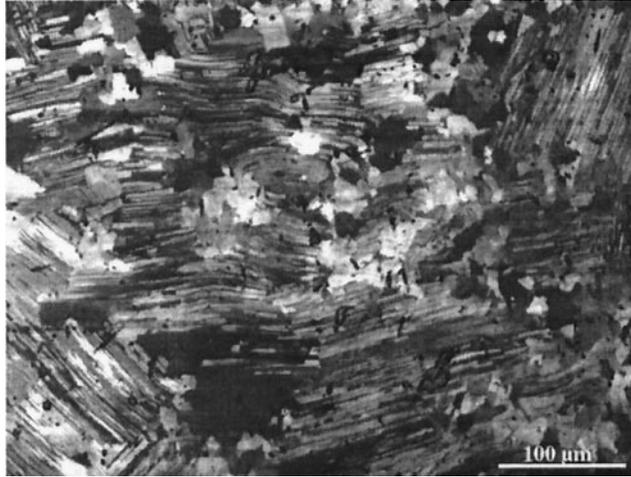
Figure 1. Optical micrograph of the near-fully lamellar Ti-46.8Al-2.1Nb-1.1Mn-0.1Si-1.4B alloy showing 110 μ m lamellar colonies with smaller equiaxed γ grains within the lamellar colonies.

present primarily as lamellar plates, the γ phase was found both in lamellar colonies as well as small ($\sim 16\mu$ m) equiaxed gamma grains located within the lamellar colonies.

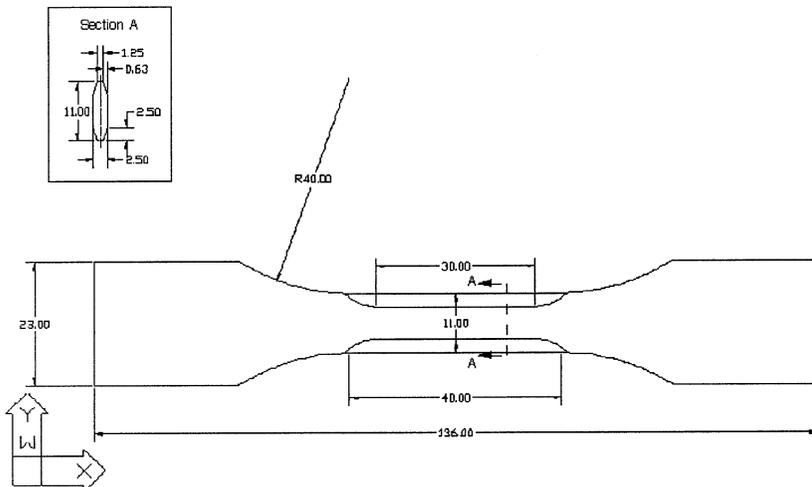
Figure 2. Specimen geometry of blade-like fatigue specimens used for simulated foreign object damage study.

Fatigue specimens were produced by electro-discharge machining the cast plates into blanks that were then low stress ground to the nominal dimensions shown in Figure 2. The specimen geometry was designed to represent the leading edge of a turbine blade. The chamfered surfaces in the gage section (see inset in Figure 2) were produced by surface grinding. Each specimen was electropolished to a mirror finish in a perchloric solution.

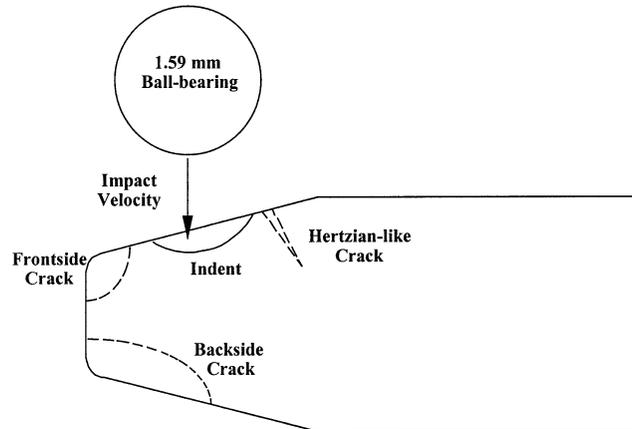
Figure 3. Schematic illustration of the ballistic impact process and the damage introduced in the fatigue specimen. The figure shown is one-half of the cross-sectional view of the gage section.

Ballistic impacts were performed using a gas powered barrel to propel 1.6mm steel ball-bearings at the chamfered face of the specimens as shown schematically in Figure 3. The projectiles were fired at the specimens at nominal speeds of 100–250m/s. All impacts were conducted at room temperature under zero load. Figure 3 also indicates the general appearance of the various damage classifications observed following impact. These classifications are used for establishing general damage conditions.

Ballistic impacts resulted in cracks of one of three different types, in addition to an impact crater. These categories are described as backside cracks, frontside cracks and Hertzian-like cracks as shown schematically in Figure 3. Backside cracks are believed to form when a bending moment is introduced during the impact that acts about the axis perpendicular to the loading axis and parallel to the specimen's width. Consequently, the high tensile stresses and plastic strain developed on the back face of the specimen lead to crack formation. Cracks of this type are typically the largest, being over 1mm in length on average. Frontside cracks are corner cracks that form at the base of the impact crater, and are typically smaller than backside cracks (100–500 μ m). These cracks are likely a result of the lack of constraint near the specimen edge of the hoop stresses surrounding the impact crater.

A special variety of crack was observed in one of the impacted specimens referred to as a Hertzian-like crack for its resemblance to the Hertzian cone cracks formed during impact of a brittle material [11]. As shown in the schematic illustration in Figure 3, the Hertzian-like cracks tend to form behind the impact crater and propagate into the depth of the specimen at an angle to the specimen surface, roughly 55° in the case of the 47XD alloy. From the surface, these cracks have a crescent shape. It is believed that the formation of a Hertzian-like crack is a result of the radial stresses surrounding the impact crater exceeding a critical value. Additional research is currently being conducted to further investigate the crack formation mechanism.

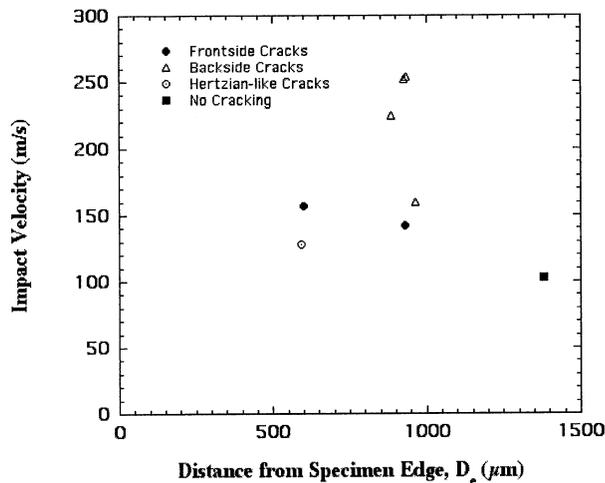
Figure 4. Effect of impact velocity and the location on damage type in the ballistically impacted 47XD alloy.

For the ballistic impacts, the position of the impact site and the impact velocity were chosen to produce a variety of crack sizes and geometries suitable for fracture mechanics analysis. Each specimen was impacted once according to the procedure described above. Specimens were impacted at nominal positions of 500, 1000 and 1500 μm from the specimen edge. For each impact damaged specimen, the critical damage type was identified as that which led to fatigue failure as determined from fractography. As Figure 4 shows, at a distance of 1000 μm from the specimen edge, the dominant damage type was a backside crack at moderate to high impact velocities. Backside crack size was observed to increase with increasing impact velocity. At low velocities, frontside cracks appear to be the dominant damage type. Closer to the specimen edge, impacts at relatively low velocities resulted in the formation of frontside and Hertzian-like cracks, suggesting that the formation of these sorts of cracks may be highly dependent on impact location. Furthermore, far from the specimen edge and at very low impact velocities, the impact resulted in only the formation of a crater with no signs of cracking at the specimen surface. This suggests that for the specimen geometry and impacting procedure examined here there is a critical combination of impact location and velocity below which no cracking will occur.

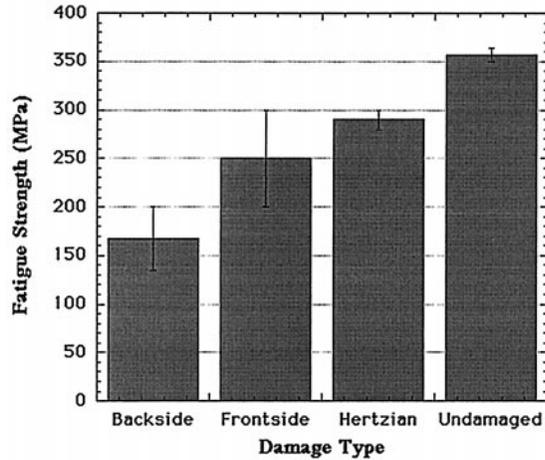
Figure 5. Reduction in fatigue strength for ballistically impacted 47XD as a function of damage type. The fatigue strength of undamaged material is shown for comparison.

The reduction in fatigue strength caused by the impact event was examined both in terms of the type of damage, as well as, the size of the critical crack that grew to failure. The reduction in fatigue strength resulting from each damage type is shown in Figure 5. Relative to the fatigue strength of undamaged specimens, Hertzian-like cracks appear to be the least severe form of damage, though only a single specimen failed by this damage type. Frontside cracks appear to cause the next greatest reduction in fatigue strength on average, though there is considerable scatter in the measured results. Finally, backside cracks cause the most significant reduction in fatigue strength.

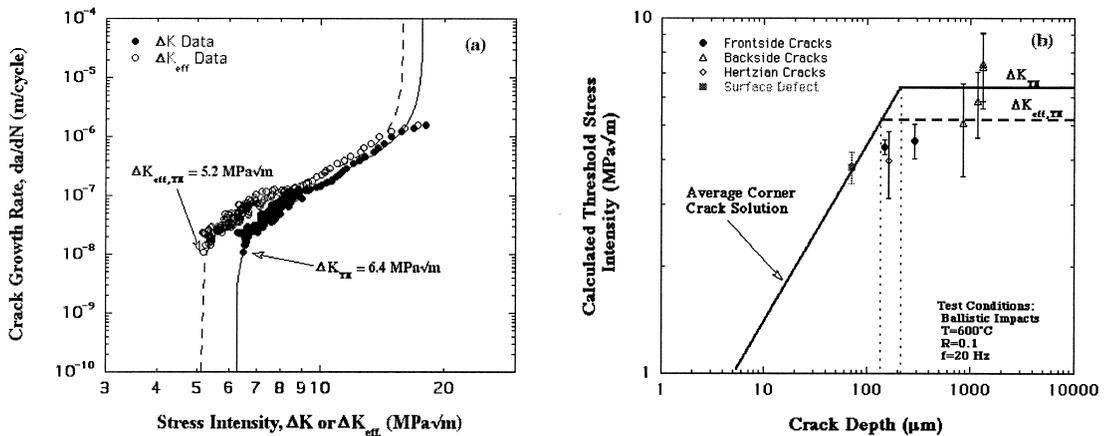
Figure 6. a) Results of fatigue crack growth rate tests on the 47XD alloy, b) Calculated threshold stress intensity of impact damage as a function of crack depth and damage type. The sloped line represents the endurance limit of undamaged material. Error bars relate to the variation in stress intensity along the crack front.

To obtain the threshold stress intensity, fatigue crack growth rate tests were conducted at 600°C. The results of this experiment are shown in Figure 6a). The calculated stress intensities of the impact damage are in essence threshold stress intensities since the fatigue strength was used in the Raju-Newman calculation. Therefore, direct comparison can be made between the long-crack fatigue thresholds in Figure 6a) and the calculated stress intensities. This is accomplished using the modified Kitagawa-like plot shown in Figure 6b). Good correlation between the long-crack thresholds (ΔK_{TH} and

$\Delta K_{\text{eff,TH}}$) and calculated stress intensity is observed for large, backside cracks. However, for cracks less than approximately $400\mu\text{m}$ in size, the calculated stress intensity is less than both the long-crack threshold stress intensity and the endurance limit. This suggests that for cracks less than approximately 5 times the average lamellar colony size the long-crack fatigue threshold stress intensity may be inappropriate for estimating the fatigue strength. Instead, a small-crack threshold may be needed.
