EFFECT OF FOREIGN OBJECT DAMAGE ON THE FATIGUE STRENGTH OF AN XD™ γ -TiAl ALLOY

T.S. Harding¹ and J.W. Jones²

¹Industrial and Manufacturing Engineering and Business Department, Kettering University, Flint, MI 48504-4898

²Department of Materials Science and Engineering, University of Michigan, Ann Arbor, MI 48109-2136

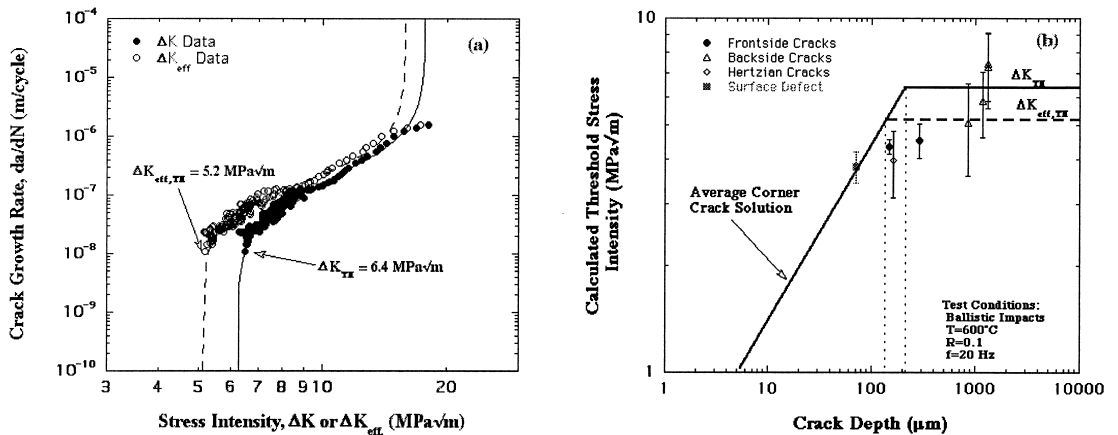
Figure 6. a) Results of fatigue crack growth rate tests on the 47XD alloy, b) Calculated threshold stress intensity of impact damage as a function of crack depth and damage type. The sloped line represents the endurance limit of undamaged material. Error bars relate to the variation in stress intensity along the crack front.

To obtain the threshold stress intensity, fatigue crack growth rate tests were conducted at 600°C. The results of this experiment are shown in Figure 6a). The calculated stress intensities of the impact damage are in essence threshold stress intensities since the fatigue strength was used in the Raju-Newman calculation. Therefore, direct comparison can be made between the long-crack fatigue thresholds in Figure 6a) and the calculated stress intensities. This is accomplished using the modified Kitagawa-like plot shown in Figure 6b). Good correlation between the long-crack thresholds (ΔK_{TH} and

$\Delta K_{\text{eff,TH}}$) and calculated stress intensity is observed for large, backside cracks. However, for cracks less than approximately $400\mu\text{m}$ in size, the calculated stress intensity is less than both the long-crack threshold stress intensity and the endurance limit. This suggests that for cracks less than approximately 5 times the average lamellar colony size the long-crack fatigue threshold stress intensity may be inappropriate for estimating the fatigue strength. Instead, a small-crack threshold may be needed.
