Senior Project: Masonry Core Testing

By: Enrico Alvaro and Onessa Anastasio

Date: June 20, 2017

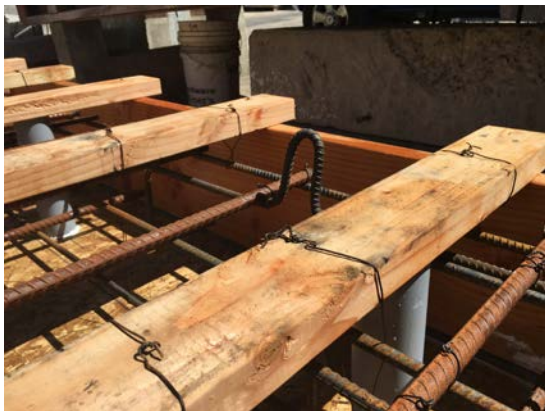
Figure 2: Hooks designed for lifting

Prior to construction, the Failure Wall needed a new testing slab in High Bay. The existing testing slab would be used for the control wall. This way, we can construct and test both walls simultaneously. The dimensions of the new slab was 9 feet by 4.5 feet and 1 foot thick. It was reinforced with no. 4 longitudinal rebar at 11" o.c and no. 6 latitudinal rebar at 10" o.c, top and bottom. 1.5-inch anchor bolts at 3 feet o.c was considered in the form work. These anchor bolts would be bolted to the High Bay Lab floor to prevent uplift. Reinforcing for the openings were also considered. Hooks were designed for mobility of the foundation to be lifted with the crane. See Appendix 1 for plans and sections of the slab.

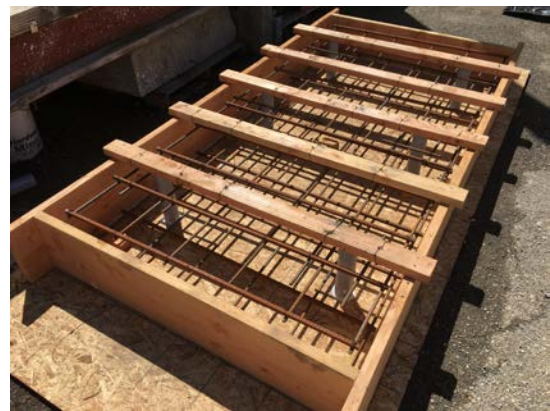
Figure 3: Formwork and Reinforcing

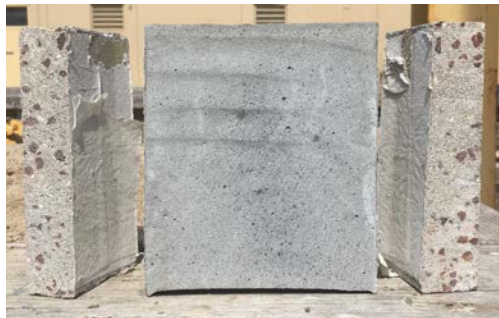
Figure 9: (2) Paper Towels

From figure 9 and 10, both tests were successful such that the face shells fell from both samples. The determining factor of what agent was used was based on constructability and application. First, the Thompson's and Acrylic paint was the cheapest and easiest to apply on the inner face shells. Secondly, knowing we would have to grout the cells, we needed a delaminating agent that would not be affected by grouting. The paper towel had a greater chance of falling off during grouting and was difficult to apply. Therefore, Thompson's Water Seal and acrylic paint was chosen as the delaminating agent.

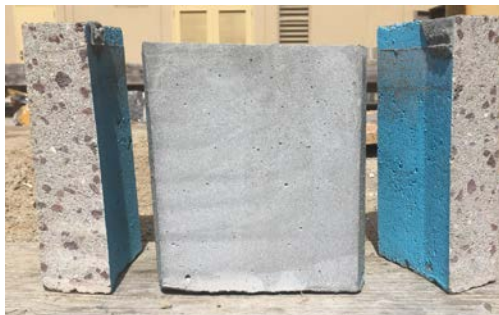
Figure 10: Thompson's Water Seal and Acrylic Paint

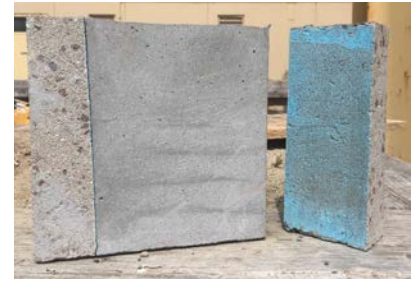
Figure 5: Acrylic Paint

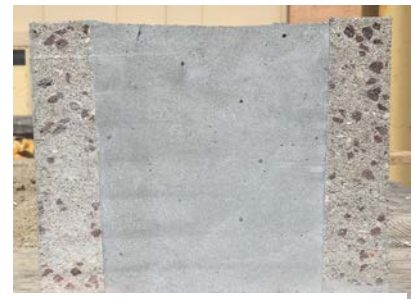
Figure 6: Thompson's Water Seal

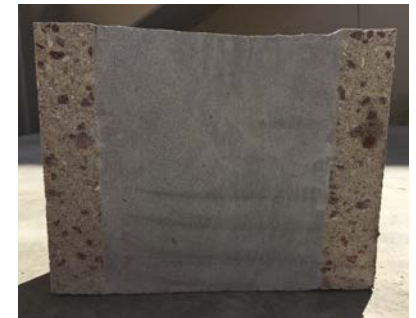
Figure 7: Candle Wax

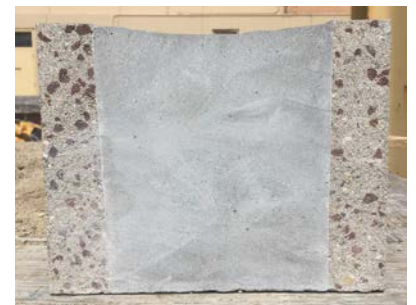
Figure 8: Paper Towel

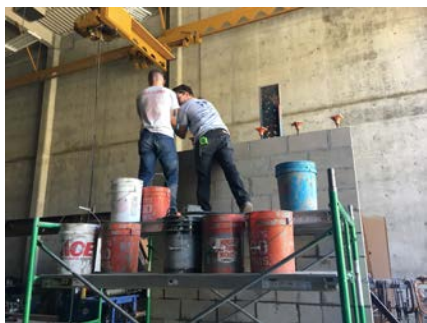
Figure 14: Buckets were used for grouting method

Type S mortar was used in construction and donated by AirVol Block. The walls were grouted 3 days after laying the blocks. To avoid cleanouts, we grouted in 4' lifts. Grouting proportions were 1 part gravel, 3 parts sand, 1 part cement and mixed to an 10" slump. Grouting materials were also donated by AirVol block. The wall cured for 17 days before coring.

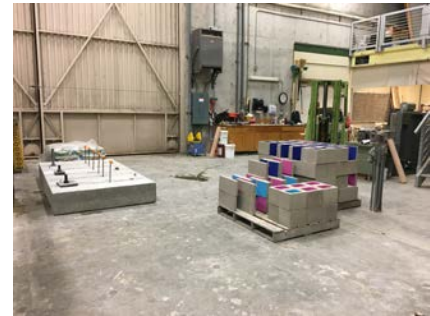
Figure 11: Prepared block and epoxied dowels.

The wall was constructed to have pinned connections top and bottom. Therefore, we prepared the slabs with epoxied no. 4 dowels at 18" o.c. and embedded anchor bolts in the finished grout at roughly 16" o.c. along the wall.

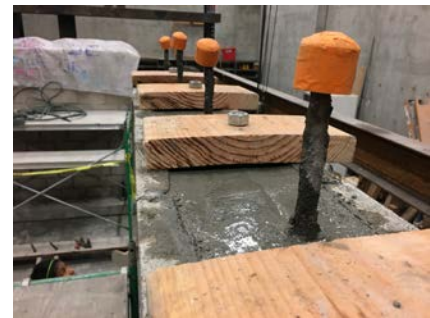
Figure 12: Anchor bolts embedded into grout.

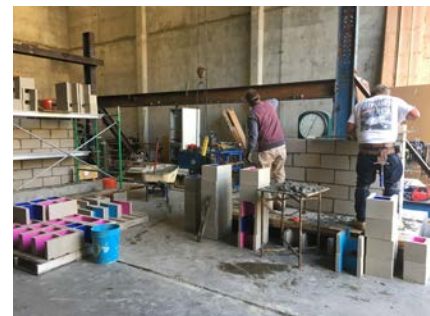
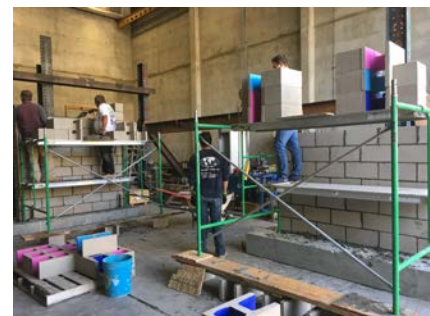
Figure 13: Wall Construction

Fortunately, we had the opportunity to have two masons construct the two walls for this experiment. They were brought onto the project by John Chrysler from the Masonry Institute of America. The walls were built on April 27, 2017. The dimensions of the walls were 8 feet by 7.5 feet with 10-inch masonry block. No. 4 vertical reinforcement was laid at 18" o.c. and no. 4 horizontal reinforcement was laid at 32" o.c. We designed reinforcement to code minimums. However, we overdesigned the steel to ensure the CMU didn't crack before the entire wall was engaged. This way, we can observe a flexural response of the wall. Also, we wanted to model the wall assuming it would take load similarly to a typical school or hospital building. See Appendix 2 for wall section and elevation.

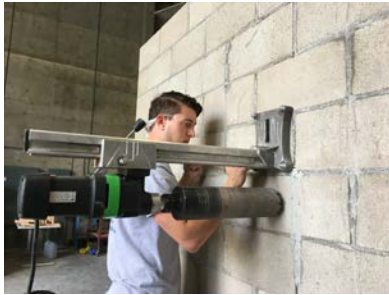
Figure 15: Mounted coring drill

Core testing will validate the efficiency of the delaminating agent and ensures a failure so the experiment may proceed as designed. Coring was performed per CBC 2105A.4. The holes were re-grouted with the same grouting mix during construction. Using a coring rig lent by Kurt Siggard, the drill was mounted with Hilti expansion anchors at the same locations in both walls. This was to maintain control of any differences between the two walls – aside from the grout to CMU bond.

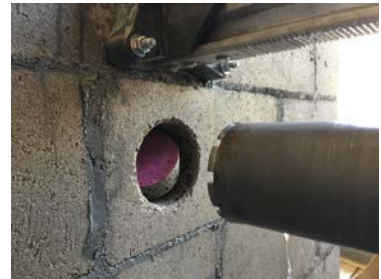
Figure 16: Failed core test

The results were as planned. The core specimen from the control wall was intact and the specimen from the failure wall was not. In the process of extracting the core from the failure wall, the face shell fell off into the coring hole. As defined earlier, this is an automatic failure of the test.

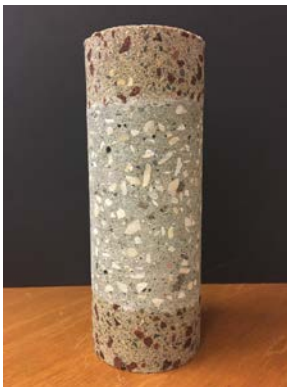
Figure 17: Controlled wall core specimen

Figure 17 shows the intact core specimen from the controlled wall. Figure 18 shows a visible cohesion of the grout into the CMU block.

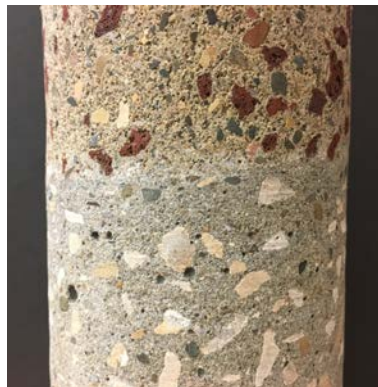
Figure 18: Grout to CMU bond

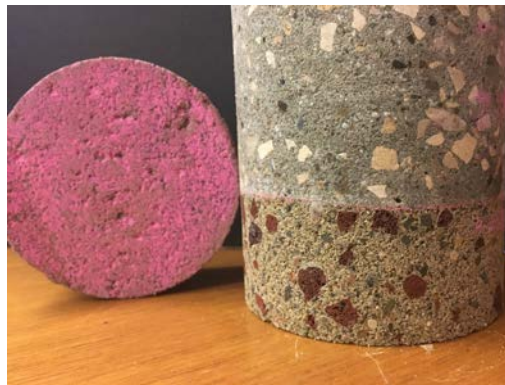
Figure 19: Fallen face shell

Figure 20 shows the failed core specimen of the failure wall. Figure 19 shows an obvious separation between the grout and the CMU. The pink acrylic paint is the visible barrier proving the efficiency of the delaminating agent.

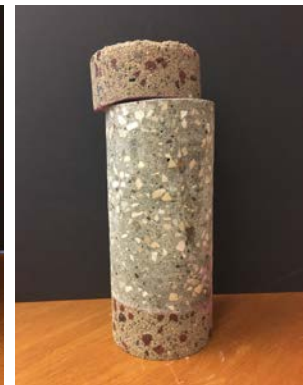
Figure 20: Failure wall core specimen

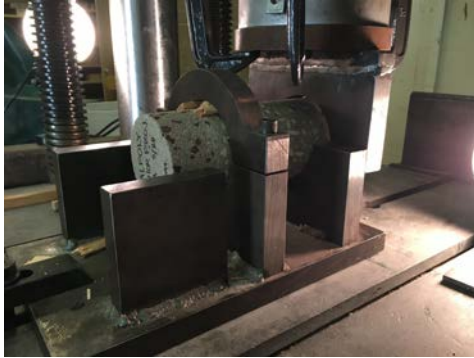
Figure 21: Testing apparatus

The code requires a proper testing apparatus to be used when testing the shear value of the bond. For this experiment, we used a testing apparatus constructed by a previous senior project. The apparatus was designed for a 4" core specimen – acceptable for the 2016 CBC. Using the Tinius Olsen universal testing machine, we mounted the testing apparatus. The cores were tested roughly 40 days after grouting.

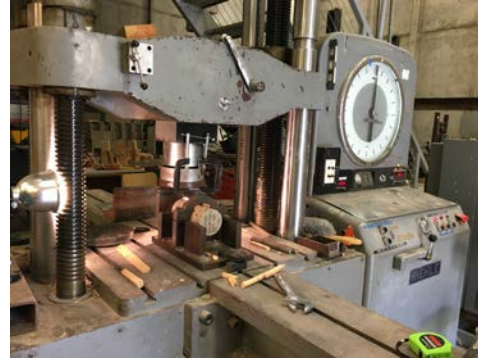
Figure 21A: Tinius Olsen Universal Testing Machine

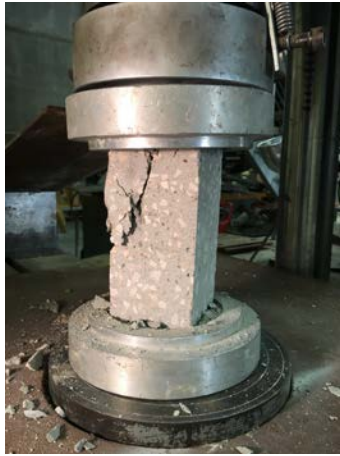
Figure 22: Grout sample compression test

A CMU block was filled entirely with grout to duplicate the curing conditions. A total of 12 samples were poured from one batch of grout - 6 control and 6 failure samples. After 28 days, rectangular samples were cut from the grout and compression tested using the Tinius Olsen Universal Testing Machine. Table 2 displays the compression test results.

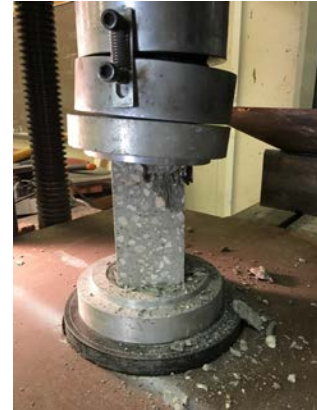
Figure 23: Omitted sample

The average grout strength for both the failure samples and the control samples was roughly 3400 psi. One failure sample was omitted. During testing, the top plate shifted applying load at an angle causing spalling. Therefore, the entire sample was not properly engaged by the compression device.

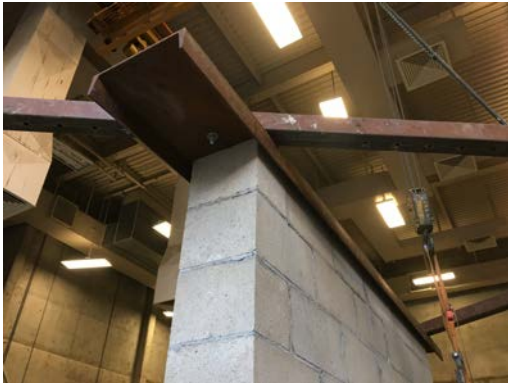
Figure 24: Top bracing

Before we can proceed to testing, we created a pinned connection at the top of the wall. The anchor bolts embedded at the top of the wall were engaged to produce a connection similar to a wall fully braced by a diaphragm. We used a C12x20.7 faced down to hug the top of the wall and engage the bolts. 3-inch square tubes were bolted at each end of the channel and clamped to the wide-flange column approximately 6-feet away from the wall. The tubes were purposely placed at each end to reduce any possible torsion effects from testing. To save material and time, the bracing was constructed to fit both walls.

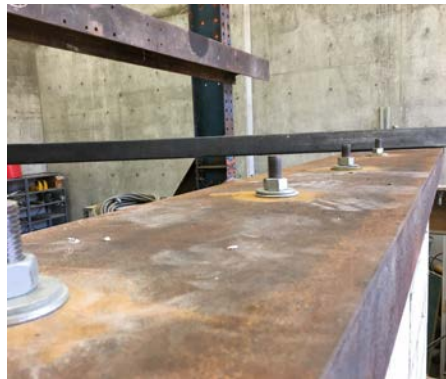
Figure 25: Channel engaging top anchor bolt

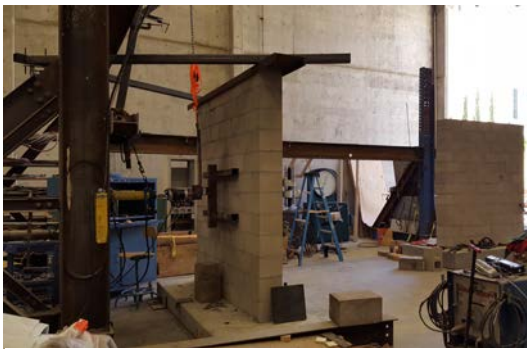
Figure 26: Typical testing configuration

This experiment focuses on the deformation and force applied to the wall. The load applied for testing would be concentrated at the center of the wall and distributed with a previously constructed H-frame. This was the closest model we could achieve for a distributed out-of-plane force. A hydraulic ram with a pushing capacity of 50,000 lbs was used for this testing. A load cell and deformation gauge was attached to record results and linked to a computer analysis program. The results were recorded every second. Of the recorded results, we compared the maximum load and the maximum displacement. We determined the end of the test would be when the load applied would no longer increase. The calculated the capacity of the control wall was roughly 10,000 lbs, and the failure wall was 7,000 lbs per code design equations.

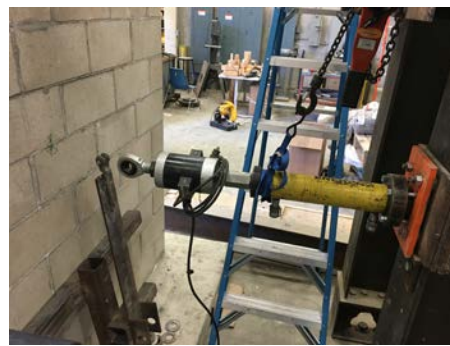
Figure 27: Ram and load cell

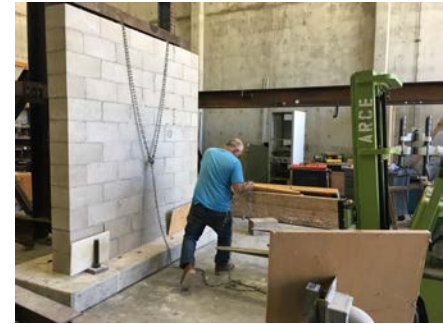
Figure 28: Demolition set-up

After testing, we also observed the walls performance during demolition. Originally this was not an intended process for this experiment; however, it gave us promising results. The walls were pulled down and broken into 4 pieces. Two chains were hooked on the inner anchor bolts at the top of the wall, and pulled with a forklift.

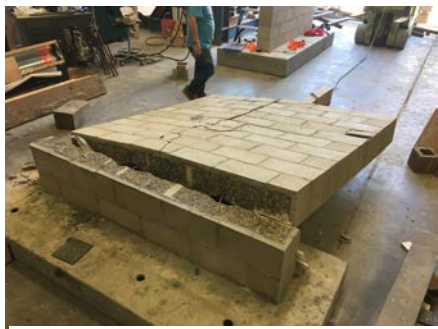
Figure 29A: Controlled wall demolition

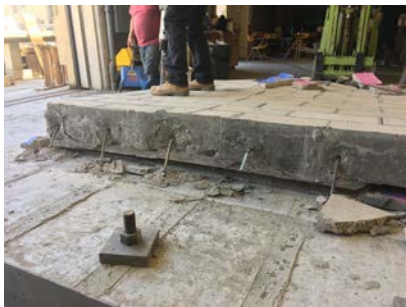
Figure 30A: Failure wall demolition

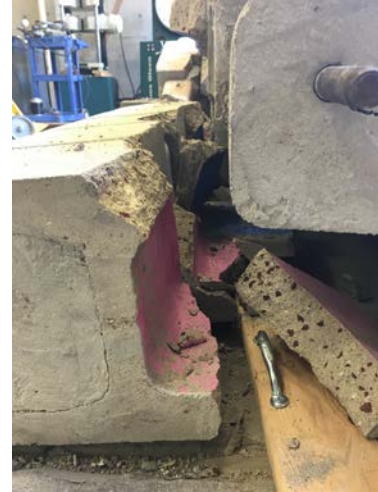
Figure 31: Delamination of corner section

To address our hypothesis as stated on page 3, we can conclude the failure wall could act in composite action. We can confirm the mechanical interlock of the webs and grout and tapering of the masonry allowed composite effects. The results from the out-of-plane testing and demolition of the wall proved the ability of the wall to perform as a unit. However, we cannot conclude the performance of the wall to be acceptable past failure. The corner of the wall that fell off in Figure 30 was proof that the wall may not be durable enough for life safety. While it's common for cracking to occur, the CMU to grout bond controls a reduction in section under cracking. Without the bond, there's no way to ensure the wall will act in its fully designed section. Had there been a positive bond in the failure wall, the corner section would remain intact with the entire wall. Figure 31 highlights obvious area where the bond should have formed.

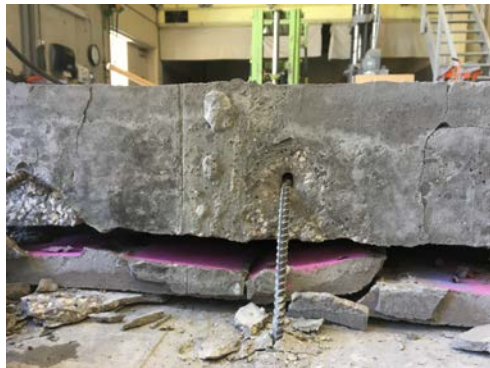
Figure 32: Failure wall base

The foundation that the failure wall was built on was not completely roughened at the base of the wall. During the demolition process of the failure wall, it was apparent the foundation was too smooth for stronger cohesion. There could have been a stronger bond at the base like that of the other foundation. The other foundation had a cross hatch on the slab to allow the mortar and grout to interlock. Figure 29C shows the remaining two block layers still attached to the slab. Figure 31 shows the base of the failure wall completely detached from the slab. The smooth surface of the grout and mortar can be observed.

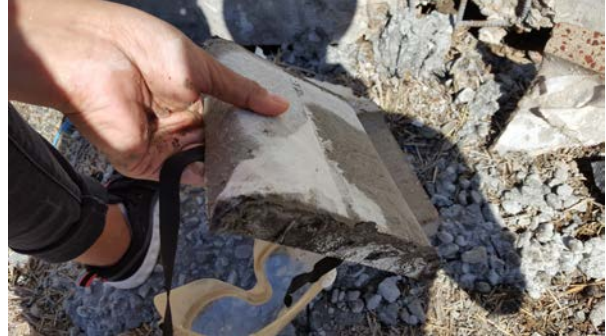
Figure 33: “Throw Test”

- 1) During the small-scale testing, the first indication we received of a working delaminating agent was tossing a cut off piece of the prisms into the recycling pile. We noticed the slight force of impact caused the grout to be ejected from the face shell as a solid piece (Figure 33). Although this was not purposeful in considering a proper failure mechanism, we discovered it was a worthy test to influence our choice of the delamination agent.
- 2) The demolition of the failure wall allowed us to discover a couple of concerns with the performance of failure. This changed our perception of the assumed unitary performance that we witnessed from the out of plane test.

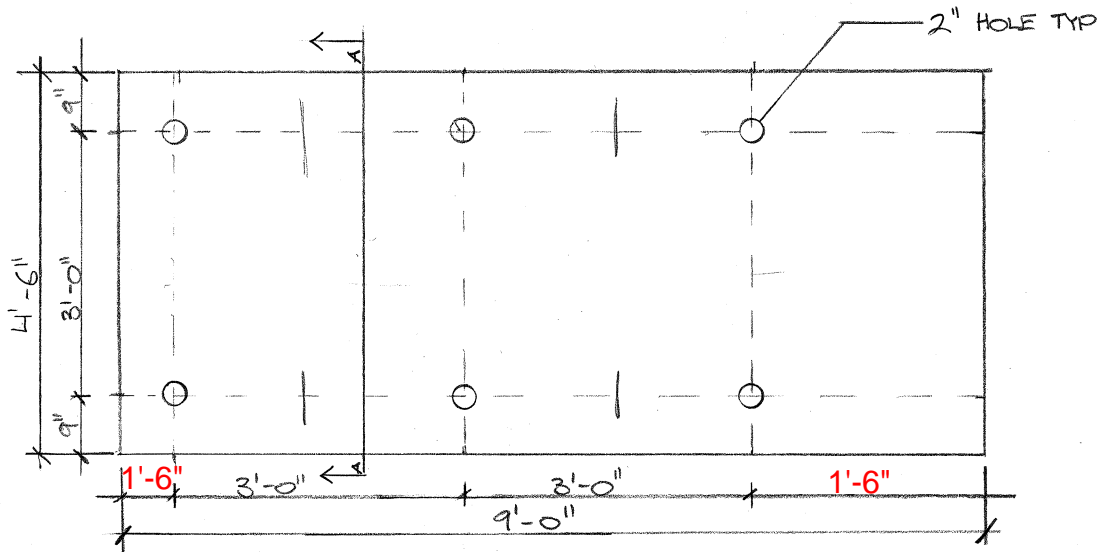
TESTING SLUG DESIGN

THICKNESS = 12"

PLAN

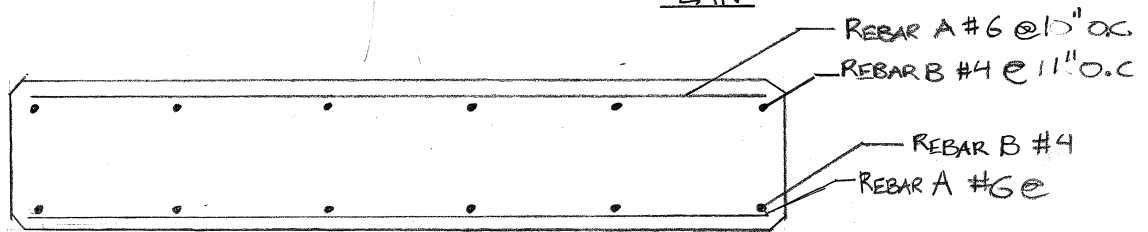
SECTION A-A

- REBAR A/B TYP. TOP AND BOTTOM

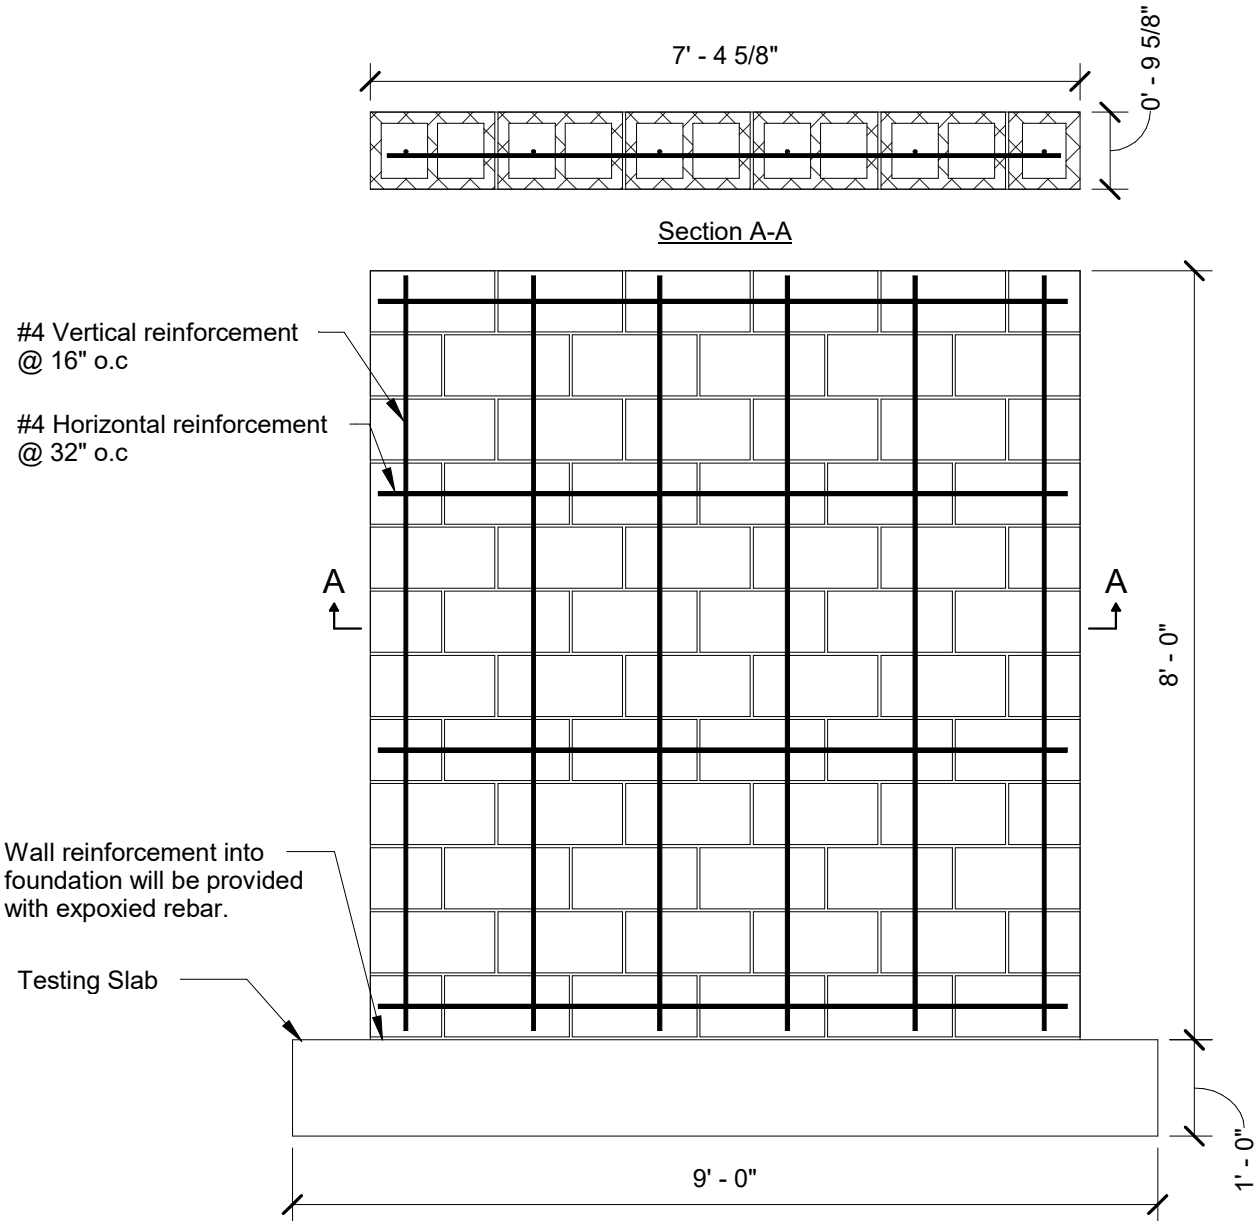
- Note:
- 1. Lay masonry in running bond
 - 2. Bed and Head joints to be 3/8" thick.
 - 3. Bond beams where horizontal rebar occurs
