LAWRENCE TECHNOLOGICAL UNIVERSITY

INSPECTION AND DETERIORATION OF BRIDGE DECKS CONSTRUCTED USING STAY-IN-PLACE METAL FORMS AND EPOXY-COATED REINFORCEMENT

October, 2004

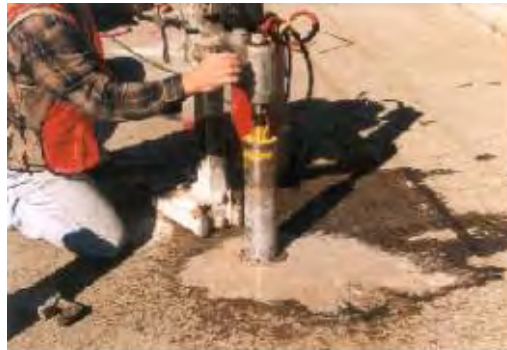
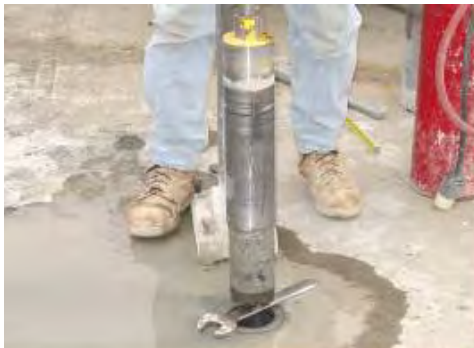
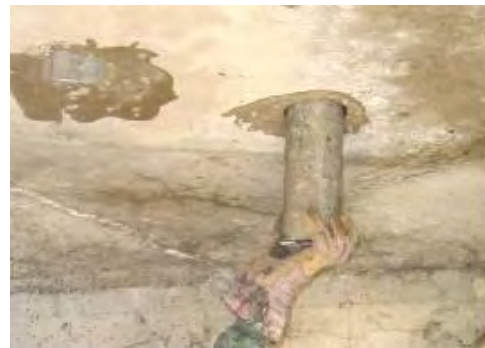
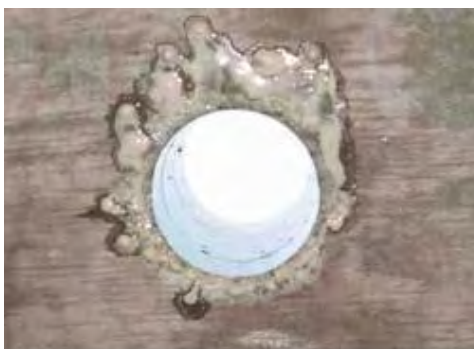
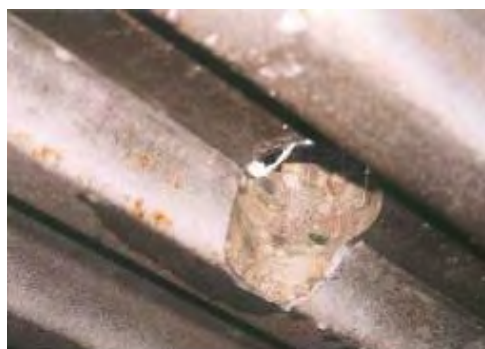
a. Coring

b. Collecting the core from the top

c. Collecting the core from the bottom

d. Resulting hole in a concrete deck slab without SIPMF, view from below

e. Resulting hole in a concrete deck slab with SIPMF, view from below

Figure 3.1. Coring procedures

The coring apparatus consisted of a core drill with diamond-impregnated bits attached to a core barrel for obtaining cylindrical core specimens. The full depth cores were 3.75 in. diameter. The coring procedure is shown in Figure 3.1. The drilled cores were either collected from the top or from the bottom of the bridge deck depending on accessibility. Collection of cores is shown in Figure 3.1.

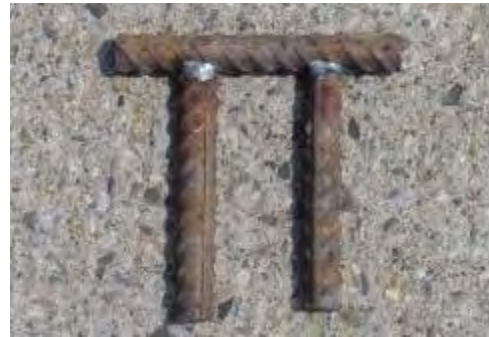
a. Schematic diagram of reinforcement for plug

b. Reinforcement unit

Figure 3.2. Reinforcement details.

Procedures were established for preparing the holes for plugging and subsequently filling the holes with concrete mixture. Prior to drilling the full depth core, a circular ring was formed by coring to a depth of 2 in. using a 6 in. diameter core barrel. Subsequent to full-depth coring, a circular ring was removed to provide a shelf for support of the reinforcement (Figure 3.2).

To fill the hole left after the extraction of the core, the hole had to be filled with concrete using a simple reinforcement arrangement to ensure that the plug will not crack or separate from the deck. Reinforcement details are shown in Figure 3.2. Before casting, the opening had to be blocked from underneath using a plug. Circular plastic covers, conical wooden blocks, and plastic-rubber blocks were used for this test program.

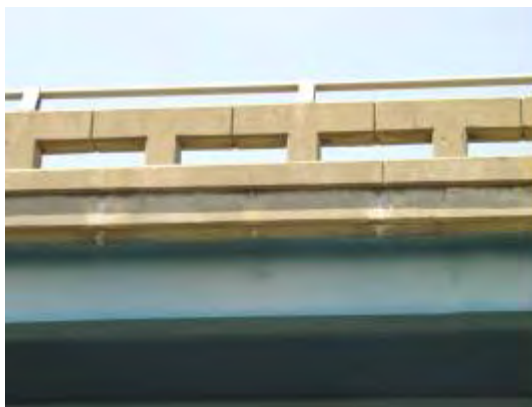
Figure 3.7. Cracks propagated through the sides

Cracks were found at the top surface of the road and the curbs as shown in Figure 3.6. The cracks propagated longitudinally, transversely, and diagonally along the entire length of the bridge. The cracks were found at the sides of the deck slabs as shown in Figure 3.7. A different type of concrete (as indicated by the difference in color) was encountered at the sides of the joints in the top surface (Figure 3.8).

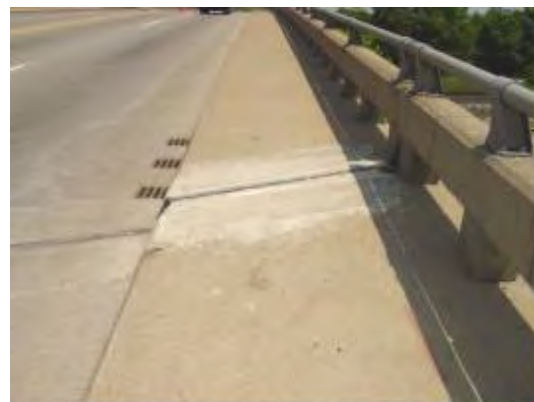
Figure 3.8. Different types of concrete around the joints

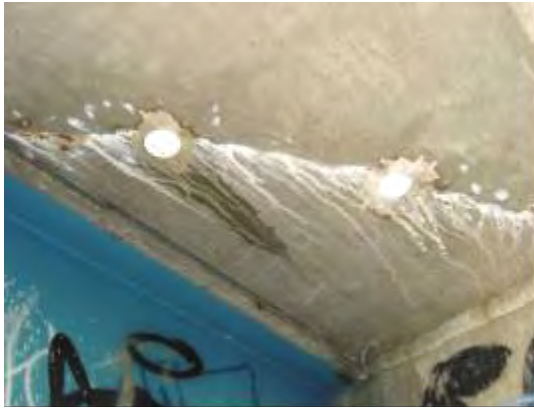
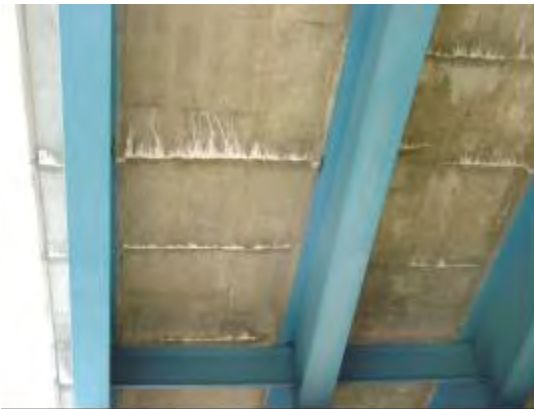
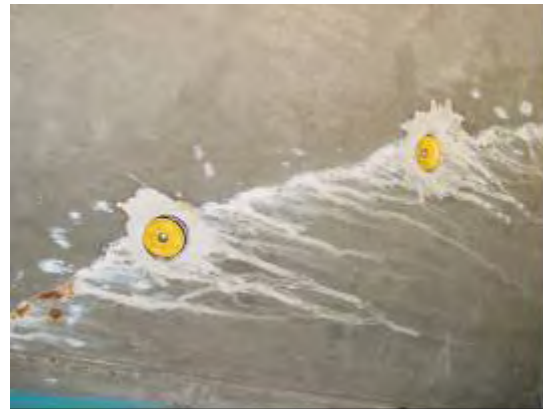
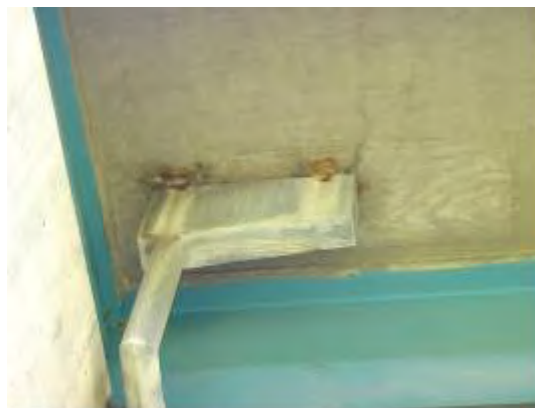
a. Diagonal cracks with white traces

b. Longitudinal cracks with white traces

c. Transverse cracks with white traces

d. Cracks with corrosion and white traces in the direction of slope

e. Rust traces from reinforcement around the drainage holes

Figure 3.9. Cracks, rust, and white traces propagated on the bottom surface

The bottom surface of the deck slab had cracks propagated transversely, longitudinally and diagonally (Figures 3.9 a, b and c). A thick layer of light colored material filled the cracks and spread in the direction of the bridge slope (Figure 3.9d). Some of the cracks also had corrosion traces. The drainage holes had corrossions in the deck without SIPMF (Figure 3.9e).

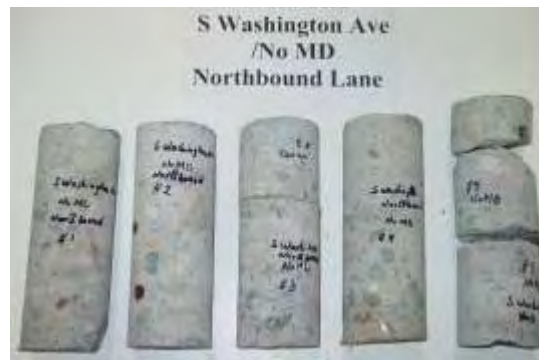
Figure 3.10. The 5 cores taken from Bridge Deck Number 1 (Structure No. R01-13012)

The visual inspection of cores indicated that all of the cores had no wearing surface at the top surface. The steel reinforcement was coated with brown epoxy and generally showed severe signs of rust. Several voids were encountered. The coarse aggregate was well bonded to the concrete. The heights of the cores were not significantly different thus indicating uniformity of the bridge deck. The five cores removed from Bridge Deck Number 1 are presented in Figure 3.10. Each Core was carefully inspected and illustrated as follows:

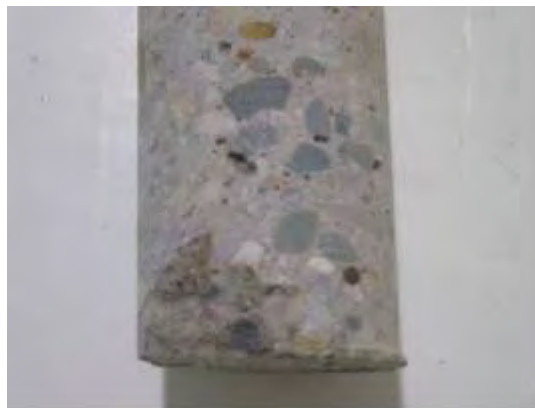
- 10.0 in. height.
- Part of the edge of the core at the bottom was fractured during the coring.
- Two locations of honeycombing of approximate length of 0.3 in. were encountered at 2.5 in. and 3.0 in. from the bottom.
- Large voids of average diameter of 0.2 in. were located 3.0, 4.5, 5.0, and 6.2 in. from the bottom.

Figure 3.11. Core 1a shows large region of honeycombing

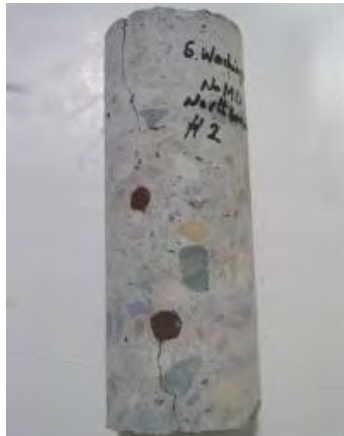
- 10.0 in. height.
- A crack of average width of 0.05 in. extends the entire length of the core.
- Four axial cuts in the reinforcement were present at 4.5 and 7.5 in. from the top.
- The exposed reinforcement showed severe signs of rust.
- A large region containing honeycombing of approximate width 0.4 in. was located 5.2 in. from the top.

Figure 3.12. Core 1b shows rust in reinforcement

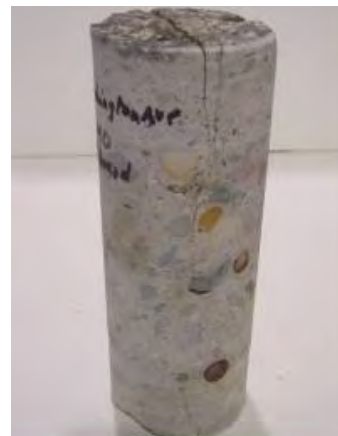
Figure 3.13. Core 1b longitudinal crack

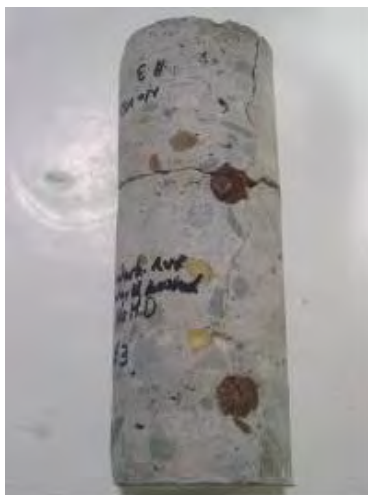
- 10.0 in. height.
- The core was cracked and split by a lateral crack at the location of the reinforcement at 4.0 in. from top.
- A crack of average width of 0.05 in. extends the entire length of the core.
- Four axial cuts in the reinforcement showed severe signs of rust.
- Part of the edge of the bottom of the core was fractured during coring.
- Two locations of honeycombing of average width of 0.3 in. located 2.5 in. and 5.0 in. from top.
- Two large voids of average diameter of 0.3 in. were located 7.0 in. and 8.0 in. from top.

Figure 3.14. Core 1c transverse and longitudinal cracks

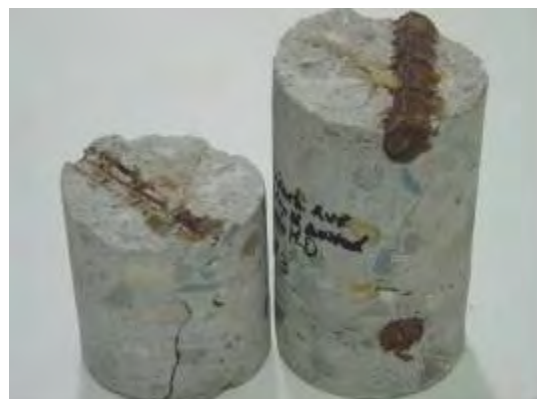
Figure 3.15. Core 1c rust in steel

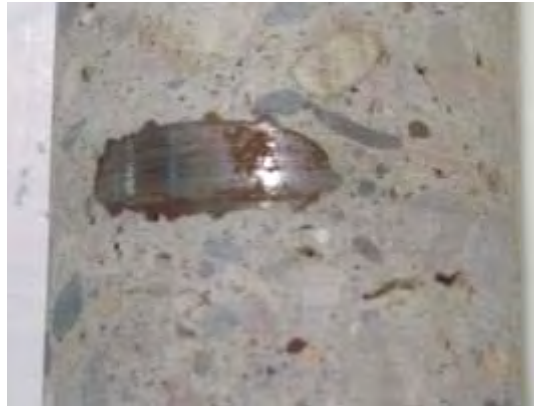
- 10.1 in. height.
- Two axial cuts in the reinforcement located 8.8 in. from the top.
- One longitudinal cut in the reinforcement located 4.8 in. from the top.
- Two large voids of average diameter of 0.3 in. located 5.3 in. from the top.
- Exposed steel reinforcement showed slight signs of rust.

Figure 3.16. Core 1d

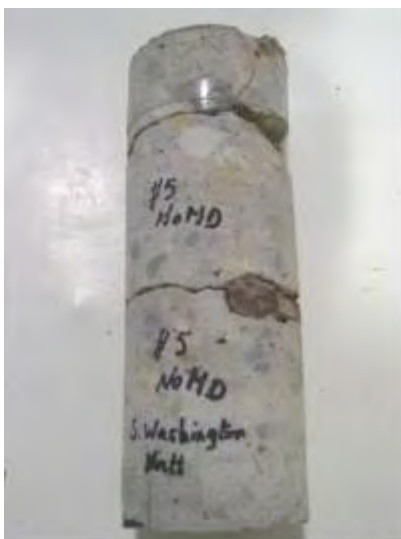
- 10.2 in. height.
- The core was cracked and split into three segments by two lateral cracks; both at the locations of the reinforcement. The cracks are located 4.5 in. and 8.3 in. from the top.
- Two longitudinal cuts in the reinforcement located 4.5 in. and 8.3 in. from the top.
- The exposed reinforcement showed severe signs of rust.
- Part of the concrete was fractured at the crack located 8.3 in. from the top.
- A crack of average width of 0.03 in. width propagated along the entire depth of the core.
- Two large voids of average diameter of 0.3 in. located 5.8 in. and 7.8 in. from the top.

Figure 3.17. Core 1e cracks at the reinforcement bars

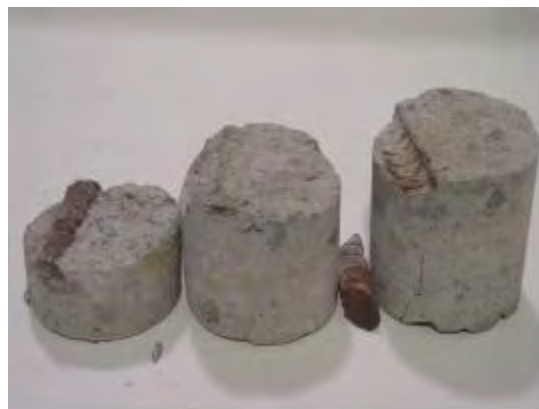
Figure 3.18. Core 1e rust in the reinforcement bar

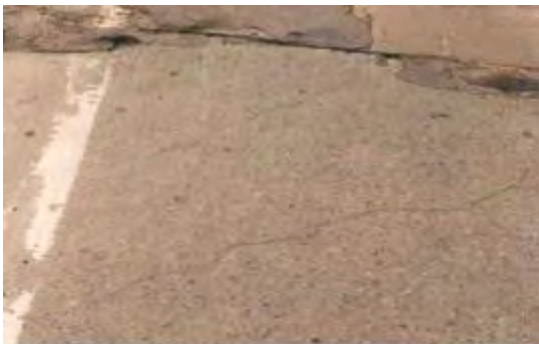
a. Diagonal cracks

Figure 3.23. Cracks on the top surface

Major cracks were found at the top surface of the concrete slabs at the first and fourth spans (Figure 3.23). These cracks penetrated the entire slab thickness (Figure 3.24). In many locations along the bridge, the concrete curbs were deteriorated and the steel reinforcement bars were uncovered (Figure 3.25). White and rust traces were observed underneath the concrete slab, along the side of the bridge, and at the location of the steel hanger rods supporting PVC conduit for telephone wires (Figures 3.26 to 3.29). Traces of corrosion existed at the location of the first and second joints (Figure 3.30). For the abutment located at the north of the bridge, cracks, white traces and traces of corrosion in steel reinforcements existed at the middle and extreme bays (Figure 3.31).

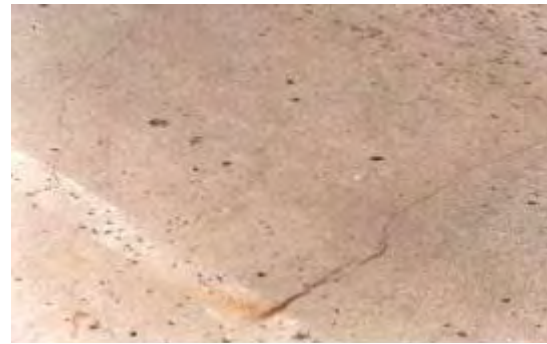
b. Transverse cracks with rust traces

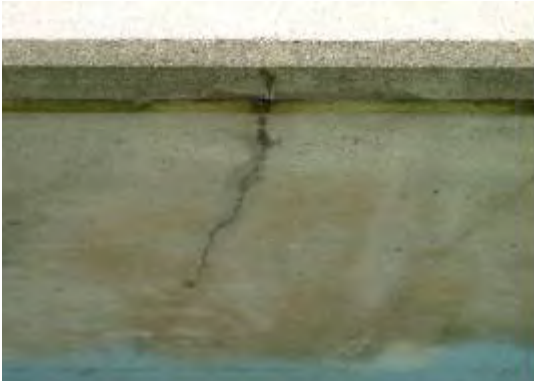
Figure 3.24. Cracks through the slab thickness

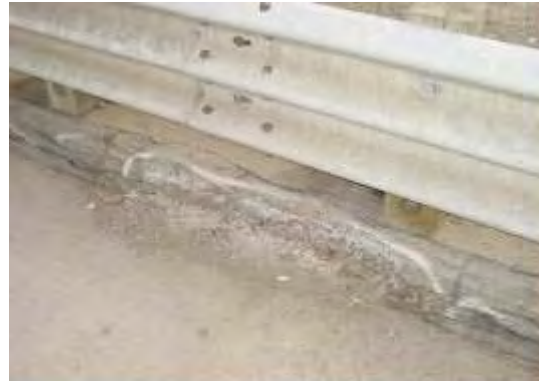
Figure 3.25. Severe deterioration of the curb

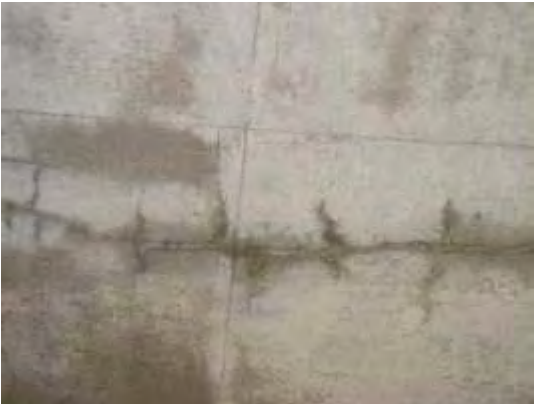
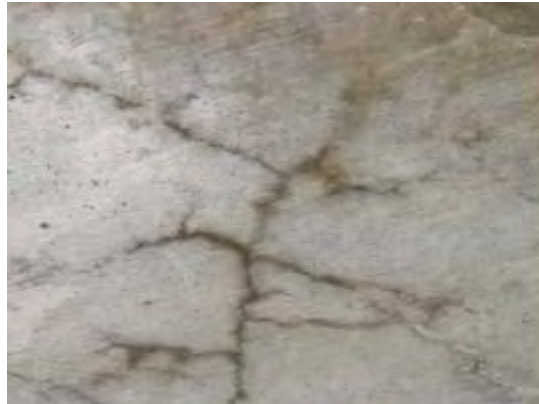
a. Longitudinal crack

b. Diagonal and Transverse cracks

Figure 3.26. Cracks at the bottom surface of the slab

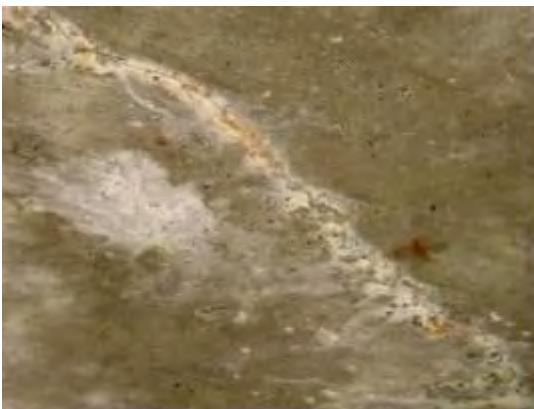
Figure 3.27. White traces on the bottom surface

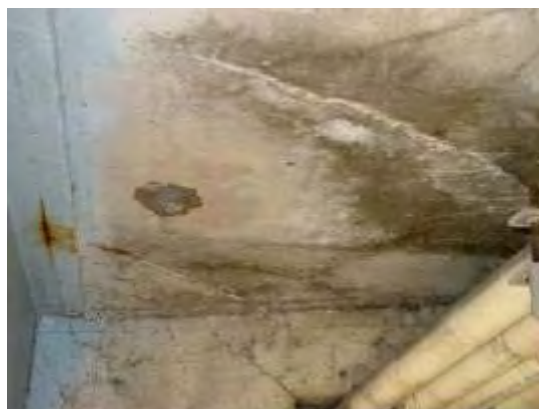
Figure 3.28. Rust traces on the bottom surface

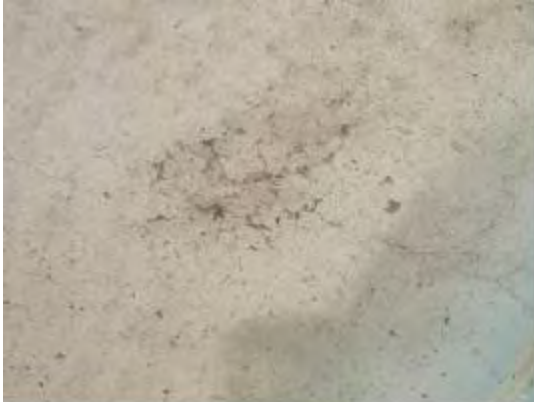
Figure 3.29. Honeycombing at the bottom surface of the slab

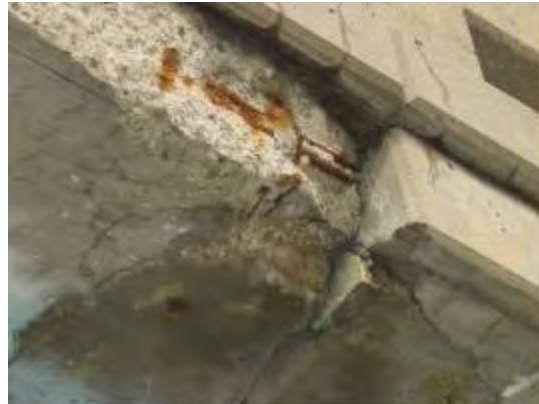
Figure 3.30. Deterioration of the concrete cover and rust traces at the joint

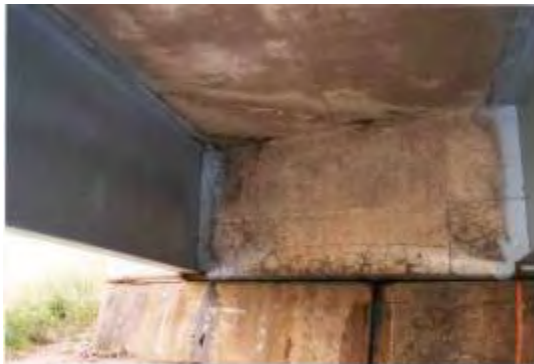
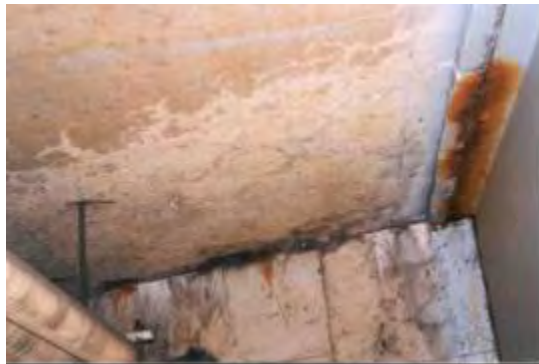
a. Water leakage

b. Cracks and rust traces

Figure 3.31. Deterioration of the deck slab at the north abutment

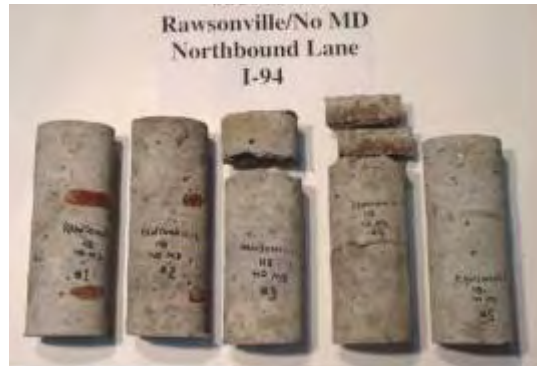
Figure 3.32. The 5 cores taken from Bridge Deck Number 2 (Structure No. S03-81041)

The visual inspection of cores from Bridge Deck Number 2 indicated that the bridge had no separate wearing surface at the top surface and the top surface of all cores had a grooved texture. The steel reinforcement was not coated and had traces of rust. Many voids were encountered with an average diameter of 0.3 in. The coarse aggregate was well bonded to the concrete. The cement paste had high porosity. Slag as well as conventional aggregates were used in the deck slab. All of the cores had approximately the same height of average 9.8 ± 0.3 in. The five cores that were taken are shown in Figure 3.32.

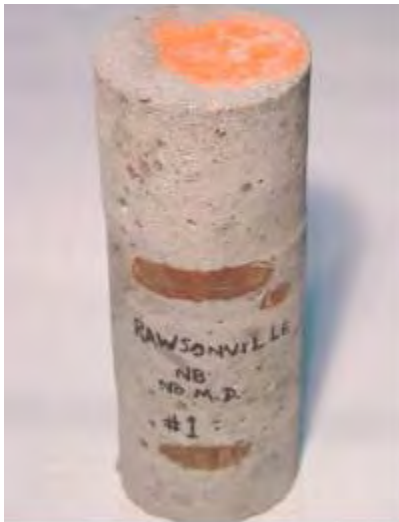
Figure 3.33. Core 2a reinforcement bars are rusted

- 9.8 in. height.
- Many voids of average diameter of 0.3 in. were encountered.
- Two axial cuts in the reinforcement bars located 4.5 in. from the top surface.
- Three longitudinal cuts in the reinforcement located 3.8, 7.0 and 8.3 in. from the top.
- Two full depth cracks.
- Slag as well as conventional aggregates were used; and cement paste had high porosity.
- One longitudinally cut in the steel reinforcement bar located 3.5 in. from the top.
- All exposed steel reinforcement bars showed signs of rust.

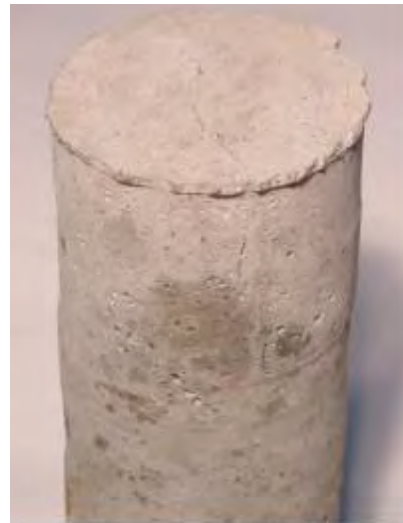
Figure 3.34. Core 2a crack propagated through the depth of the core

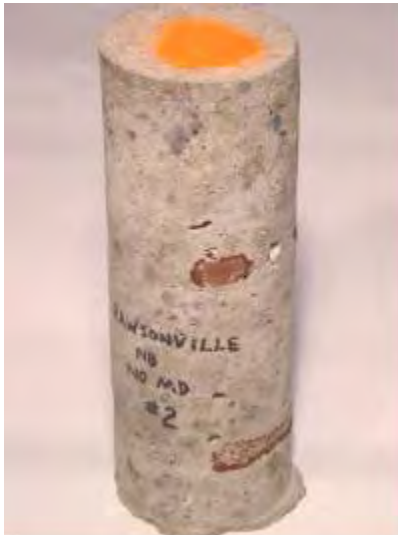
Figure 3.35. Core 2b

- 10.0 in. height.
- Slag as well as conventional aggregates were used; and cement paste had high porosity.
- Four locations of honeycombing present with average width of 0.5 in. and located approximately 3.5 in. from the top.
- Two axial cuts in the reinforcement bars located 4.5 in. from the top.

- One longitudinal cut in the reinforcement bars located 8.5 in. from the top.
- The exposed reinforcement bars showed traces of rust.

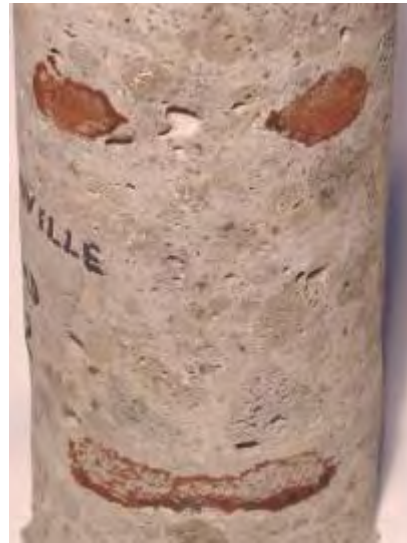
Figure 3.36. Core 2b rust in the reinforcement bars

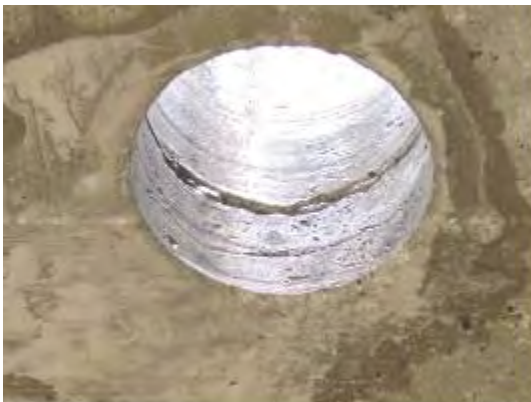
Figure 3.37. Crack in the thickness of the slab (Core 2c location)

- 9.8 in. height.
- Slag as well as conventional aggregates was used; and cement paste had high porosity.
- Core was broken at 8.0 in. from the top surface due to crack existing horizontally in the slab thickness. The existing crack is shown in Figure 3.40.
- Two locations of honeycombing with average width of 0.4 in. were located approximately 1 in. and 6.8 in. from the top.

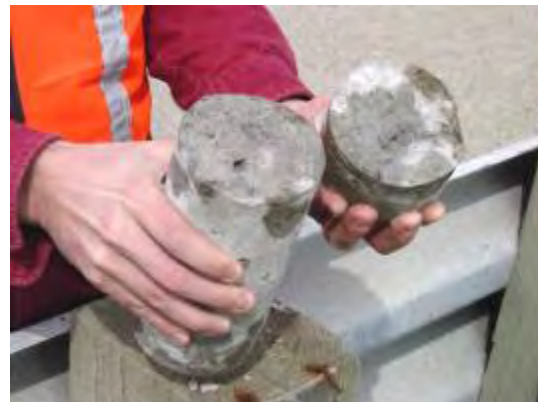
Figure 3.38. Presence of horizontal crack in Core 2c

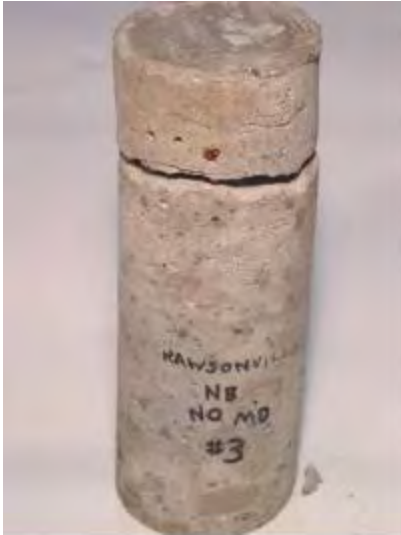
Figure 3.39. Core 2c

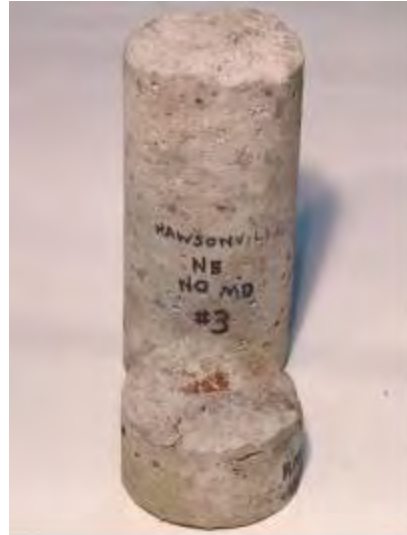
Figure 3.40. Core 2c rust traces

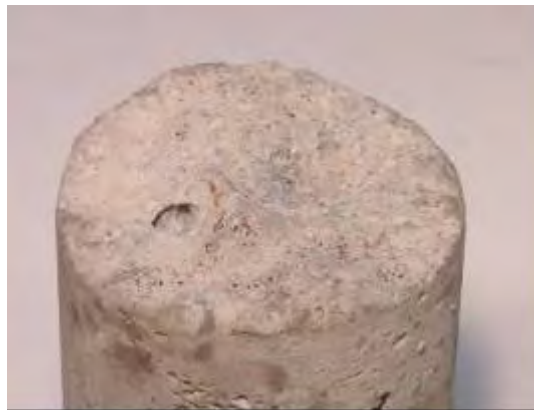
Figure 3.41. Core 2c honeycombing in the concrete

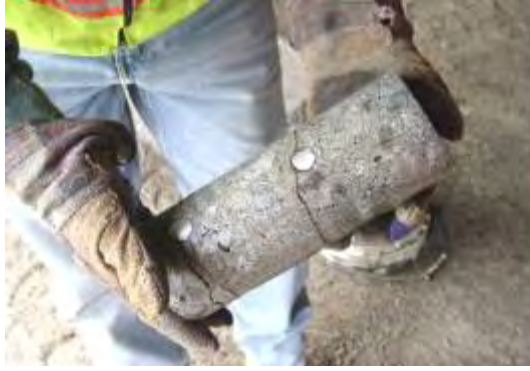
Figure 3.42. Core 2d after collecting it

- 9.8 in. height.
- Slag as well as conventional aggregates were used; and cement paste had high porosity.
- Core was broken at 8.0 in. from the top surface at the location of the steel reinforcement bar.
- The exposed steel bar at the fracture location showed severe signs of rust and concrete deterioration.
- Four axial cuts in the reinforcement bars located 3.8 in. and 8.0 in. from the top.
- Horizontal fracture plane in the core located 4.5 in. from the top. The crack width is approximately 0.08 in.
- One hairline crack propagated along the entire length of the core and through the surface.

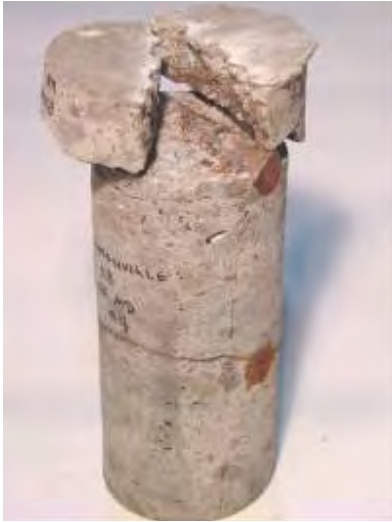
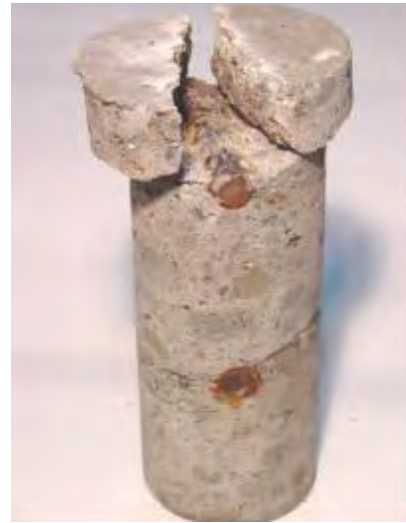
a. Core was broken at the bottom

b. Reinforcement bars are rusted

Figure 3.43. Deterioration of Core 2d

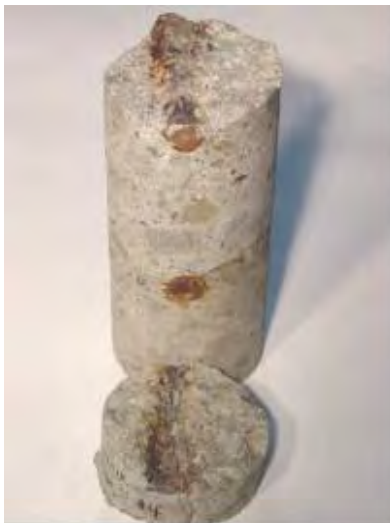
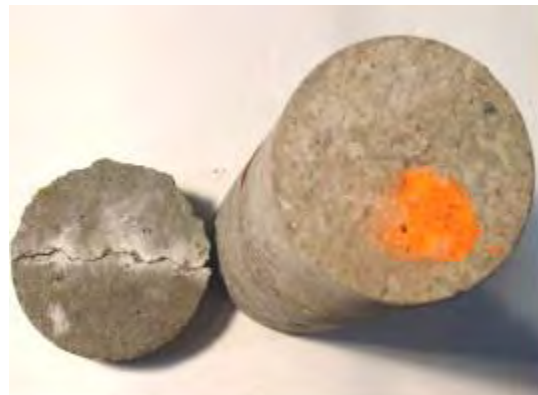
a. Rust traces

b. White traces on the bottom surface

Figure 3.44. Deterioration of Core 2d

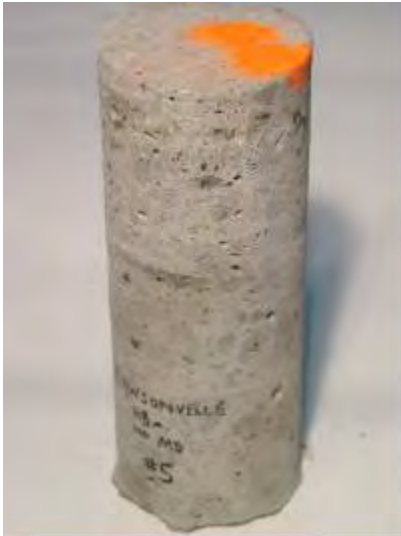
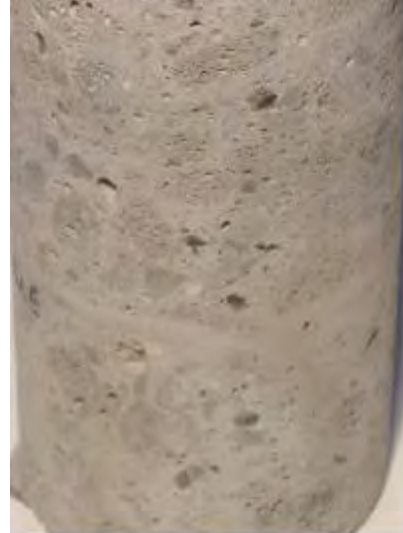
a. High porosity

b. Large voids

Figure 3.45. Core 2e

- 9.5 in. height.
- Slag as well as conventional aggregates were used; and cement paste had high porosity.
- Many large voids of 0.4 in. average diameter located 3.8 in., 5.0 in. and 6.8 in. from the top.

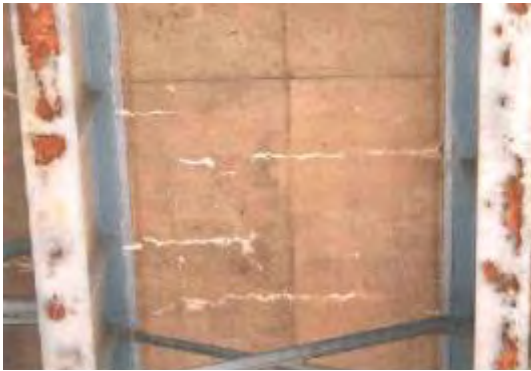
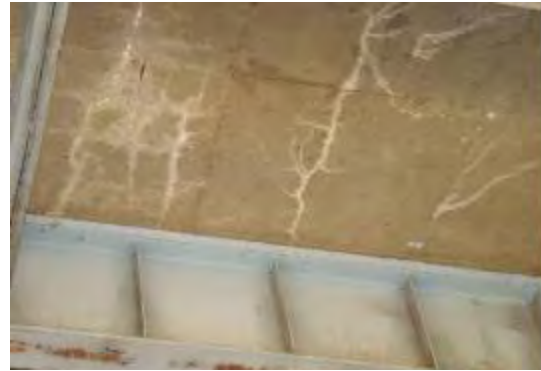
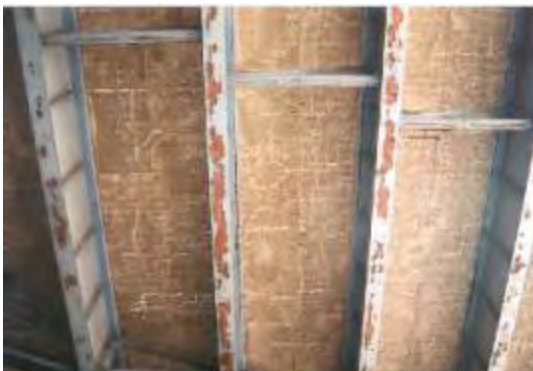
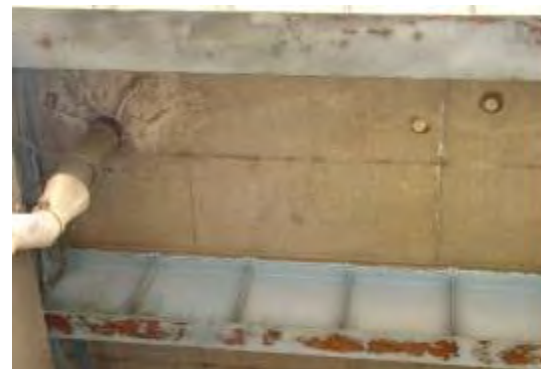
a. Transverse cracks and white traces

b. Transverse and longitudinal cracks

c. Cracks and white traces (small rectangles)

d. White traces around drainage opening

Figure 3.51. Cracks and white traces propagated on the bottom surface of the slab

An inspection of the bridge was conducted for the top and bottom surfaces of the deck slab, steel beams and piers. Cracks were observed at the top surface of the concrete slabs (Figure 3.50). Cracks propagated transversely and longitudinally dividing the surface into small rectangles (approximately one square foot each) as shown in Figure 3.51. White and rust traces were encountered underneath the concrete slab (Figure 3.51). White traces were also encountered around the drainage pipe at the bottom surface (Figure 3.51). In some locations, the concrete cover was deteriorated and the steel reinforcement bars were exposed and rusted (Figure 3.52). The bottom surface of the cantilever deck slabs had white traces and the reinforcement bars had corrosion traces (Figure 3.53).

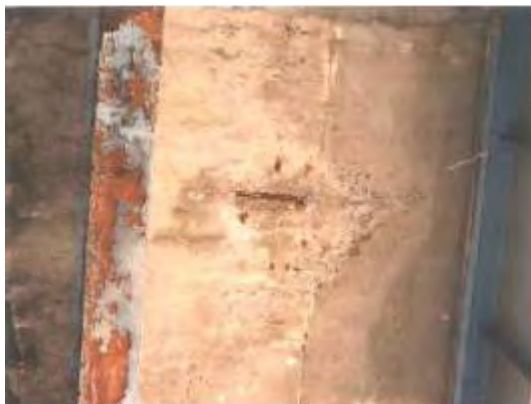
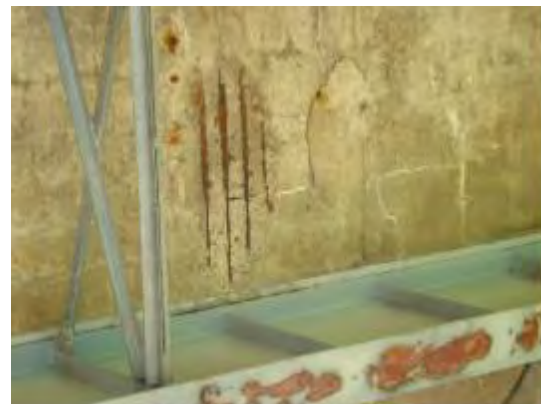
a. Deteriorated concrete cover and rust traces

b. Reinforcement bars rusted

Figure 3.52. Corrosion in the reinforcement bars at the bottom surface of the slab

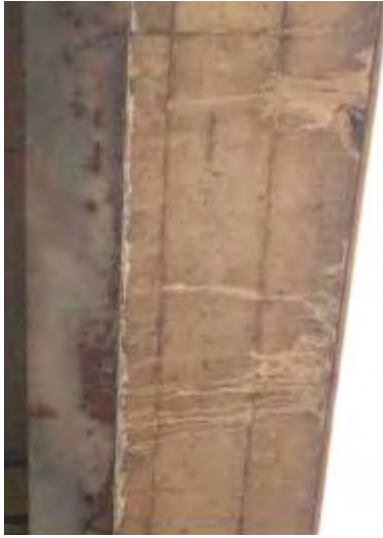
a. White traces

Figure 3.53. White and rust traces at the bottom surface of the cantilever slabs

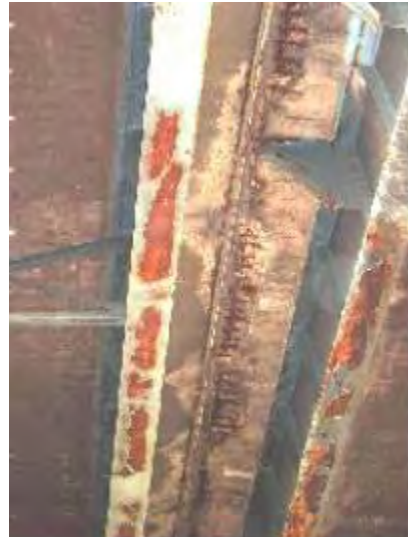
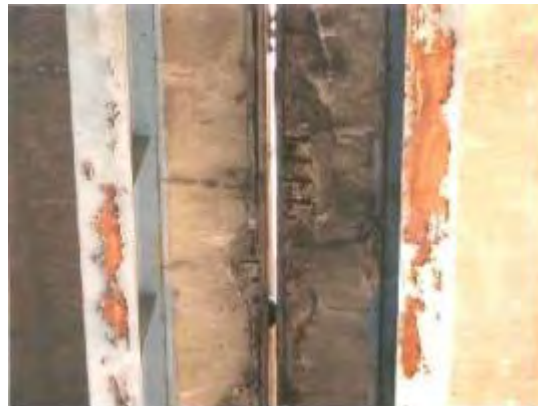
b. Rust and white traces

c. Rust and white traces

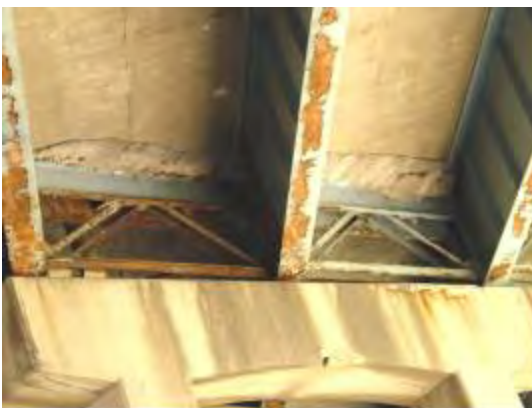
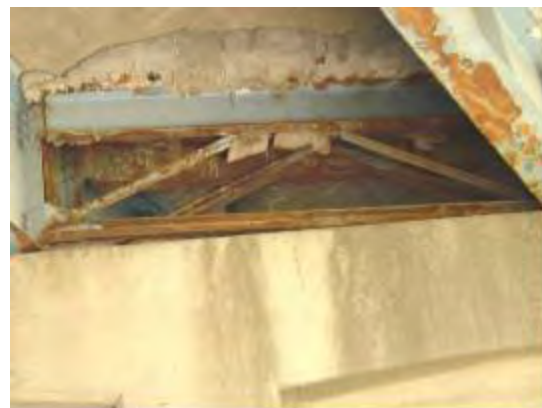
a. Deteriorated concrete cover

b. Rust traces

Figure 3.54. Deterioration at the bottom surface of deck slabs

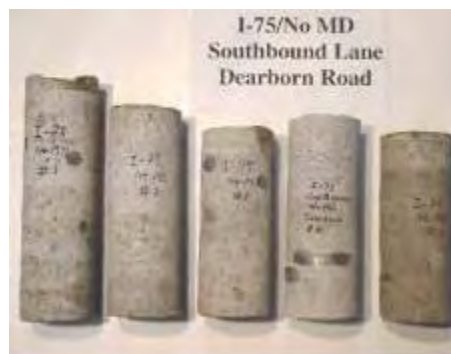
Figure 3.55. The 5 cores that were taken from Bridge Deck Number 3
(Structure No. B01-82194)

The visual inspection of cores from Bridge Deck Number 3 indicated that all of the cores except for two cores had no separate wearing surface at the top surface. The top surface was grooved for all of the cores. The steel reinforcement was not epoxy-coated and some of the reinforcement had traces of rust. No regions containing high porosity were observed. Slag as well as conventional aggregates were used. The coarse aggregate was well bonded to the concrete. The heights of the cores varied from 9.3 to 12.3 in. indicating non-uniformity of the bridge deck thickness. Five cores were taken from the concrete deck slab without SIPMF. The cores are shown in Figure 3.55.

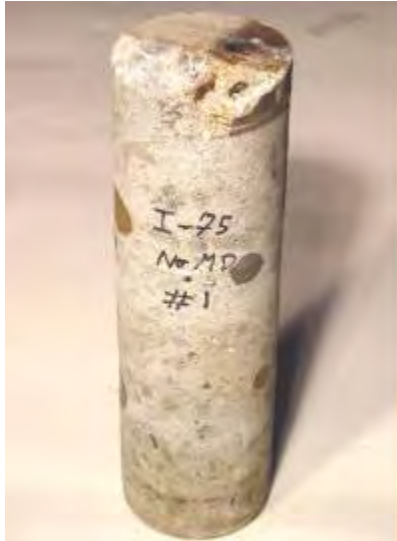
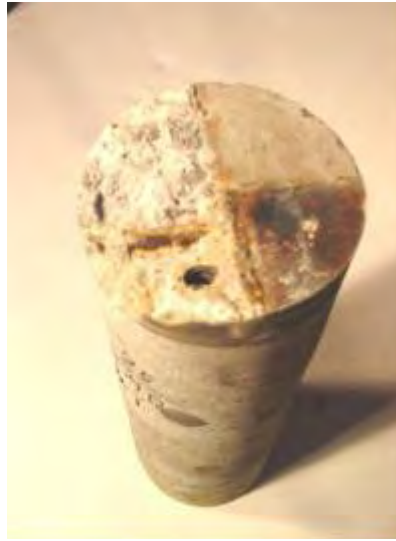
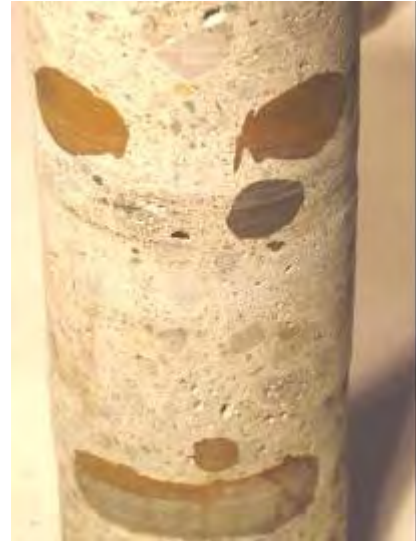
a. Broken bottom

b. Large void and rust at the bottom

c. Rusted reinforcement bars

Figure 3.56. Core 3a

Core 3a (Figure 3.56)

- 12.3 in. height.
- Part of the connection between the steel beam and the slab was cut and there were traces of corrosion on it.
- Six axial cuts located 4.8, 8.0 and 9.0 in. from top.
- One longitudinal cut located 3.8 in. from top.
- Five locations of honeycombing of average diameter of 0.2 in. located 5.0, 5.5, 6.0 and 8.0 in. from top.
- There was a large void of diameter 0.4 in. and depth of 3.5 in. located the bottom of the core at the location of the connection with the steel beam.
- Slag as well as conventional aggregates were used.

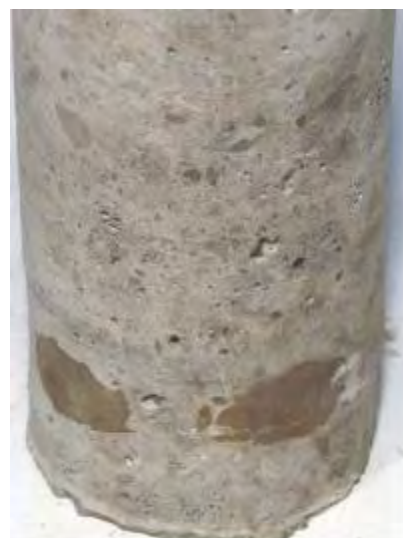
Figure 3.58. Core 3b voids and rust in the reinforcement

- 10.5 in. height.
- Two longitudinal cuts in the reinforcement bars located 2.0 in. from top.
- Many entrapped air voids of average diameter 0.3 in. were observed along the length of the core.
- Slag as well as conventional aggregates were used.
- Traces of rust were observed on the exposed steel reinforcement.

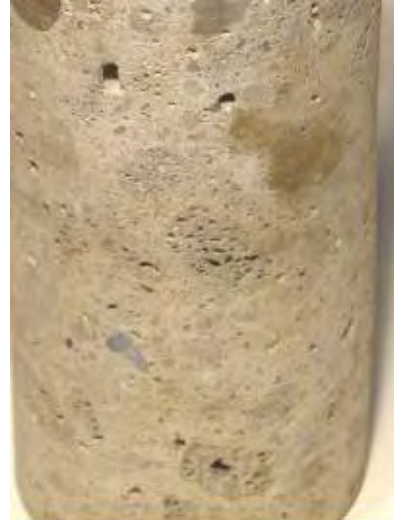
Figure 3.60. Core 3c high porosity

- 9.3 in. height.
- Slag as well as conventional aggregates were used; and cement paste had high porosity.
- Four axial cut in the reinforcement located 7.0 and 7.8 in. from the top.
- Three large voids of average diameter 0.4 in. located 2.8 and 6.0 in. from top.
- Steel reinforcement had rust traces.

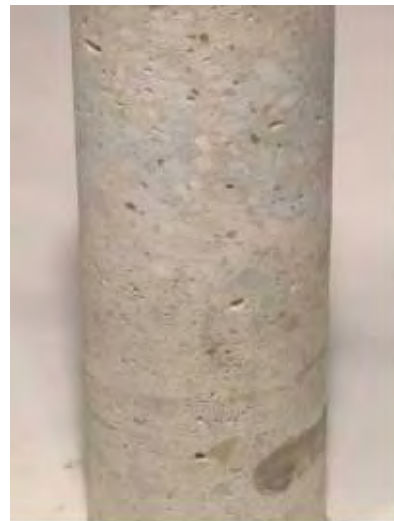
Figure 3.62. Core 3d wearing surface

- 10.0 in. height.
- The core showed that it was cast in two different layers of concrete: an interface existed 4.0 in. from top.
- Slag as well as conventional aggregates were used.
- Two longitudinal cuts in the reinforcement were observed at 7.3 and 8.0 in. from the top.
- Many voids of average diameter 0.2 in. were distributed along the length of the core.
- Three regions containing honeycombing existed at 1.5, 5.8 and 6.0 in. from top.
- Steel reinforcement bars had traces of rust.
- One large void (0.3 in. diameter) was present 1.3 in. from top.

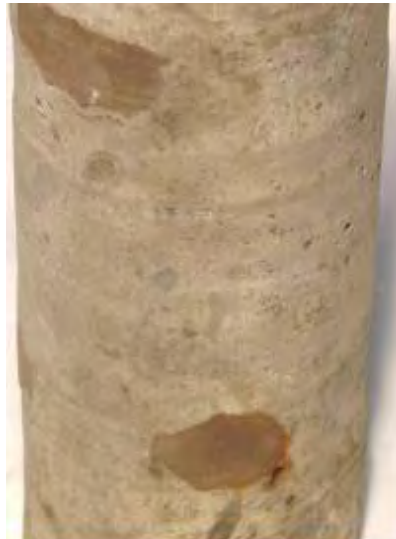
Figure 3.65. Rust in steel bars
Core 3e

- 9.3 in. height.
- One longitudinal cut in the reinforcement located 7.3 in. from top.
- Two axial cuts in the reinforcement located 3.0 in. from the top.
- Traces of rust were observed in the exposed steel reinforcement.
- Slag as well as conventional aggregates were used.
- The bottom surface of the core had a pop-out of diameter 0.1 in. and 0.2 in. depth and had rust traces in it.
- Four regions of honeycombing existed at 1.0, 2.5, 2.8 and 8.0 in. from top. These regions were of average diameter of 0.2 in.
- One location of honeycombing was near the reinforcement bar and had traces of rust in it.
- The bottom surface was partially damaged.

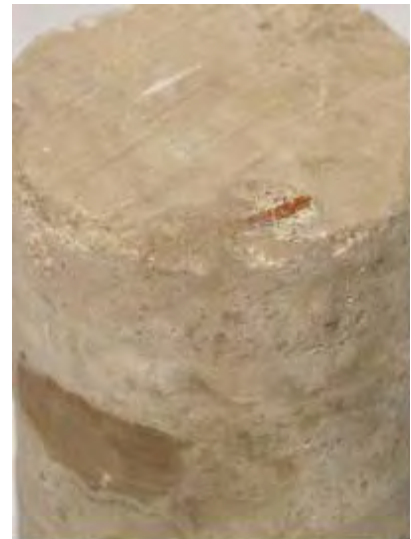
Figure 3.66. Pop-out in concrete
Core 3e

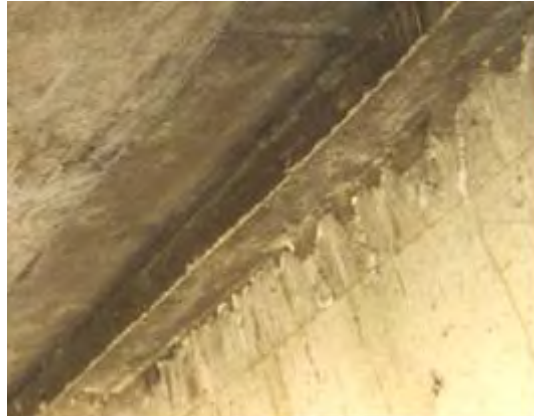
Figure 3.71. Good concrete condition

The top and bottom surfaces of the deck and beams were visually inspected. Cracks were observed at the top and bottom surfaces of the concrete slab and white traces were observed at the side of beams of the bridge. The cracks and white traces were minor and randomly propagated. The concrete condition generally appeared good.

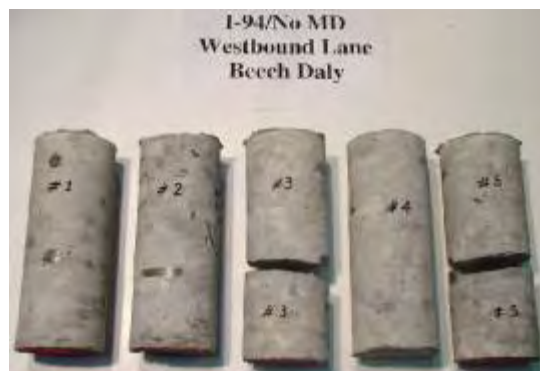
Figure 3.72. The 5 cores that were taken from Bridge Deck Number 4 (Structure No. S11-82022)

The visual inspection of cores from Bridge Deck Number 4 indicated that the concrete was placed at once, as there were no signs of a separate wearing surface. The steel appeared in excellent condition and was coated with green epoxy that was also in excellent condition. However, two cores were cracked at the reinforcement location and the steel had no traces of concrete adhering to it. The coarse aggregate was well bonded to the concrete and no regions of high porosity were observed; however, numerous entrapped air voids were observed. All of the cores had approximately the same height of average 9.8 ± 0.2 in. which indicates bridge uniformity. The five cores are shown in Figure 3.72.

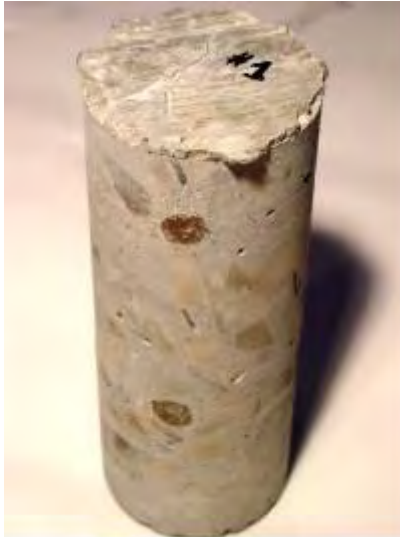
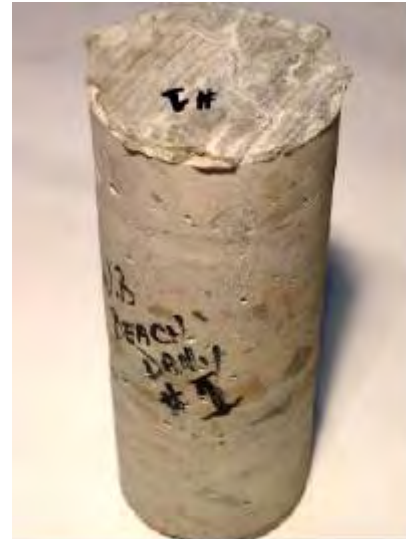
a. Reinforcement bars

b. Crack propagated through the height

Figure 3.73. Two sides of Core 4a showing a crack all along the depth of the core

Core 4a (Figure 3.73)

- 9.8 in. height.
- A full depth crack propagated all through the height and cross section of the core.
- Steel bars were observed at 4 in. and 8 in. from the top.

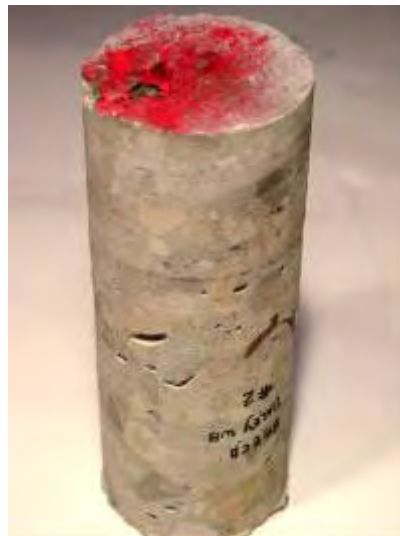
Figure 3.74. A few large voids near the mid-height and reinforcing steel were observed in Core 4b

Core 4b (Figure 3.74)

- 9.8 in. height.
- A groove existed on the surface.
- Numerous voids of approximately 0.3 in. diameter.
- A #4 steel bar was observed located 3.5 in. from the top.

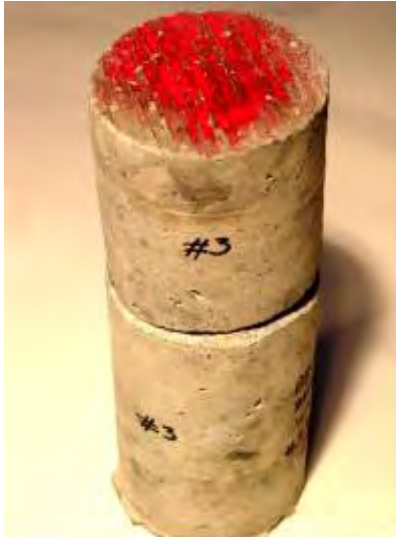
Figure 3.75. Core 4c fractured at the reinforcement location

Core 4c (Figure 3.75)

- 9.8 in. height.
- Core fractured at the reinforcement located 3.8 in. from the top.
- Numerous voids of approximately 0.1 in. diameter.

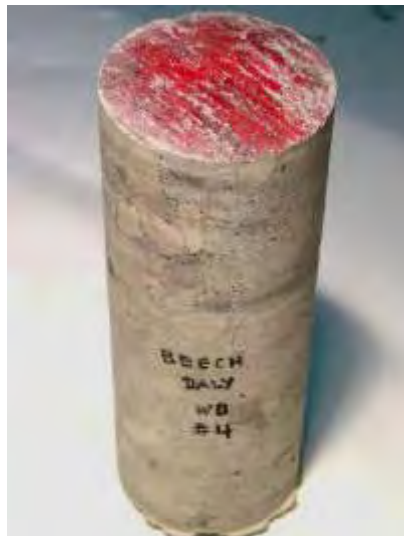
Figure 3.76. Core 4d

Core 4d (Figure 3.76)

- 9.9 in. height.
- Overall, good concrete quality.

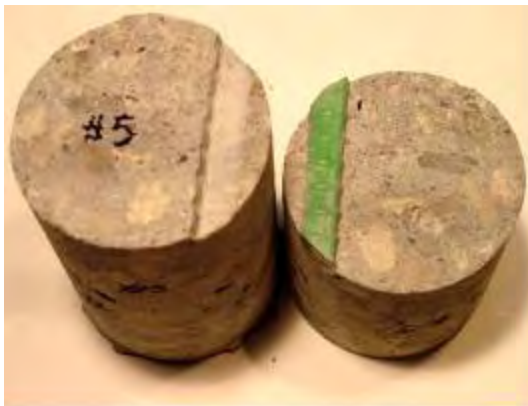
Figure 3.77. Exposed reinforcement where core fractured in Core 4e

- 9.6 in. height.
- Core fractured at the reinforcement located 4 in. from the top.
- Core appeared more porous than the other cores from this bridge deck.
- Numerous entrapped air voids with an average diameter of 0.15 in. were observed.

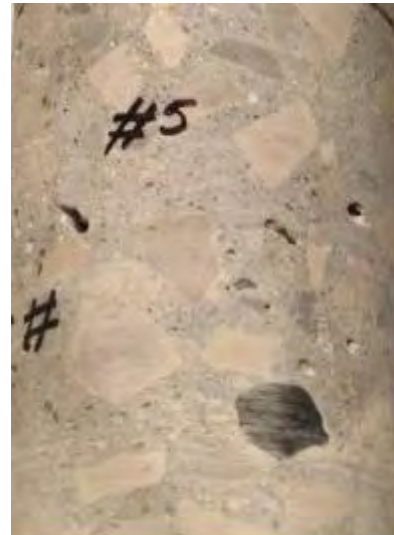
Figure 3.78. Voids observed in Core 4e

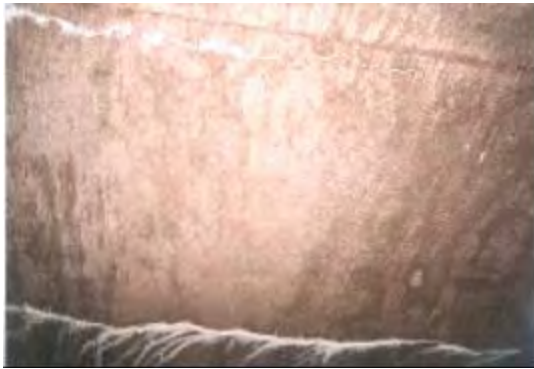
a. White traces at approximately 4 ft

b. White traces with transverse crack

Figure 3.83. White traces at the bottom surface of the deck

Cracks were observed at the top surface of the concrete slab. White traces were observed underneath the concrete slab at approximately 4 ft. intervals as shown in Figures 3.83 and 3.84.

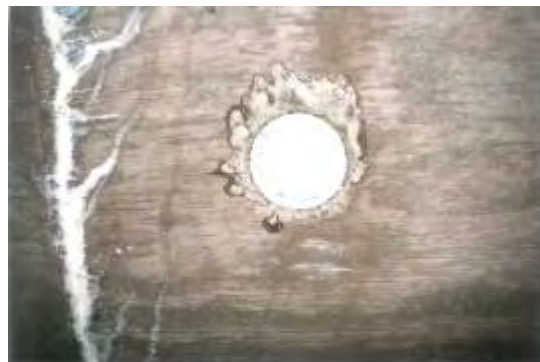
Figure 3.84. White traces near coring location

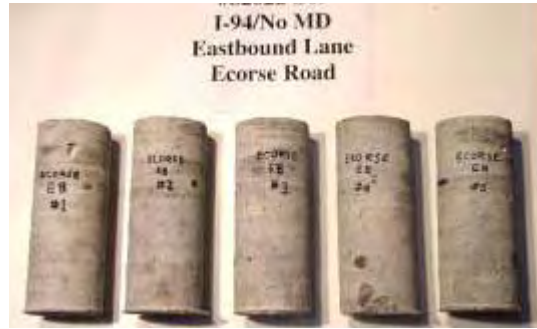
Figure 3.85. The 5 cores that were taken from Bridge Deck Number 5 (Structure No. S09-82022)

The visual inspection of cores from Bridge Number 5 indicated that the bridge had no separate wearing surface at the top surface. The top surface of all of the cores had a grooved texture. The steel reinforcement bars were coated with green epoxy and had slight traces of rust. The coarse aggregate was well bonded to the concrete, which had no porosity however few voids were encountered. All of the cores had approximately the same height of average 9.4 ± 0.2 in. which indicates bridge uniformity. The five cores that were taken are shown in Figure 3.85.

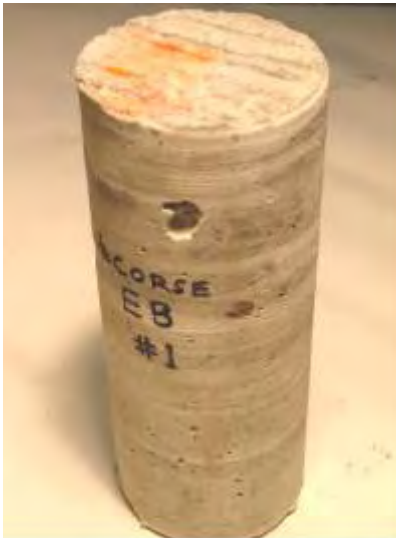
Figure 3.86. Core 5a with a large void

Core 5a (Figure 3.86)

- 9.5 in. height.
- One large void of 0.6 in. located 2.0 in. from the top.
- Axial section of a steel reinforcement #4 appeared at 3.3 in. from the top.
- Exposed steel showed traces of rust.
