LAWRENCE TECHNOLOGICAL UNIVERSITY

INSPECTION AND DETERIORATION OF BRIDGE DECKS CONSTRUCTED USING STAY-IN-PLACE METAL FORMS AND EPOXY-COATED REINFORCEMENT

October, 2004

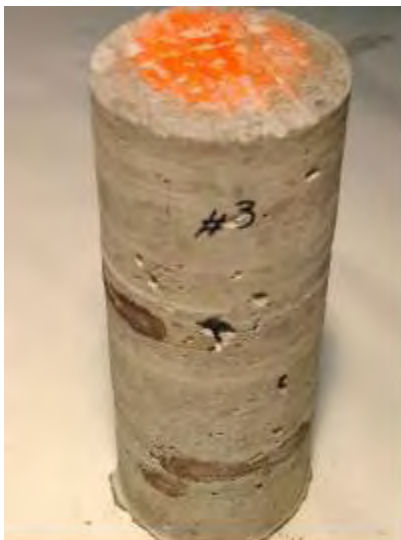
- 9.5 in. height.
- Two axial sections of steel reinforcement located 7.8 in. from the top.
- Two longitudinal sections of steel reinforcement located 3.8 and 6.8 in. from the top.
- Exposed reinforcement bars had traces of rust.
- Honeycombing in regions of average width 0.5 in.
- Many entrapped air voids of average dimension 0.2 in.
- Two longitudinal hair cracks observed along the entire length of the core.

Figure 3.88. Presence of honeycombing in Core 5c

Core 5c (Figures 3.88-3.89)

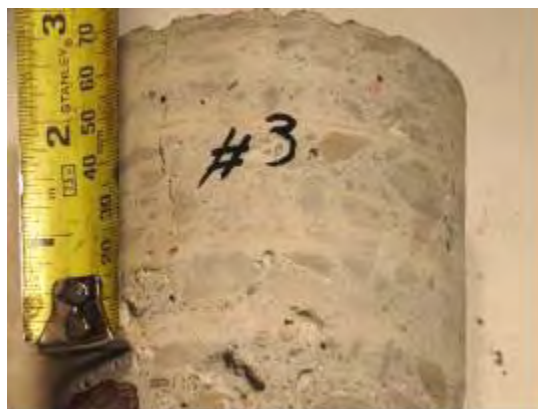
Figure 3.89. Hairline crack along surface of core in Core 5c

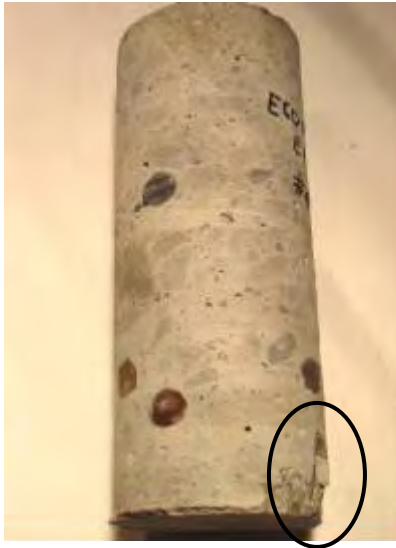
Core 5d (Figure 3.90)

- 9.2 in. height.
- Some reinforcement bars had rust traces while others did not.
- Many voids of average diameter 0.2 in.
- Five axial sections of reinforcement bars located 3.8, 4.0, 7.0, 7.8 and 8.0 in. from the top.
- The core was partially damaged in the coring from the bottom surface.

Figure 3.90. Damage of bottom region of Core 5d

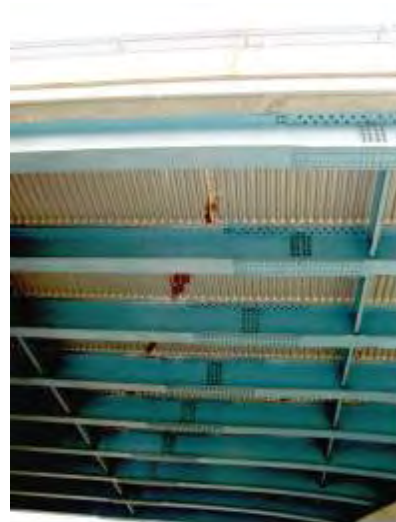
Figure 3.97. Corrosion at the SIPMF

An inspection of the bridge was conducted for the top and bottom surfaces of the deck slab, steel beams, piers and abutments. The cracks propagated longitudinally, transversely or diagonally through the bridge. Some of the top surface cracks were accompanied by corrosion of the SIPMF indicating that these cracks were full depth cracks as shown in Figures 3.96 and 3.97. A different type of concrete (as indicated by a difference in color) was encountered at the sides of the joints in the top surface (Figure 3.98). The SIPMF at bottom surface of the deck slab was corroded diagonally and transversely at the same location of the top cracks (Figure 3.99). The connections between the SIPMF and the steel beams showed rust accompanied with white traces as shown in Figure 3.100. The drainage holes had corrosions in the deck with SIPMF (Figure 3.101)

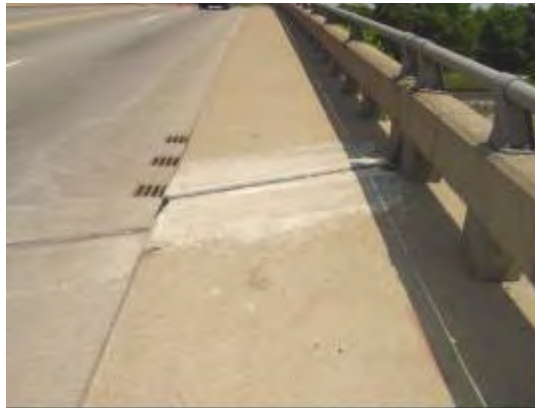
Figure 3.98. Different types of concrete around the joints

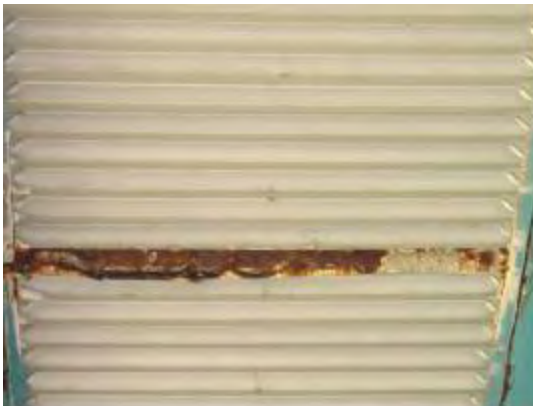
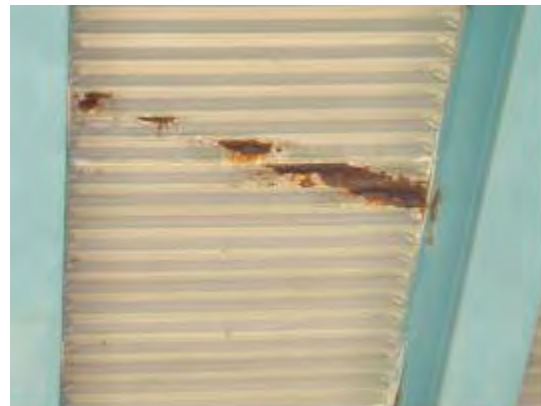
a. Corrosion in the SIPMF oriented diagonally

b. Corrosion in the SIPMF oriented transversely

c. Corrosion and white traces in the SIPMF

Figure 3.99. Corrosion in the SIPMF is oriented diagonally and transversely

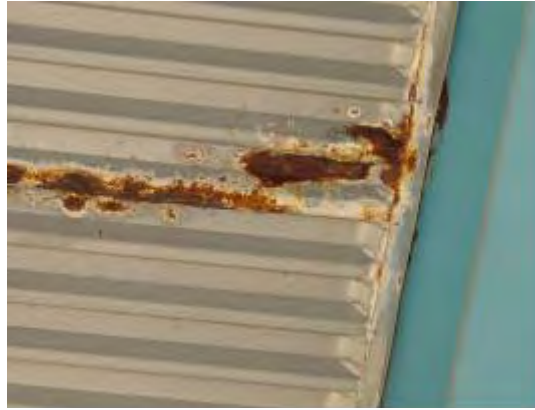
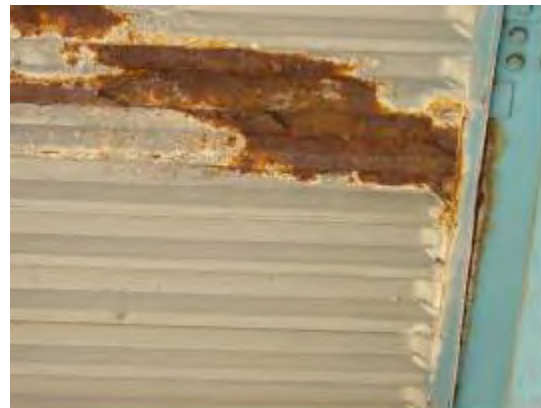
a. Corrosion and white traces near the connection

b. Corrosion in SIPMF near connection
between main and bracing beams

c. Corrosion in SIPMF and steel beam
at the connection

Figure 3.100. Corrosion and white traces at the connection between SIPMF and steel beams

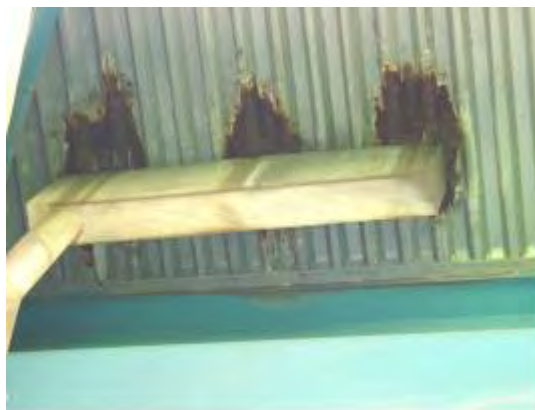
Figure 3.101. Corrosion around the hole in the deck with SIPMF

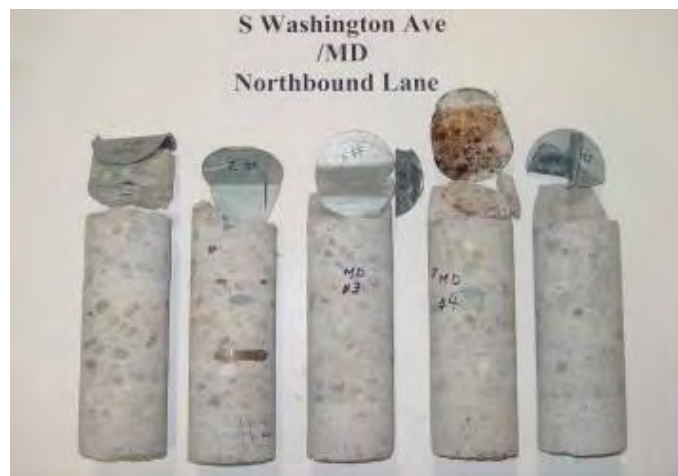
Figure 3.102. The 5 cores that were taken from Bridge Deck Number 6 (Structure No. R01-13012)

The visual inspection of the cores from Bridge Number 6 indicated that all of the cores had a wearing surface of 2.3 in. at the top as indicated by the change in concrete color and the aggregate size. This wearing surface had a higher porosity than the rest of the core. The top surface was grooved for all of the cores. The steel reinforcement was coated with brown epoxy and some of the exposed reinforcement bars had rust traces. The coarse aggregate was well bonded to the concrete. Regions of high porosity and large voids were observed. The SIPMFs for all of the cores are separated from the concrete without leaving concrete traces adhering to its inner face. The height of the cores did not vary thus indicating uniformity of the bridge. The five cores that were taken are shown in Figure 3.102.

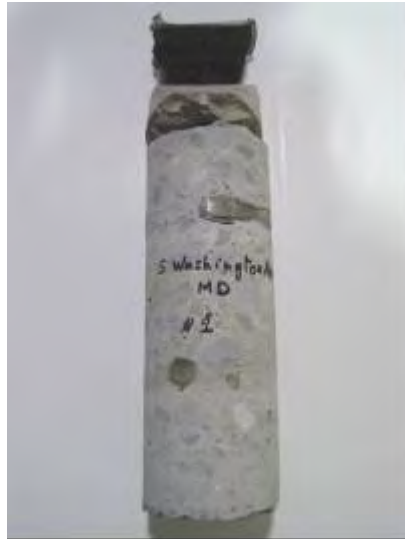
Core 6a (Figure 3.103)

- 10.0 in. height.
- Two axial cuts in the reinforcement located 4.3 in. from the top.
- One longitudinal cut in the reinforcement located 8.3 in. from the top.
- Reinforcement bars had signs of rust.
- The SIPMF was separated from the core.
- Part of the concrete in the region of the valley of the SIPMF was broken at 10.8 in. from the top during coring.
- Two regions of honeycombing of average width of 0.3 in. were located 5.8 in. and 9.3 in. from the top.

Figure 3.103. Core 6a broken concrete in the region of the valley of the SIPMF and separated SIPMF

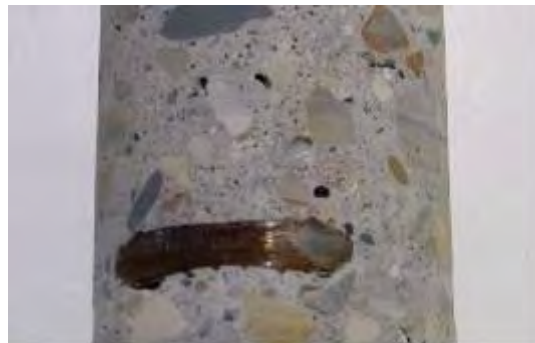
Core 6b (Figure 3.104)

- 10.0 in. height.
- SIPMF was separated from the core.
- One longitudinal cut in the reinforcement located 5.0 in. from the top.
- High porosity.
- Many large voids of average diameter of 0.2 in.
- Three regions of honeycombing of average width of 0.3 in. were located 3.8, 5.0 and 5.8 in. from the top.

Figure 3.104. Core 6b many honeycombing and rust in the reinforcement bars

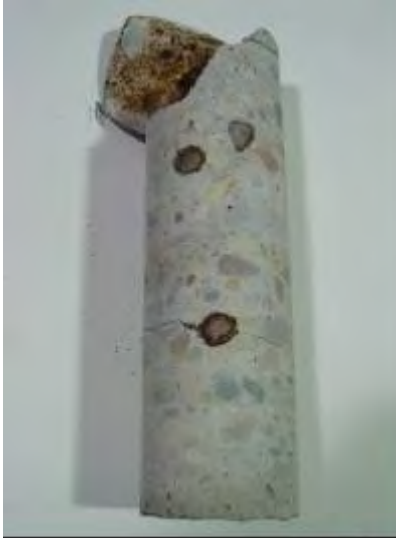
Core 6c (Figure 3.105)

- 10.0 in. height.
- The concrete in the region of the valley of the SIPMF was partially broken during the coring.
- SIPMF separated from the core.
- The concrete had high porosity.

- Many large entrapped air voids of average diameter of 0.2 in. were observed.
- Seven locations of honeycombing of average width of 0.3 in. were located 3.0, 3.5, 5.5, 6.5, 6.8, and 8.0 inches from the top.
- Reinforcement bars had rust traces.

Figure 3.105. Core 6c crack
at the reinforcement

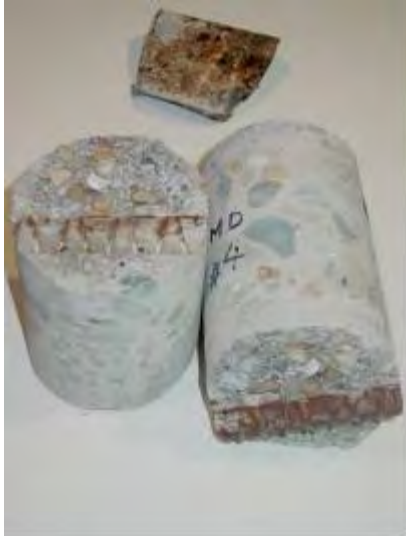
- 10.0 in. height.
- Lateral crack caused splitting at 4.5 in. from the top at the location of the reinforcement, which showed traces of corrosion.
- Four axial sections of reinforcement bars located 4.5 and 8.5 in. from the top.
- SIPMF separated from the core.
- The SIPMF left signs of rust on the surface of contact with the concrete.
- Reinforcement bars had rust traces.
- Four locations of honeycombing of average width of 0.3 in. were located 6.0, 7.5, 8.5 and 9.3 in. from the top.

Figure 3.106. Core 6d rust at the reinforcement bar

Core 6d (Figures 3.106-3.107)

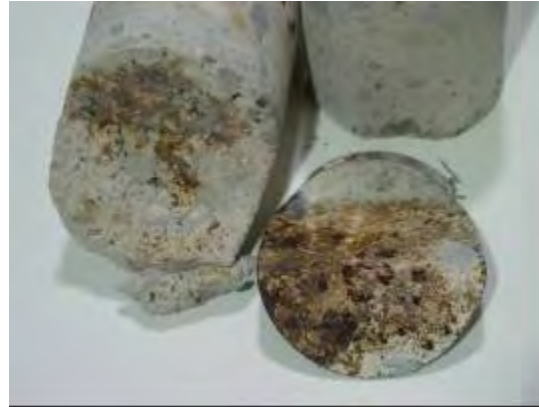
Figure 3.107. Core 6d rust on the SIPMF

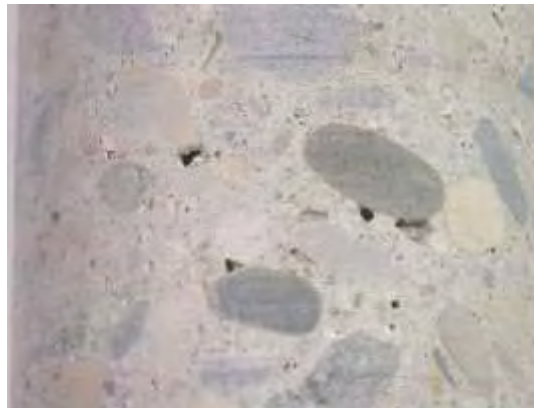
Core 6e (Figure 3.108)

- 10.0 in. height.
- High porosity.
- Many large voids of average diameter 0.2 in.
- SIPMF was separated during the coring.
- Two locations of honeycombing of average width of 0.3 in. were located 5.5 and 8.3 in. from the top.

Figure 3.108. Core 6e many locations of entrapped air

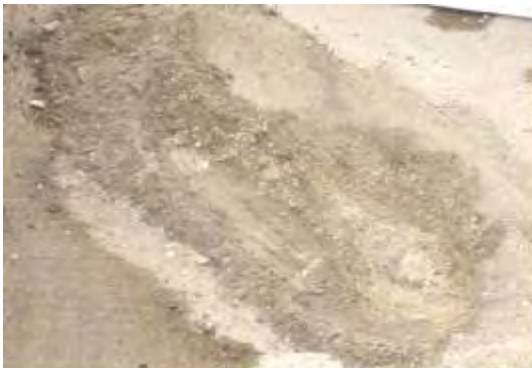
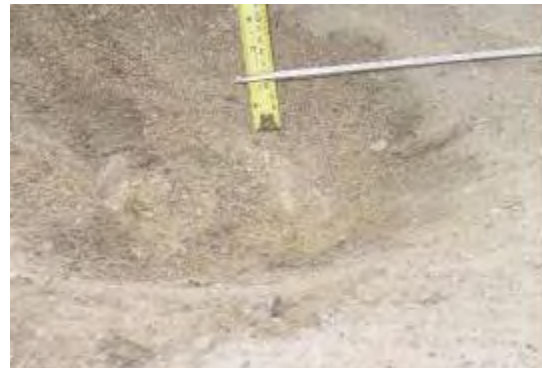
a. Large depression in bridge deck

b. Depth of large depression

Figure 3.113. Deteriorated section in the deck slab

A deteriorated section of approximately 2 in. depth and 2 feet in diameter existed in the top surface of the bridge (Figure 3.113). In many locations along the bridge, the concrete curbs were deteriorated and the steel reinforcement bars were uncovered (Figure 3.114). The SIPMF was in good condition (Figure 3.115).

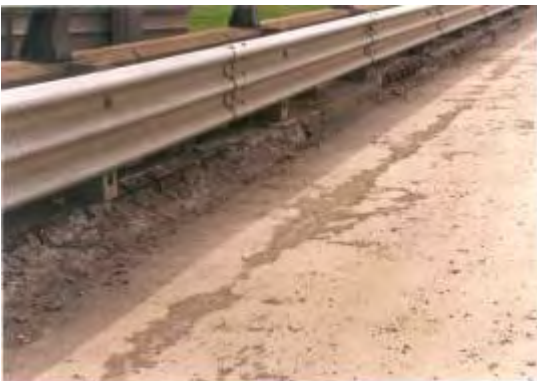
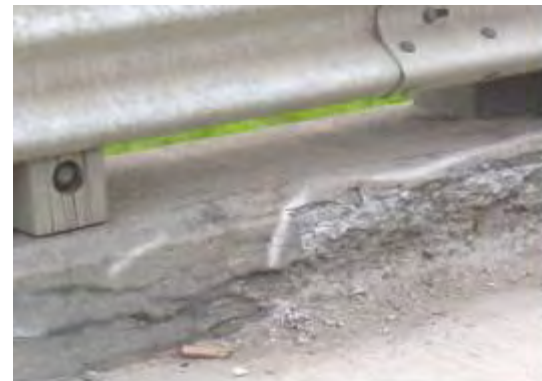
a. Severe deterioration along the curb

b. Deteriorated section and white traces

Figure 3.114. Severe deterioration on the curbs

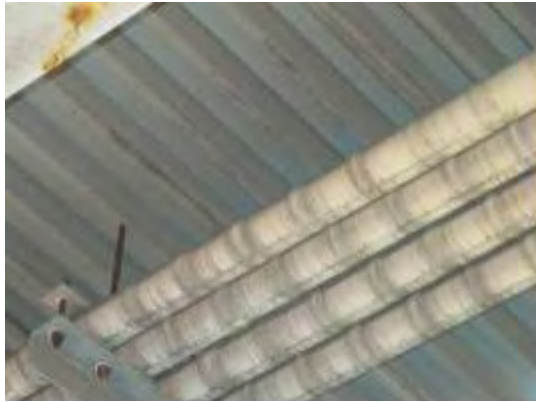
Figure 3.115. Good condition of SIPMF

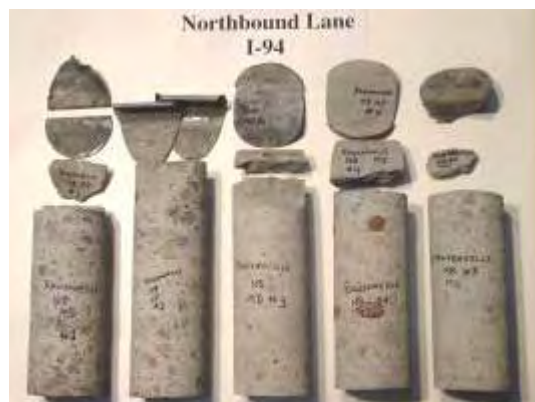
Figure 3.116. The 5 cores that were taken from Bridge Deck Number 7 (Structure No. S03-81041)

The visual inspection of cores from Bridge Number 7 indicated that the bridge had no separate wearing surface at the top surface. The steel reinforcement was not epoxy-coated and had traces of rust. The coarse aggregate was well bonded to the concrete. The cement paste had high porosity. Slag was used as aggregates in the deck slab. The SIPMFs for all of the cores were separated from the concrete (without leaving big traces adhering to its inner face). All of the cores had approximately the same height of average 9.3 ± 0.2 in. (not including concrete placed in the valley of the corrugation of the SIPMF) which indicates bridge uniformity. The five cores are shown in Figure 3.116.

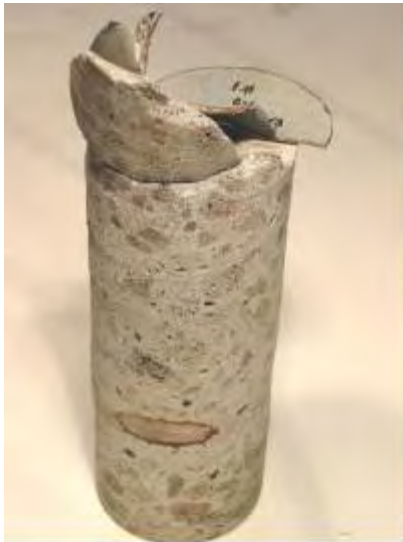
- 9.3 in. height.
- The concrete in the region of the valley of the SIPMF was broken during coring.
- Slag was used as aggregates in the deck slab; and cement paste had high porosity.
- One longitudinal cut in the steel reinforcement bar located 3.5 in. from top.
- Reinforcement bar had signs of rust.
- SIPMF was separated from the concrete and had 2 overlapping sections.

Figure 3.117. Core 7a is broken and reinforcement bar is rusted

Core 7a (Figures 3.117-3.118)

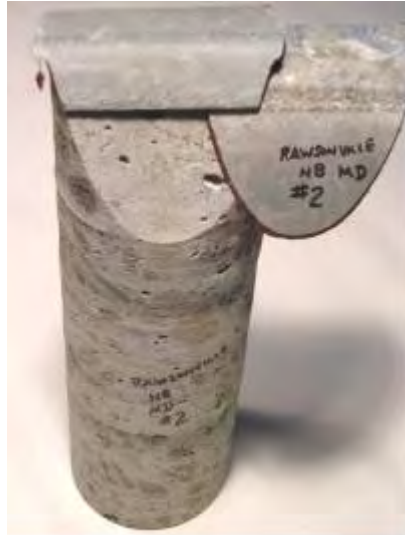
Core 7b (Figure 3.119)

- 9.3 in. height (11.5 in. with the concrete in the region of the valley of the SIPMF).
- Large entrapped air voids of approximately 0.3 in. diameter occurred at the concrete in the region of the valley of the SIPMF at 0.8 and 1.5 in. from bottom.
- Four axial cuts in the steel reinforcement bars located 3.5, 3.8, 7.8, and 8.0 in. from top.
- SIPMF was separated with 2 overlapping sections.
- Slag was used as aggregates in the deck slab.

Figure 3.119. Core 7b shows large entrapped air voids and overlap of SIPMF sections

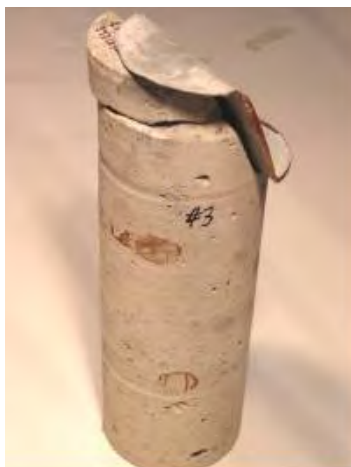
Core 7c (Figure 3.120)

- 9.0 in. height (11.8 in. with the concrete in the region of the valley of the SIPMF).
- Slag was used as aggregates in the deck slab; and cement paste had high porosity.
- Many large voids of 0.3 in. average diameter.
- Two axial cuts in the steel reinforcement bars located 3.8 in. from top.
- One longitudinal reinforcement bar located 7.8 in. from top.
- Reinforcement bars had signs of rust.
- SIPMF separated from the core.
- Concrete in the region of the valley of the SIPMF was damaged during the coring.

Figure 3.120. Core 7c shows the broken concrete in the region of the valley of the SIPMF and the rust in the reinforcement bars

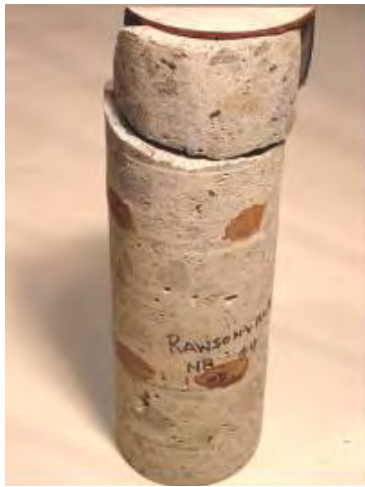
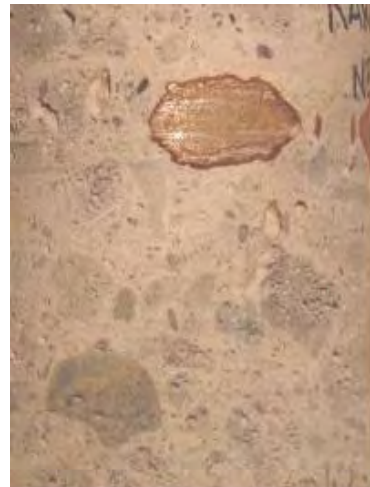
Core 7d (Figure 3.121)

- 9.5 in. height (12.0 in. with the concrete in the region of the valley of the SIPMF).
- Concrete in the region of the valley of the SIPMF was broken during the coring.
- Slag was used as aggregates in the deck slab; and cement paste had high porosity.
- Large voids of average diameter 0.4 in. occurred 4.3, 6.0, and 8.0 in. from top.
- Two axial sections of reinforcement bars located 8.0 in. from top.
- Two longitudinal sections of reinforcement located 3.8 in. from top.
- Reinforcement bars had signs of rust.
- SIPMF separated from the core.
- Region of honeycombing observed 2.8 in. from top.

a. Broken concrete in the region of the valley of the SIPMF

b. Rust in the reinforcement bar

Figure 3.121. Core 7d

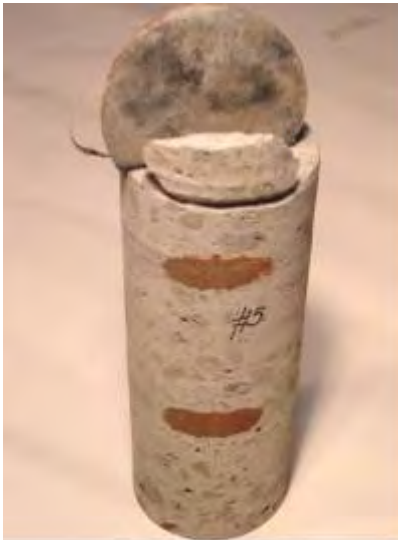
Core 7e (Figure 3.122)

- 9.5 in. height (11.0 in. with the concrete in the region of the valley of the SIPMF).
- The concrete in the region of the valley of the SIPMF was broken during the coring.
- Slag was used as aggregates in the deck slab; and cement paste had high porosity.
- Large entrapped air voids of average diameter 0.2 in. occurred 3.0 in. from top.
- Two longitudinal sections of reinforcement occurred at 4.0 in. and 8.0 in. from top.
- Reinforcement bars have signs of rust.
- SIPMF was separated during the coring.

Figure 3.122. Broken concrete in the region of the valley of the SIPMF and the rust in the reinforcement bars in Core 7e

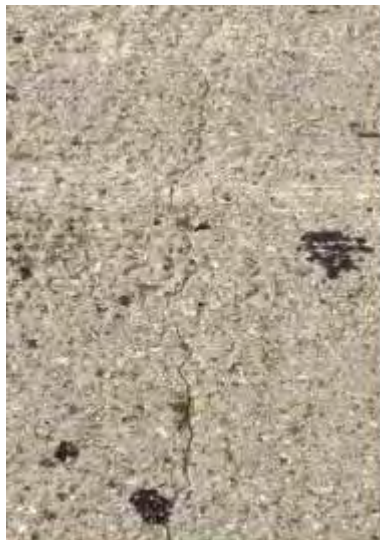
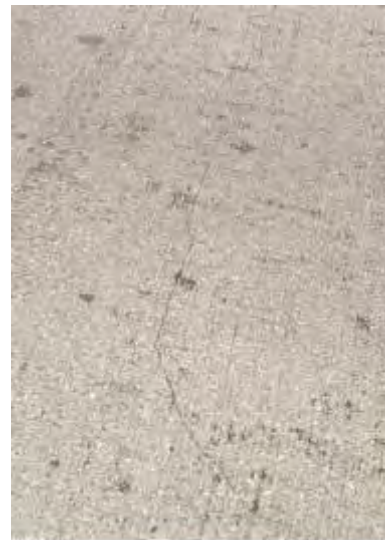
a. Longitudinal Crack

b. Diagonal and transverse cracks

Figure 3.127. Top cracks propagated on the top surface of the slab

Cracks were found at the top surface of the concrete slabs. Cracks were propagated transversely and longitudinally (Figure 3.127). Deterioration was encountered in the joints between deck slabs (Figure 3.128). Wide regions of corrosion were found at the bottom surface of the SIPMF concrete placed in the valley of the corrugation of the SIPMFs (Figure 3.129). Traces of steel rust existed in the connections between the SIPMF and the steel girders (Figure 3.130).

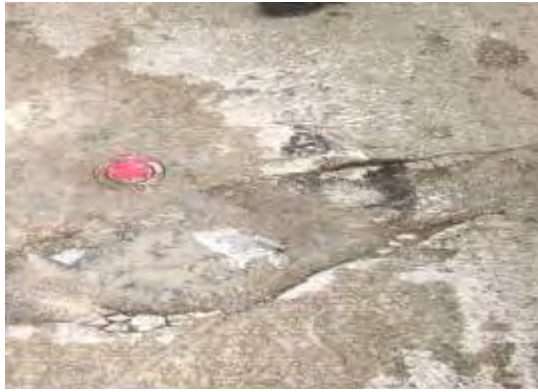
Figure 3.128. Deterioration in the joint

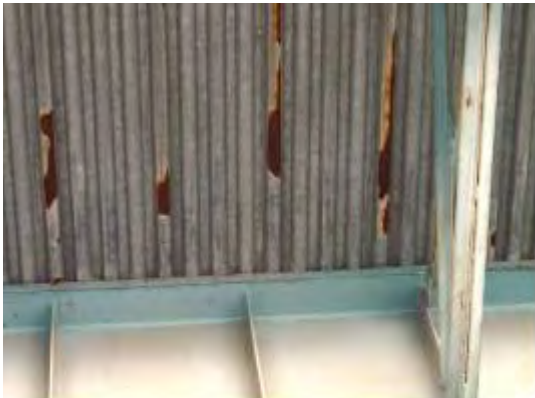
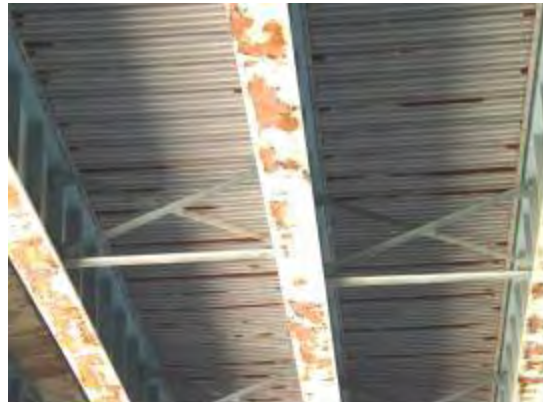
a. Rust traces in SIPMF

b. General view of the rusted SIPMFs

Figure 3.129. Corrosion in the SIPMF

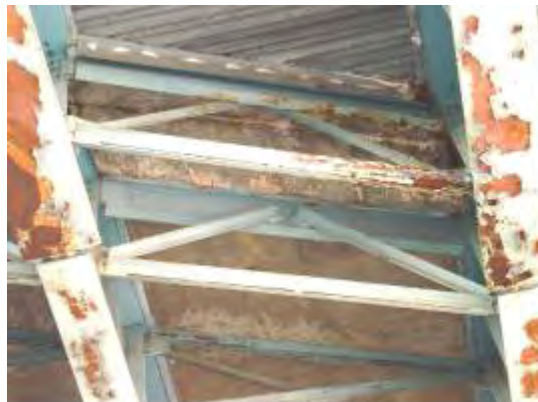
Figure 3.130. Rust in the connection between steel girders and SIPMFs

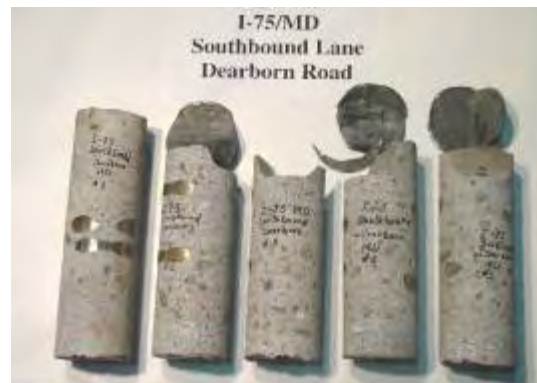
Figure 3.131. The 5 cores that were taken from Bridge Deck Number 8
(Structure No. S03-81041)

The visual inspection of the cores from Bridge Number 8 indicated that the bridge had a wearing surface of average 1.5 in. thickness at the top surface as shown by the different size of aggregates used. This wearing surface had a higher porosity than the rest of the core, and conventional aggregates were used for the wearing surface. Slag was used as aggregates in the remaining part of the core. The coarse aggregate was well bonded to the concrete. No regions of high porosity were observed. Many entrapped air voids were encountered and had an average diameter of 0.2 in. Many regions of honeycombing existed in all of the cores. The top surface was grooved for all of the cores. The steel reinforcement was not coated with epoxy. Some of the exposed reinforcement bars had rust traces while others were in good condition. The SIPMFs for all of the cores were separated from the concrete without leaving concrete traces adhering to its inner face. The height of the cores varied indicating non-uniformity of the bridge deck thickness. The five cores that were taken are shown in Figure 3.131.

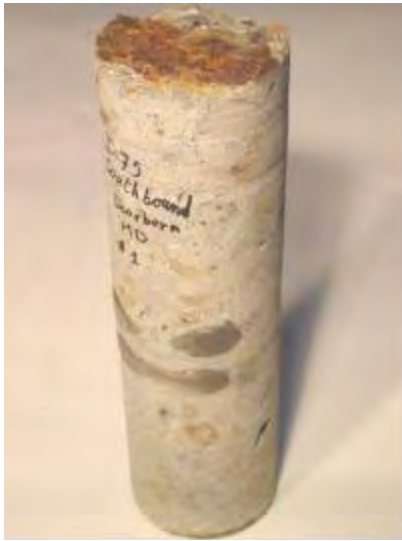
Core 8a (Figures 3.132-3.133)

- 12.5 in. height.
- The concrete in the region of the valley of the SIPMF was broken during coring.
- Three longitudinal cuts through steel reinforcement bar located 5.5 and 6.5 in. from the top were observed.
- Two regions of honeycombing of average diameter 0.6 in. were observed at 3.5 and 9.5 in. from the top surface.
- One bar had minor rust traces while the others did not.
- The reinforcement bars were epoxy coated.
- SIPMF was separated from the concrete.
- The connection between the concrete and the bracing angle had traces of rust.

Figure 3.132. Core 8a

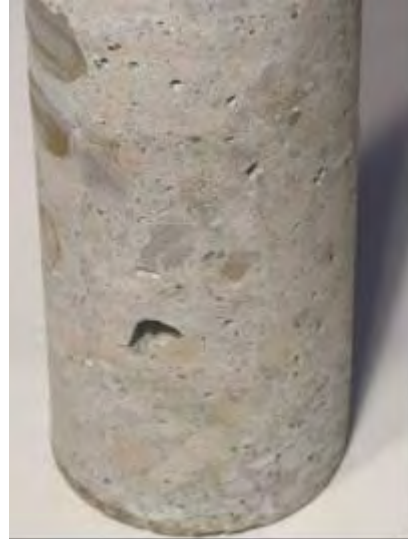
Figure 3.133. Core 8a honeycombing and large single void in the concrete

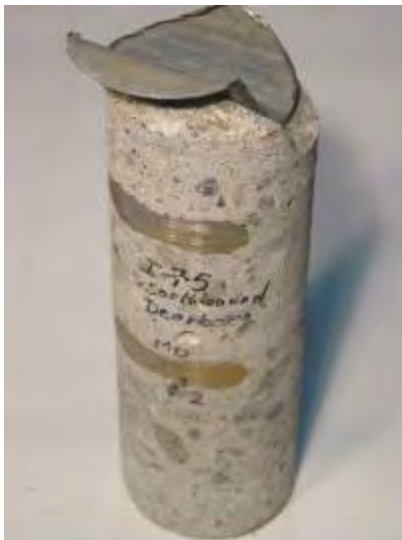
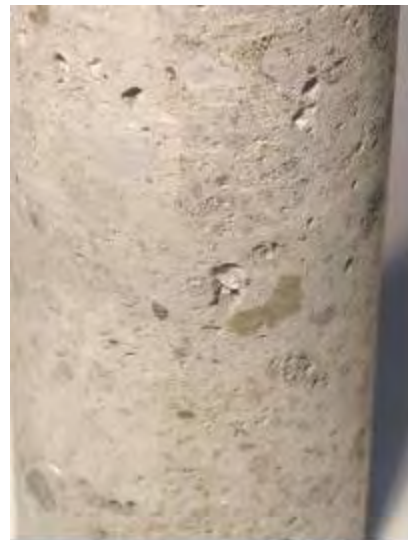
Core 8b (Figure 3.134)

- 9.5 in. height (11.6 in. with the concrete in the region of the valley of the SIPMF).
- The concrete in the region of the valley of the SIPMF was broken during coring.
- Two longitudinal cuts in the reinforcement located 5.0 in. and 8.5 in. from top.
- One region of honeycombing of approximate width of 0.4 in. located 5.5 in. from top.
- Two large voids of average diameter 0.5 in. located 5.0 in. and 7.5 in. from top.
- The wearing surface had very high porosity and many voids of average diameter 0.3 in.
- SIPMF was separated.
- Steel reinforcement bars were in good condition.

a. Rust traces

b. Large region of voids

Figure 3.134. Core 8b with large region of voids and rust in the reinforcement bars

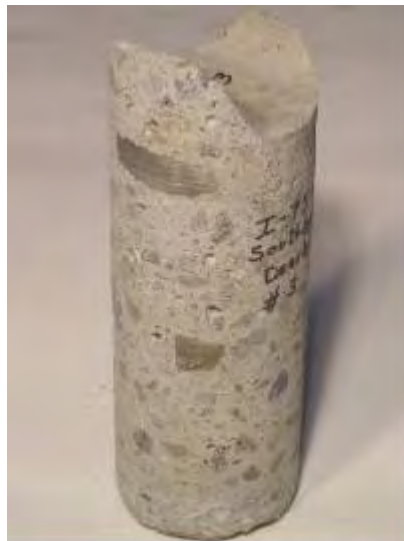
Core 8c (Figure 3.135)

- 9.0 in. height (10.5 in. with the concrete in the region of the valley of the SIPMF).
- The concrete in the region of the valley of the SIPMF was partially broken during the coring.
- Three longitudinal cuts in the reinforcement located 4.5, 6.5, and 8.3 in. from top.
- Large entrapped air voids of average diameter 0.3 in. located 5.0, 5.5, 5.8, and 6.0 in. from top were observed.
- SIPMF separated from the core.
- Slag was used as aggregates; and cement paste had high porosity.
- The wearing surface had higher porosity and more voids.
- Steel reinforcement bars were in good condition.

Figure 3.135. Core 8c

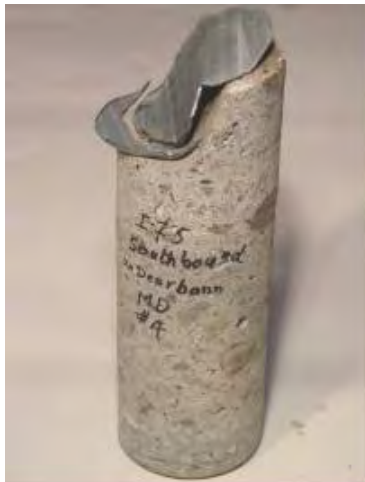
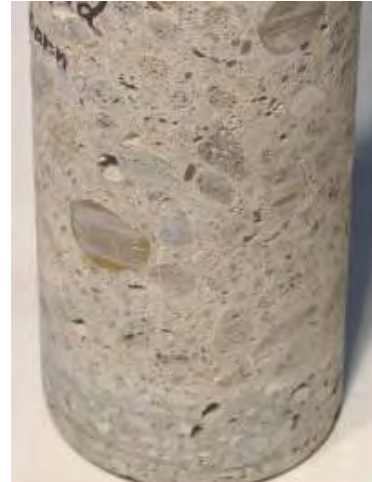
Core 8d (Figure 3.136)

- 9.0 in. height (11.0 in. with the concrete in the region of the valley of the SIPMF).
- One longitudinal cut of reinforcement bar located 3.5 in. from the top.
- Five axial sections of reinforcement bars located 4.0, 4.5, 6.5, 6.8 and 7.5 in. from top.
- SIPMF separated from the core and cut to two parts.
- Slag was used as aggregates; and cement paste had high porosity.
- Wearing surface had entrapped air voids of average diameter 0.5 in. located 2.3 and 5.8 from top.
- Steel reinforcement bars were in good condition.

a. High porosity

b. Entrapped air voids in the wearing surface

Figure 3.136. Core 8d with the high porosity of the concrete

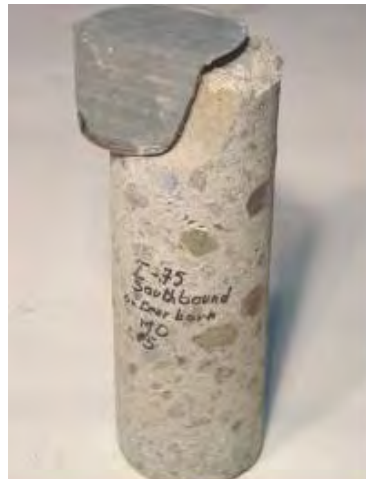
Core 8e (Figure 3.137)

- 9.1 in. height (11.0 in. with the concrete in the region of the valley of the SIPMF).
- Concrete in the region of the valley of the SIPMF was partially broken during the coring.
- Slag was used as aggregates; and cement paste had high porosity.
- The wearing surface has higher porosity than remainder of the core.
- Three Large voids of average diameter 0.2 in. observed 5.0 and 7.0 in. from top.
- Six axial cuts in the steel reinforcement bars 4.5, 5, 8, and 8.5 in. from top.
- One of the axial cuts in the reinforcement bars had slight traces of rust while the others were in good condition.
- SIPMF was separated during the coring.

Figure 3.137. Core 8e with the broken concrete in the region of the valley of the SIPMF

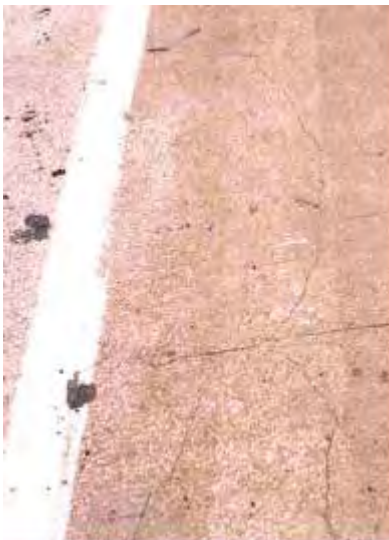
Figure 3.142. Cracks at the top surface

The top and bottom surfaces of the deck slab were visually inspected. Propagated cracks were observed at the top surface of the concrete slab as shown in Figure 3.142. Corrosion in the steel forms was observed near the northeast abutment, at the connection between steel beams and the form and around the concrete in the region of the valley of the SIPMFs (Figure 3.143). In some specific regions corrosion was so excessive that the steel forms were completely damaged and the concrete was exposed as shown in Figure 3.144. White traces and rust traces were seen on the side of the edge beam as shown in Figure 3.145.

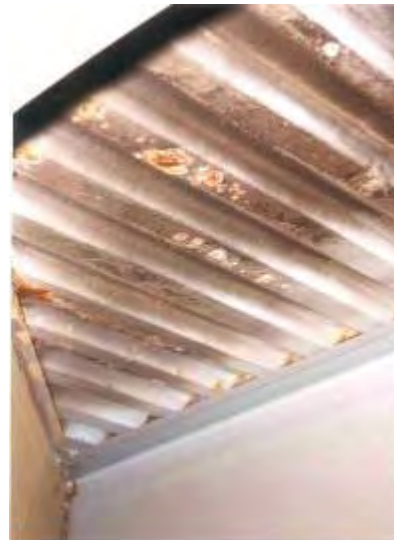
Figure 3.143. Traces of corrosion in SIPMF

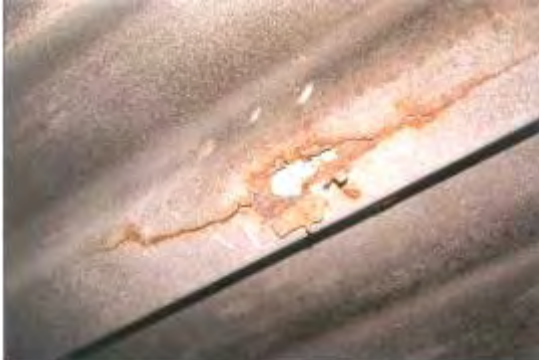
Figure 3.144. Excessive corrosion in SIPMF

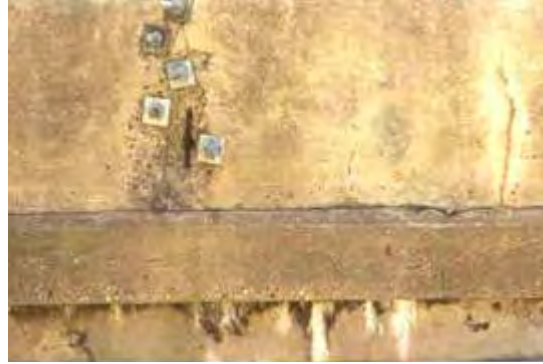
Figure 3.145. White traces and rust traces at Cracks

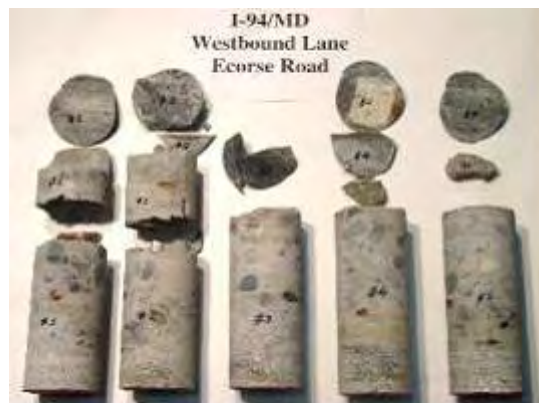
Figure 3.146. The 5 cores taken from Bridge Deck Number 9 (Structure No. S10-82022)

The visual inspection of cores from Bridge Number 9 indicated that the bridge had a 2.0 in. thick wearing surface. The top surface of all of the cores taken had a grooved texture. The steel reinforcement was not coated with epoxy and had traces of rust at the interface between steel and concrete. The coarse aggregate was well bonded to the concrete. The wearing surface had higher porosity and there were many voids. All of the cores had approximately the same height of average 9.4 ± 0.2 in. which indicates bridge uniformity. The five cores that were taken are shown in Figure 3.146.

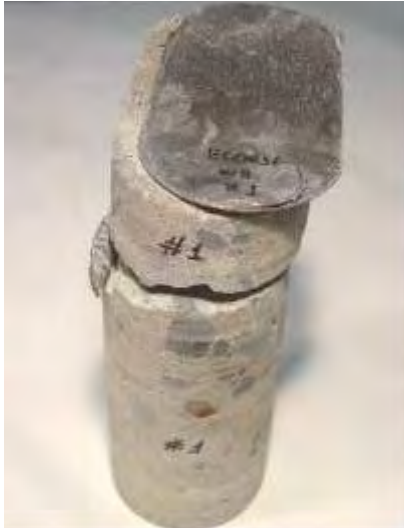
Core 9a (Figures 3.147-3.148)

- 9.7 in. height (11.3 in. with the concrete in the region of the valley of the SIPMF)
- Core fractured at the bottom steel reinforcement located approximately 7.5 in. from top.
- Axial section of a steel bar located 3.8 in. from top showed traces of rust.
- The SIPMF separated from the concrete.

Figure 3.147. Core 9a fractured at reinforcement location

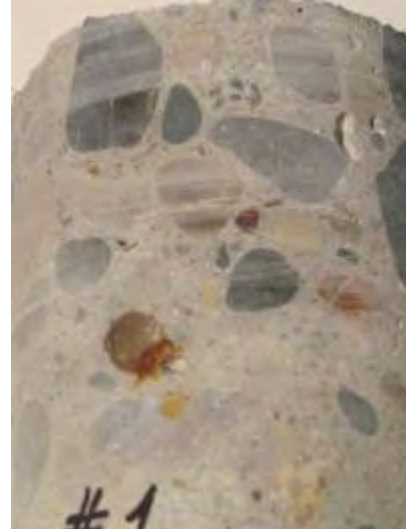
Figure 3.148. Core 9a rust in the reinforcement bar

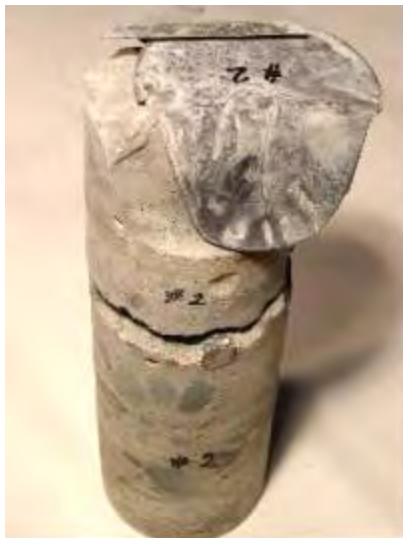
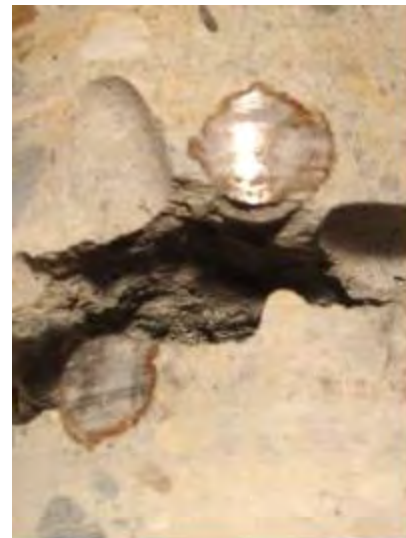
Core 9b (Figure 3.149)

- 9.3 in. height (11.3 in. with the concrete in the region of the valley of the SIPMF).
- Core broke at the bottom steel reinforcement located approximately 7.5 in. from top.
- Axial section of a steel bar located 3.8 in. from top showed traces of rust.
- The SIPMF separated from the concrete and consisted of two overlapping parts.
- The reinforcing steel had rust traces on its boundary.

a. Broken at reinforcement location

b. Rust in the reinforcing steel

Figure 3.149. Core 9b

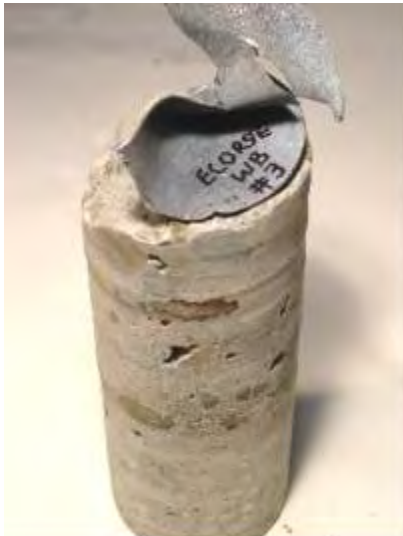
Core 9c (Figures 3.150-3.151)

- 9.4 in. height
- Axial section of a steel bar located 3.8 in. from top showed traces of rust.

- The SIPMF separated from the concrete and was damaged during the coring.
- The reinforcing steel had rust traces on its boundary.
- Part of the concrete in the region of the valley of the SIPMF was damaged during the coring.
- Large entrapped air voids of average width 0.3 in. were observed on the surface of the core.

Figure 3.150. Core 9c

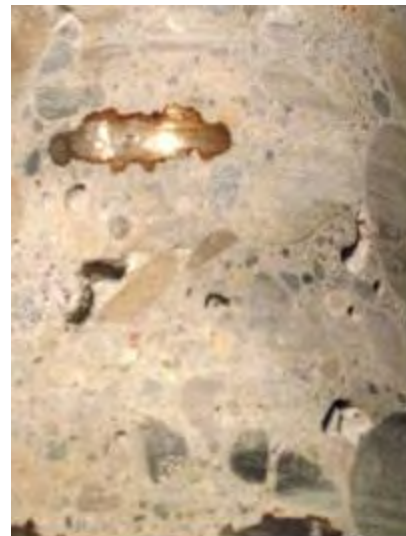
Figure 3.151. Core 9c Large voids and rust in the reinforcing steel

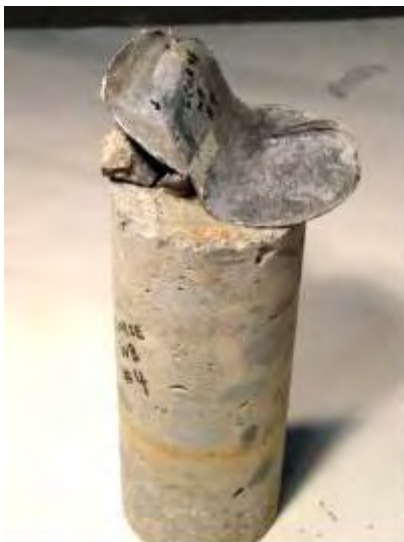
Core 9d (Figures 3.152-3.153)

- 9.4 in. height.
- The SIPMF separated from the concrete.
- SIPMF had rust traces on the surface that was in contact with the concrete.
- Part of the concrete in the region of the valley of the SIPMF was broken during the coring.
- Large voids of average diameter 0.3 in. were observed.

Figure 3.152. Core 9d

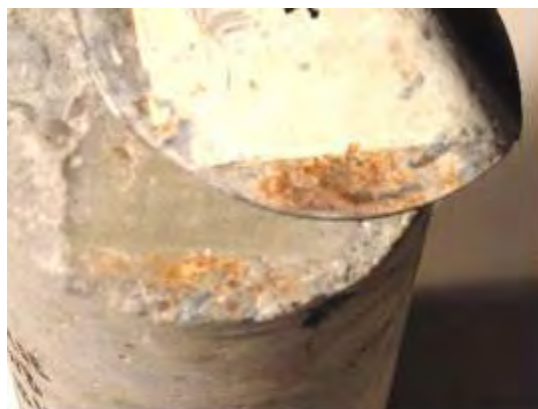
Figure 3.153. Core 9d rust traces on SIPMF and concrete

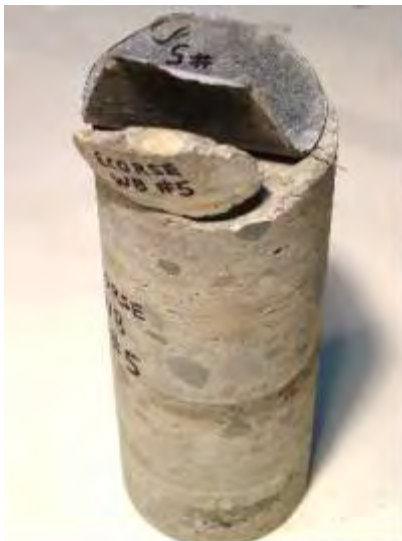
Core 9e (Figures 3.154 to 3.156)

- 9.5 in. height.
- The SIPMF separated from the concrete.
- SIPMF had rust traces on the surface that is in contact with the concrete specifically at the location of the voids on the concrete surface.
- Part of the concrete in the region of the valley of the SIPMF was broken during the coring.
- Hairline cracks were observed on the top (surface layer) of the core.

Figure 3.154. Core 9e

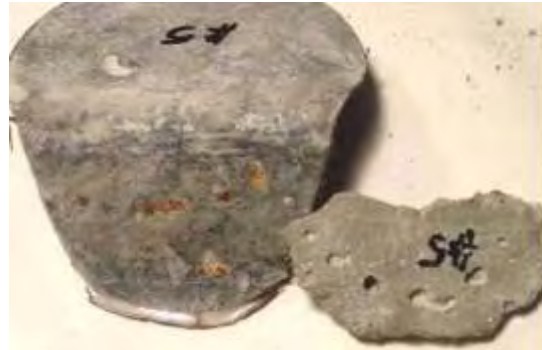
Figure 3.155. Core 9e rust traces on the SIPMF at the entrapped air voids

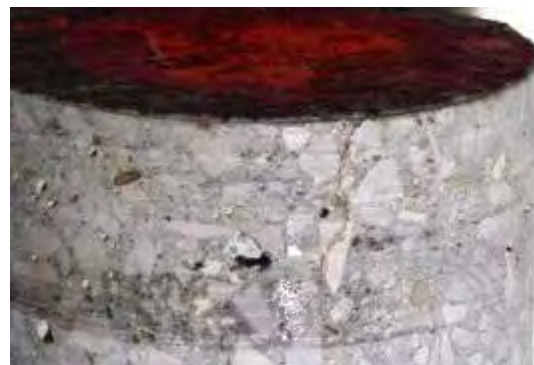
Figure 3.156. Core 9e hairline cracks at the top surface layer of the deck

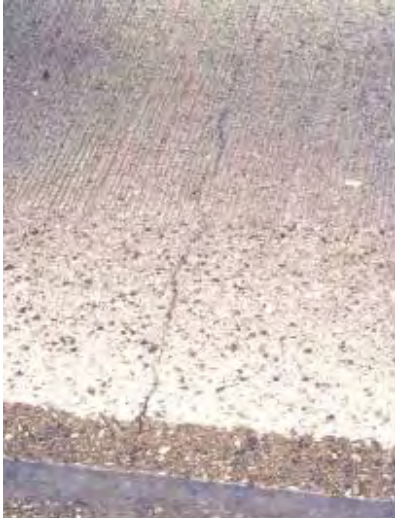
Figure 3.161. Top cracks propagated transversely in the slab

Cracks were observed at the top surface of the concrete slabs. The propagation of cracks was transversely and diagonally across the entire bridge deck as shown in Figures 3.161 and 3.162. Some of the major cracks were found around the joints (Figure 3.163). In some locations the cracks in the parapet were at the same place as in the slab continuing through the entire depth of the deck slab (Figure 3.164). A different type of concrete was encountered at the sides of the joints in the parapet and the top surface as shown in Figure 3.165.

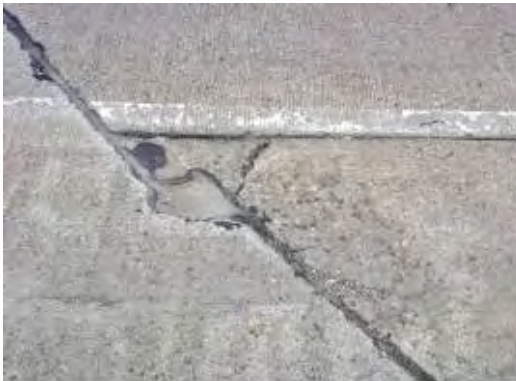
Figure 3.163. Top cracks propagated around the joint

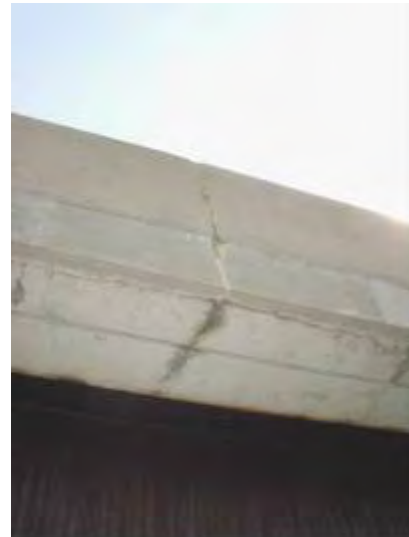
Figure 3.164. Cracks with white traces propagated in the parapet and the whole depth of the slab

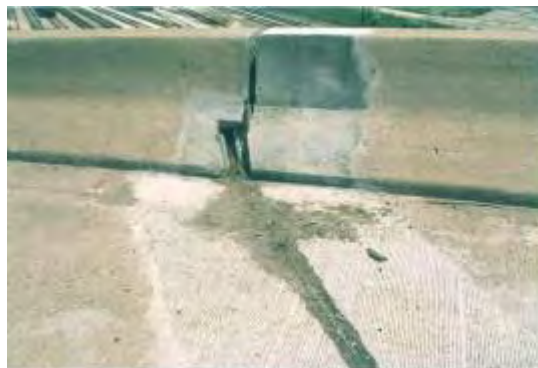
Figure 3.165. Different types of concrete around the joints

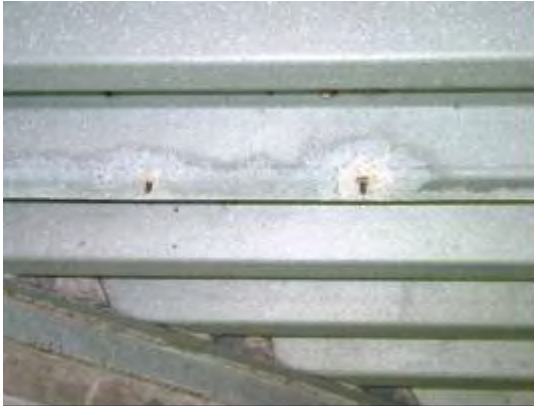
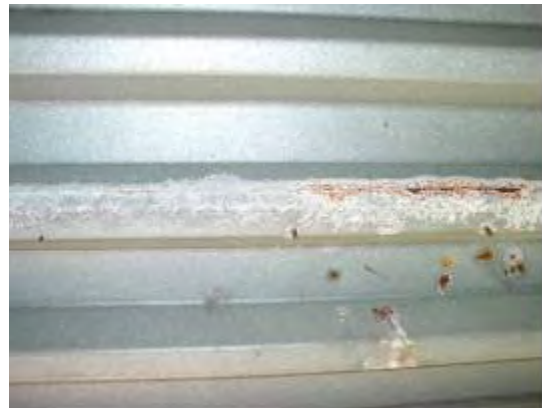
a. White traces

b. White and rust traces

Figure 3.166. Corrosion and white traces in the SIPMF

White and rust traces were encountered underneath the deck slab in the SIPMF. Major traces were observed at the overlap between SIPMFs and at the connection between the deck slab and the abutment. The holes where screws were fixing the SIPMF had some of white and rust traces. In some locations, the connection between the steel beams and the SIPMF had white traces (Figure 3.166). The bottom surface of the cantilever parts of the deck slabs had white and rust traces as shown in Figure 3.167.

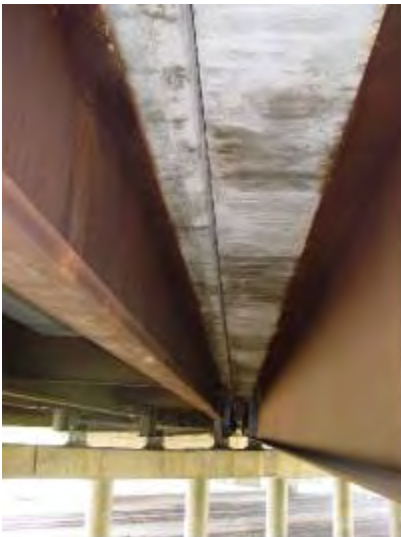
Figure 3.167. Corrosion and white traces on the bottom face of the cantilever slabs

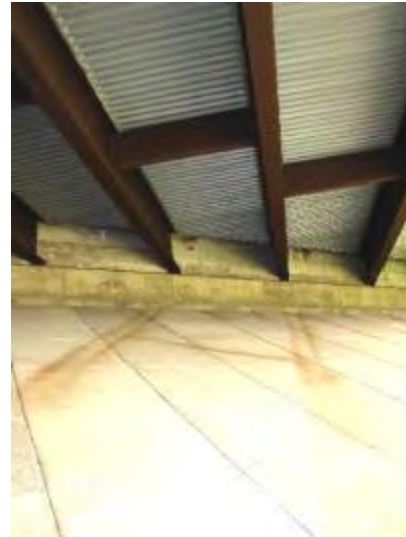
Figure 3.168. Corrosion traces underneath the steel beams

Vertical traces of corrosion were observed on the webs of the steel beams (Figure 3.168). Corrosion and white traces were found at the connection between steel beams and the SIPMF (Figure 3.169). In some locations, major traces of corrosion were found at the connection between the SIPMF and the abutment walls, as shown in Figure 3.170.

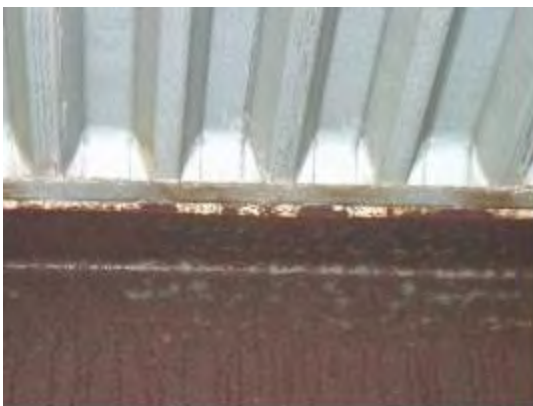
Figure 3.169. White and corrosion traces at the connection between steel beams and the SIPMF

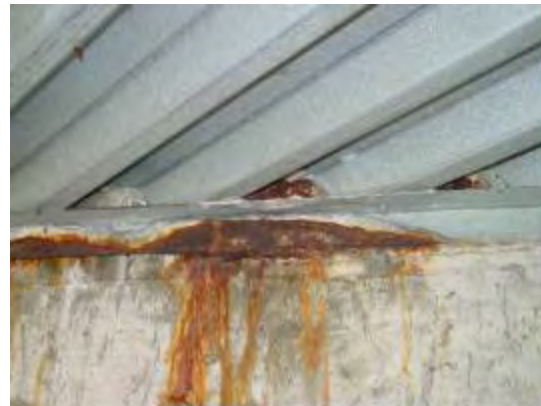
Figure 3.170. White and corrosion traces at the connection between SIPMF and the abutment

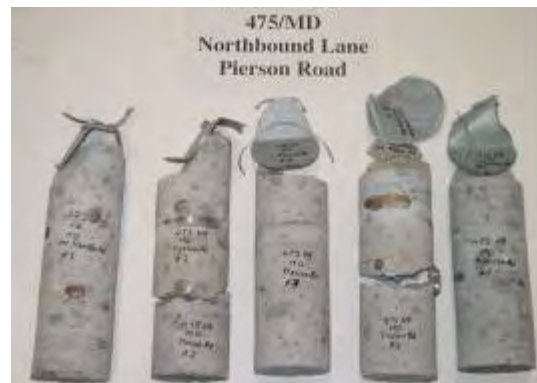
Figure 3.171. The 5 cores that were taken from Bridge Deck Number 10 (Structure No. R03-25132)

The visual inspection of the cores indicated that the bridge had a wearing surface of average 1.5 in. thickness at the top surface as shown by the different size of aggregates used. This wearing surface had a higher porosity than the rest of the core. The top surface was grooved for all of the cores. The steel reinforcement was coated with green epoxy. Some of the exposed reinforcement bars had rust traces while others were in good condition. The coarse aggregate was well bonded to the concrete. No regions of high porosity were observed. Many entrapped air voids were encountered that had an average diameter of 0.2 in. Many regions of honeycombing existed in all of the cores. The SIPMFs for all of the cores are separated from the concrete without leaving concrete traces adhering to its inner face. Cores had approximately the same height of average 9.5 ± 0.2 in. which indicates bridge deck thickness uniformity. The five cores that were taken are shown in Figure 3.171.

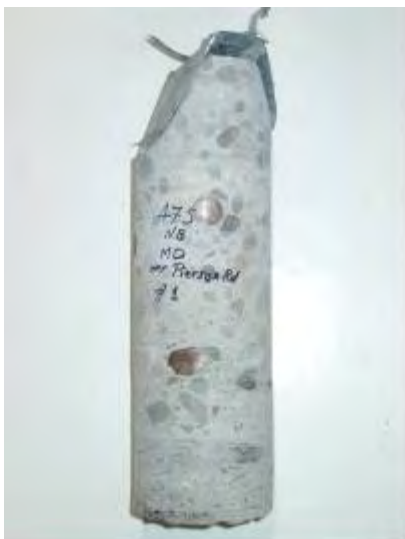
Figure 3.172. Core 10a

- 9.7 in. height (12.0 with the concrete in the region of the valley of the SIPMF).
- The concrete in the region of the valley of the SIPMF was partially broken during coring.
- Six axial sections in the steel reinforcement bar located 4.0, 7.3, and 8.0 in. from top.
- One region of honeycombing of 0.4 in. diameter located 8.3 in. from the top surface.
- Many small voids of average diameter of 0.2 in. were observed.
- One reinforcement bar had minor rust traces while the other did not.
- SIPMF was separated from the core.
- Large horizontal crack was observed at 8.0 in. from top.

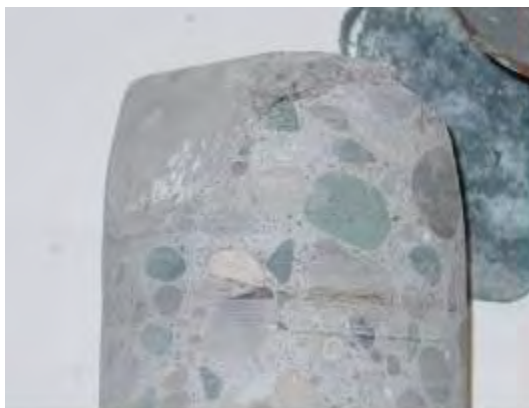
Figure 3.173. Core 10a concrete placed in the valley of the corrugation of the SIPMF partially broken

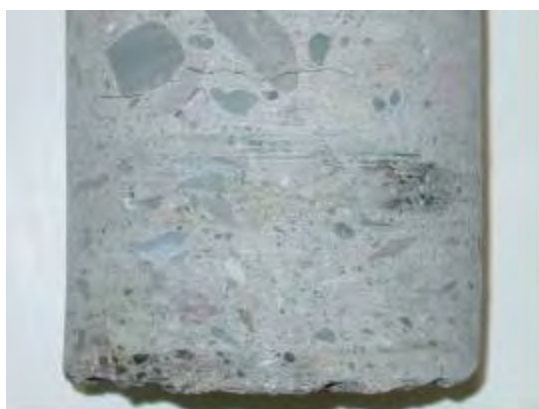
Figure 3.174. Core 10a horizontal crack.

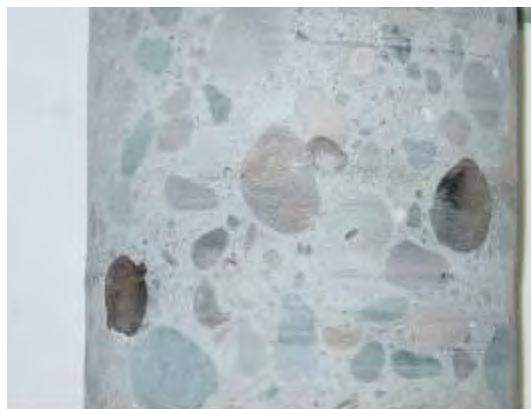
Figure 3.175. Core 10a small voids in the concrete
