LAWRENCE TECHNOLOGICAL UNIVERSITY

INSPECTION AND DETERIORATION OF BRIDGE DECKS CONSTRUCTED USING STAY-IN-PLACE METAL FORMS AND EPOXY-COATED REINFORCEMENT

October, 2004

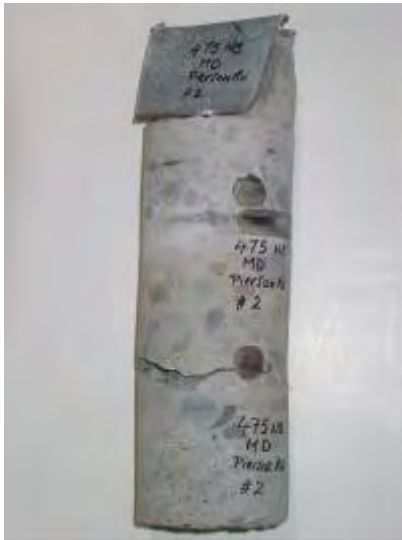
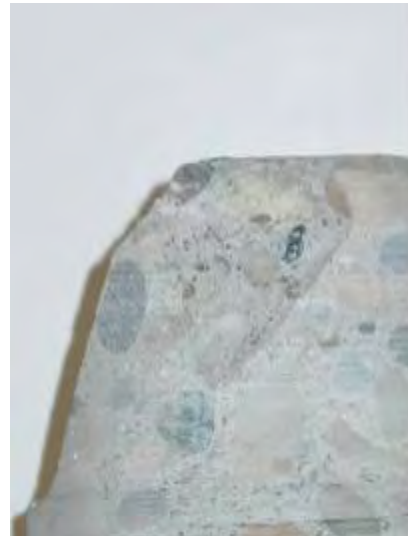
a. Broken Core

b. The concrete in the region of the valley of the SIPMF was partially broken

Figure 3.176. Core 10b with the concrete in the region of the valley of the SIPMF partially broken

- 9.5 in. height (12.0 in. with the concrete in the region of the valley of the SIPMF).
- The core was broken during coring at reinforcement location (4.0 in. from top).
- One longitudinal cut in the reinforcement located 7.3 in. from top.
- Four axial sections in the reinforcement located 4.0 and 8.0 in. from top.
- SIPMF was separated from the core.
- Steel reinforcement bars had traces of corrosion.
- The concrete in the region of the valley of the SIPMF was partially broken.
- Small voids of 0.1 in. were observed throughout the entire core.

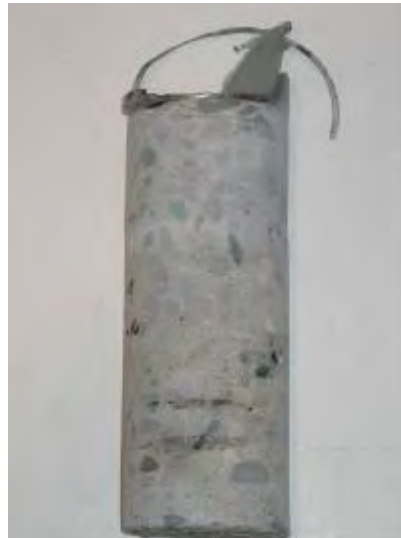
Figure 3.177. Core 10c

- 9.5 in. height (11.0 in. with the concrete in the region of the valley of the SIPMF).
- Many small voids existed of average dimensions 0.2 in.
- SIPMF separated from the core.
- No steel reinforcement bars existed.

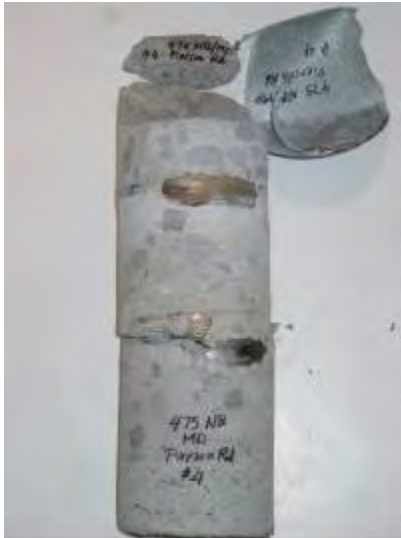
a. Core was broken

b. Reinforcement bar had traces of corrosion

Figure 3.178. Core 10d with corrosion in the reinforcement

- 9.5 in. height (12.0 in. with the concrete in the region of the valley of the SIPMF).

- Two longitudinal cuts of reinforcement bars: one was located 4.3 in. from the top and separated from the core and the other one was located 7.8 in. from top.
- Two axial sections of reinforcement bars located 4.8 in. from top.
- SIPMF separated from the core.
- Many small voids of average diameter of 0.1 in. were propagated at the entire surface.
- Steel reinforcement bars had traces of corrosion.
- Core was broken at 4.5 in. from top at the reinforcement location.
- One large region of honeycombing of 0.5 in. diameter located 3.5 in. from top.
- The concrete in the region of the valley of the SIPMF was broken during coring.

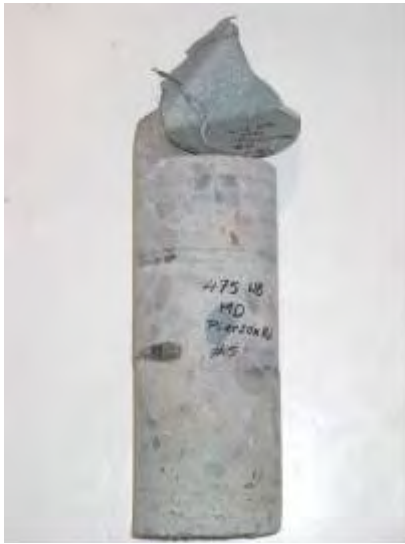
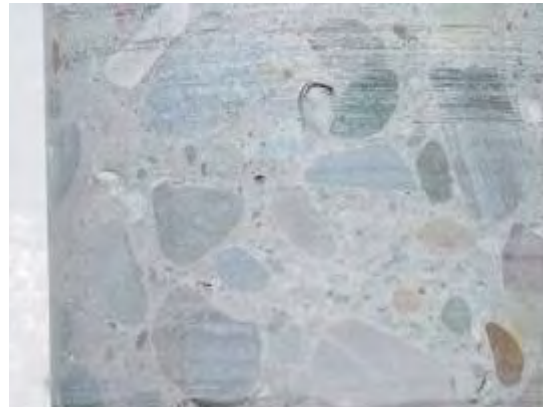
a. High porosity

b. Region of honeycombing

Figure 3.179. Core 10e with honeycombing

- 9.3 in. height (11.5 in. with the concrete in the region of the valley of the SIPMF).
- High porosity in the aggregate and cement paste.
- Many voids of 0.2 in. were observed.
- One region of honeycombing of 0.3 in. diameter was observed 8.6 in. from top.
- SIPMF was separated during the coring.
- One longitudinal cut of reinforcement bar located 4.5 in. from top.
- Traces of corrosion on the exposed reinforcing steel.

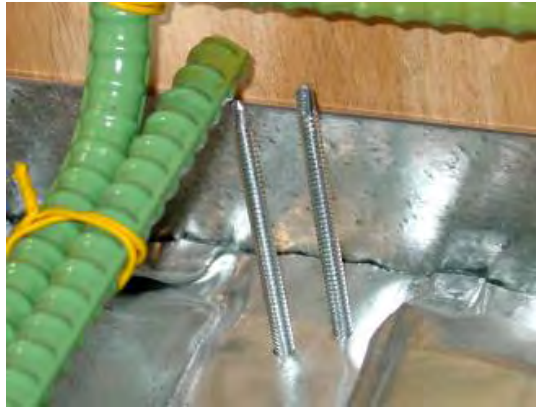
Figure 4.5. Shear connectors

An 18.0 in. long galvanized steel angle was provided at each end of the specimen in order to connect the vertical sides of the formwork (wooden) to the SIPMF base. The cross sectional dimensions of the angle were 3.0 in. x 2.5 in. and the thickness of the angle was 0.25 in.

Shear connectors were used to provide anchorage between the SIPMF and the concrete at the ends of the specimens. The shear connectors were # 3 self-drilling zinc-plated steel screws (hexagonal head) with a length of 4.0 in. The role of the shear connectors was to prevent complete pullout of the SIPMF during the various stages of the test program. The shear connectors were provided only at the ends of the specimen in order not to influence the contact between the concrete and the SIPMF. The detail for the shear connector and the steel angles at the end of the specimens is presented in Figure 4.5.

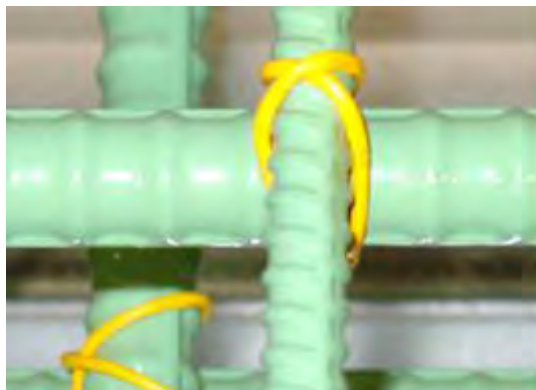
The reinforcement cages for both types of specimens were identical. The top and bottom longitudinal reinforcement layers consisted of three # 5 epoxy-coated steel bars with center-to-center spacing of 7.5 in. The top transverse reinforcement bars were # 3 epoxy-coated steel bars with 10 in. spacing between the centerlines of the bars. The bottom transverse reinforcement bars were # 5 epoxy-coated steel bars with 10 in. spacing between the centerlines of the bars. The thickness of the clear concrete cover for the longitudinal reinforcement was 1.5 in. for the top and bottom faces, while for the ends the clear cover had a thickness of 1.25 in. The reinforcement details are shown in Figures 4.3 and 4.4. The top longitudinal reinforcement was bent with a radius of 2.5 in. to form a hook to provide sufficient development length. Twenty-four cages were assembled using 0.08 in. diameter epoxy-coated steel wire to tie the reinforcement bars together as shown in Figure 4.6. The bottom and top reinforcement layers were assembled first then tied together to form the cage.

Figure 4.6. Epoxy-coated tying wire

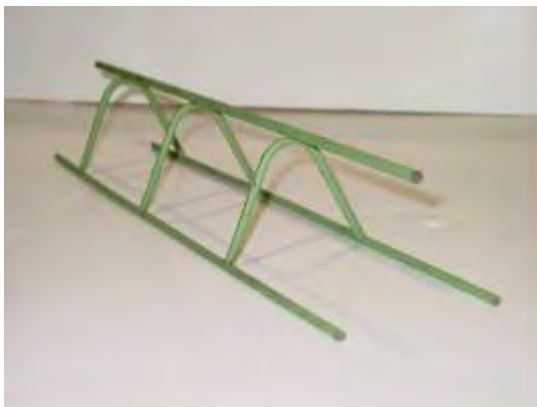
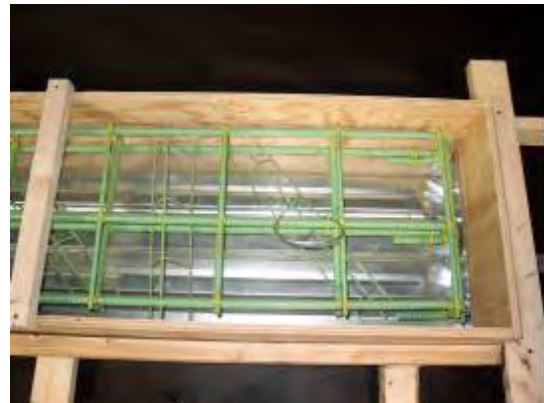
Figure 4.8. Epoxy-coated steel chairs

Epoxy-coated steel chairs were used to maintain the vertical distances for the reinforcement cage (Figure 4.8). Chairs with height of 3.25 in. were used to maintain the distance between the top and bottom reinforcement layers. Chairs of 1.5 in. height were placed under the bottom reinforcement layer to maintain the clear concrete cover. Five chairs were placed inside a form such that 2 were located 90° from the main reinforcement alignment and 3 were located 45° from the main reinforcement alignment.

a. Epoxy-coated steel chairs

b. Chairs inside the form

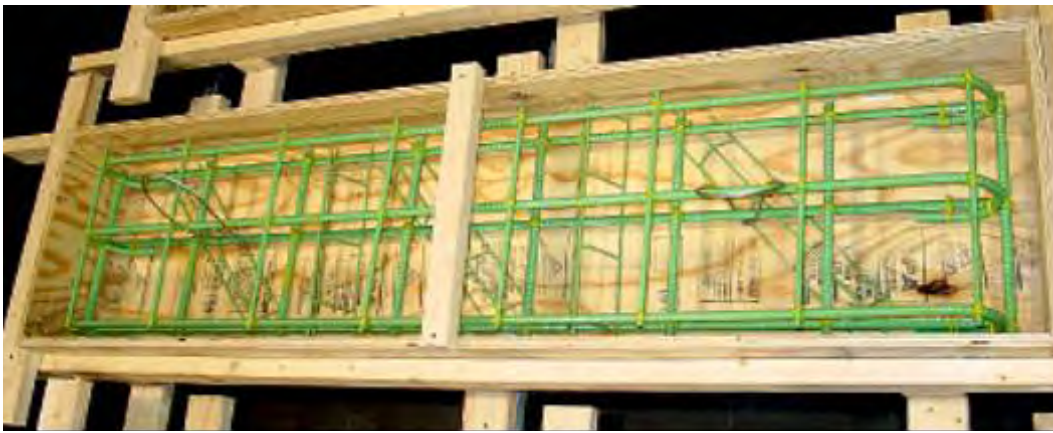
Box-shaped forms were made using 0.75 in. thick plywood reinforced with wooden bars with a cross-section of 2.0 in. x 4.0 in. The forms were constructed to have internal dimensions equal to the dimensions of the specimens. For the specimens without SIPMFs, the bottom of the form was made from sheets of plywood as shown in Figure 4.9. For the specimens with SIPMF, the bottom of the form consisted of the SIPMF as shown in Figure 4.10. The concrete from a single ready-mix truck was placed in the 24 forms on the same day. Concrete was compacted inside the forms using mechanical vibrators.

Figure 4.9. Complete forms with the cages (without SIPMF)

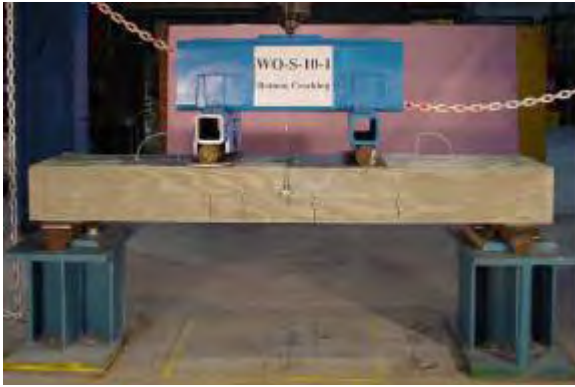
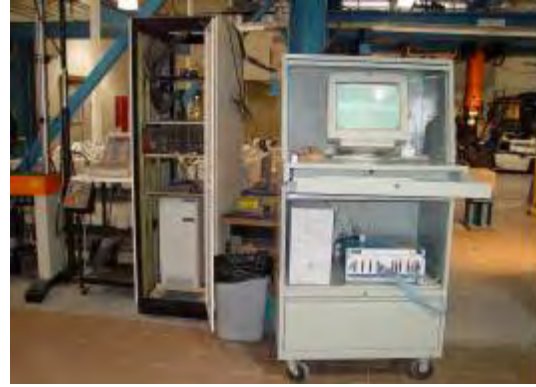
Figure 4.13. Actuators, controllers, and data acquisition

The vertical and horizontal alignments of the load setups were verified prior to initiation of the service load application. Supports for the setup were designed to provide a hinged support on one end and a roller support on the other end of the specimen. Customized contour bearings were fabricated for use with the specimens containing SIPMF. The design of the bearing allowed for good contact between the specimens and the supports (Figure 4.16). Each specimen was instrumented with 2 linear potentiometers at the left and right midspan edges to monitor vertical displacement during a test. Load was applied using a 20 kip actuator. A data acquisition system was used to monitor the load-displacement response of a specimen during a test (Figure 4.13).

a. Actuator applying load on the specimen

b. Controllers and data acquisition

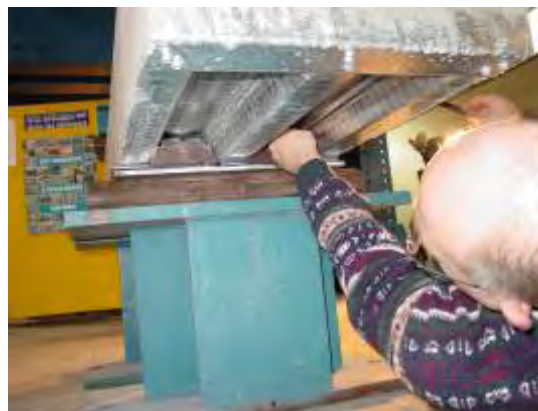
The general specimen setup including supports, instrumentation, and load application system was similar to the positive moment loading setup with the exception of the inverted position of the setup. A photo showing the custom contour bearing for the specimens with SIPMF is presented in Figure 4.16. A photo showing the negative moment loading setup is presented in Figure 4.17.

Figure 4.16. Alignment of the custom fabricated contour bearing underneath the specimen on top of the support

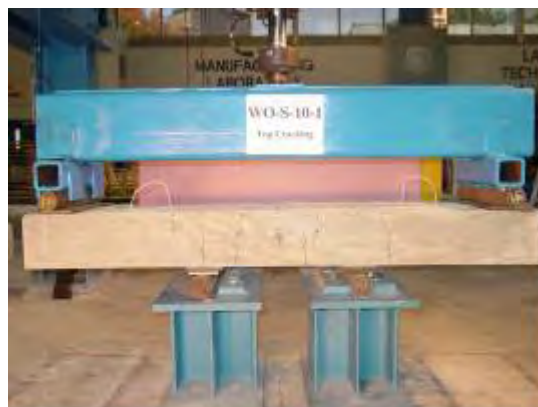
Figure 4.17. Negative moment loading setup

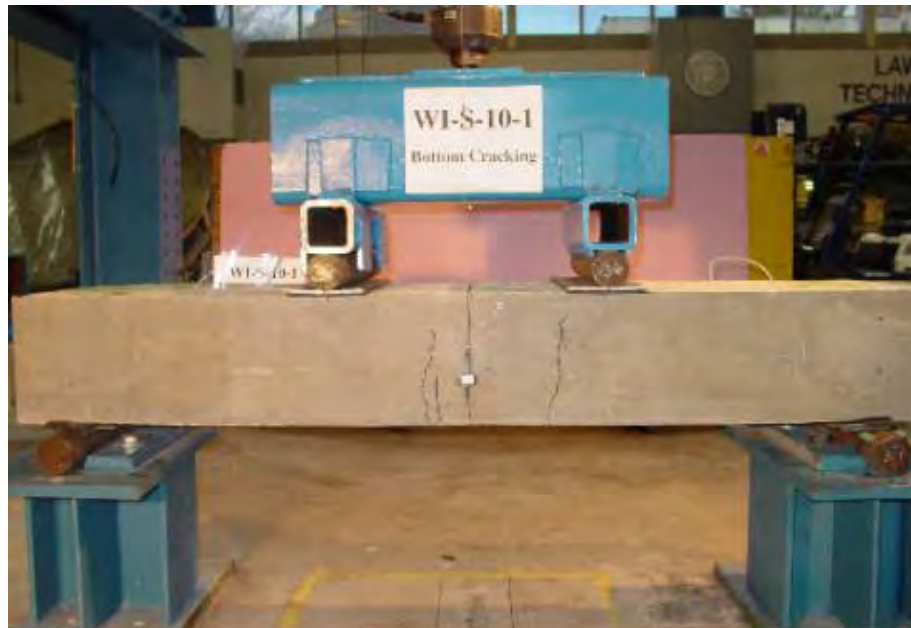
Service load application for specimens with SIPMF consists of two steps. Initially, positive moment is applied to the specimens. The load was maintained on a specimen until cracking of the specimen was observed. The load increased with increasing displacement initially, which was followed by constant load with increasing displacement indicating presence of cracking in the specimens (Figure 4.18). Negative moment is applied to the specimens subsequent to observation of cracking during positive moment application. The load was increased on a specimen until full-depth cracks were observed in a specimen (Figure 4.19). A similar procedure was used for specimens without SIPMF (Figures 4.20 and 4.21).

Figure 4.18. Positive moment application
(cracking along the bottom of specimen with SIPMF)

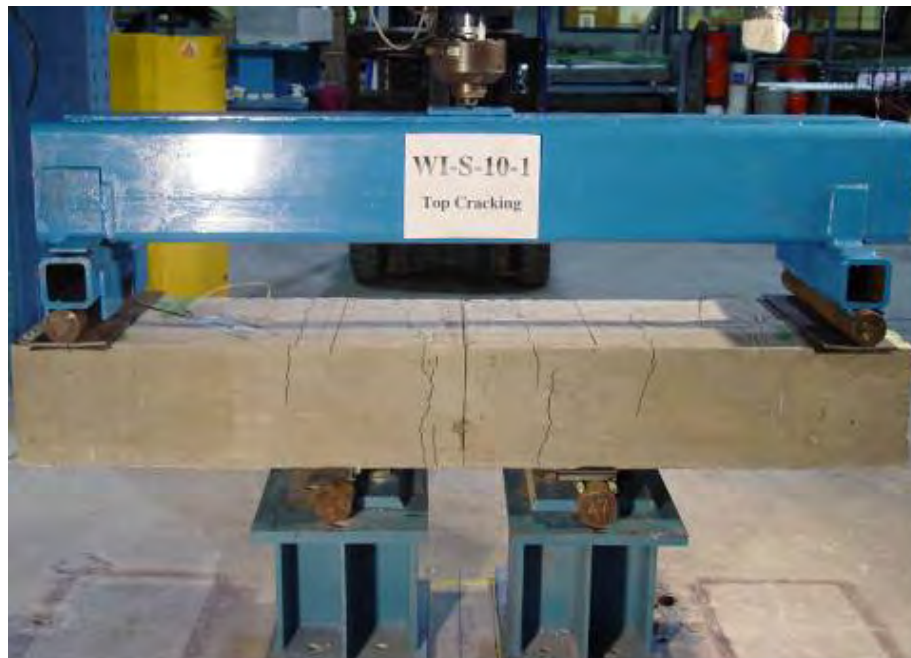
Figure 4.19. Negative moment application
(cracking along the top of specimen with SIPMF)

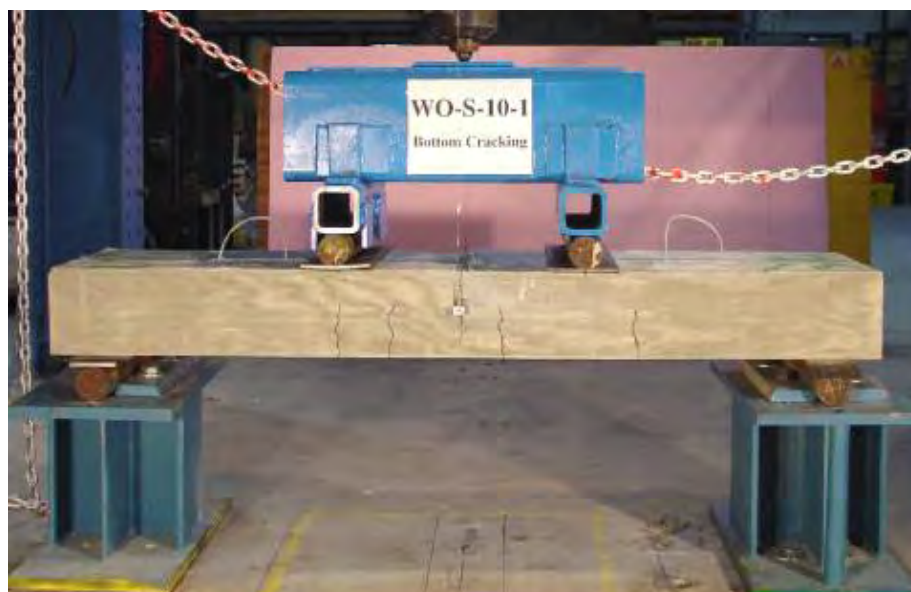
Figure 4.20. Positive moment application
(cracking along the bottom of specimen without SIPMF)

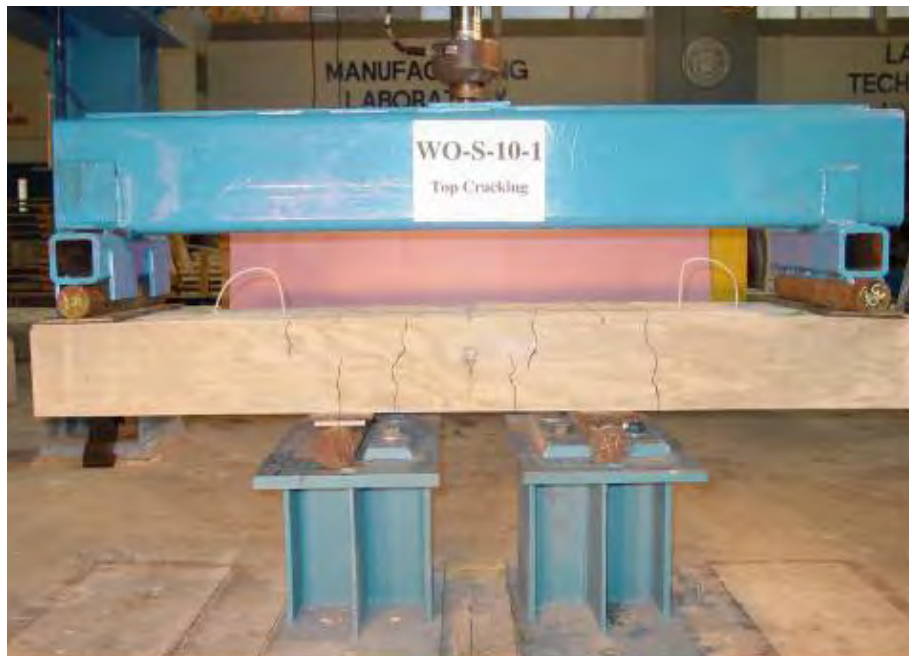
Figure 4.21. Negative moment application
(cracking along the top of specimen without SIPMF)

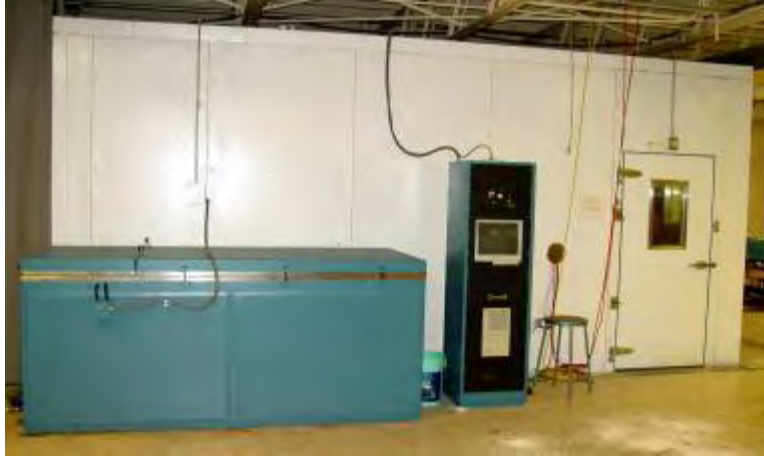
The specimens were subjected to the freeze/thaw cycles in a large (19.5 ft x 11.75 ft x 8.92 ft) walk-in environmental chamber (Figure 4.23). The specimens were placed inside a holding tank in the chamber. The holding tank had dimensions of 6.5ft x 4.0 ft x 5.0 ft and eight specimens could be placed in the tank at a given time.

Figure 4.23. Freeze/Thaw system

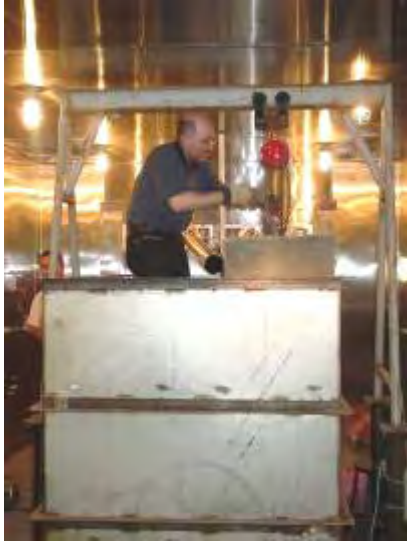
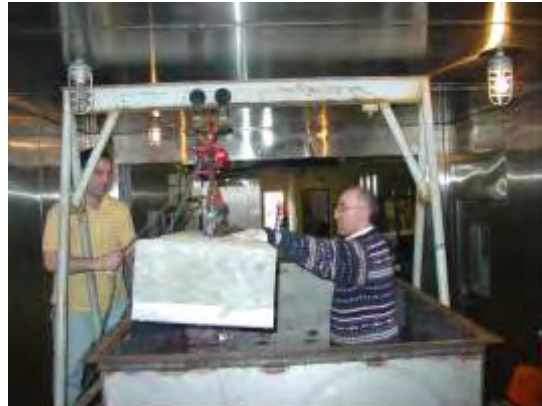
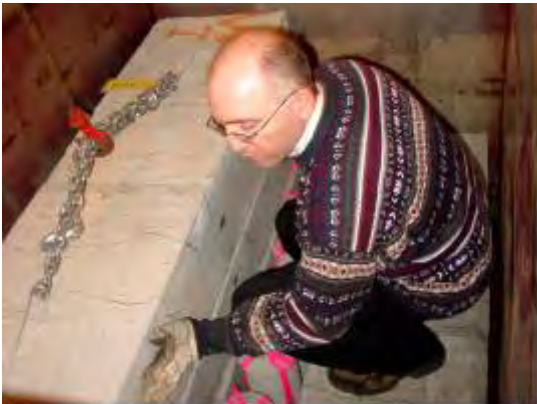
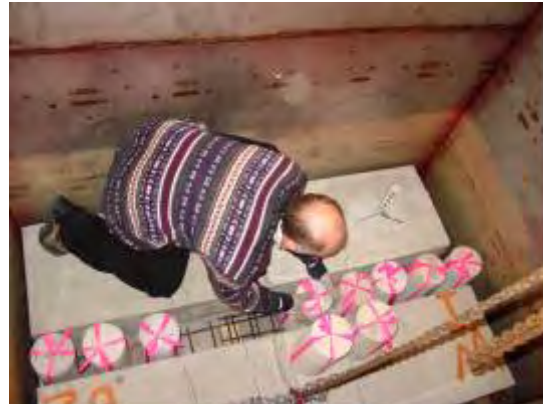
Figure 4.24. Placement of the 8 freeze/thaw specimens in the holding tank

Specimens were subjected to freeze/thaw cycles subsequent to initial service load exposure (and resulting cracking of the specimens). Thermocouples were installed in the specimens to monitor the temperature of the specimens during exposure. Most of the specimens were instrumented with 2 thermocouples: one near the corner of the specimen (3 in. x 3 in. x 3 in. from the corner) and one at the center (and mid-depth) of the specimen. The specimens were drilled, then the thermocouples were placed at the specified location, and then they were coated with epoxy. The thermocouples were extended and connected to a data acquisition system located outside of the chamber. All of the 8 freeze/thaw specimens were placed in the holding tank subsequent to installation of the thermocouples (Figure 4.24 and 4.25). The specimens were separated by wooden platforms to allow exposure to the entire surface of each specimen. In addition to the bridge deck specimens, 20 cylinders were placed in the tank for freeze/thaw exposure. Special provisions, such as air ducts and fans above the holding tanks were used to improve circulation of air in the holding tank and thus exposure of the specimens.

a. Custom-designed crane system

b. Moving specimens to holding tank

c. Placement of bridge deck specimens in holding tank

d. Placement of cylinders in holding tank

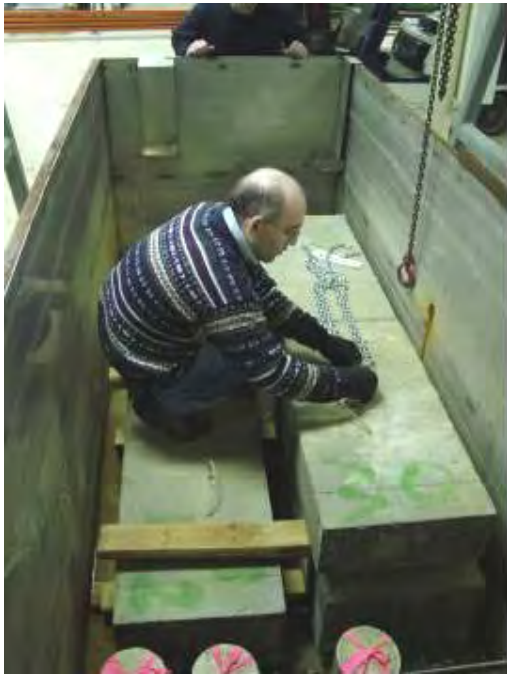
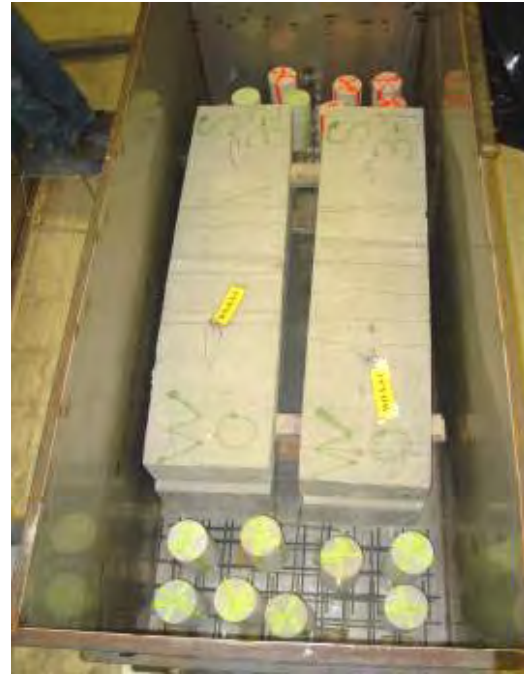
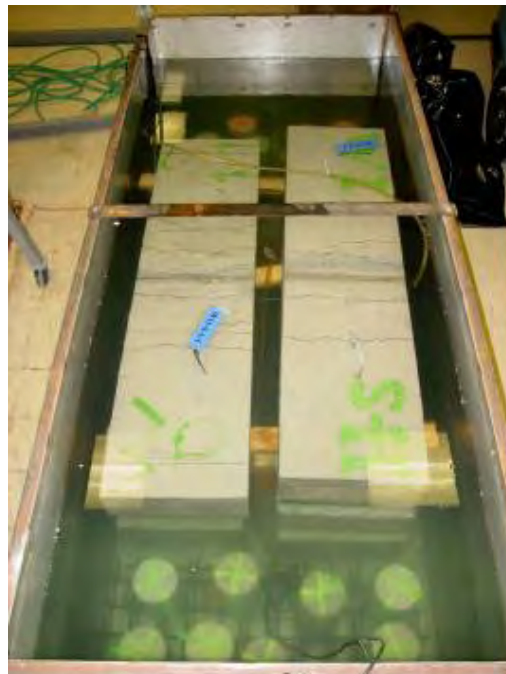
Figure 4.29. Placement of specimens inside salt-water tanks

groups of 10 (Figures 4.29 and 4.30). The salt solution was added to the tanks to entirely cover all of the specimens. Submersible pumps were used in the tanks to promote circulation and air pumps were used to maintain adequate levels of oxygen in the solution. Plastic tarps were placed over the tanks to prohibit growth of algae. The specific gravity and the temperature of the solution were weekly measured during the test program.

a. Placement of specimens and cylinders in the tank

b. Final arrangement of specimens before filling tank with salt-water

c. Specimens in tank after filling with salt-water

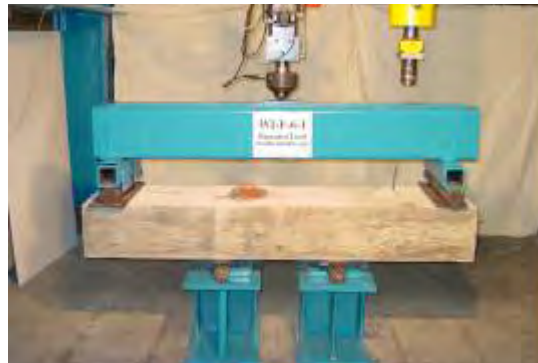
The negative moment load setup was used for the repeated load exposure tests, which was “TW” (negative moment) for specimens with SIPMF (Figure 4.33a) and was “T” (negative moment) for specimens without SIPMF (Figure 4.34a). A specimen with SIPMF under repeated load exposure is shown in Figure 4.33b, and a specimen without SIPMF under repeated load exposure is shown in Figure 4.34b. The diagram for cycles of repeated load for specimens with SIPMF is shown in Figure 4.35a, and the diagram for cycles of repeated load for specimens without SIPMF is shown in Figure 4.35b.

Figure 4.33. Repeated load for specimen with SIPMF

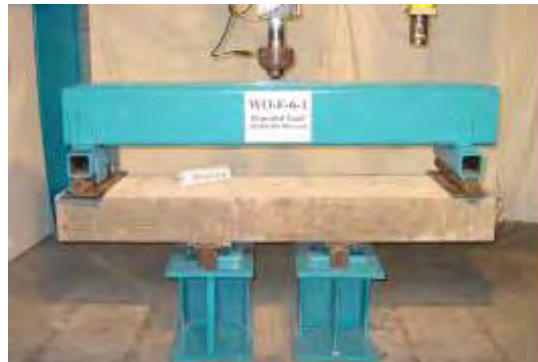
Figure 4.34. Repeated load for specimen without SIPMF

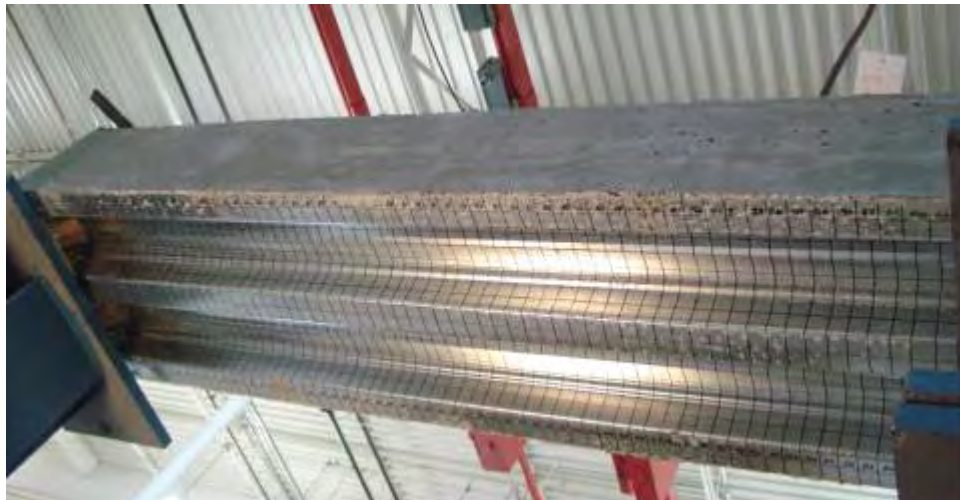
Figure 4.37. Grid for ultrasonic pulse-echo measurements for specimens with SIPMF

A test is conducted by placing the transducer on the SIPMF on the underside of a bridge deck specimen and then sending and receiving waves at the measurement location. The transducer is used to both send and receive the waves. A couplant is placed between the transducer and SIPMF to ensure full transmission of the waves into the test material (Figure 4.36). Each measurement consisted of the average of 10 waveforms obtained at a time. Grids were drawn on the test specimens to mark the measurement locations (Figure 4.37). The grid was divided into 64 segments with 1-in. spacing along the length of the specimen. The grid was divided into 11 segments following the contour of the SIPMF along the width of a specimen as following: one segment at each of the 3 ribs, one segment at each of the 4 slopes, and 2 segments at the 2 flat areas (Figure 4.37). The transverse gridlines were labeled 1 through 64 and the longitudinal gridlines were labeled A through K. The grid contained a total of 704 measurement points at the intersections of transverse and longitudinal gridlines.

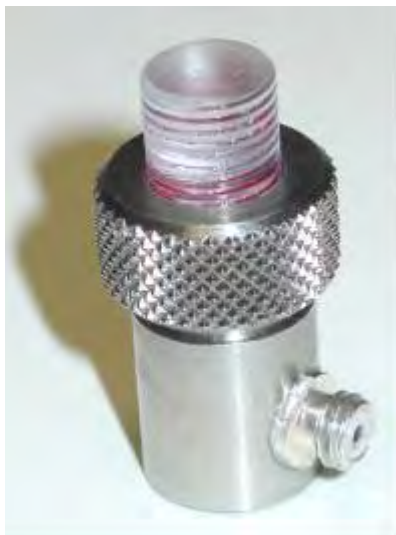
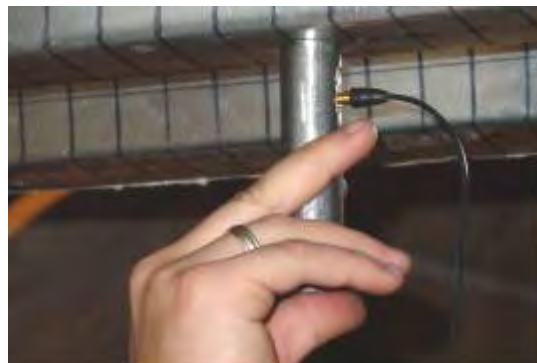
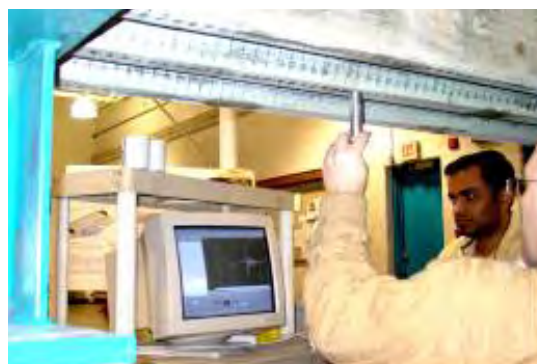
a. Transducer unit

b. Close-up of transducer holder

c. Use of transducer holder in tests

Figure 4.38. Pulse-echo method

A custom-built transducer holder was used in the tests (Figure 4.38). Contact pressure between the transducer and the SIPMF can affect the transmission of waveforms into the test materials. This is particularly a concern when the amplitude measurements are conducted on the waveforms. The transducer holder has a spring-loaded mechanism that allows for application of a constant pressure to the test material at each measurement location. In addition, the holder is designed to ensure perpendicularity of the transducer to the SIPMF. The angle of incidence can also affect the transmission of waveforms into the test material. The holder allows for maintaining a constant incidence angle at each measurement location. The holder also eliminates operator variability in the pulse-echo tests.

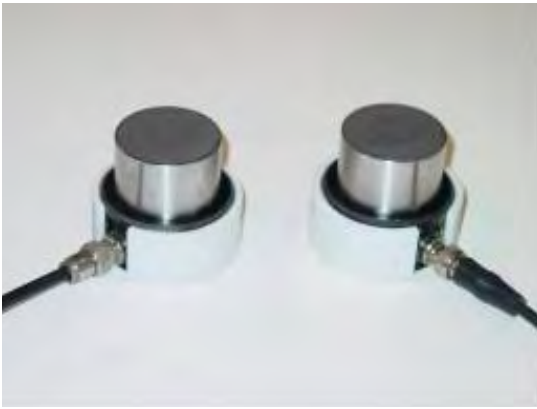
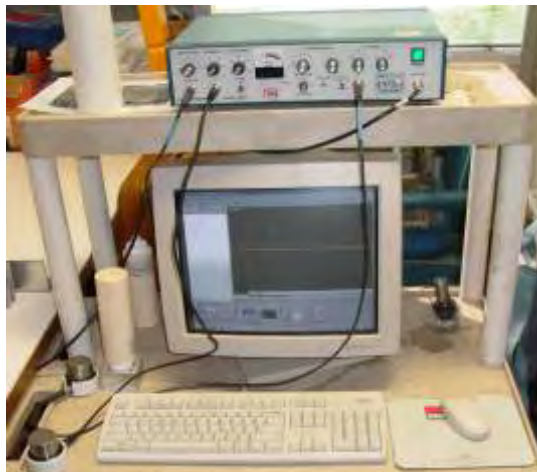
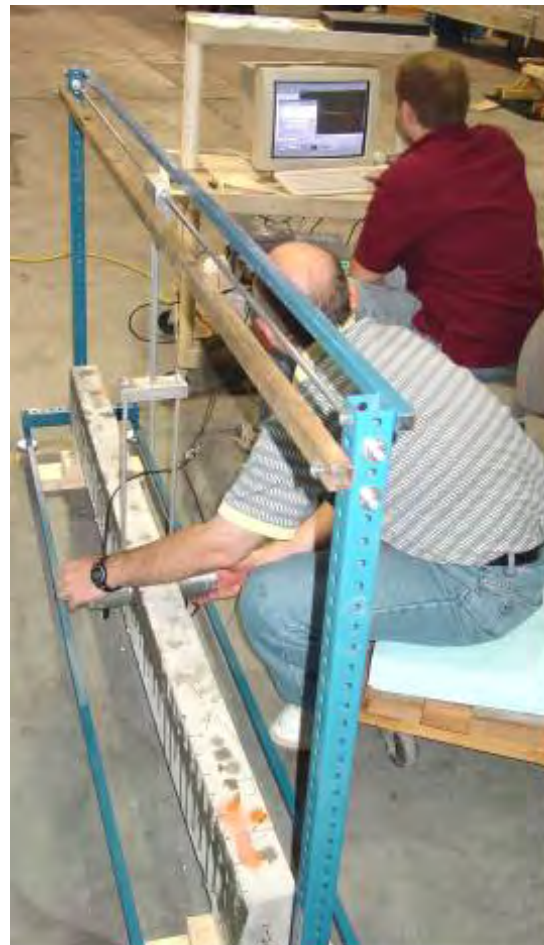
a. Transducers

b. Through-transmission test setup

c. Through-transmission measurements apparatus

Figure 4.47. Transducers and testing setup

Ultrasonic through-transmission technique was used in the test program to evaluate the quality and condition of the concrete in the bridge deck specimens. The tests were used to evaluate the effects of the environmental exposure conditions on the quality of the concrete (Figure 4.47).

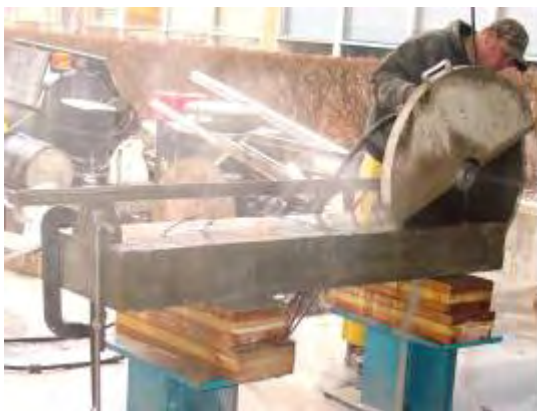
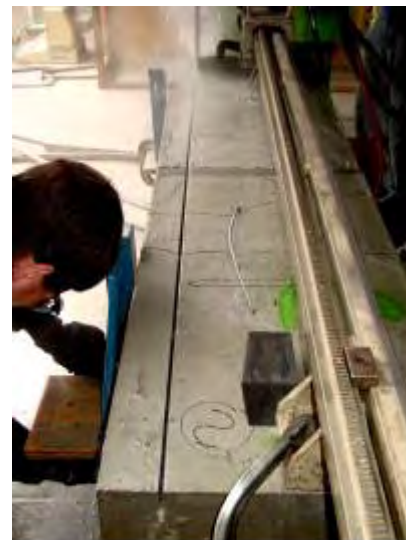
a. Cutting a 3 in. slice

b. Partially cut slice

Figure 4.49. Removal of slices from bridge deck specimens

A through-transmission test is conducted by placing one transducer on one surface of a test material and the second transducer on the opposite surface of the test material (directly across from the first transducer) (Figure 4.48). In this arrangement, one transducer is used to transmit waves and the other transducer is used to receive the transmitted waves. Each measurement consisted of the average of 10 waveforms obtained at a time. Tests were conducted on bridge deck specimens subsequent to exposure tests. A 3 in. wide section was cut from the long edge of specimens prior to ultimate load tests to conduct the ultrasonic through-transmission tests (Figure 4.49). These slices had dimensions of 72.0 in. length, 3.0 in. width, and 7.5 in. depth for specimens without SIPMF and 10.0 in. depth for specimens with SIPMF.

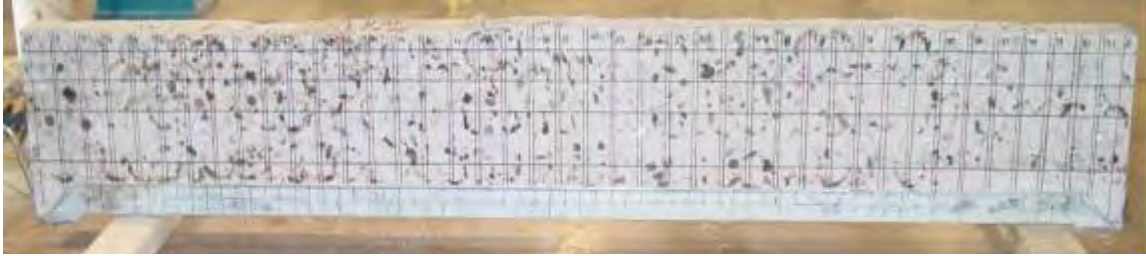
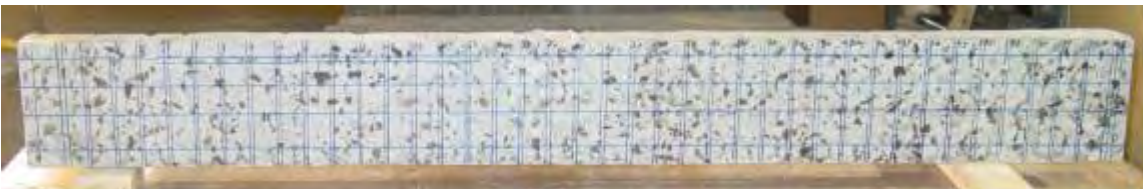
a. Grid on slice from specimen with SIPMF

b. Grid on slice from specimen without SIPMF

Figure 4.50. Grids for through-transmission tests

Grids were constructed on side surfaces of each slice to mark the measurement locations (Figure 4.50). The grid was divided into 41 segments with 1.75 in. spacing along the length of the specimen. The grid was divided into 4 segments with 1.75 in. spacing along the depth of a

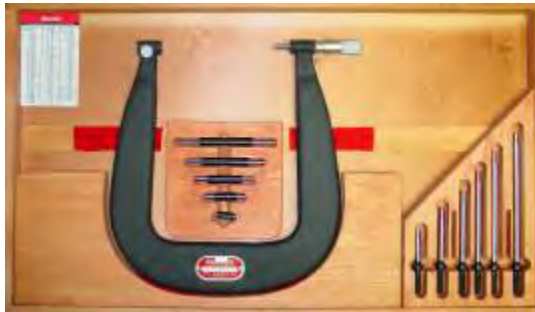
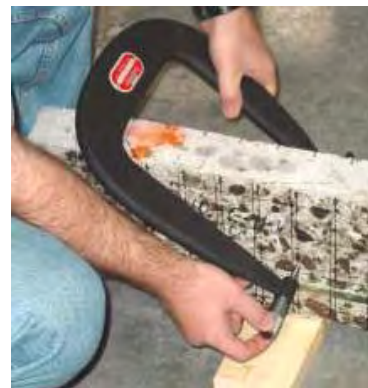
a. Custom-made micrometer

b. Measuring thickness at a measurement location on a slice

Figure 4.51. Thickness measurement

A custom-built micrometer was used to measure the distance between the transducers (i.e., thickness of a slice) at each measurement location. The micrometer had a 0.001 in. resolution (Figure 4.51). The tests were conducted using a custom-designed and built transducer guide setup (Figure 4.52). The setup was designed to fully align the transducers on both sides of a specimen and also to apply constant pressure to the transducers. Misalignment of transducers across a test materials and variations in pressure applied to the transducers can affect transmission of waves and thus results obtained in a test program. The guide setup allowed for maintaining full alignment and constant pressure at each measurement location (Figure 4.53).

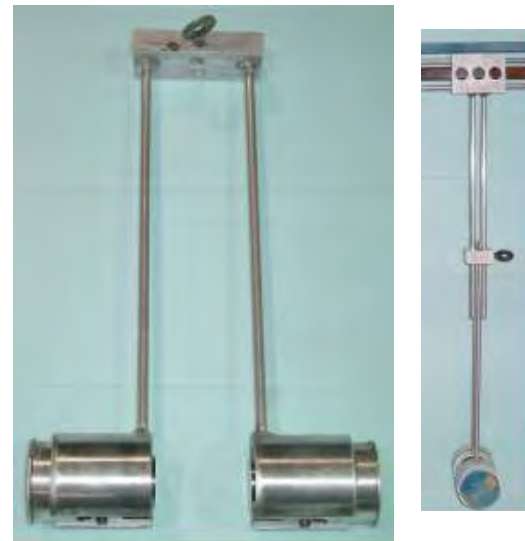
a. Parts of the transducer guide assembly

b. Assembled transducer guide

c. Transducer guide setup used for a slice

Figure 4.52. Transducer guide setup

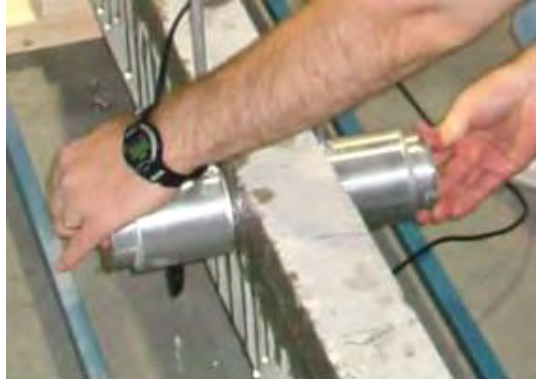
Figure 4.53. Transducers applied to specimen with transducer guide

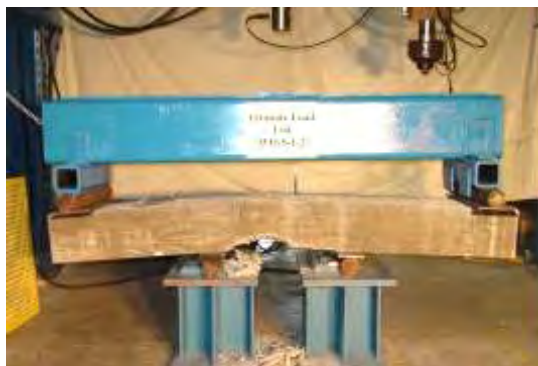
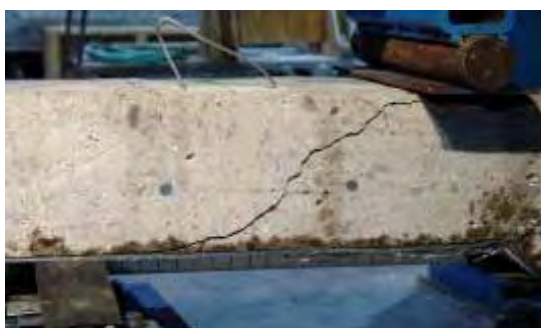
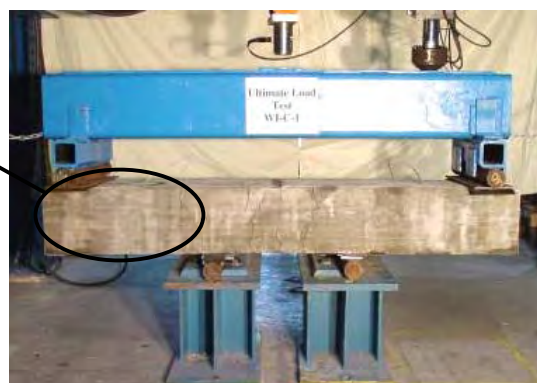
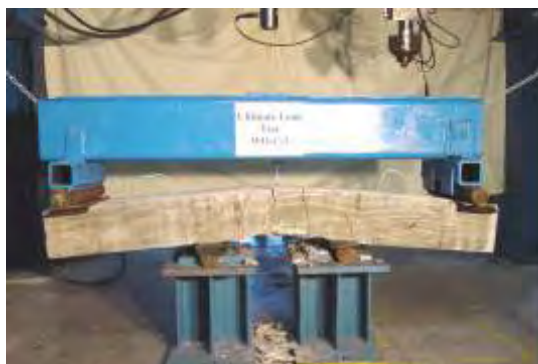
a. Flexural failure mode for a specimen

Front face

Rear face

Entire specimen

b. Shear failure mode for a specimen

c. Combined flexural/shear failure mode

Figure 4.56. Failure modes for ultimate load tests

All specimens were subjected to ultimate load test subsequent to their respective environmental exposure. The ultimate load tests were conducted after the removal of 3 in. slices from the long edge of the bridge deck specimens. Negative moment test setup was used for ultimate load tests (Figures 4.14 and 4.15) with a 200 kip actuator. The loading was in the range of 2.4 to 3.2 kips/min, and 1.6 to 2.3 kips/min for specimens with and without SIPMF, respectively. The load rate ranges were calculated for the specimens, after having been sliced, to have a stress in the extreme fiber in the range from 125 to 175 psi/min (ASTM C78-94). The ultimate failure mode for any specimen was as one of the following modes: flexural mode (Figure 4.56 a), shear mode (Figure 4.56 b), or combined flexural/shear mode (Figure 4.56 c). A load-displacement curve is generated for each test to determine the ultimate load (Figure 4.57).

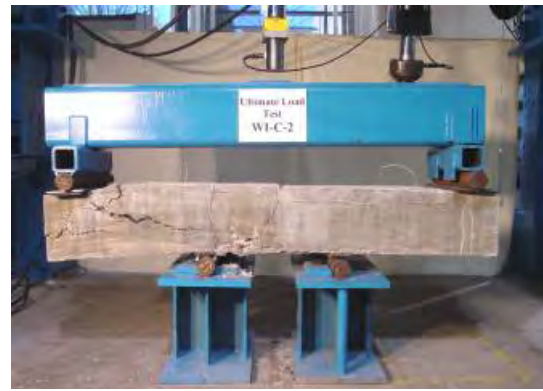
b. Shear failure mode

Figure 5.72. Mode of failures for specimens with SIPMF

Ultimate load test was applied on each specimen at the end of the environmental exposures, and the load setup “TW” was used for ultimate load tests. Ultimate load test results are presented for control specimens, freeze/thaw specimens, and salt-water specimens with SIPMF in this section. For ultimate load tests on specimens with SIPMF, failure modes observed were flexural, shear, and flexural/shear (Figure 5.72).

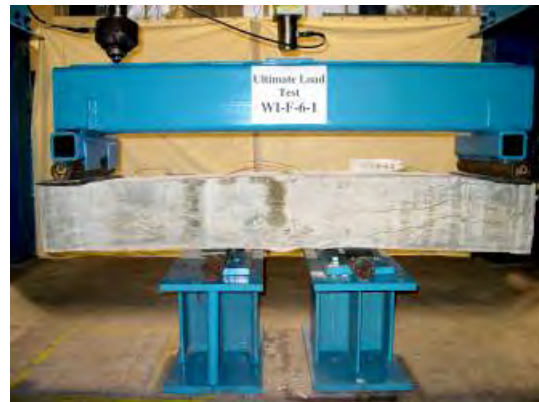
c. Flexural/shear failure mode

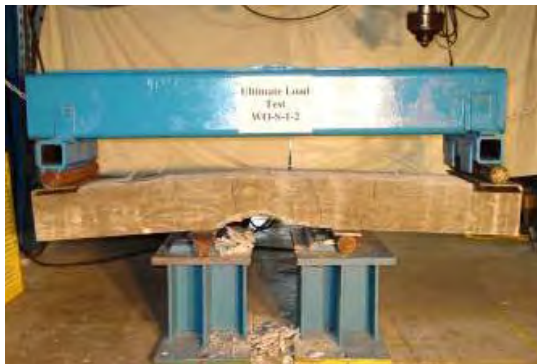
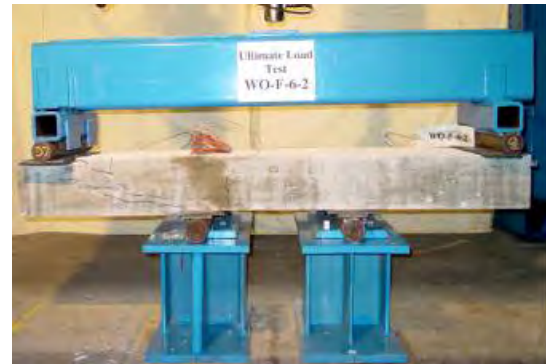
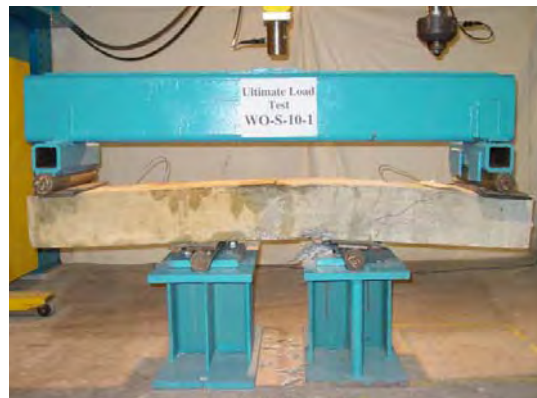
a. Flexural failure mode

b. Shear failure mode

c. Flexural/shear failure mode

Figure 5.94. Modes of failure for specimens without SIPMF

Ultimate load test was applied on each specimen at the end of the environmental exposures, and the load setup “T” was used for ultimate load. Ultimate load test results are presented for control specimens, freeze/thaw specimens, and salt-water specimens without SIPMF in this section. For ultimate load tests on specimens with SIPMF, failure modes observed were flexural, shear, and flexural/shear (Figure 5.94).
