AUTOMATED EXPANDING CHRISTMAS TREE

FINAL DESIGN REPORT

Mechanical Engineering Department
California Polytechnic Department
San Luis Obispo
June 2024

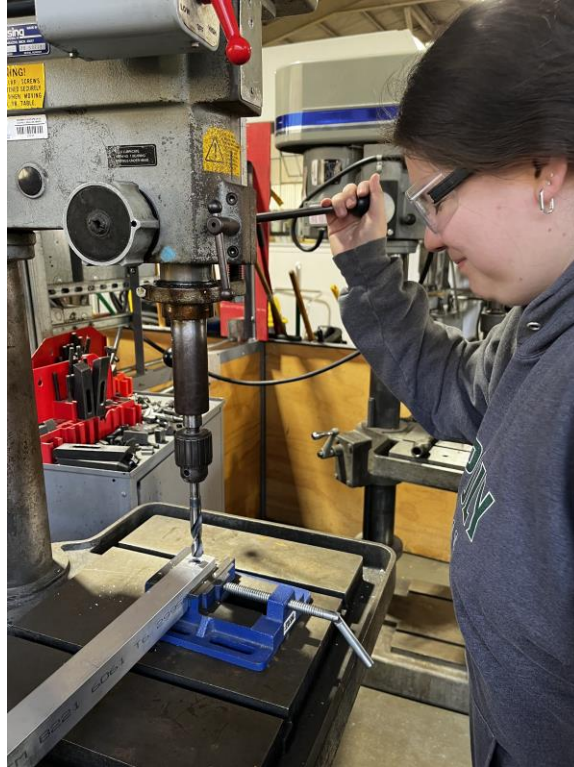
Figure 1. Drilling holes into the scissor lift links.

The scissor lift links were made from 1.5” square aluminum tubing which was cut from the stock length into equal lengths of 48” long each. Each link has three drilled holes (one near each end and one in the middle). This process, shown in **Figure 1** on the next page, took the longest for us to complete as there were so many links that needed to be manufactured. One of the drilled scissor links is shown below in **Figure 2**.

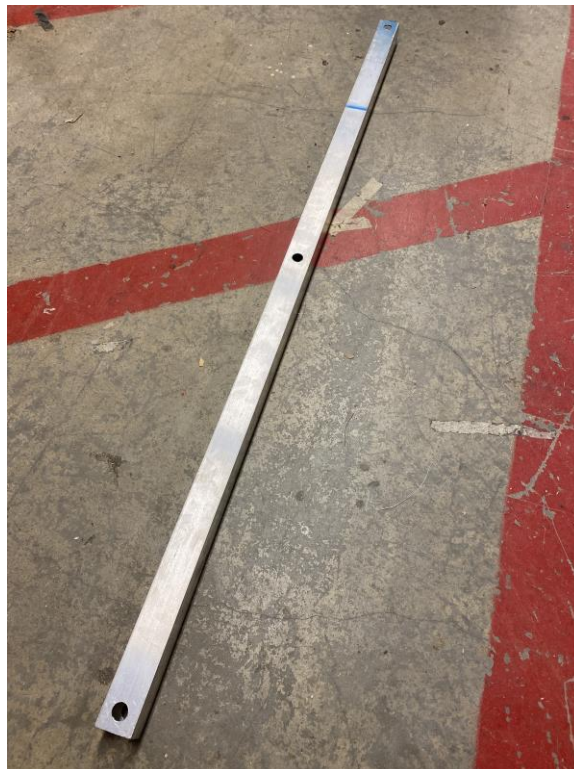
Figure 2. Cut and drilled scissor lift link.

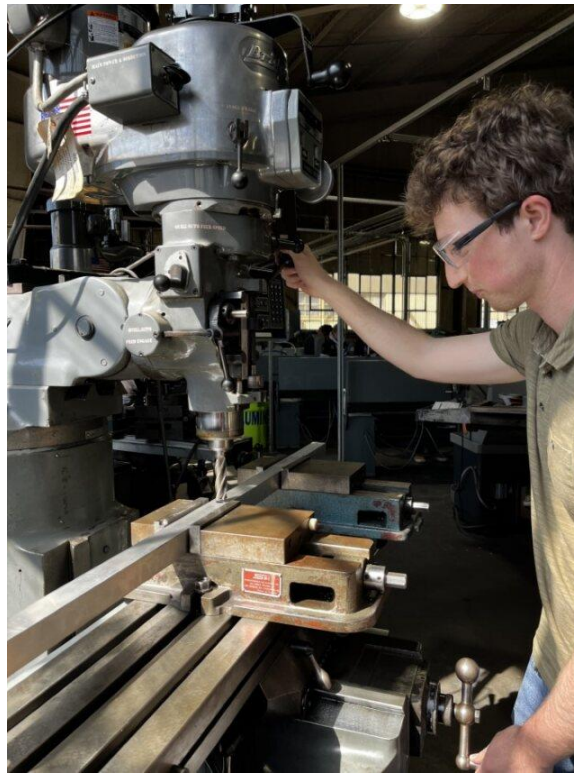
Figure 3: Manual Milling Slots into D-ring Links

The D-ring links were also made of 1.5” square aluminum tubing, but the links were cut to various increasing lengths with the largest link being 66” long and the shortest link being 48” long. Ventura steel cut the stock material for us before shipping it to us. Each D-ring link had holes drilled at each end and an 18” long slot which matches the stroke length of the pneumatic pistons. We used a manual mill to create the slots as shown below in **Figure 3**. As mentioned earlier, the slots allow the Christmas tree frame to horizontally expand while simultaneously vertically expanding.

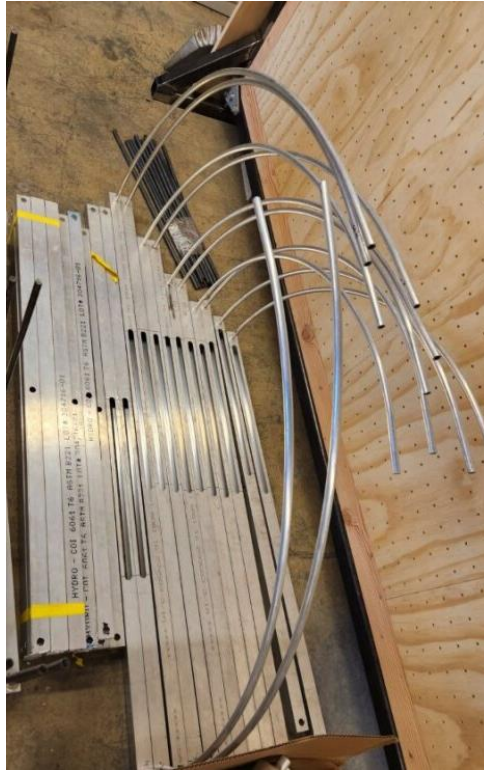
Figure 4: Completed Manufactured Scissor Lift and D-ring Links.

Once the D-ring links had been drilled and milled and all the tubing had been bent, we handed the material off to Kevin “Kevo” Williams, a welding instructor who works at Cal Poly. The final step of manufacturing the D-rings was to weld the round aluminum tubing to the D-ring links and we trusted Kevin with completing this task. The completed D-ring links and the scissor lift links are shown below in **Figure 4**.

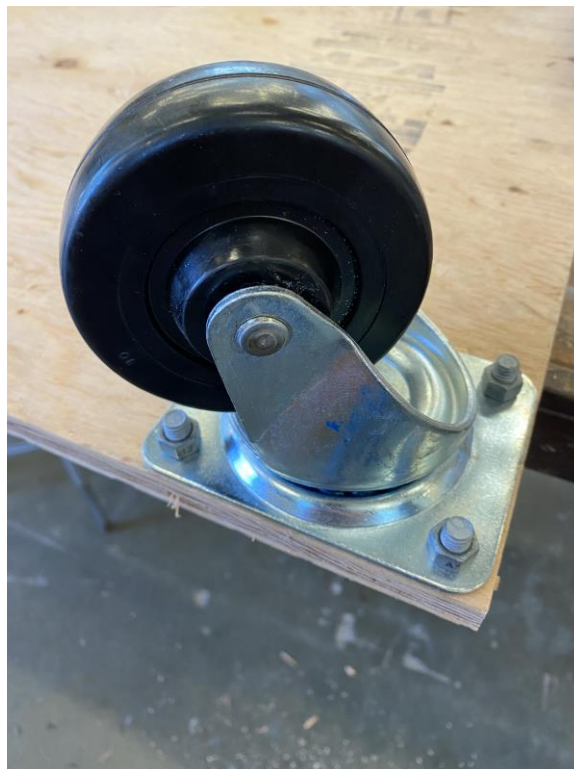
Figure 6. Swivel caster wheel bolted in the corner of the plywood base.

The plywood that makes up the base was first sized down at Home Depot and then cut down to the final dimensions of 36" x 52" using the table saw in **Figure 5** on the next page. Then four holes were drilled into each corner to bolt the caster wheels in **Figure 6** to the plywood.

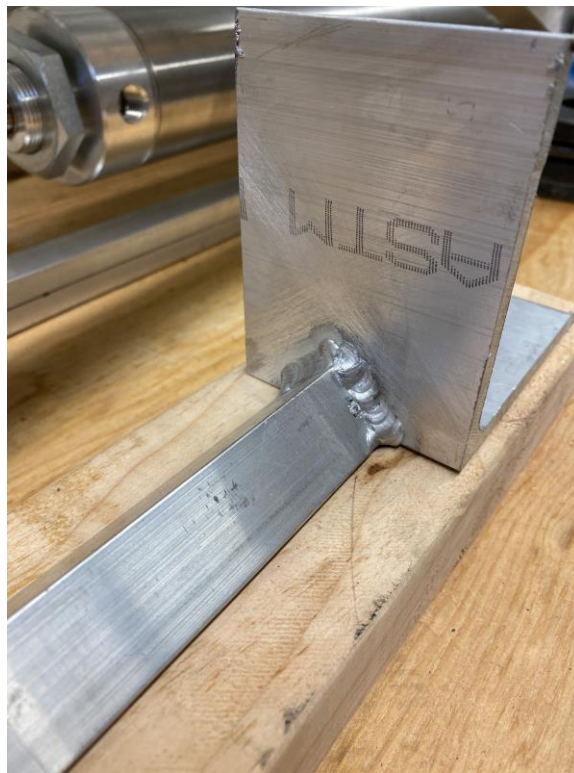
Figure 9. Close-up of V-groove track weld

The V-groove wheel track was manufactured from pieces of two different sizes of aluminum angle cut on the metal saw seen in **Figure 8** on the next page and welded together by Kevin Williams. The V-groove wheel track after welding is pictured in **Figure 9**.

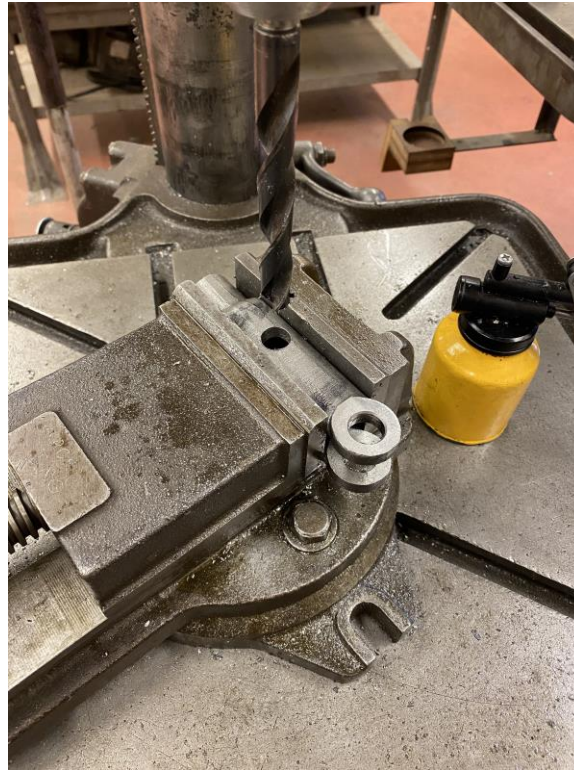
Figure 10. Modified piston clevis next to the drill press set up used.

Additionally, to connect the piston rod end to the steel rod in the scissor lift that would have the V-groove wheels attached to it, our team needed to modify the threaded piston clevis that we purchased from McMaster-Carr. To produce the exact piston stroke length required, we drilled a new hole in the clevis using a drill press, the result of which can be seen in **Figure 10**.

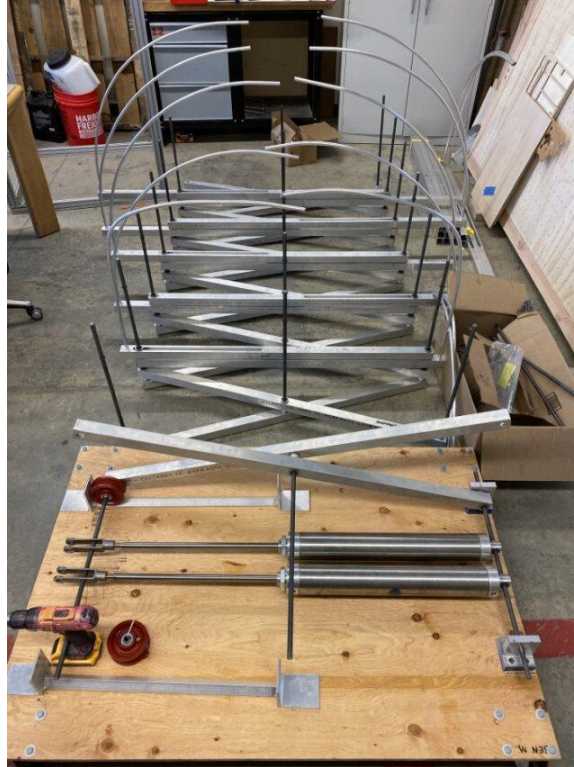
Figure 13: The scissor lift assembly and base assembly side by side.

We had a notation that we used when assembling the scissor lift to ensure we were placing all the links in the right order. We had “outside links” and “inside links” that needed to be attached to each other in an alternating pattern. We started by assembling the scissor lift on its side to make it easier for us to place the links on the rods. The “outside links” needed to be placed down on the ground before the “inside links” could be added on top of them. Once half of the scissor lift had been assembled, we then added the D-rings to their designated spots. **Figure 12** shows the bulk of the scissor lift assembly on its side. As seen, only half of the scissor lift was built first because we needed to attach the base to the scissor lift before we could assemble the second half of the scissor lift. **Figure 13** shows the scissor lift assembly and the base assembly side by side.

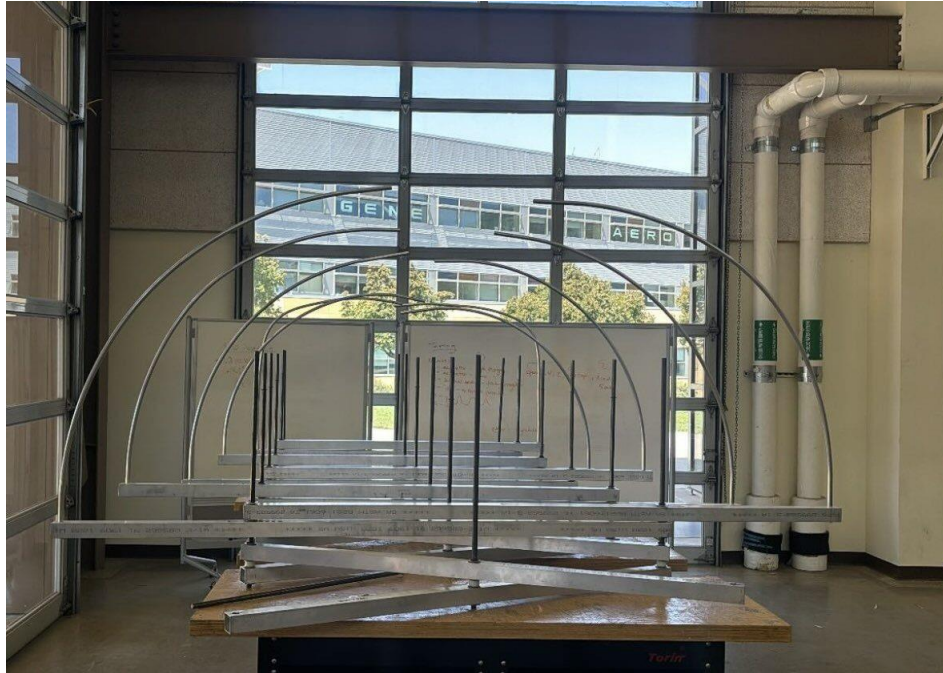
Figure 14. Scissor lift on high bay tabletops.

Once the base and one half of the scissor lift were complete, we could attach them together. To do so, we lifted the scissor lift onto tables as shown in **Figure 14**. This was done because the base platform is wider than the scissor lift. When the scissor lift is elevated however, two of our team members could lift and hold the base platform in place while the other two put on the retaining rings, washers, and spacers as seen in **Figure 15**.

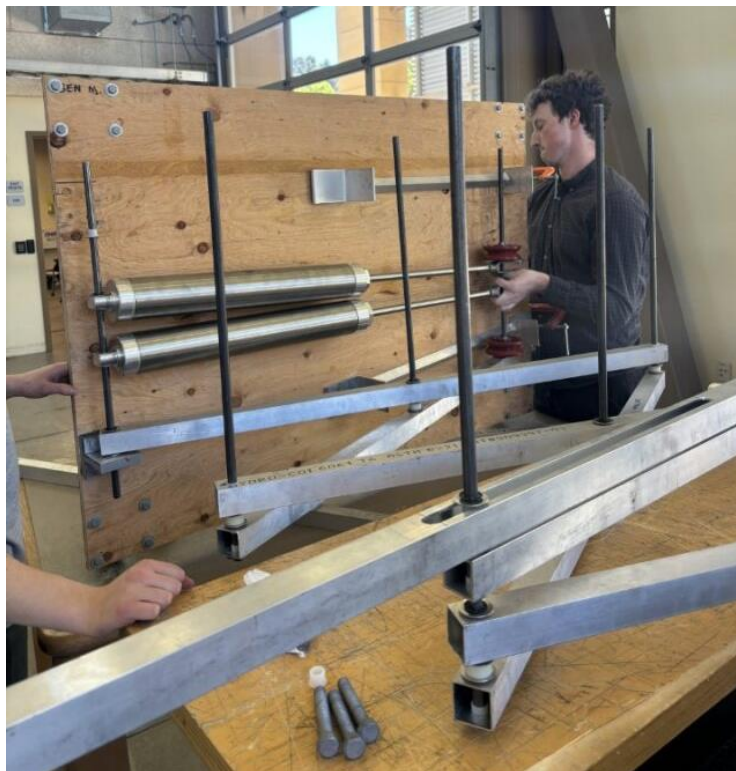
Figure 15. Attaching the scissor lift to the base platform assembly.

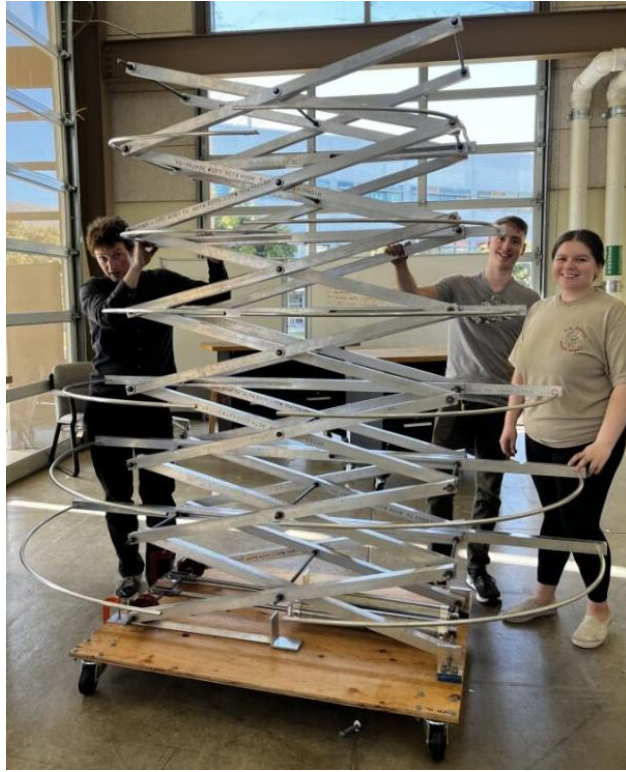
Figure 16. Completed Christmas tree frame assembly.

Once the scissor lift and base were attached to each other, we began assembling the second half of the scissor lift. Then once everything was completed, we were able to turn the Christmas tree off its side so that it stood up vertically. The completed Christmas tree assembly is shown in **Figure 16**.

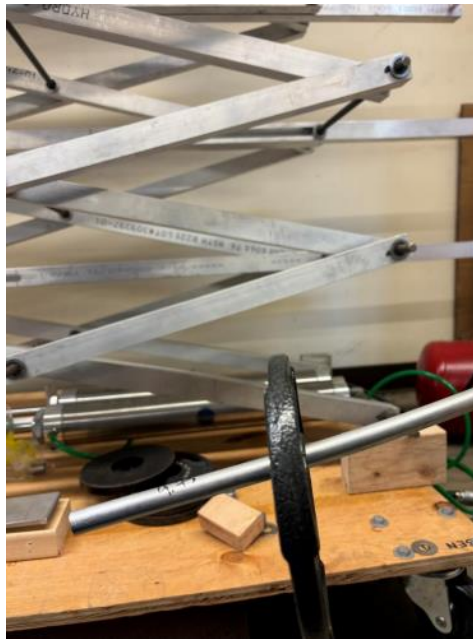
Figure 18. Applied 2.5 lb weight to edge of D-ring.

The D-ring deflection test was originally outlined as 5% of the maximum lift height, however this became difficult to account for, so we determined the revised specification to be no more than 2 inches of deflection. For this test a 2.5 lbs. point load was applied to the D-rings which resulted in an average of 4 inches of deflection per D-ring which failed the test. The test set up is pictured in **Figure 18**. The data for each D-ring and its uncertainty can be found in **Table 2**, while further information on the formulas used can be found in **Appendix E**.

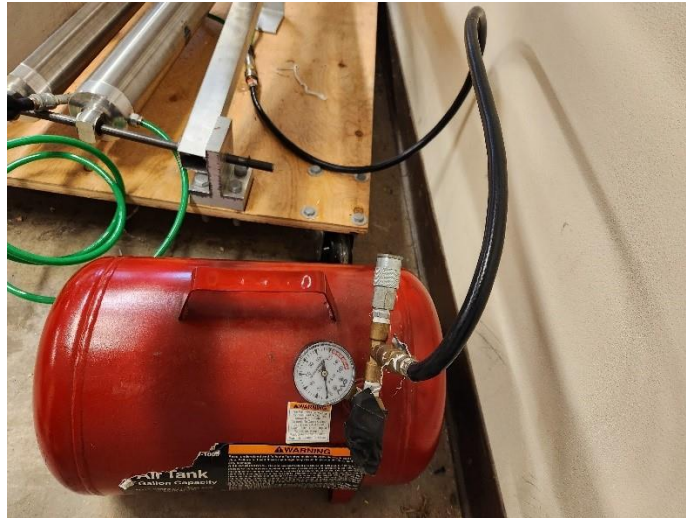
Figure 1A: 5-gallon air tank with dial pressure indicator.

1. Fill the 5-gallon air tank to a minimum of 100 psi. When filling, read the dial pressure indicator in **Figure 1A** to ensure the pressure is correct and does not exceed 120 psi.

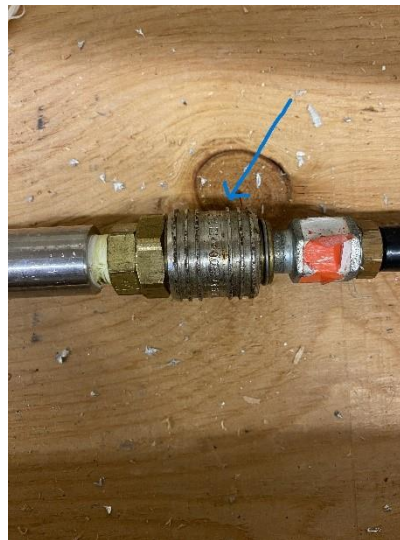
Figure 2A: Pneumatic quick connector.

2. Connect the air tank to the tree pneumatic system using the quick connector in **Figure 2A**.

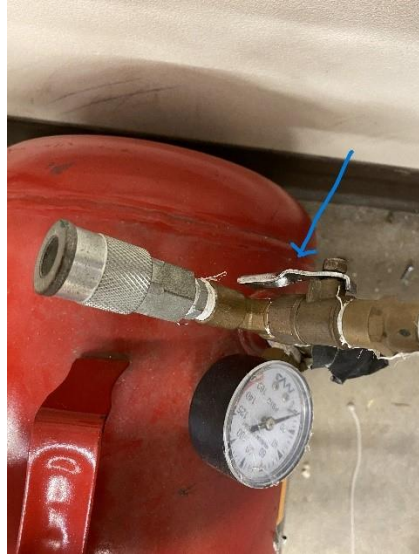
Figure 3A: Silver valve handle used to control the airflow into pistons.

3. Rotate the silver valve handle in **Figure 3A** perpendicular to the pipe to release the airflow into the two pistons. This will cause the Christmas tree to expand. The speed of the expansion can be slowed by rotating the silver valve handle to less than 90 degrees.

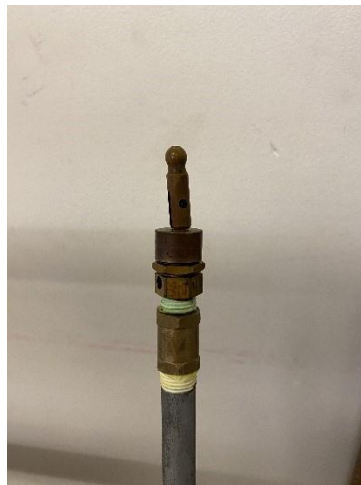
Figure 4A: Fully open position of the pressure relief valve.

4. When the Christmas tree needs to be collapsed, turn the pressure relief valve on the exit side of pistons in **Figure 4A** to release the air. Note: this must be done in a slow controlled manner otherwise the Christmas tree will collapse rapidly and unsafely. Ensure the dial indicator on the air tank reads zero so that all the pressure has left the system.
