A RISK ANALYSIS MODEL FOR THE MAINTENANCE AND REHABILITATION
OF PIPES IN A WATER DISTRIBUTION SYSTEM:
A STATISTICAL APPROACH

A Thesis
presented to
the faculty of California Polytechnic State University,
San Luis Obispo

In Partial Fulfillment
of the Requirements for the Degree
Master of Science in Civil Engineering

June 2015

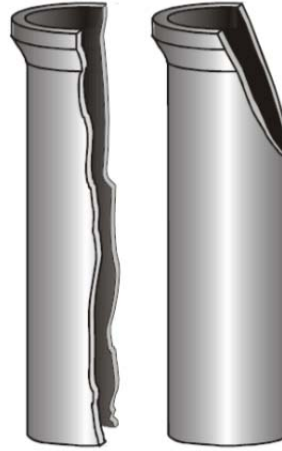
Figure 2.4 Failure modes for Large (>500 mm) diameter pipes (Makar, 2001)

Figure 2.4 provides visuals of typical failure methods for large diameter pipes (>500 mm). Large diameter pipes generally experience longitudinal cracking (left) or bell shearing (right). Longitudinal cracking is a form of failure that seems to affect large diameter pipes exclusively. This failure mode is due to high internal water pressures or compressive/crushing forces acting along the pipe (building loading or vehicular loading). Once the crack has initiated,

it may propagate along the entire length of the pipe. Bell shearing can be a result of bending forces along the bell or spigot of a pipe would cause the shearing at the bell.
