Effect of Chromium-Gold and Titanium- Titanium Nitride-Platinum-Gold Metallization on Wire/Ribbon Bondability

¹Jianbiao Pan, ²Robert M. Pafchek, ²Frank F. Judd, ²Jason Baxter

¹California Polytechnic State University

²Agere Systems, Allentown, PA

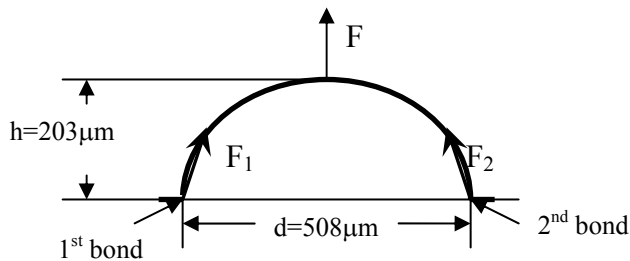
**Figure 1.** Ribbon bonds pull test geometry

Bond pull strength testing was accomplished in accordance with MIL-STD-883E, method 2011.7. Per MIL-STD-883E, the minimum bond pull strength for the 25.4 μm x 254 μm (1 x 10 mil) gold ribbon bonds is 20 grams. Note that pull strength is loop dependent. In this study, measured loop height was 203 μm (8 mil) and measured loop length was 508 μm (20 mil) with the loop profile parameters listed in Table 2. The two bonds were at the same level on wafer surface and the pull hook was at the center of the loop as shown in Figure 1. The tensile strength in the 1st bond and the 2nd bond can be calculated according the following equation [3].

$$F_1 = F_2 = \frac{F}{2} \sqrt{1 + \left(\frac{d}{2h}\right)^2}$$

The loop profile in this study results in both the break strength at the 1st bond and at the 2nd bond were the same and about 0.8 times of the pull strength at the hook.

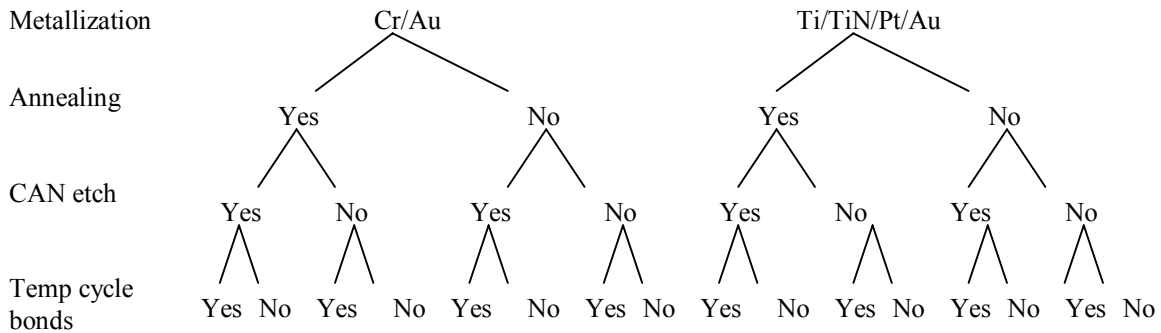
Figure 2. Experiment 2 design

The second experiment was split into 16 cells as illustrated in Figure 2. The two metallizations each had one annealed and one no-annealed sample with each of these being with or without CAN etch. After ribbon bonding, half of the bonds were pulled right away and half were pulled after temperature cycling of 0 ~ 85 °C for 4 cycles.

The CAN etch was 1 minute. The solution for CAN etch consists of 65-75% water, 20-30% ceric ammonium nitride, and 1-5% acetic acid. All of the samples received the 10 minutes UV ozone cleaning after the CAN etch.

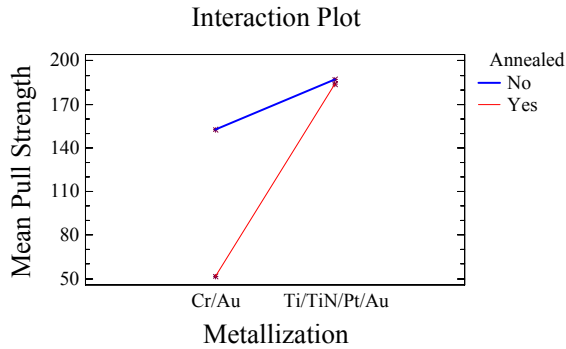
Figure 3. Interaction plot of annealing and metallization.

The data were analyzed using Analysis of Variance (ANOVA). The ANOVA Table for the average pull strength is shown in Table 5. It shows that metallization and annealing have statistically significant effects on the mean pull strength and strong interaction exists between metallization and annealing. The interaction plot of metallization and annealing

in Figure 3 shows that annealing has significant effect on Cr/Au metallization, but not for Ti/TiN/Pt/Au metallization. The bondability of Cr/Au degraded dramatically after the wafers were annealed.

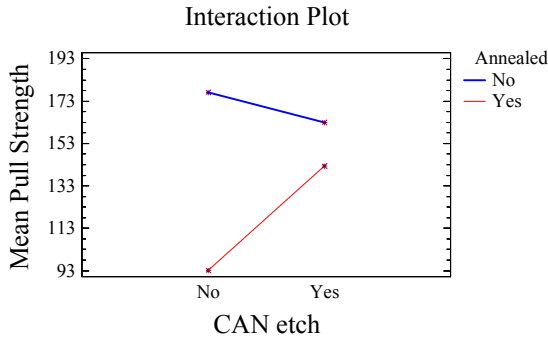
Figure 4. Interaction plot of annealing and CAN etch

The ANOVA analysis in Table 5 also shows that CAN etch and temperature cycles do not have statistically significant effect on mean pull strength. There is interaction between annealing and CAN etch at 90% confidence level. The interaction plot of annealed and CAN etch is shown in

Figure 4. Table 4 shows that CAN etch improved the ribbon bond pull strength on annealed Cr/Au metallization. However, the failure mode is 80% foot-lift and 20% non-stick, which is not acceptable for good wire/ribbon bondability. The investigation of the experimental phenomena is described in the next section. ANOVA analysis shows that temperature cycling does not significantly degrade Au-Au ribbon bonds.

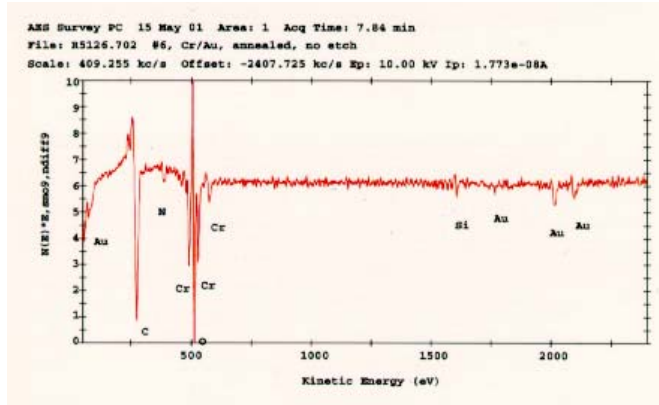
Figure 5. AES surface surveys for annealed, no CAN etch, Cr/Au wafer

To further investigate what caused the bondability difference between two metallizations, Auger Electron Spectroscopy (AES) was used to analyze all wafer surfaces. The AES surface analysis results are summarized in Table 6. Chromium was detected on annealed Cr/Au metallization, and the chromium-gold ratio decreased from 3.7 to 0.3 after CAN

etch for 1 minute. Panousis and Bonham [1] reported that no chromium was detected after CAN etch for 10 minutes. It implies that the CAN etch time in this experiment was not long enough and increasing etch time may remove all chromium and chromium oxide on the gold surface. It was expected that the amount of chromium diffusing on the gold surface would increase with higher annealing temperature, longer annealing time, and thinner gold thickness. Therefore, a proper CAN etch time should be determined according to the annealing process (annealing temperature and annealing time) and the gold thickness. The AES surface survey for annealed, no CAN etch, Cr/Au wafer is illustrated in Figure 5 and that for annealed, CAN etched, Cr/Au wafer is illustrated in Figure 6.

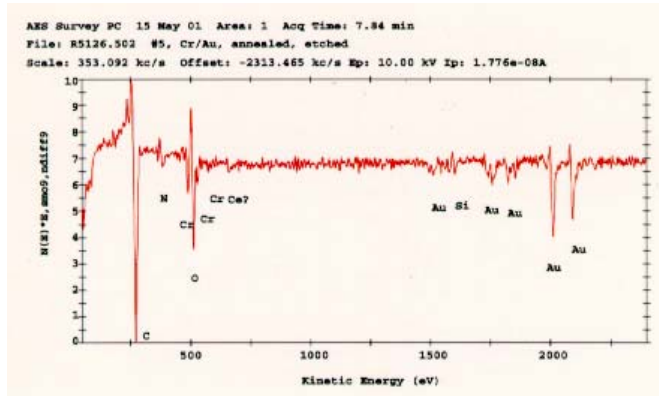
Figure 6. AES surface surveys for annealed, CAN etched, Cr/Au wafer

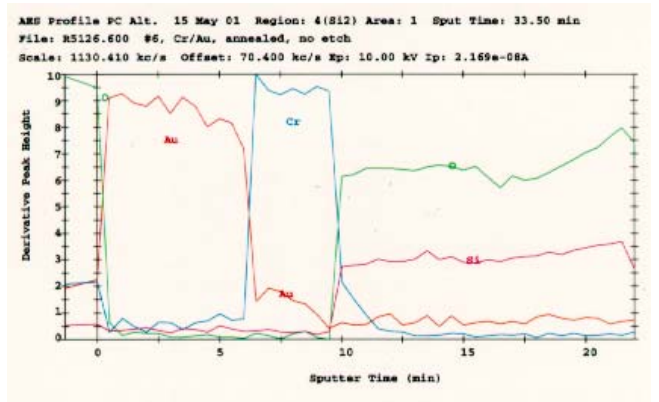
Figure 7. AES profile for annealed, no CAN etch, Cr/Au

To determine why Au peeled off from annealed Cr/Au wafers during dicing, AES was used to do ion sputtered depth profiles, which is an analytical technique capable of identifying elemental concentration profiles. Ion sputtered depth profile of annealed, no CAN etch, Cr/Au wafer is shown in Figure 7 and that of annealed, CAN etched, Cr/Au wafer is shown in Figure 8. Au was found in Cr layer of annealed Cr/Au metallization. For comparison, ion sputtered depth profiles of no anneal, no CAN etch, Cr/Au and that of annealed, no CAN etch, Ti/TiN/Pt/Au are shown in Figure 9 and 10. Figure 9 shows that no Au was in Cr layer. Chromium's function is to promote adhesion between substrates and sputtered gold films. That Au diffused to Cr layer may be the reason that Au peeled off during dicing.

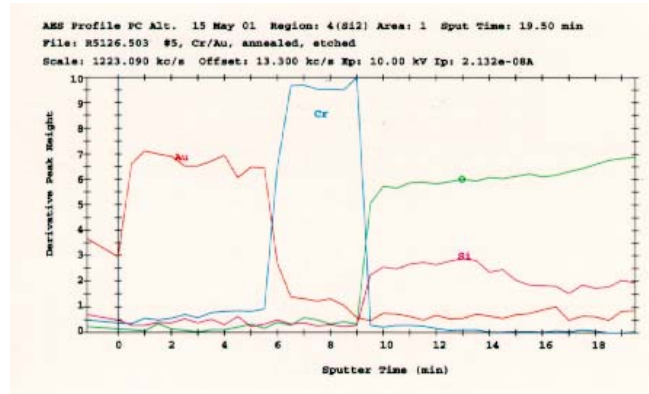
Figure 8. AES profile for annealed, CAN etched, Cr/Au

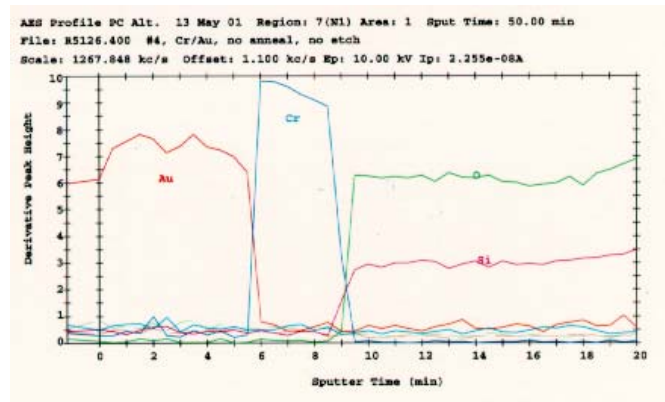
Figure 9. AES profile for no annealed, no CAN etch, Cr/Au

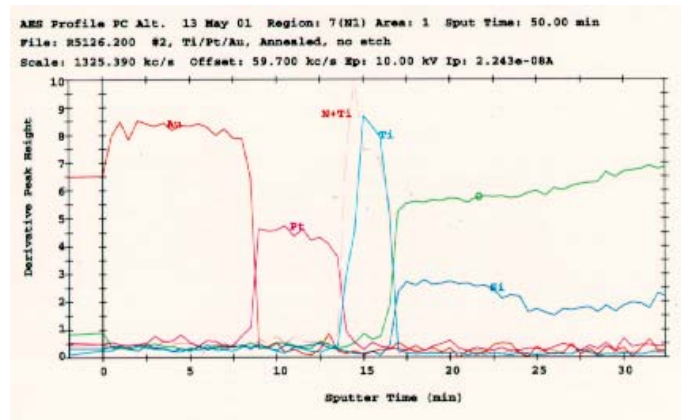
Figure 10. AES profile for annealed, no CAN etch, Ti/TiN/Pt/Au
