Case Study on Student Competence in Construction Surveying and Layout

Dejah Hilliard

California Polytechnic State University
San Luis Obispo, California

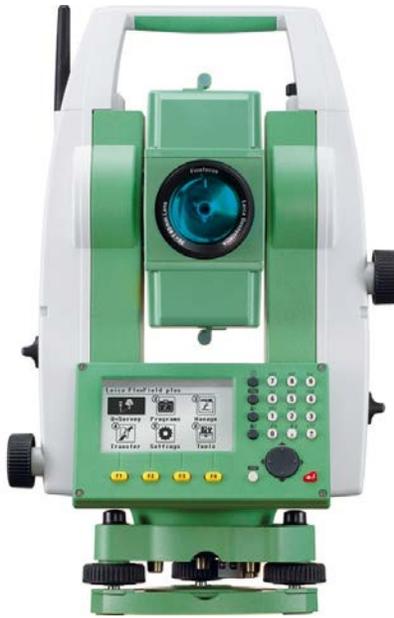
Leica Total Station

A total station or TST (total station theodolite) is an optical instrument used for surveying and building construction. The total station is an electronic theodolite integrated with an electronic distance measurement to read slope distances from the instrument to a particular point, and an on-board computer to collect data and perform advanced coordinate based calculations. For the purpose of this project in particular, the total station would set up on an existing benchmark and use another benchmark as the back sight to locate new points at 90°. Another employee on the field team would be set up along that new line at 90° with a walkie-talkie and the prism while the person looking through the total station could guide them to a spot at the correct distance away from the original point. This process would continue until all gridlines were laid out and each of the 70 column centers was located.

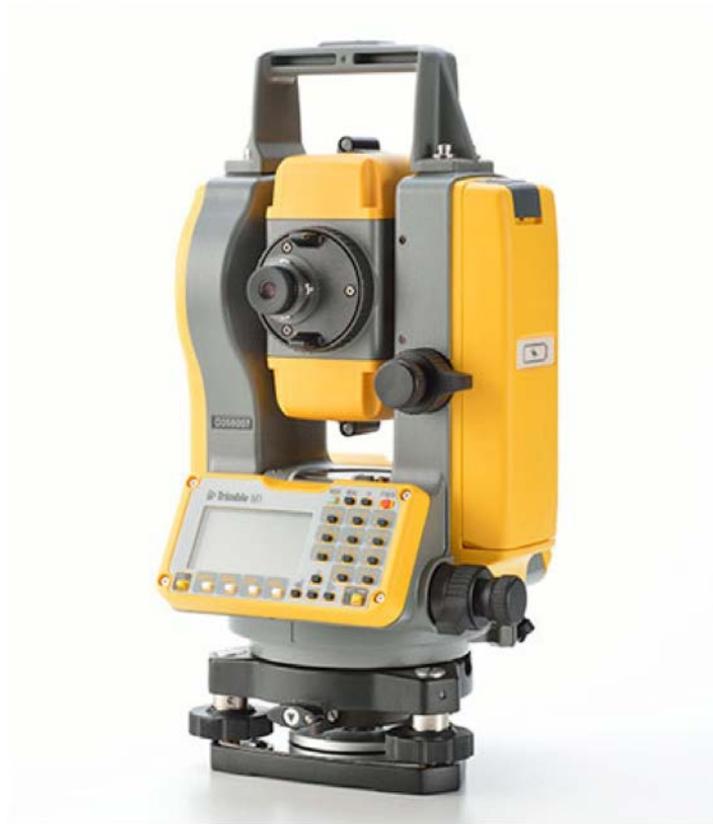
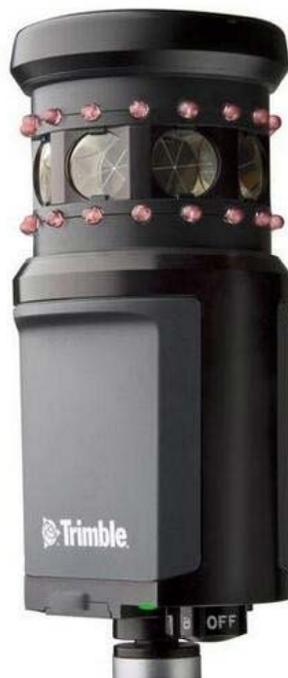
Trimble Optical Plummet and Target Prism

In response to the issues that arose, we set up the Trimble to check and redo the points created with the total stations. The Trimble Optical Plummet has the ability to locate specific points on a line on the jobsite utilizing geographic points uploaded onto the Trimble mobile computer. The points uploaded correlate exactly with the actual site and gridline endpoints are clearly defined in the system. The Trimble allows you to create points in the mobile computer based on the location of the Trimble Target Prism. This advanced equipment corrected all errors previously made in a very short amount of time and saved us the headache of setting up and taking down one total station several times over.

“The site is very tight not allowing us to get our long back sights, as we should have. We should've realized that earlier in the process and did away with the total stations and stuck to the Trimble (Robotic Total Station). Luckily we knew our MEP subs were going to utilize them on the decks for the tower so we had primary control setup for them already; it was an easy transition to a Trimble.”
